Prosecution Team Evidence List Exhibits for:

Rocklin Crossings

SD DEACON
GENERAL CONTRACTOR

Pursuant to the request of the Regional Water Quality Control Board for the Central Valley Region's staff at the meeting held on December 12, 2012, we provide the following summary of the best management practices (BMPs) and other stormwater control efforts taken before and after the unexpected stormwater discharge experienced during the large November 28, 2012 through December 2, 2012 storm event. This summary focuses on work performed and erosion control measures put in place leading up to the storm event and SD Deacon's reaction and corrective actions taken to the brief period of discharge that occurred on November 30, 2012.

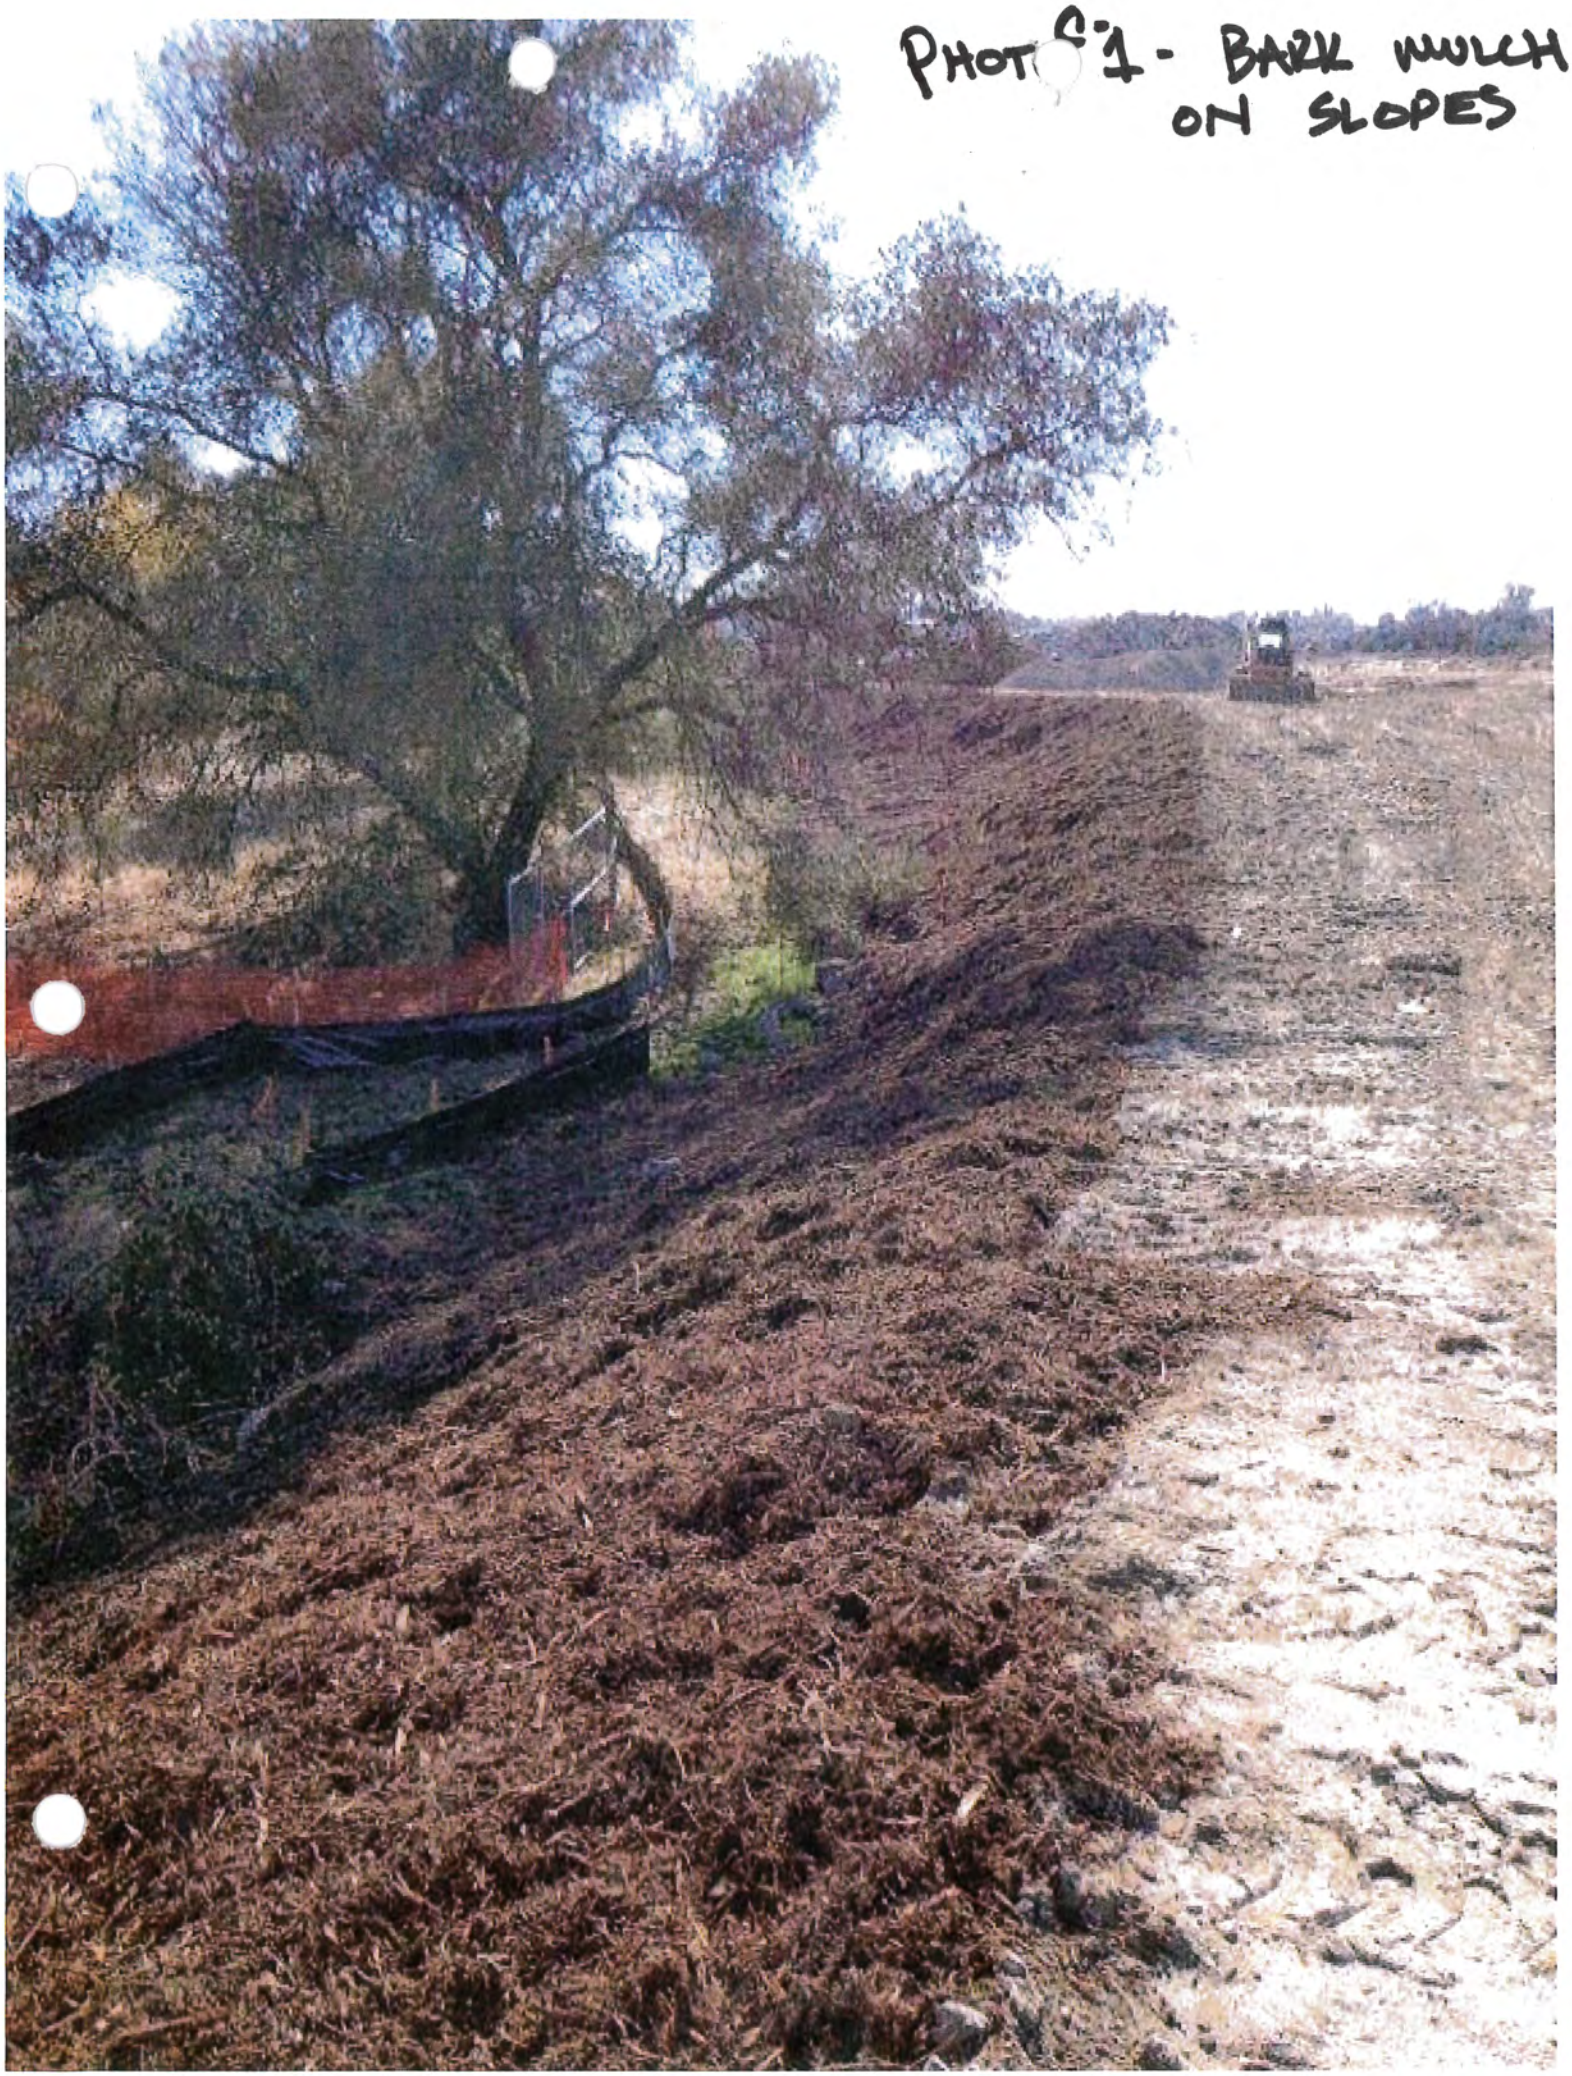
PHOTO 1 - BARK MULCH ON SLOPES

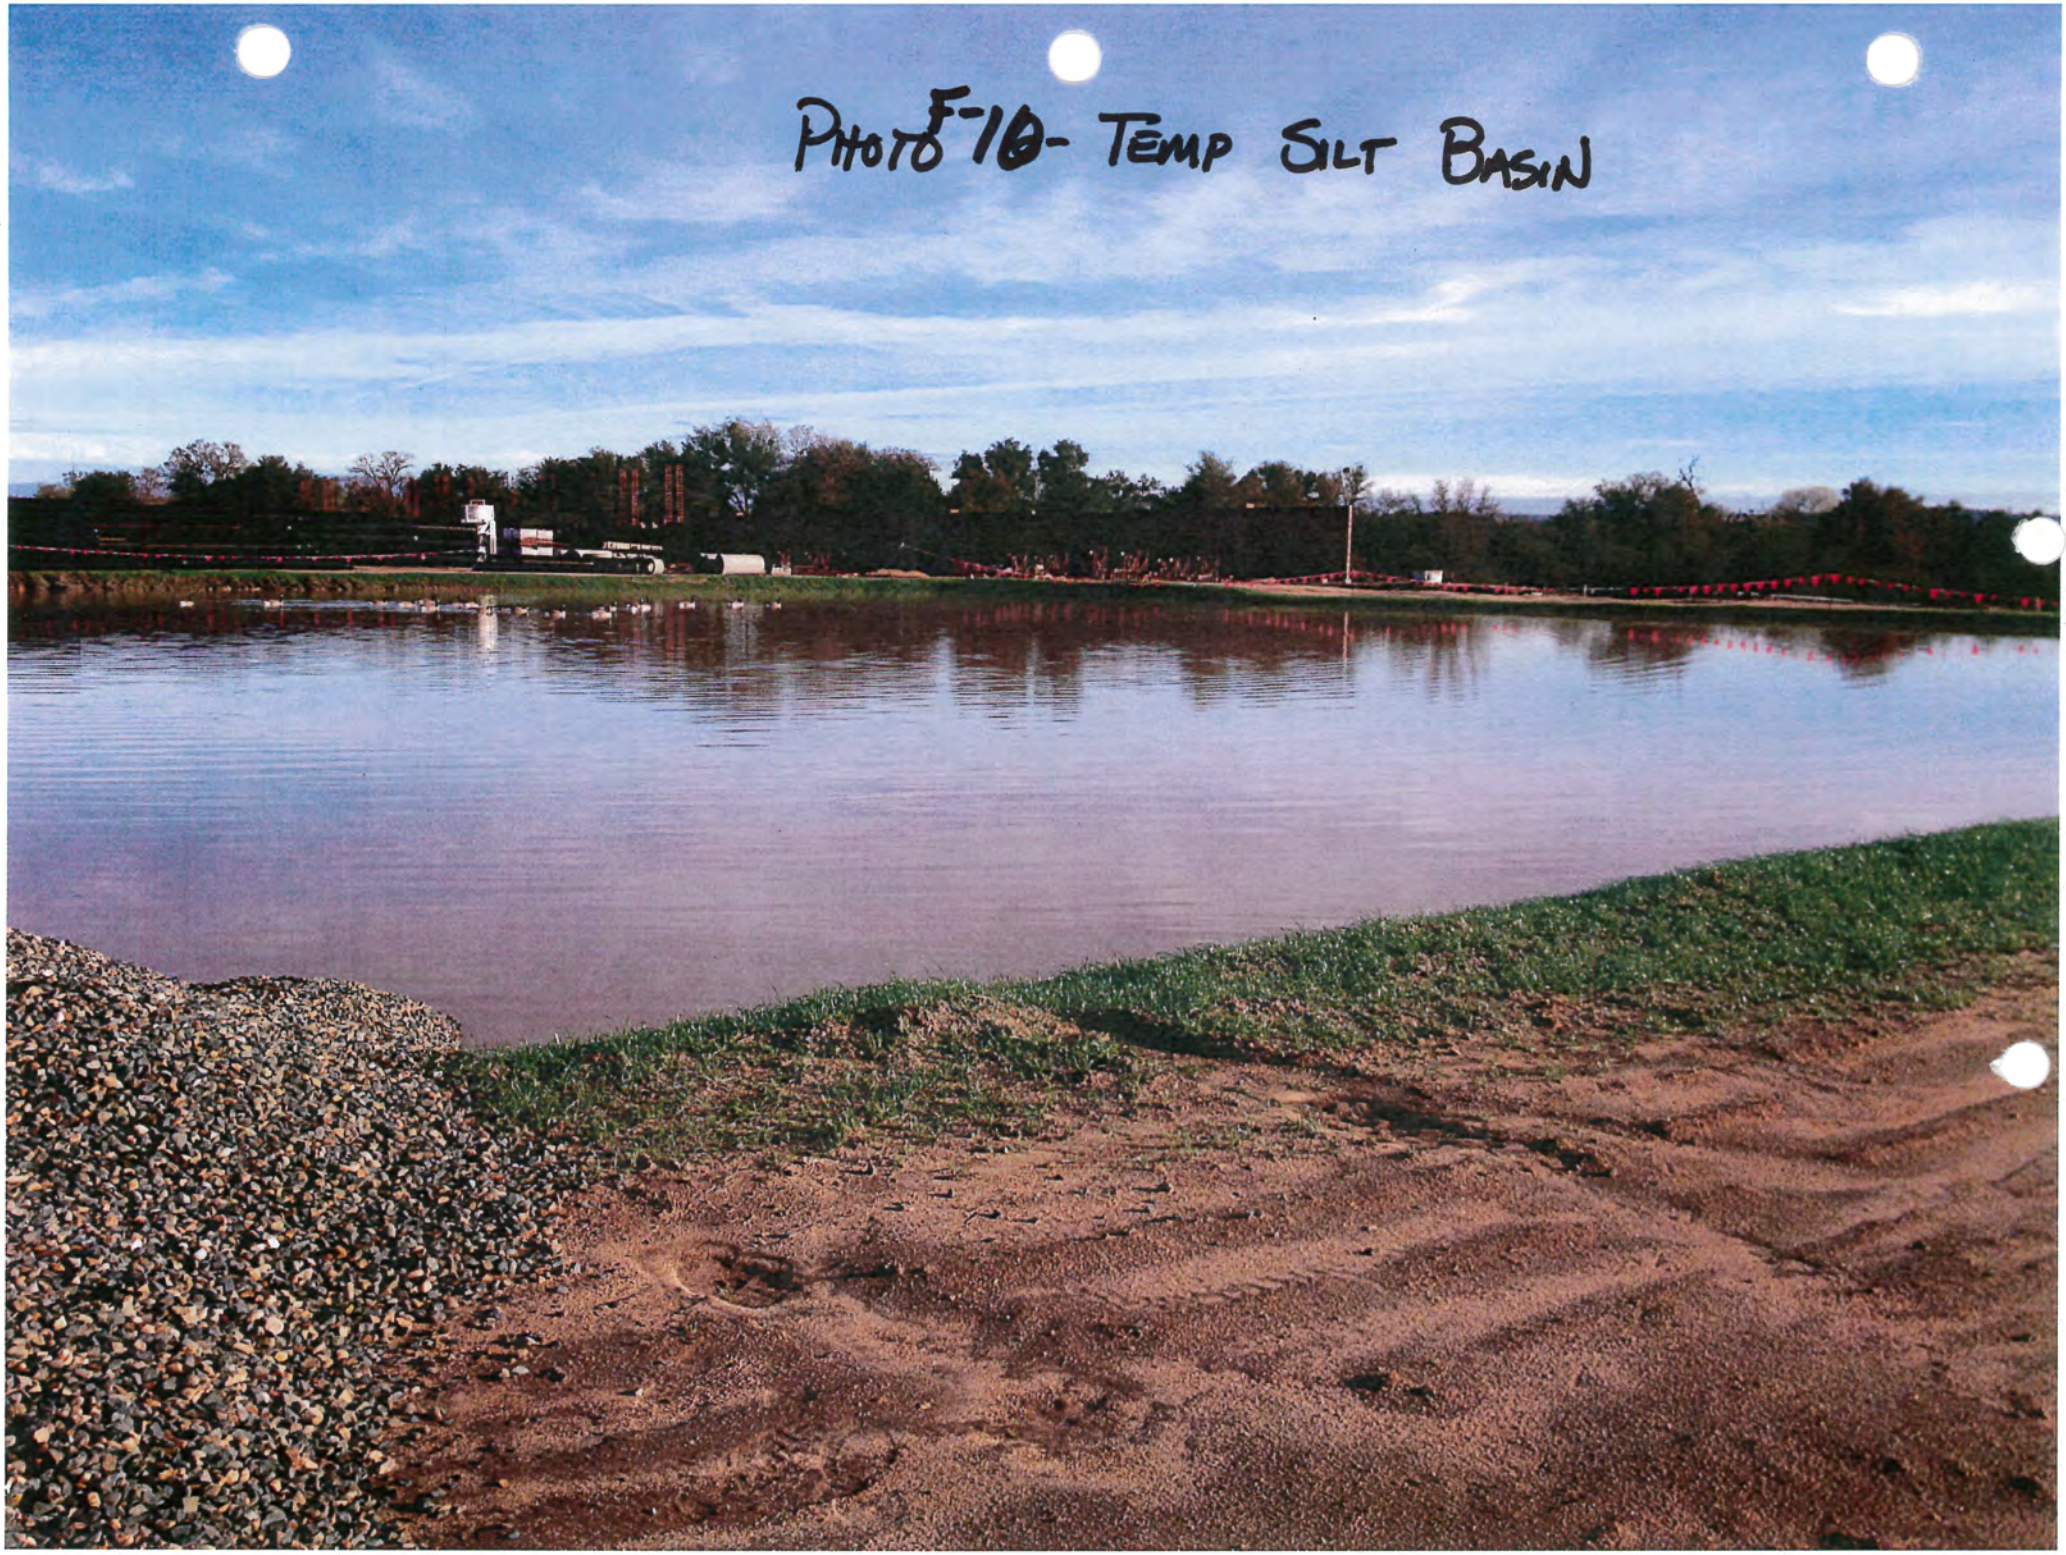
PHOTO F-9 - RETAINED WATER IN - DETENTION BASIN

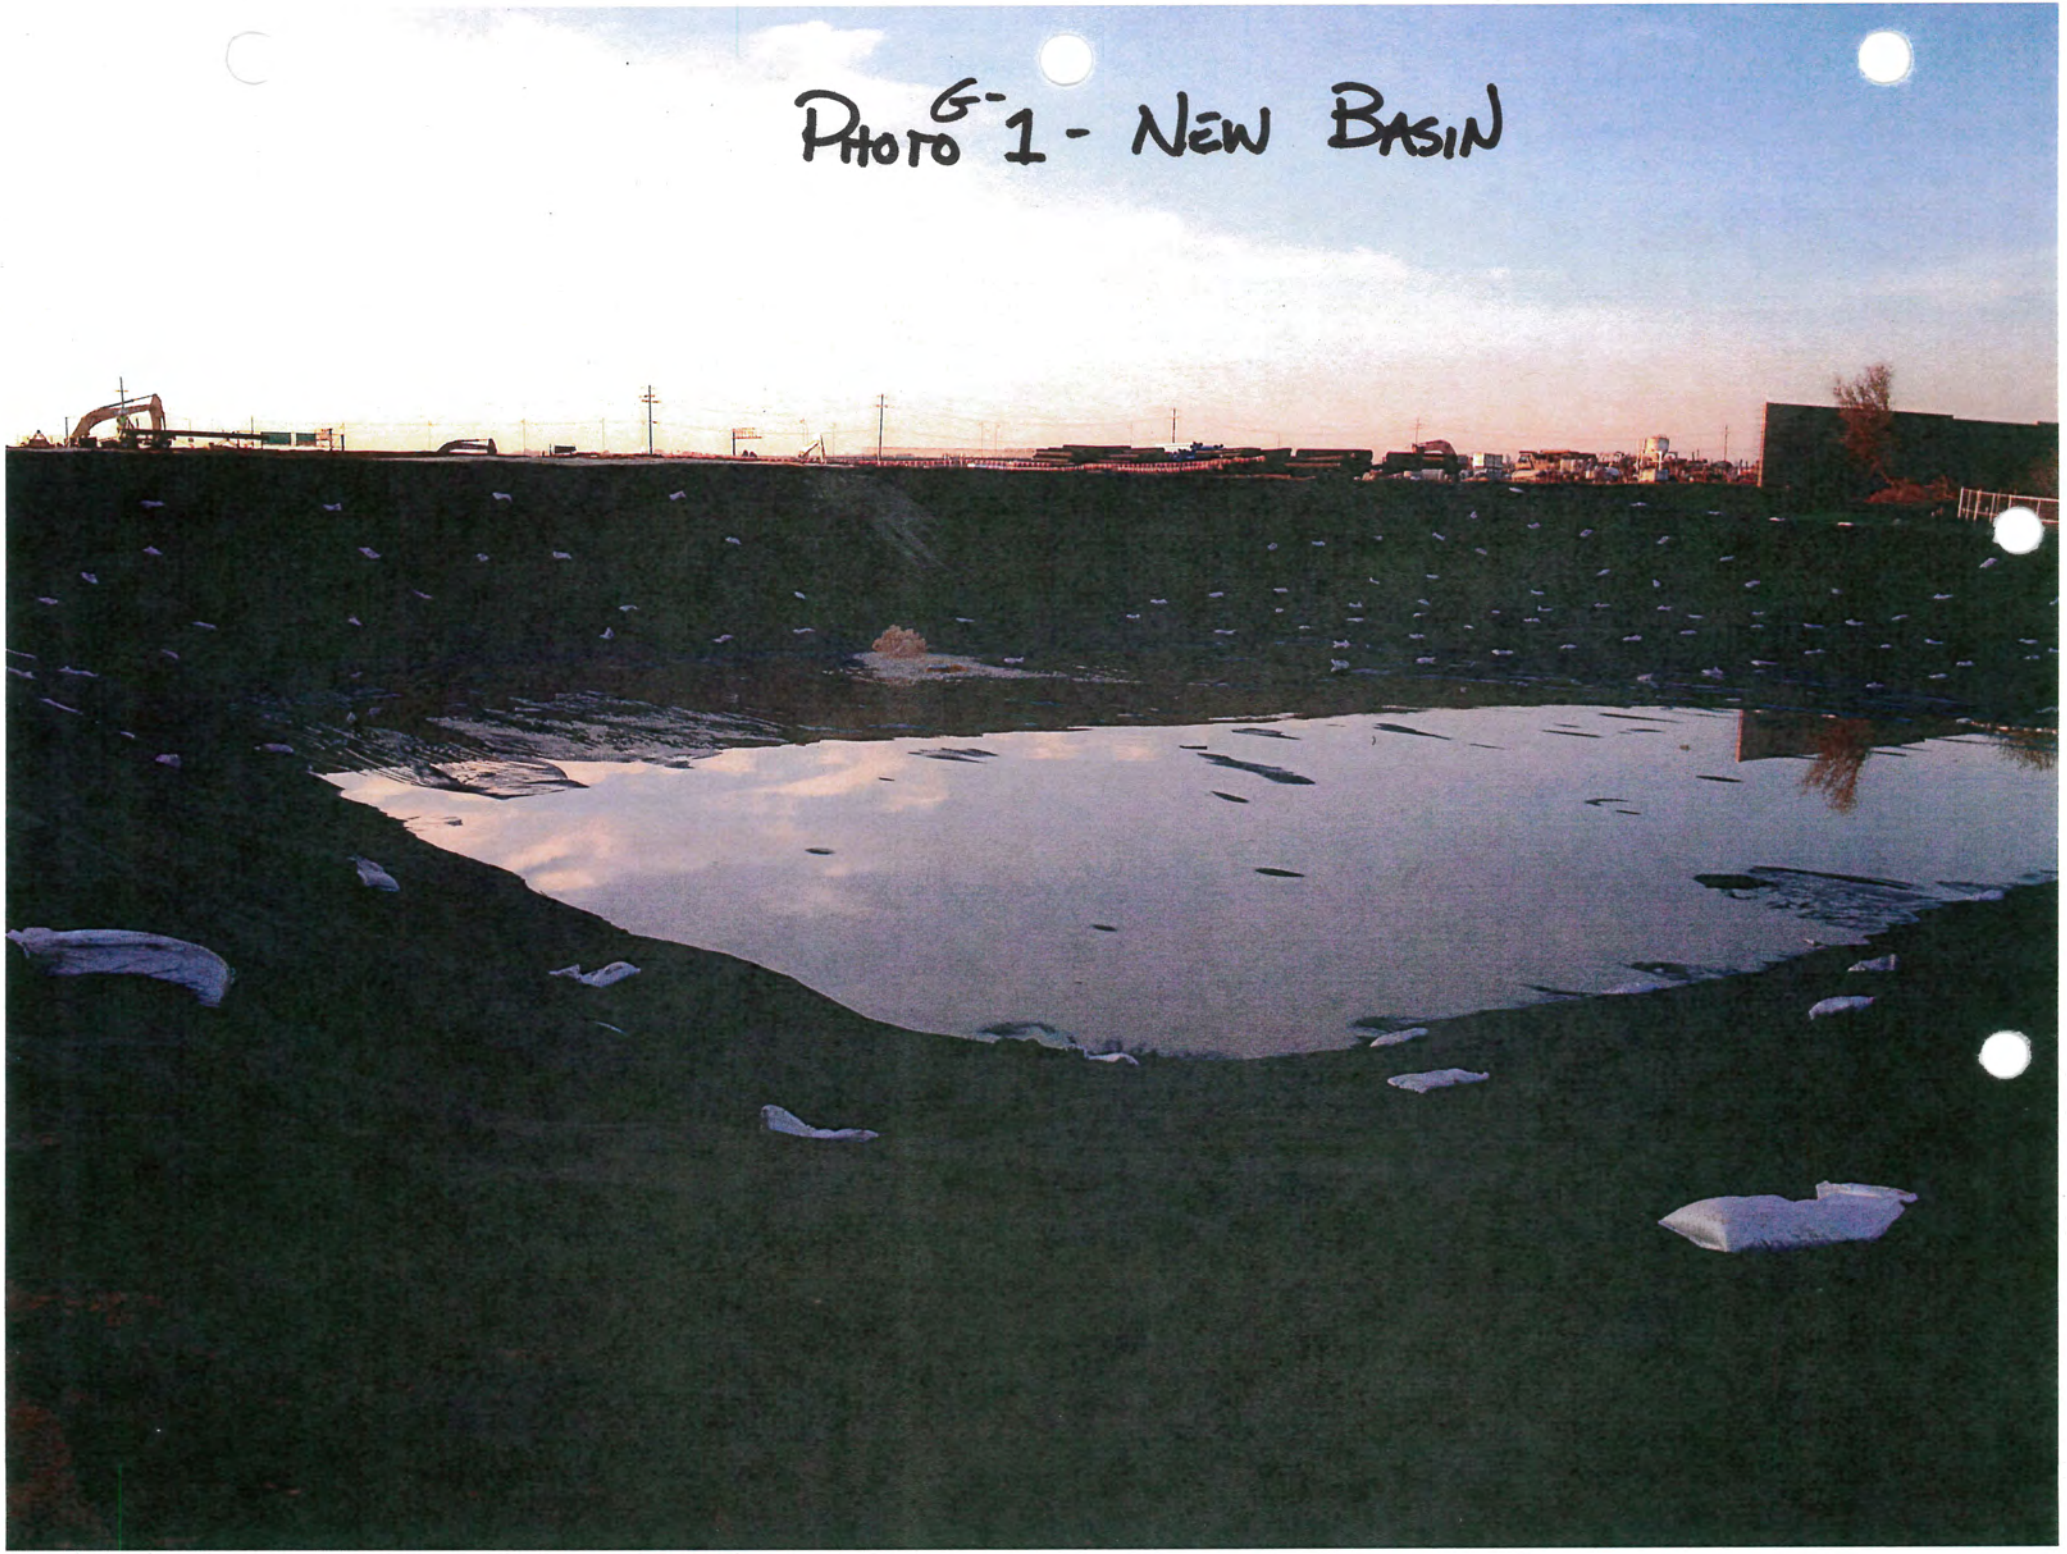
PHOTO G-1 - NEW BASIN

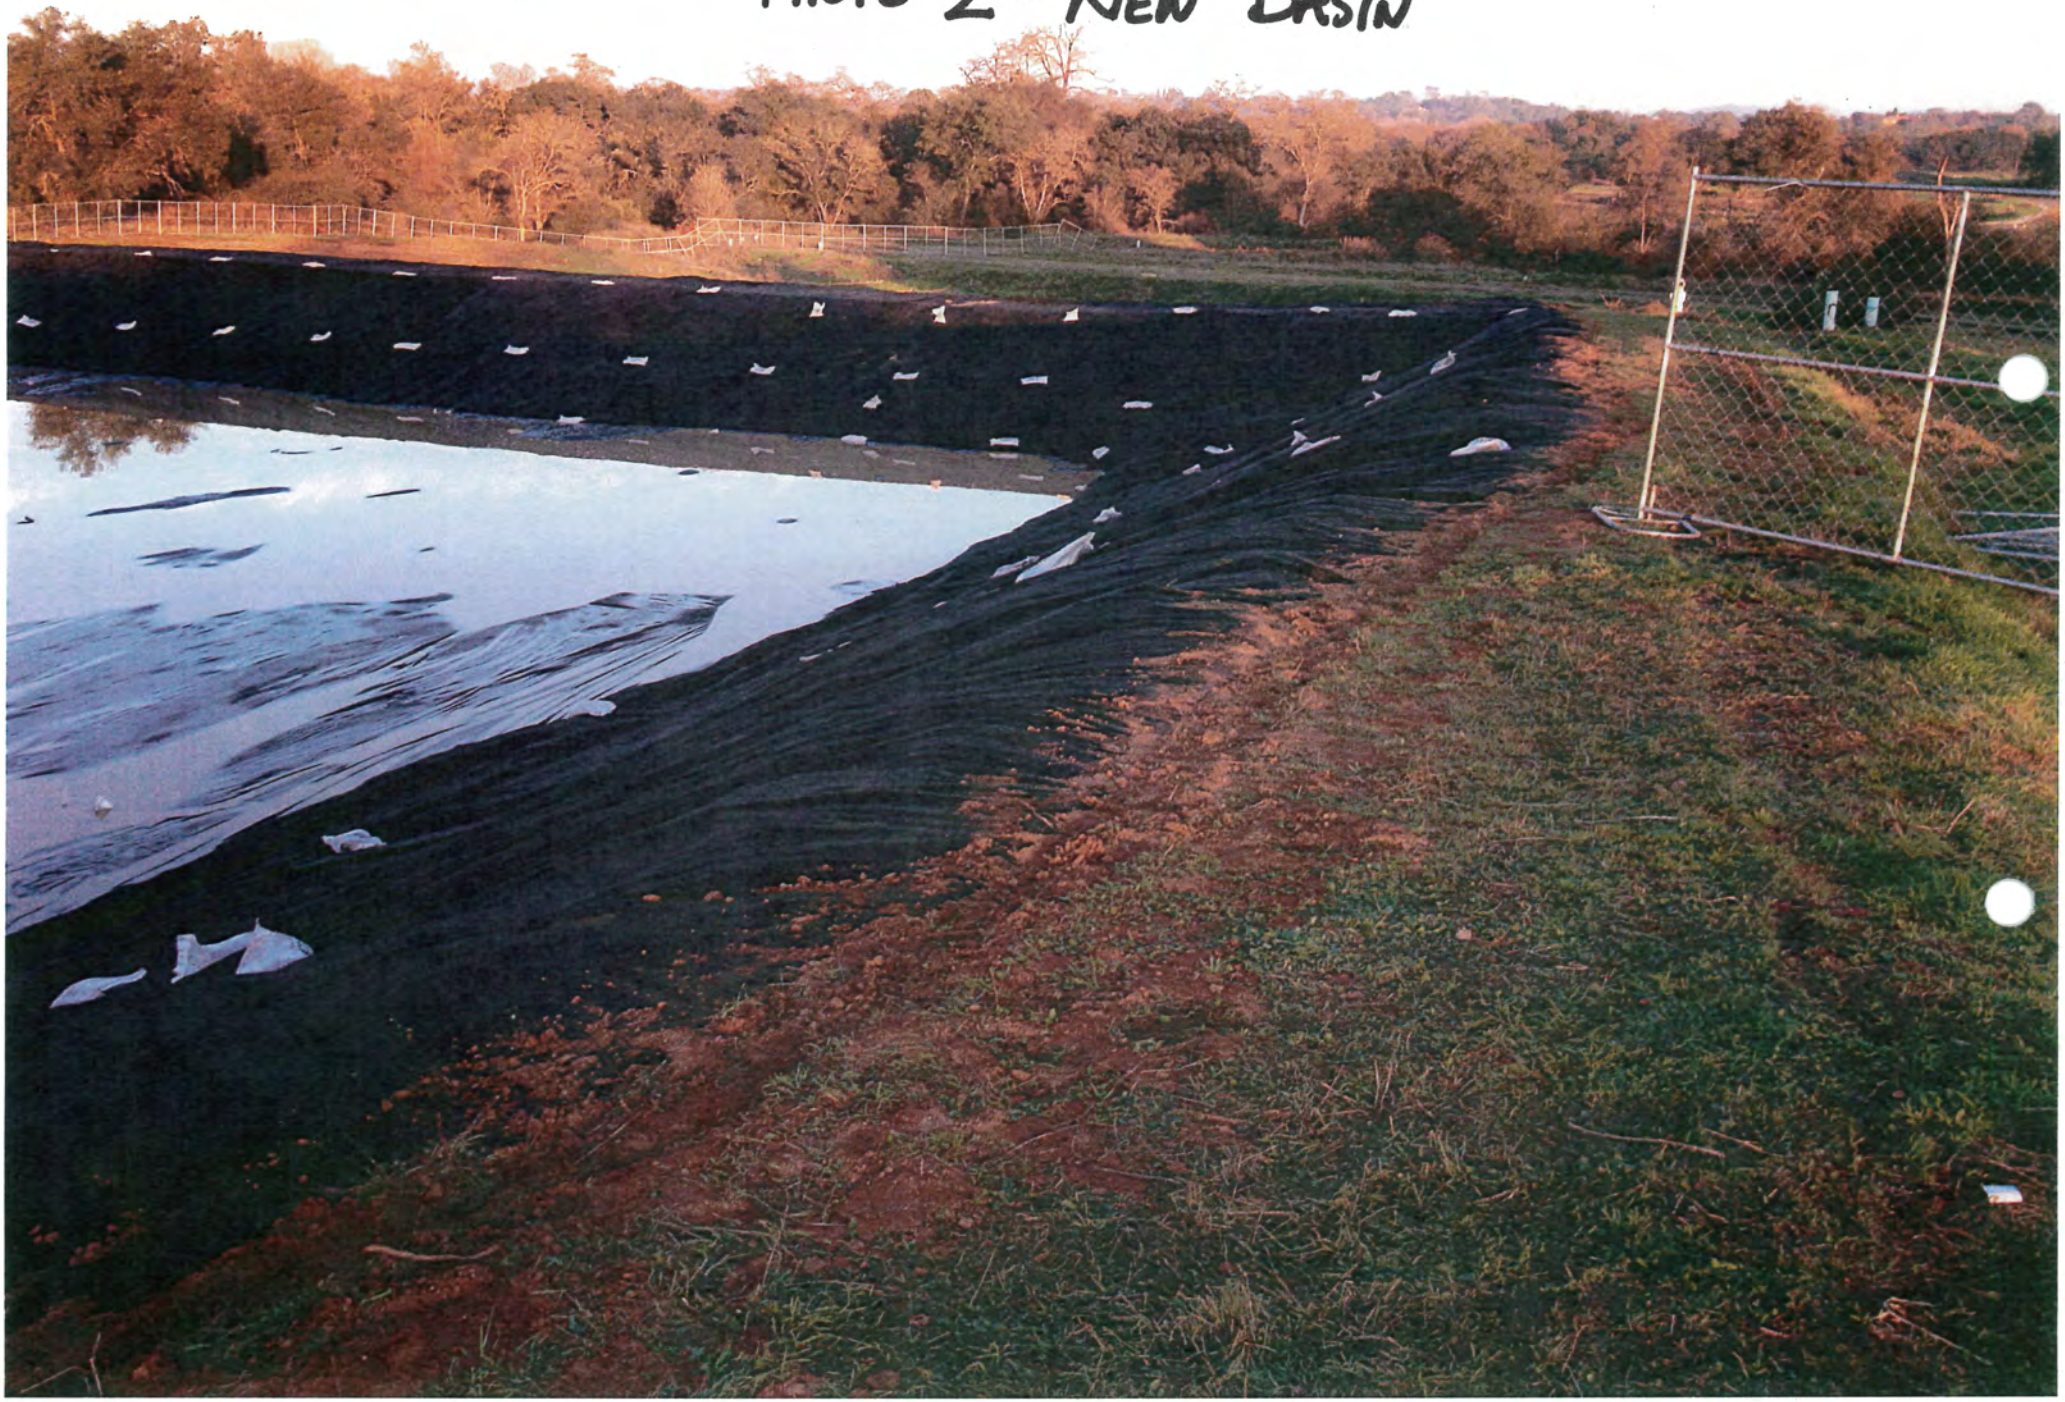
G-
PHOTO 2 - NEW BASIN

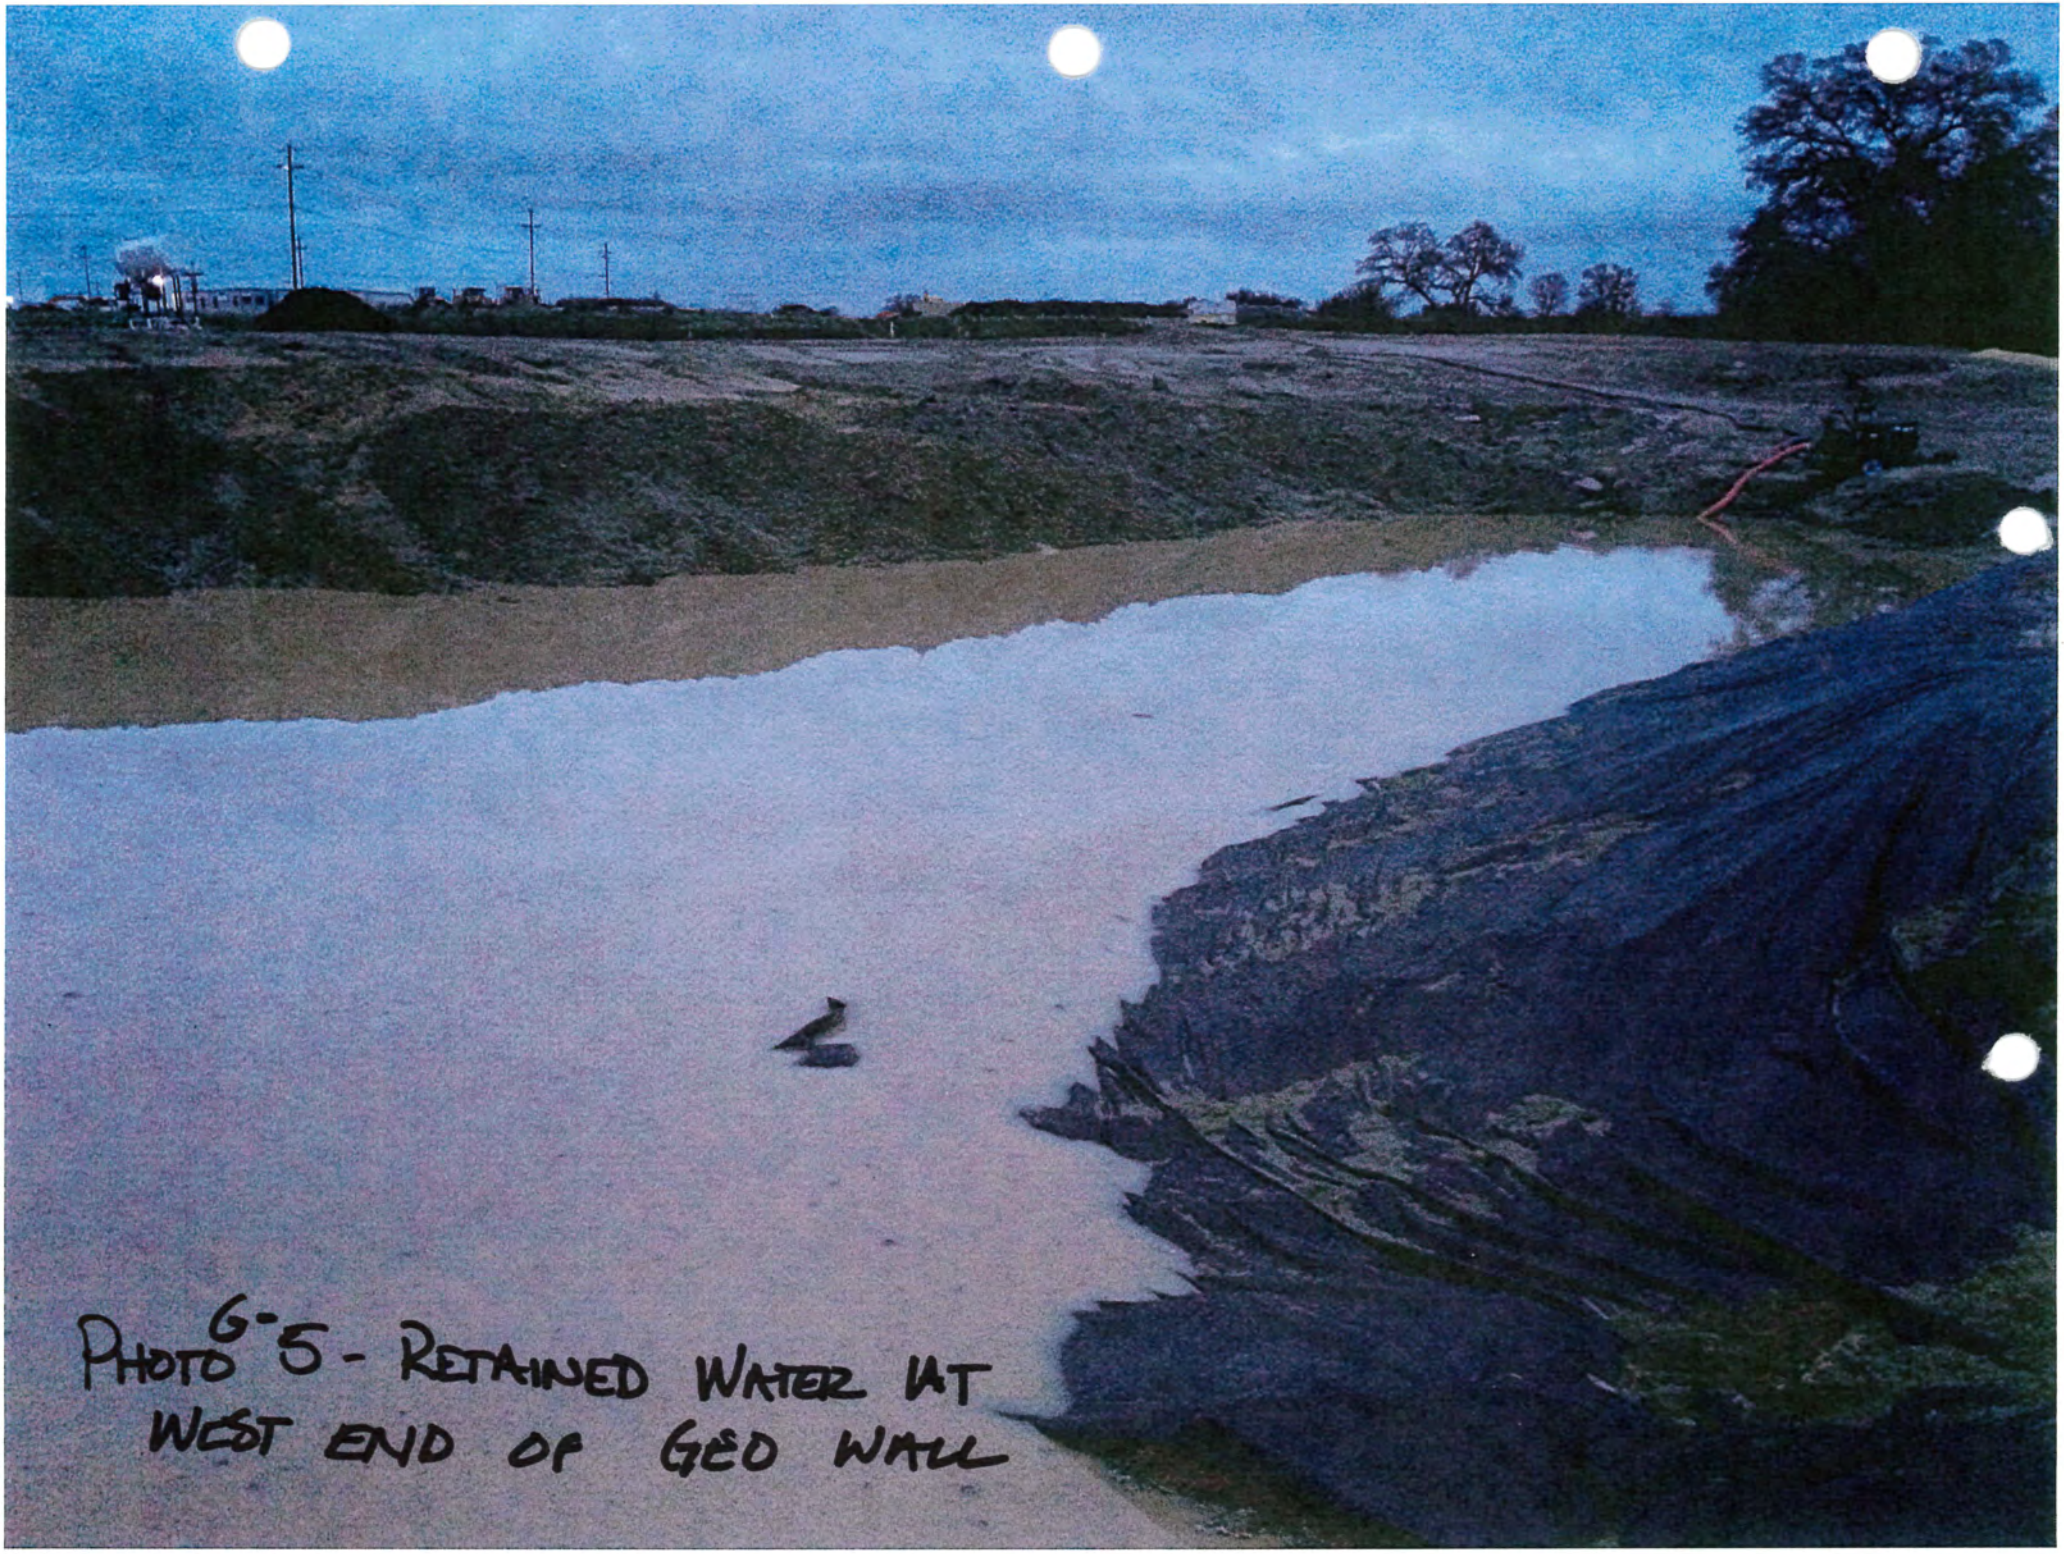
PHOTO 6-4- ATS MOBILIZING

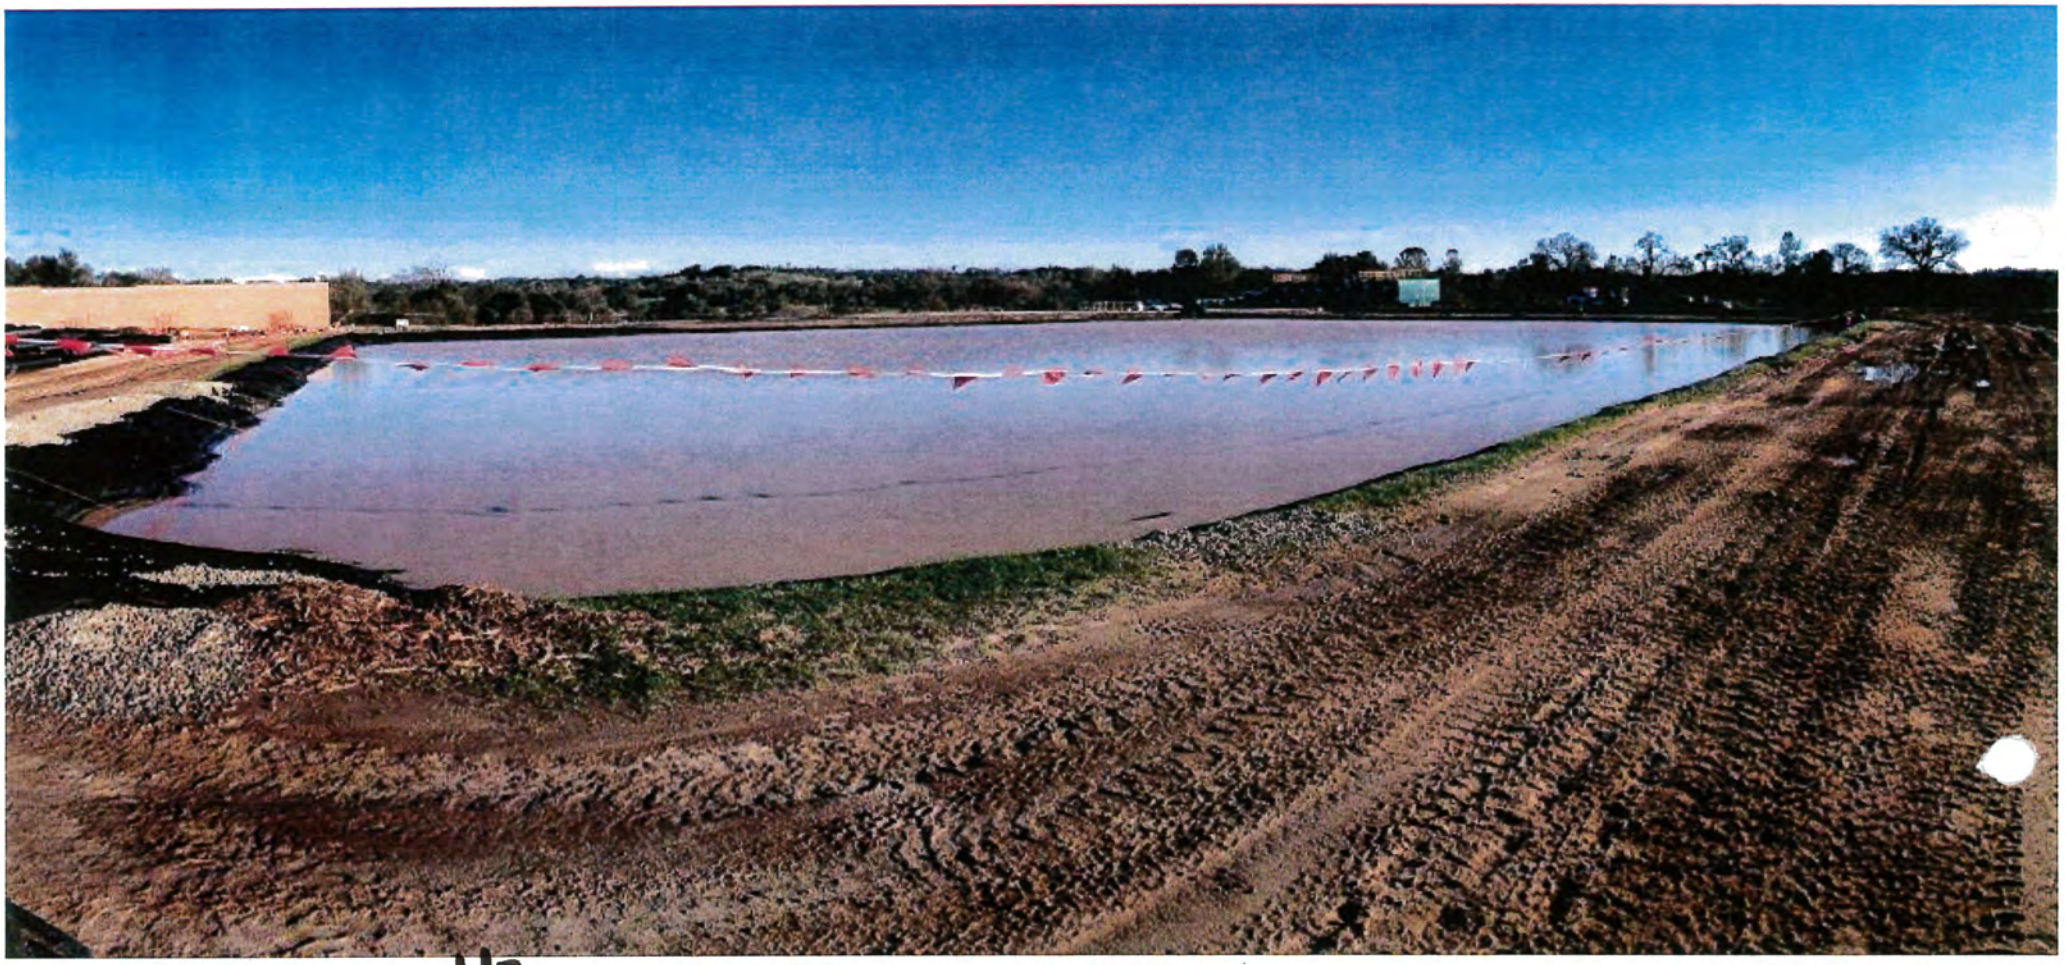
PHOTO H-1 - SIDES OF ORIGINAL SILT BASIN LINED WITH 4oz FABRIC
