SECOND QUARTER 2011
QUARTERLY MONITORING REPORT

Berry Street Mall Landfill
901 Galleria Boulevard
Roseville, California

WDR No. 89-115

August 11, 2011

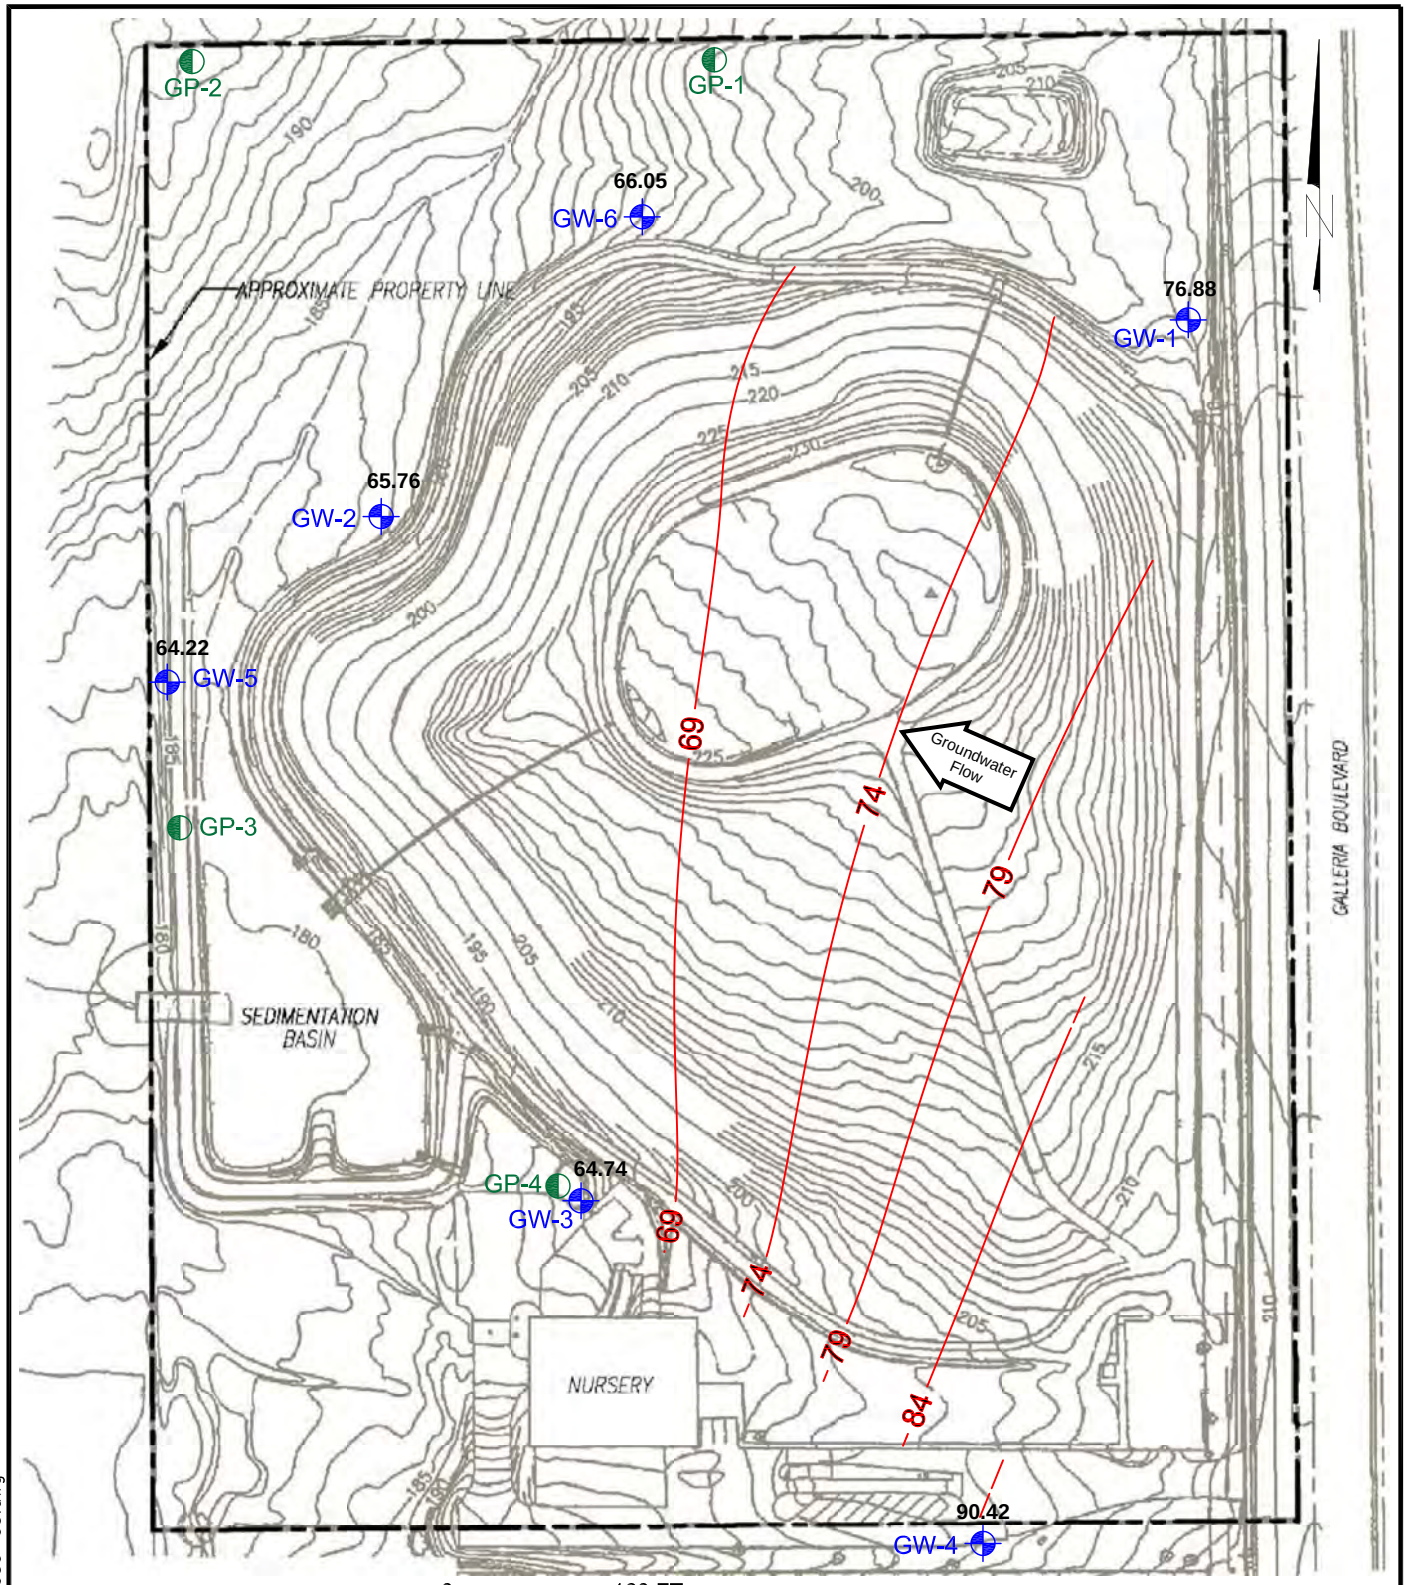
FIGURE 3

The results of groundwater potentiometric surface measurements conducted at the site on June 15, 2011 are summarized in Table 1. A potentiometric surface map illustrating the corresponding groundwater flow conditions is presented as Figure 3, “Groundwater Contour Map”. As shown in Figure 3, the southeast portion of the site is characterized by a northwesterly groundwater flow component, whereas a westerly groundwater flow component predominates beneath the central and western portions of the Landfill. These flows conditions generally mimic the original site topography and orientation of a

former ephemeral drainage that was present prior to landfill development.

The aforementioned variable groundwater flow component is also accompanied by variable hydraulic gradient conditions, with a fairly significant decrease in hydraulic gradient occurring from east to west across the site. As shown in Figure 3, the site exhibits a hydraulic gradient of approximately 0.023 foot per foot (ft/ft). Similar to the comparison noted above, the changes in hydraulic gradient generally mimic the former topographic features that characterized the site prior to landfill development.
