THIRD QUARTER 2011
QUARTERLY MONITORING REPORT

Berry Street Mall Landfill
901 Galleria Boulevard
Roseville, California

WDR No. 89-115

November 12, 2011

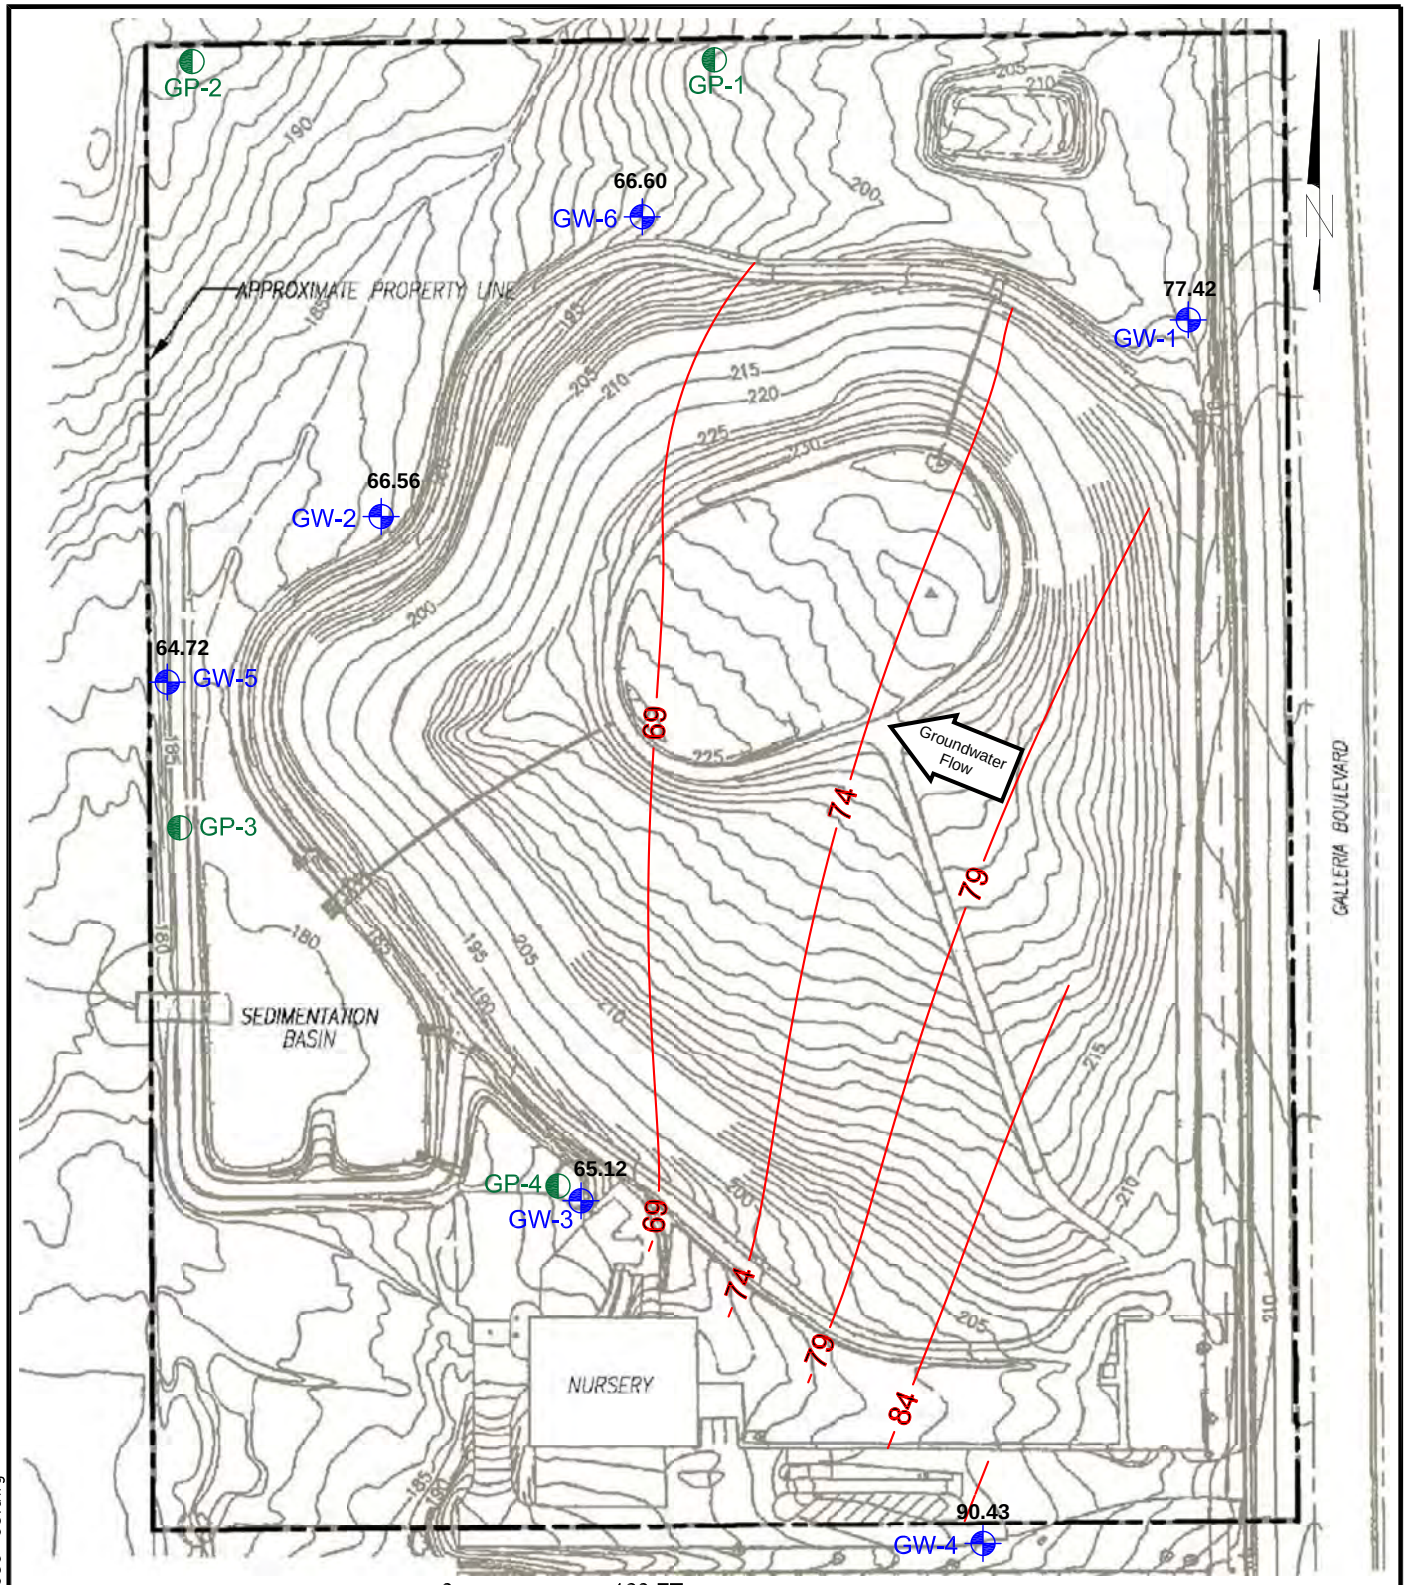
FIGURE 3

The results of groundwater potentiometric surface measurements conducted at the site on September 29, 2011 are summarized in Table 1. A potentiometric surface map illustrating the corresponding groundwater flow conditions is presented as Figure 3, “Groundwater Contour Map”. As shown in Figure 3, the southeast portion of the site is characterized by a northwesterly groundwater flow component, whereas a westerly groundwater flow component predominates beneath the central and western portions of the Landfill.

The aforementioned variable groundwater flow component is also accompanied by variable hydraulic gradient conditions, with a fairly significant decrease in hydraulic gradient occurring from east to west across the site. As shown in Figure 3, the site exhibits a hydraulic gradient of approximately 0.023 foot per foot (ft/ft). Similar to the comparison noted above, the changes in hydraulic gradient generally mimic the former topographic features that characterized the site prior to landfill development.
