Subject: **Item #2 and Item #3 Response and Data Evaluation**
13267 Order dated January 15, 2016, CMC Land Holdings LLC, 4207 West Linwood Avenue, Turlock, Stanislaus County, California

On behalf of CMC Land Holdings LLC, The Source Group Inc. (SGI) has prepared this Site Item #2 and Item #3 Response and Data Evaluation (Letter) for the dairy facility located at 4207 Linwood Avenue, Turlock, Stanislaus County, California (Site, Figure 1). This letter has been prepared in response to the January 15, 2016 Regional Water Quality Control Board (RWQCB) correspondence entitled *California Water Code Section 13267 Order – Directives for Submitting Documentation Pertaining Wastewater Discharge on 20 November 2015 and Mitigation Measures at CMC Landholdings LLC, 4207 W Linwood Avenue, Turlock, Stanislaus County* (Order, Attachment A). Specifically, this letter is intended to satisfy the following:

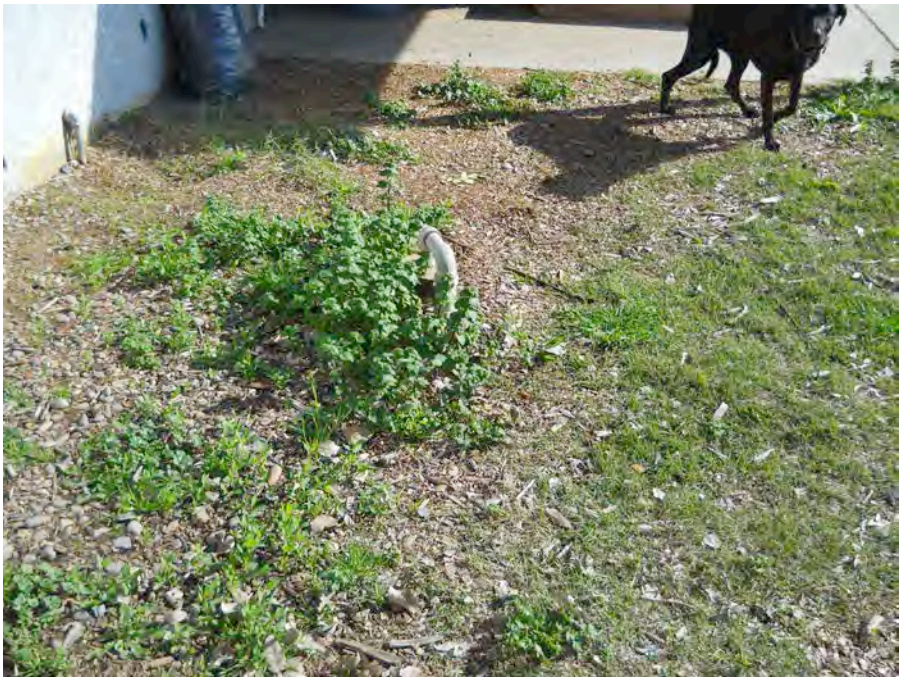
During the domestic well sampling activities, RJ Avila inspected the surface completions of each of the nearby domestic wells. The inspection included a photo log of each well to demonstrate the integrity of the surface completion at each of the nearby domestic wells. A copy of the photo log is provided in Attachment D. A review of the photo logs indicate that domestic wells generally appears to have a proper surface completion. A surface completion is intended to prevent a well from acting like a direct conduit for a surface release to impact groundwater.

Photograph 7: *4318 West Linwood Avenue, Turlock, California.*

Photograph 8: *4406 West Linwood Avenue, Turlock, California.*
