CENTRAL VALLEY REGIONAL WATER QUALITY CONTROL BOARD

INSPECTION REPORT

DISCHARGER: Rego Dairy # 2

INSPECTION DATE: 1 February 2012

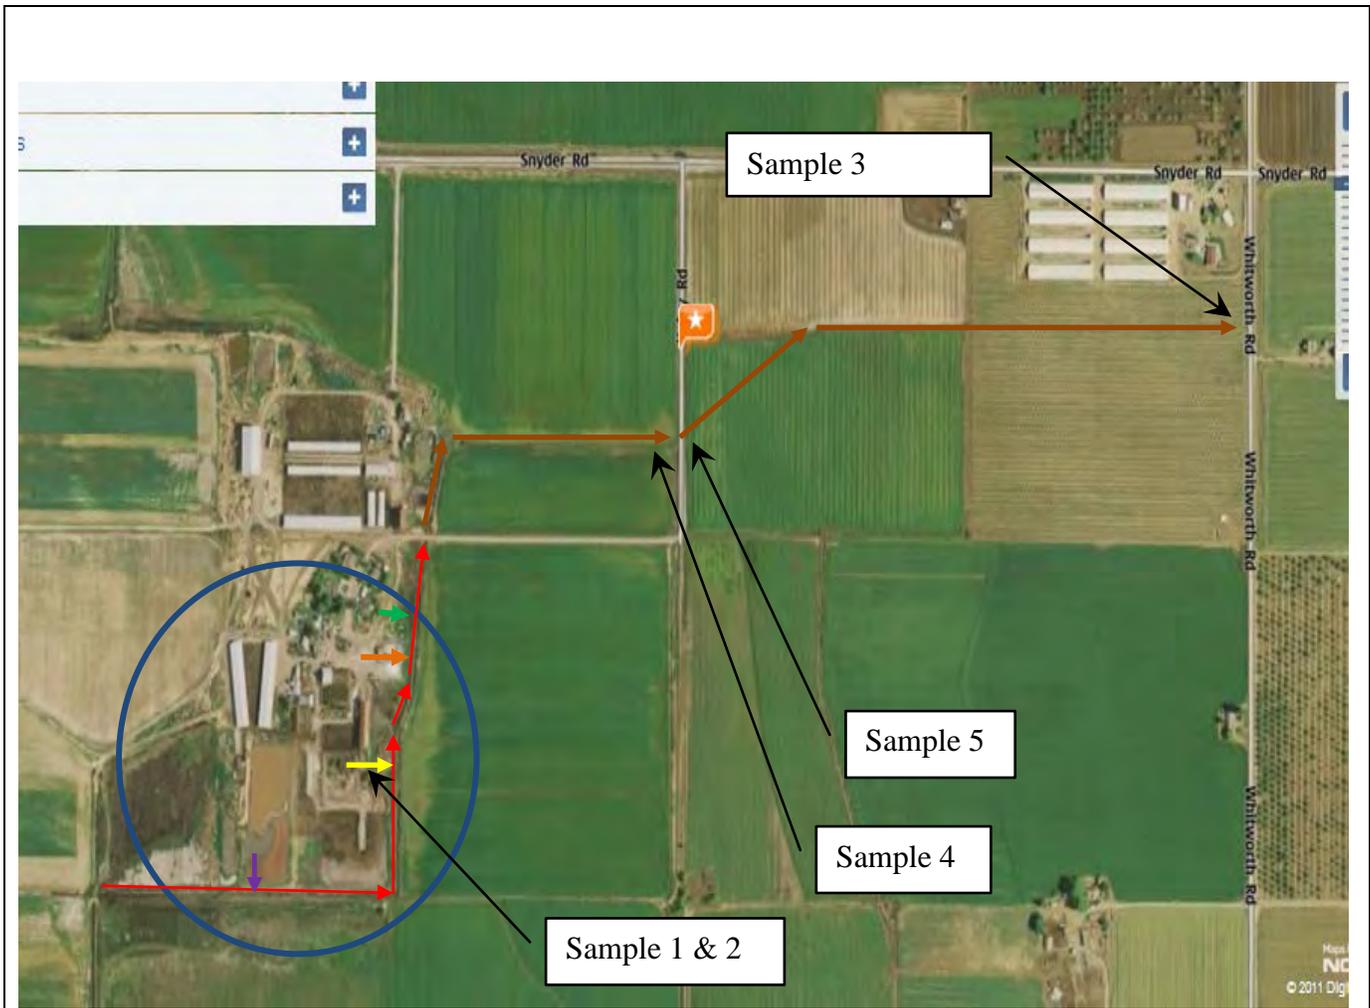
Map 1: The map shows the Rego Dairy # 2 at 6255 Haley Road in Gustine circled in blue in relation to the wastewater discharge path towards the CCID Main Canal. The red arrows represent the open drain ditch path and direction the wastewater flowed. The brown arrows represent an underground pipeline. CCID main canal is not visible in this aerial. The purple arrow represents wastewater discharging from the lagoon into the drain ditch. The yellow arrow represents corral/burial area runoff discharging to the drain ditch. The green arrow represents septic waste discharging into the drain ditch. The orange arrow represents silage leachate directed to the drain ditch. The locations of the five samples taken are shown above.

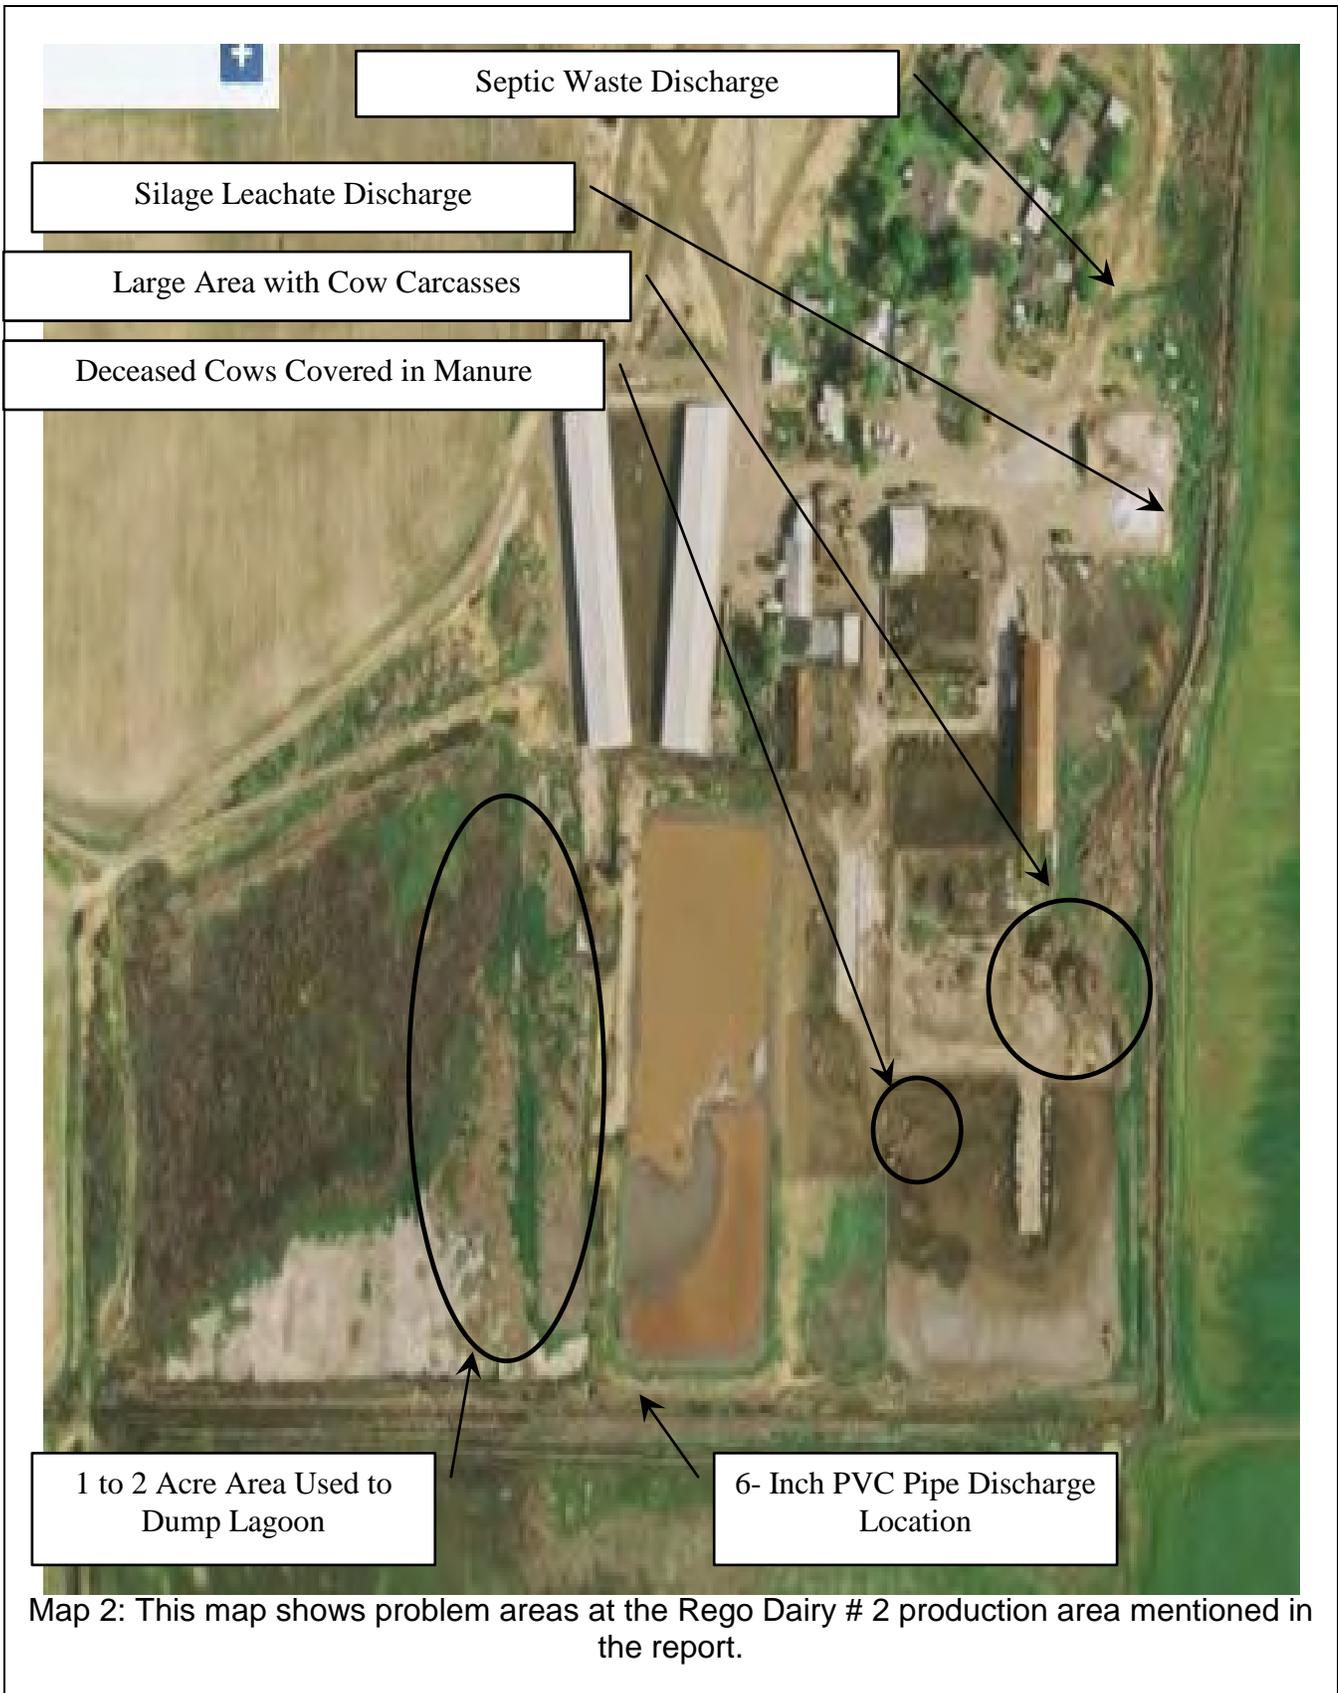
Map 2: This map shows problem areas at the Rego Dairy # 2 production area mentioned in the report.
