# CENTRAL VALLEY REGIONAL WATER QUALITY CONTROL BOARD

**ACL Complaint R5-2012-0515  
Attachment F  
19 July 2012 Inspection Report**

**INSPECTION DATE:** 19 July 2011  
**FACILITY:** Del Mar Farms  
**LOCATION & COUNTY:** Cropland APNs 027-018-055 and 049-014-001  
Westley, Stanislaus County  
**INSPECTED BY:** Terry Bechtel  
**ACCOMPANIED BY:** Lt. Phil McKay, Ca Dept. of Fish and Game

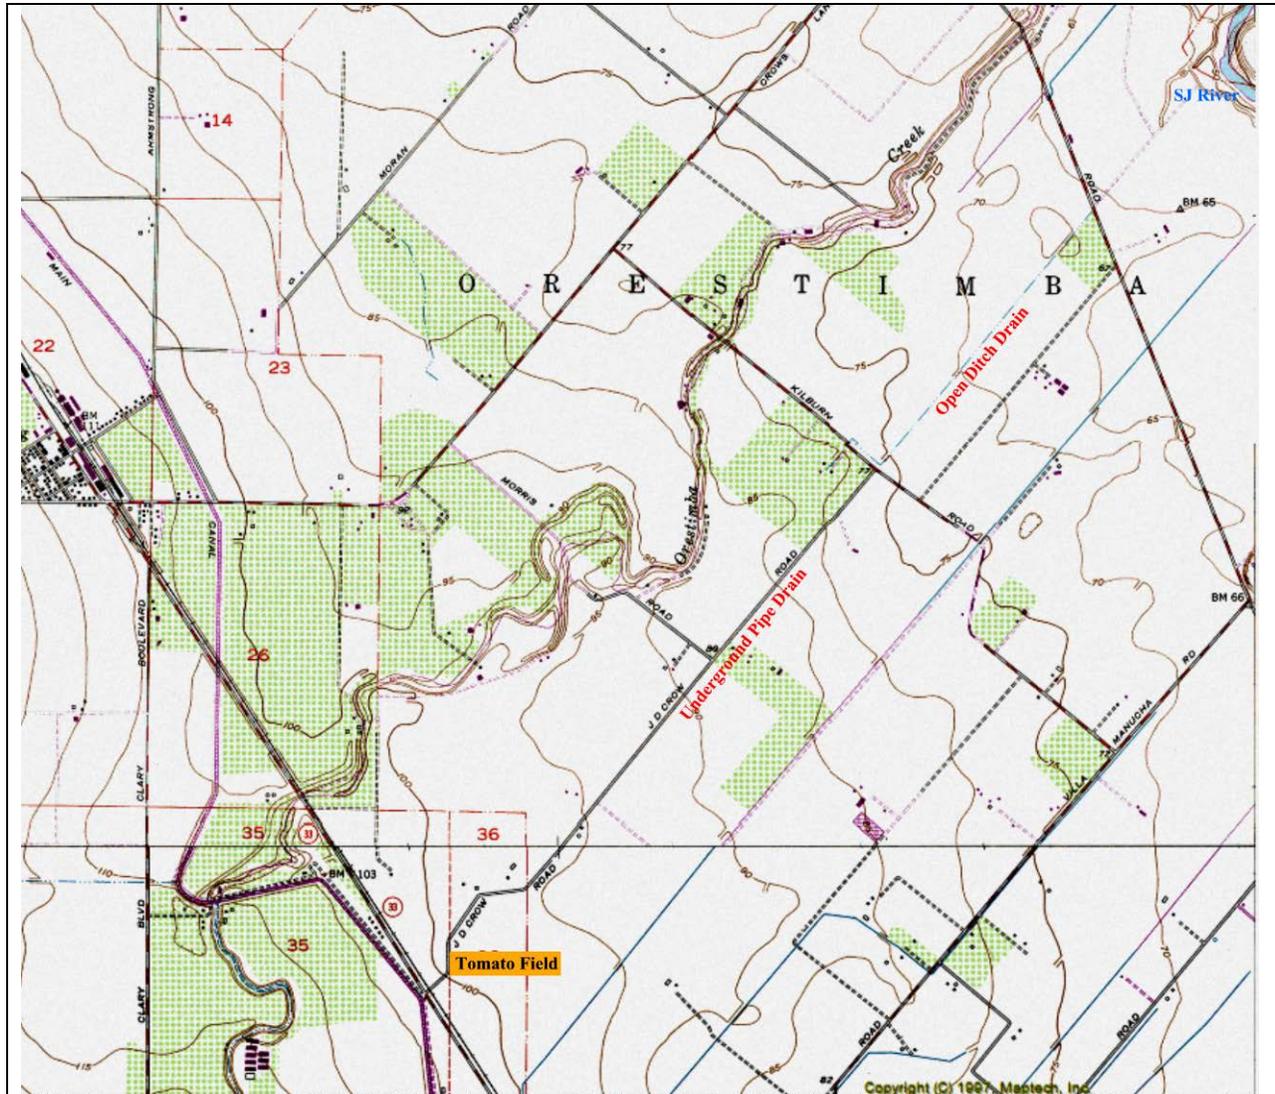
**Map:** Approximately 3.5 miles from the tomato field to the San Joaquin River

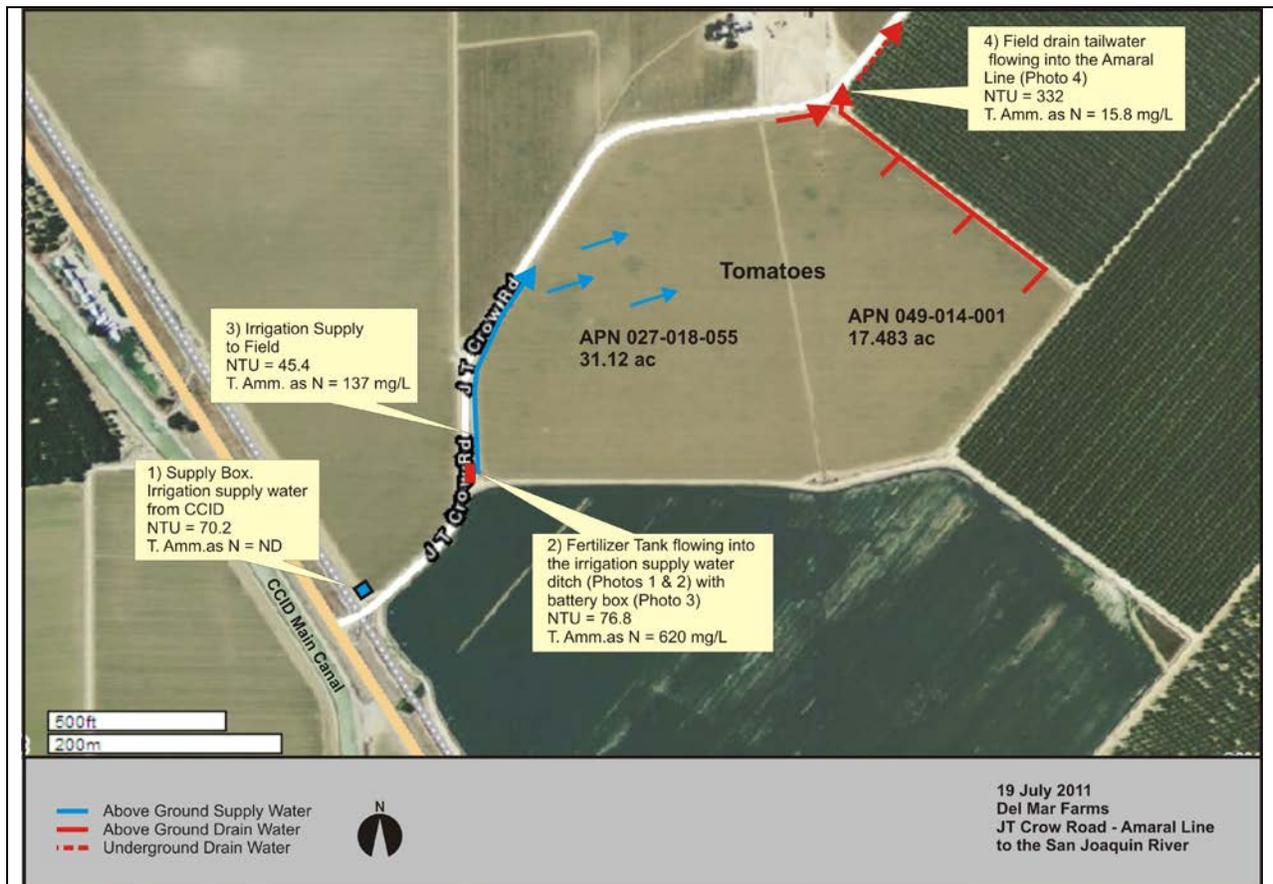
Sample Location	Turbidity (NTU)	Amm. as N mg/L	Setteable Solids mg/L	Suspended Solids mg/L	Calcium		Nitrate-N mg/L
					µg/L	mg/L	
1) 12:50 - Supply at Box	70.2	ND	ND	69.0	49,300	49.3	0.69
2) 13:02 - Fertilizer Tank	76.8	620	ND	3570	130,000,000	130,000	193,000
3) 13:22 - Supply Ditch	45.4	137	0.1	119	30,700	30.7	8.64
4) 13:40 - Tailwater	332	15.8	0.2	572	50,100	50.1	430

EC µmhos/cm	Temp C°	pH
1) Supply at Box	692	26.2	8.62
2) Fertilizer Tank	112.6	30.7	3.92
3) Supply Ditch	508	26.7	8.23
4) Tailwater	652	32.6	8.11
