CENTRAL VALLEY REGIONAL WATER QUALITY CONTROL BOARD

INSPECTION REPORT

LOCATION & COUNTY: Henry Tosta Dairy
20662 San Jose Road, Tracy
San Joaquin County

INSPECTION DATE: 7 December 2012

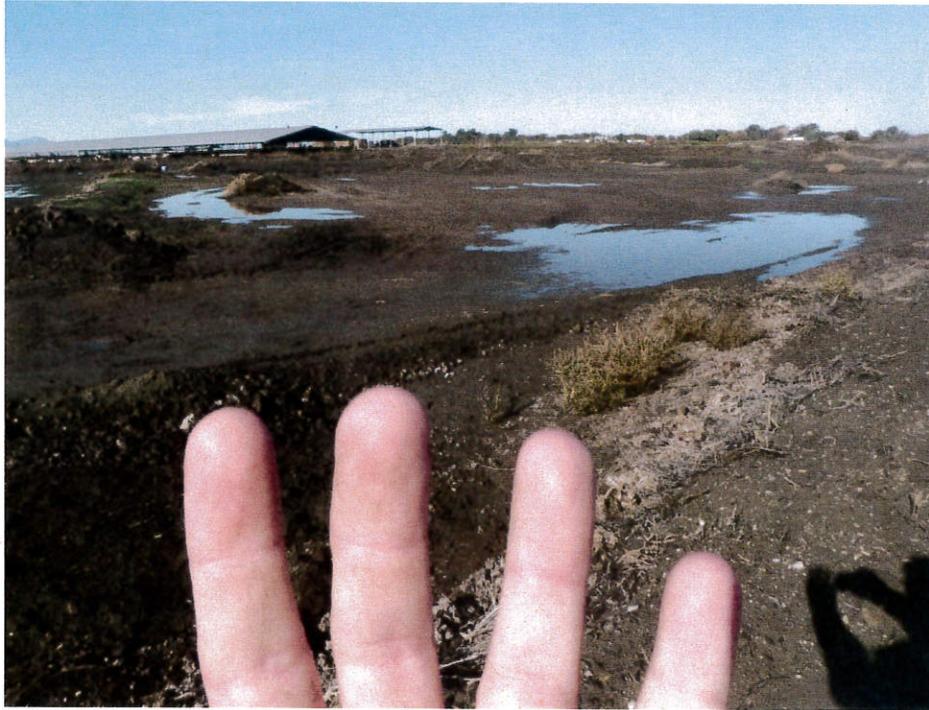
Photo 15: Looking west at Wastewater Lagoon #4.

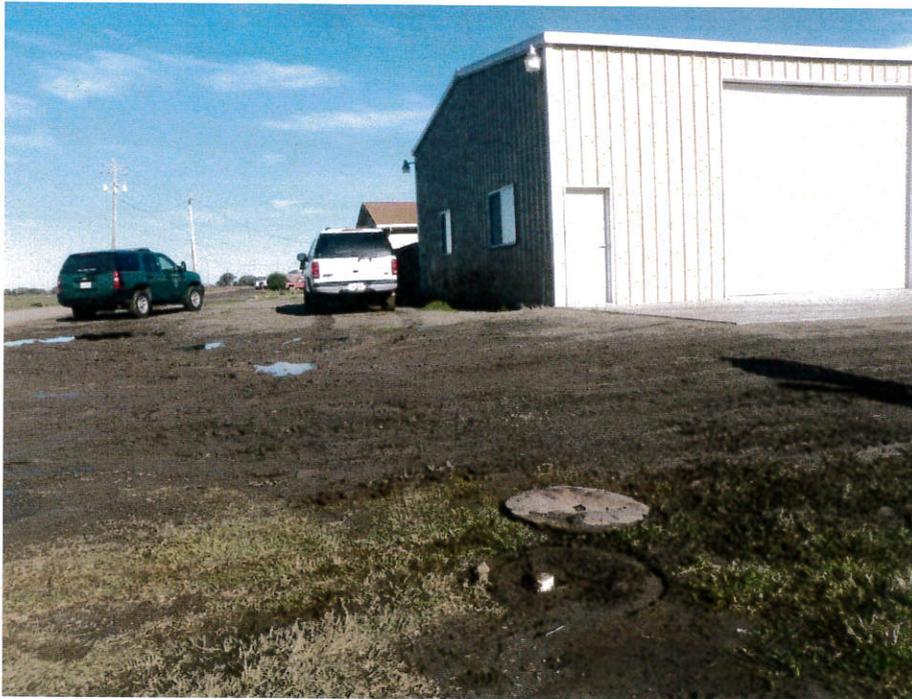
Monitoring Well #1 is located in the southwest corner of the production area and at the time of inspection was in adequate condition (Photo 29).

Photo 29: Looking north at Monitoring Well 1; located at the southwest corner of the production area.
