RE: Compost Area Improvement Report, Feather River Organics, Yuba County, California

Project No. 1301525

**RE: COMPOST AREA IMPROVEMENT REPORT FOR THE FEATHER RIVER ORGANICS  
COMPOSTING OPERATION, RECOLOGY YUBA SUTTER FACILITY, MARYSVILLE,  
CALIFORNIA**

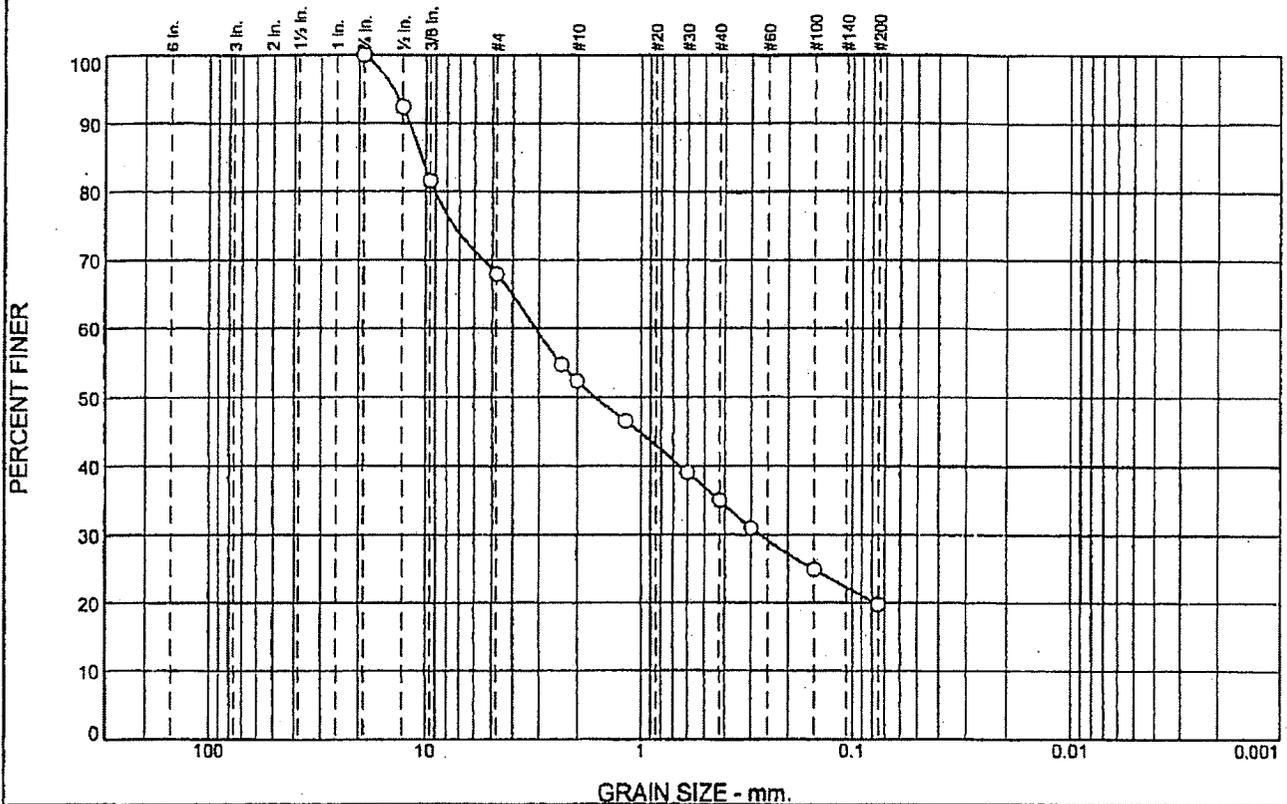
# Particle Size Distribution Report

% +3"	% Gravel		% Sand			% Fines	
	Coarse	Fine	Coarse	Medium	Fine	Silt	Clay
0.0	0.0	32.1	15.5	17.4	15.2	19.8

SIEVE SIZE	PERCENT FINER	SPEC.* PERCENT	PASS? (X=NO)
3/4 Inch	100.0		
1/2 Inch	92.5		
3/8 Inch	81.6		
#4	67.9		
#8	54.7		
#10	52.4		
#16	46.5		
#30	39.1		
#40	35.0		
#50	31.0		
#100	24.9		
#200	19.8

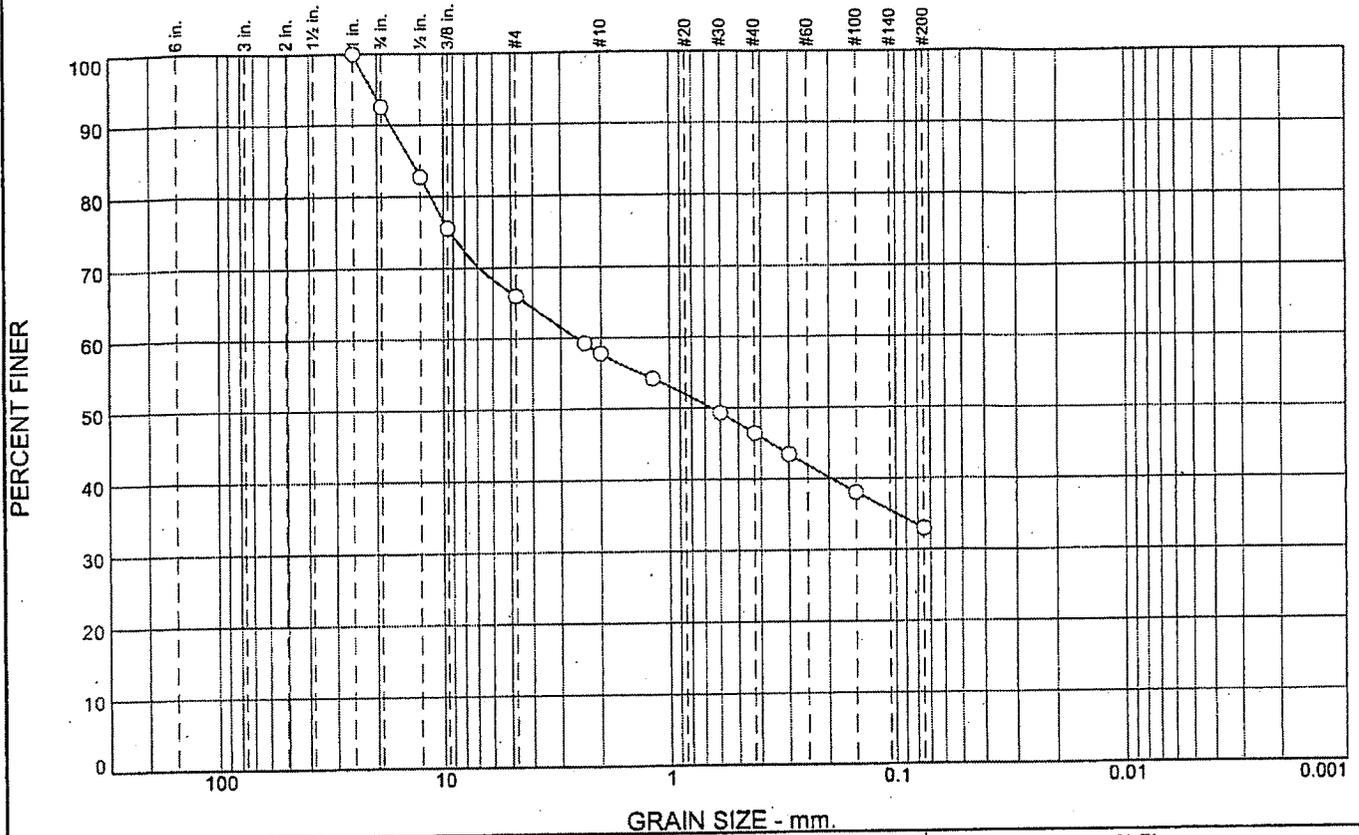
# Particle Size Distribution Report

% +3"	% Gravel		% Sand			% Fines	
	Coarse	Fine	Coarse	Medium	Fine	Silt	Clay
0.0	7.5	26.5	8.2	11.3	13.6	32.9

SIEVE SIZE	PERCENT FINER	SPEC.* PERCENT	PASS? (X=NO)
1	100.0		
3/4	92.5		
1/2	82.8		
3/8	75.6		
#4	66.0		
#8	59.2		
#10	57.8		
#16	54.2		
#30	49.3		
#40	46.5		
#50	43.4		
#100	38.0		
#200	32.9

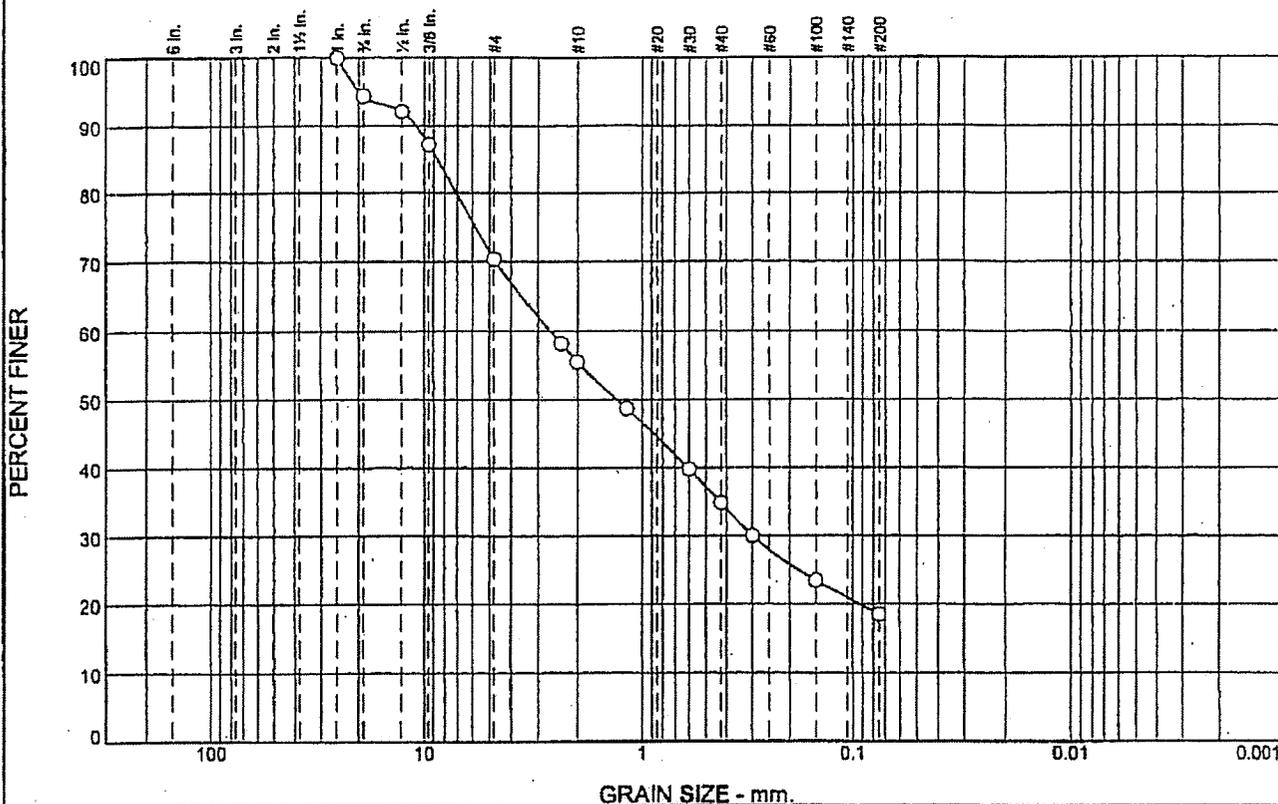
# Particle Size Distribution Report

% +3"	% Gravel		% Sand			% Fines	
	Coarse	Fine	Coarse	Medium	Fine	Silt	Clay
0.0	5.6	24.0	14.9	20.7	16.3	18.5

SIEVE SIZE	PERCENT FINER	SPEC.* PERCENT	PASS? (X=NO)
1 Inch	100.0		
3/4 Inch	94.4		
1/2 Inch	92.1		
3/8 Inch	87.2		
#4	70.4		
#8	58.2		
#10	55.5		
#16	48.7		
#30	39.8		
#40	34.8		
#50	30.0		
#100	23.5		
#200	18.5

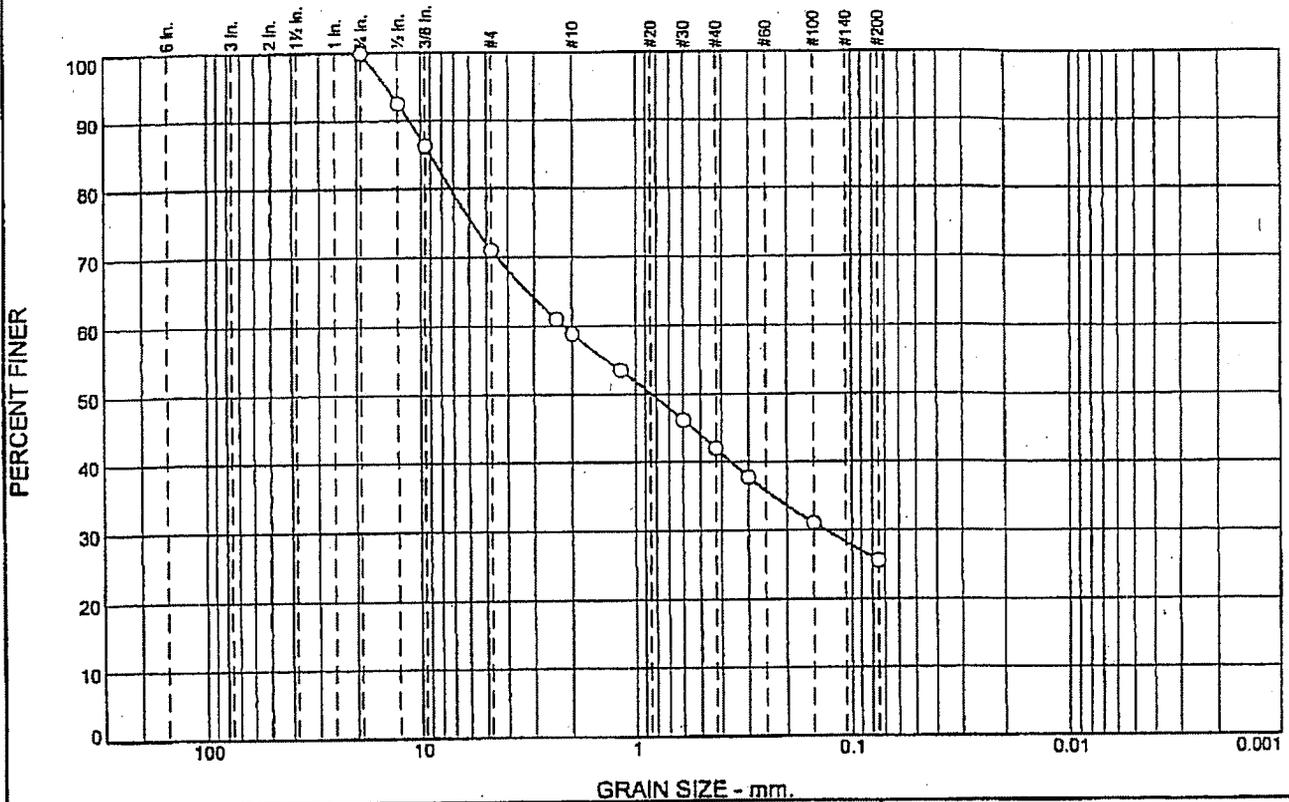
# Particle Size Distribution Report

% +3"	% Gravel		% Sand			% Fines	
	Coarse	Fine	Coarse	Medium	Fine	Silt	Clay
0.0	0.0	29.0	12.2	16.8	16.4	25.6

SIEVE SIZE	PERCENT FINER	SPEC.* PERCENT	PASS? (X=NO)
3/4 Inch	100.0		
1/2 Inch	92.5		
3/8 Inch	86.3		
#4	71.0		
#8	61.0		
#10	58.8		
#16	53.5		
#30	46.2		
#40	42.0		
#50	37.7		
#100	31.1		
#200	25.6

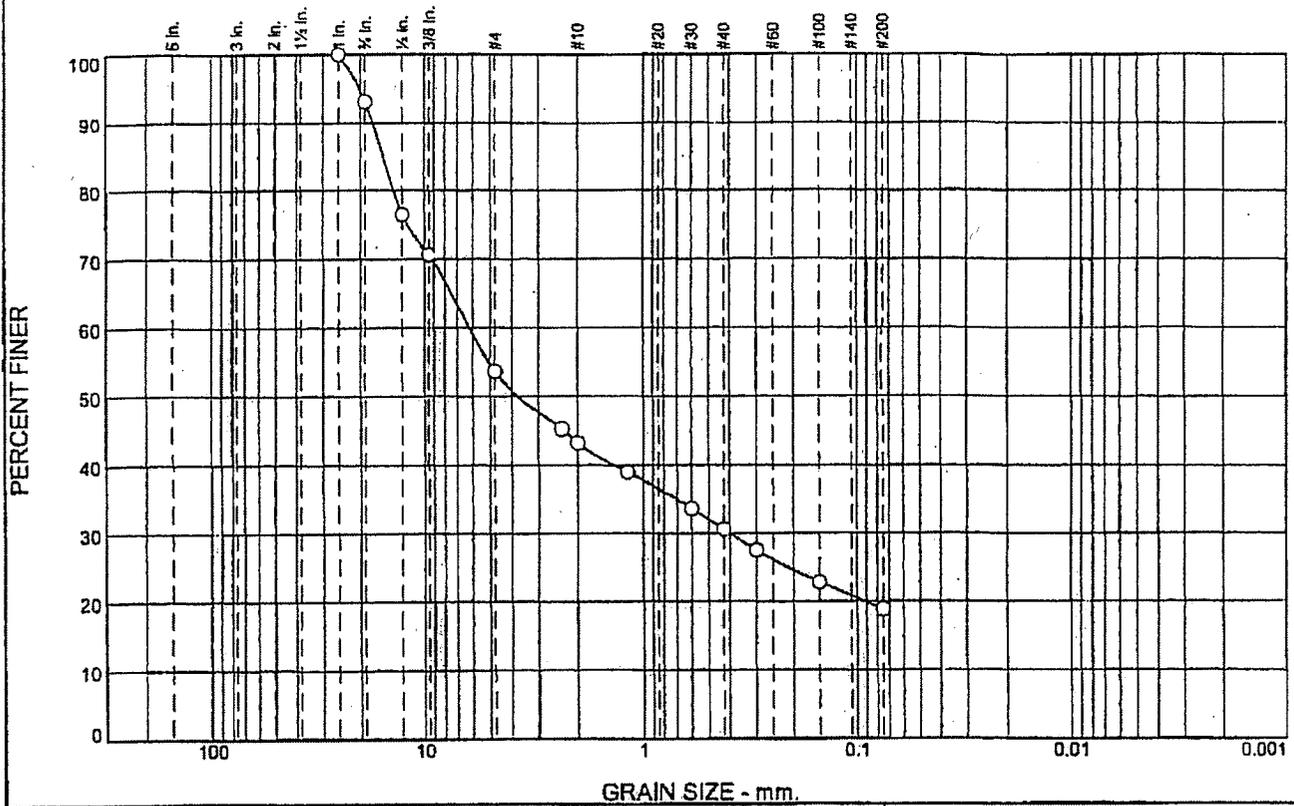
# Particle Size Distribution Report

% +3"	% Gravel		% Sand			% Fines	
	Coarse	Fine	Coarse	Medium	Fine	Silt	Clay
0.0	6.8	39.6	10.3	12.7	11.8	18.8

SIEVE SIZE	PERCENT FINER	SPEC.* PERCENT	PASS? (X=NO)
1 Inch	100.0		
3/4 Inch	93.2		
1/2 Inch	76.5		
3/8 Inch	70.7		
#4	53.6		
#8	45.3		
#10	43.3		
#16	39.0		
#30	33.6		
#40	30.6		
#50	27.5		
#100	22.8		
#200	18.8

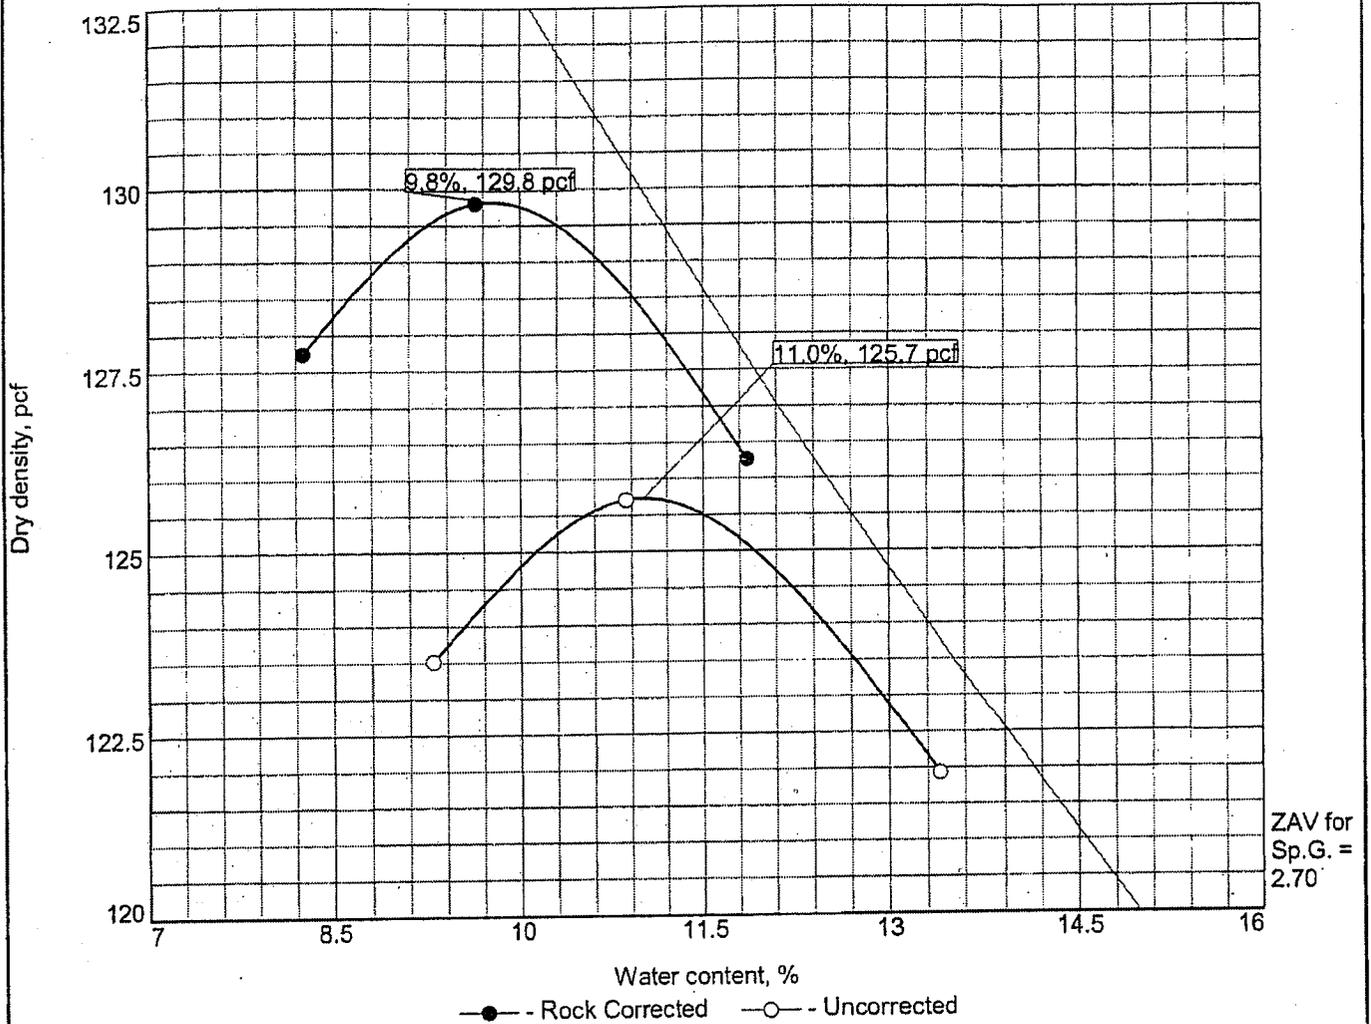
# COMPACTION TEST REPORT

Test specification: ASTM D 1557-07 Method C Modified  
 ASTM D 4718-87 Oversize Corr. Applied to Each Test Point

ROCK CORRECTED TEST RESULTS	UNCORRECTED	MATERIAL DESCRIPTION
Maximum dry density = 129.8 pcf	125.7 pcf	
Optimum moisture = 9.8 %	11.0 %	
Project No. 14-092      Client: Golder Associates Inc Project: Recology Yuba - Sutter 339-7668 Location: <del>---</del> Sample Number: S43301 Location No. 1      SIERRA TESTING LABS, INC. EI Dorado Hills, CA		Remarks:
