North Coast Regional Water Quality Control Board

Subject: Notice of Violation of Order No. R1-2013-0005, General Waste Discharge Requirements for Discharges for Timber Operations on Non-Industrial Timber Management Plans (NTMP) in the North Coast Region

File: Non-Industrial Timber Management Plan 1-95NTMP-003 MEN,
"Surprise Valley"

August 12, 2015 Site inspection

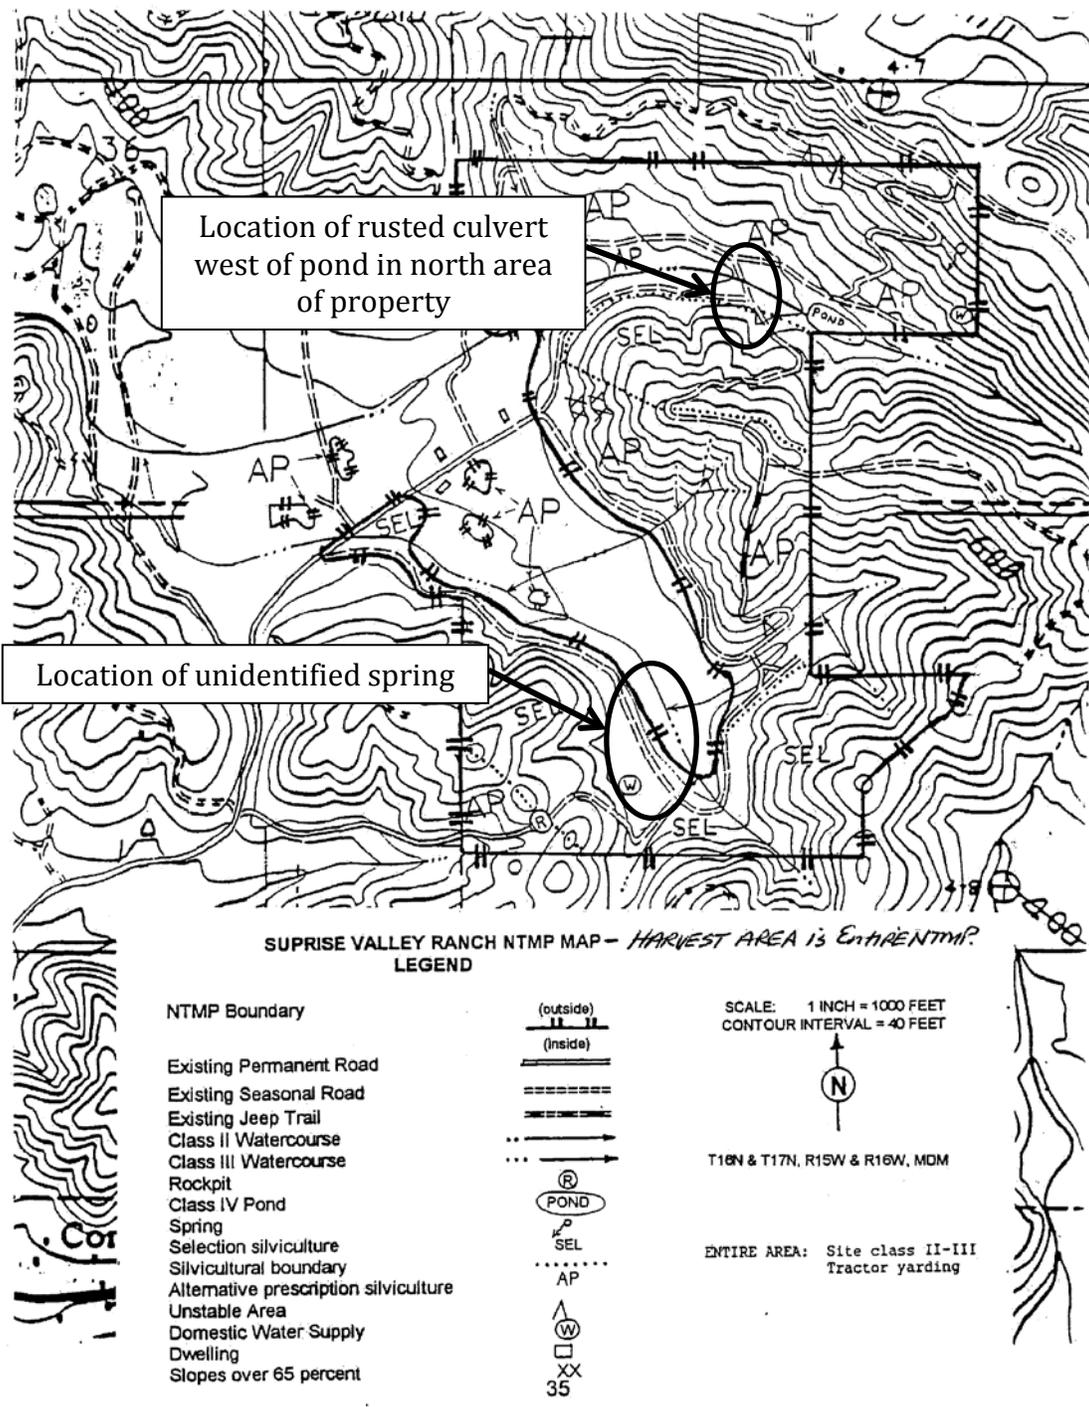
The rusted culvert Regional Water Board staff observed during the NTO #11 inspection is also west of the pond in the north area of the property (Map 1). Mr. Curtis’s November 12, 2013 report also indicates that the RPF was currently evaluating culverts and developing a replacement schedule based on a prior conversation. It does not appear that that evaluation took place.

During the inspection, at the southern section of the NTO, Regional Water Board staff observed a spring to the north of the domestic well. The NTO and NTO maps do not include this feature. The spring extends to the northeast and southwest of the road. Water flows from the southwest, through a culvert, to the northeast (Figures 5 and 6). The water then dissipates into a field occupied by cattle. The existing crossing does not need replacing. Water Board staff and the RPF agreed that this spring and associated flow path should be provided Class II watercourse protection. Currently, the NTO does not identify this watercourse, and therefore does not provide for appropriate watercourse protection. Trees in this area had been felled as part of the NTO, but at the time of the inspection, had not been hauled away (Figure 7). Failure to disclose this site and to provide appropriate protection to the beneficial uses of water associated with the spring violates both the Basin Plan and sections A (5)(a) and (b) of the NTMP GWDR. You must add the watercourse to the NTO maps, and provide for appropriate protection to ensure that the beneficial uses of water are protected.

Map 1: location of rusted culvert and unidentified spring

At the end of the inspection, RPF Randy Jacobszoon agreed to replace the rusted culvert. The RPF must submit a written description of the existing site conditions to the Regional Water Board by October 15, 2015, with proposed corrective action plan to prevent or minimize sediment discharge. The plan must include any design, installation and material specifications, and shall address the following:

All corrective actions for the rusted culvert must be fully implemented by no later than October 15, 2016. All corrective actions for the ditch relief culvert must be fully implemented by no later than October 15, 2015. Confirmation of completion of each corrective action must be provided to Regional Water Board staff no more than 30 days following completion.
