Descriptions of Proposed Project and Enhanced Compliance Action As Part of Settlement of North Coast Regional Board ACL, Prepared By Russian River County Sanitation District Staff, December 2015

Russian River County Sanitation District Natural Hazard Reliability Assessment

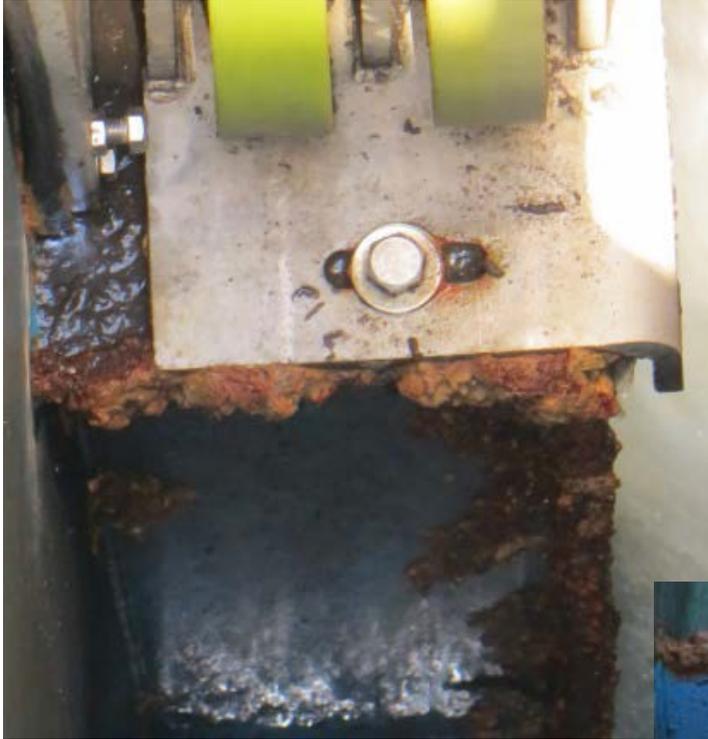
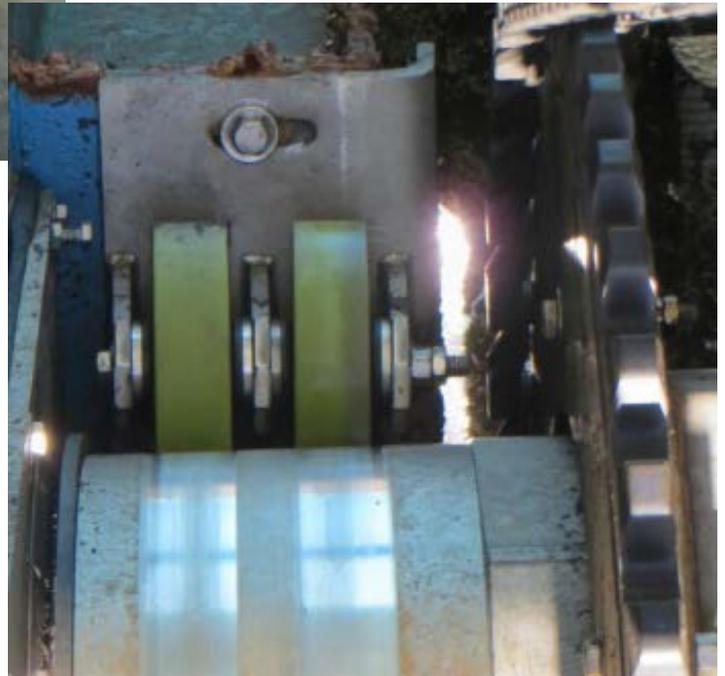
mechanical inspection would. RRCSD staff have taken many photos of severe corrosion within the filters and are concerned that without replacing some structural steel, the filters could catastrophically fail at which time replacement may be the only alternative. RRCSD staff contacted Aqua-Aerobic Systems to discuss several items, one of which was the expected life span of the filter modules and while there is not an expected lifespan, it is often the case that units do require rehabilitation including sand blasting, re-welding and re-coating. Until the units are taken offline it is not known exactly what repairs and upgrades will be needed, however if rehabilitation is selected rather than replacement it is anticipated that the CP may include: replacing the filter media with Aqua-Aerobics OptiFiber cloth media; new roof

structure; metal removal and replacement, sand blasting and recoating of the unit's interior and exterior; bearing and drive shaft replacements, control system upgrades, pipe manifold rehabilitation, various pumps and motors rebuilt or replaced; and sensor component replacement. The pictures to the left and below were taken in May 2013, severe rust/corrosion can be seen on a major structural member and severe wear can be seen on the center drum drive assembly. In general and while not as severe as these two photos depict, there are many other instances that exist both on the interior and exterior of the filter

modules. This type of corrosion is not atypical and can be expected to occur given the operating conditions both relative to waste water and the moist environment that the treatment plant exists in, even with preventative and corrective maintenance, 24 hour, 7 day a week operation will eventually wear out many mechanical appurtenances. The modules are not experiencing failure but given the observations of RRCSD staff, rehabilitation or replacement of the modules is imminent. As required by the Enforcement Policy, this project is a project that the RRCSD is obligated to perform, independent of the ACL.

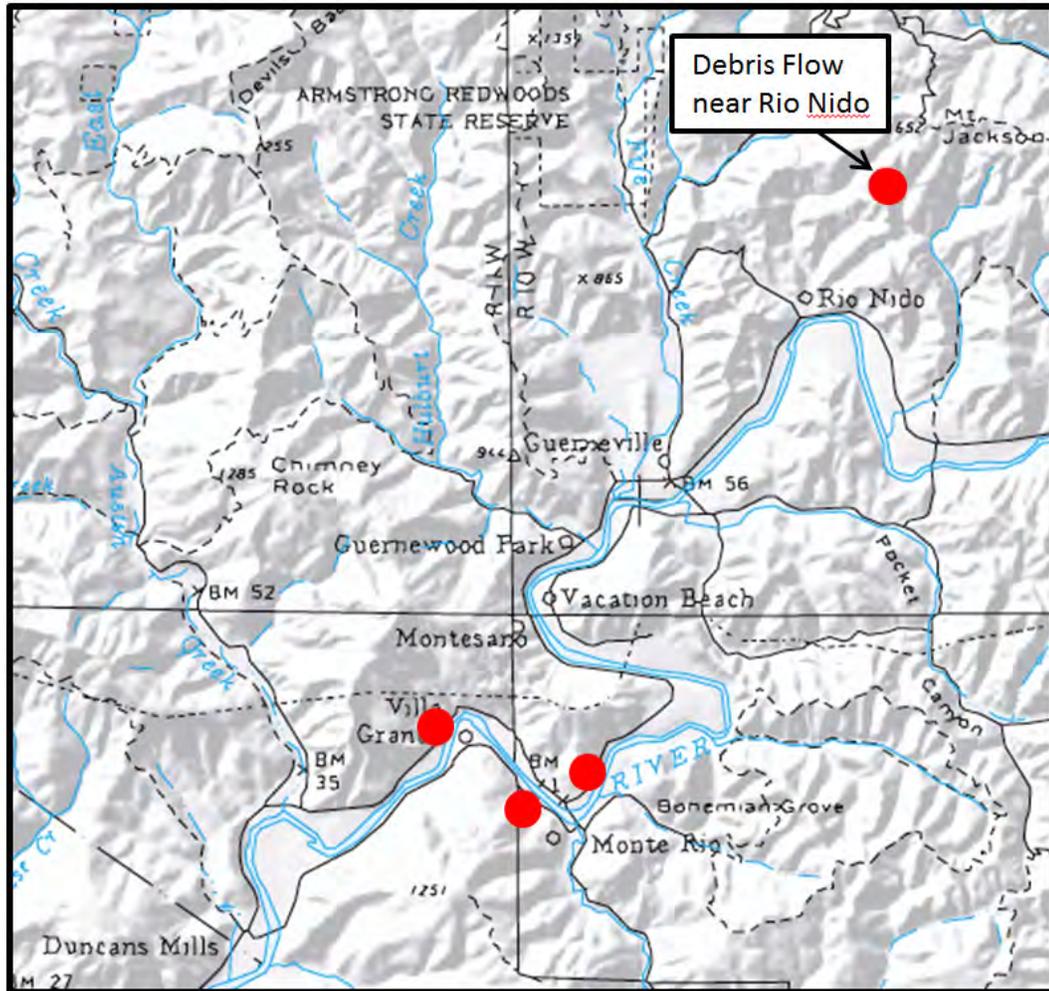
Figure 6: Mapped Debris Flows near RRCSD, adapted from Winter (1999)

Regional scale landslide maps for Sonoma County include the map prepared by David Ramsey and Jonathan Godt (1999), which maps the landslides resulting from the 1997-1998 El Niño rainstorms. Rio Nido is located at the northern edge of the RRCSD service area. This community is in and along the margins of several steep canyons. In February 1999, a rotational and translational rock slump began to move high on a ridge above the town following heavy rains of early February. The frontal part of the slide slumped and liquefied, forming debris flows that crashed into homes along Upper Canyon Three Road. Three homes were destroyed and four more were severely damaged with damage to another 32 properties. The road and all underground and above-ground utilities were destroyed. The threat of further slippage of the main slide and resulting debris flow activity forced the evacuation of 140 homes downslope from the slide. The landslides in Sonoma County, from January – April 1999, caused about \$21 million in losses in Sonoma County with most of this loss concentrated near Rio Nido Figure 6 shows the locations of mapped debris flows (red dots) from the winter of 1999 (Ramsey et al, 1999).

According to Giblin (2002), a debris flow occurred at the WWTP in 1992 during periods of heavy rainfall, with debris deposited between Clarifier 1 and the Mechanical Building, extending to the effluent storage reservoir. A San Andreas earthquake that occurs during the winter time, with $PGA > 0.3g$ and ground-saturated conditions, could trigger multiple debris flows.

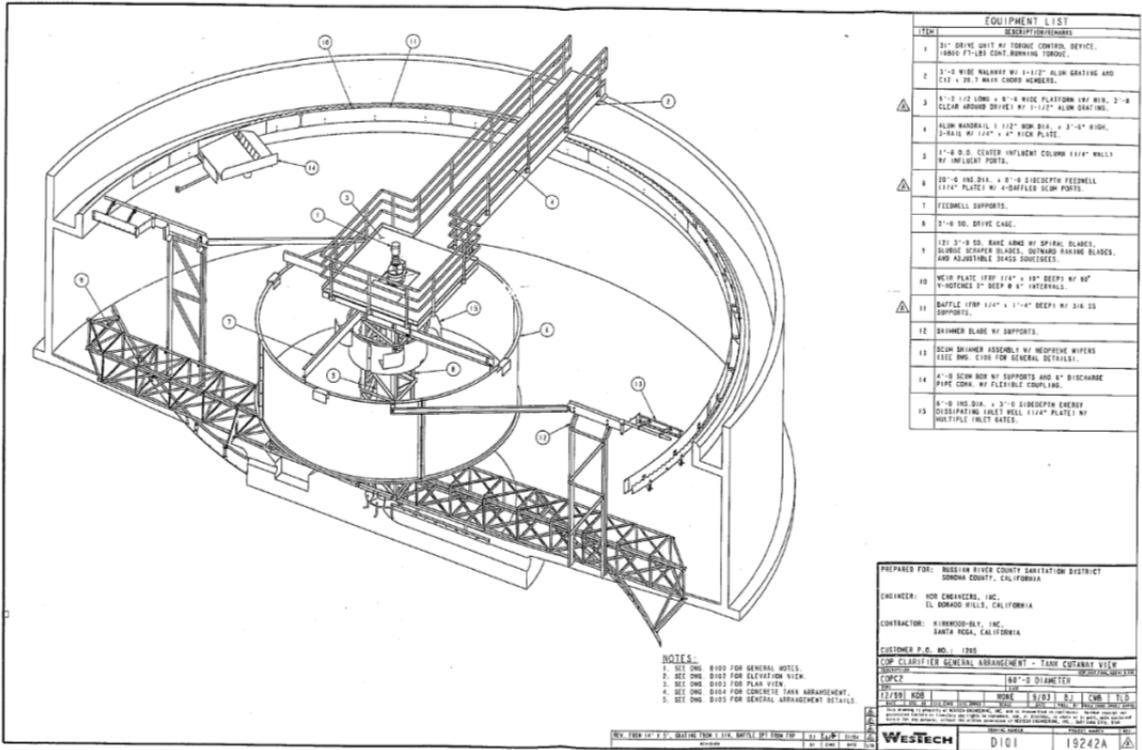
Figure 7: RRCSD WWTP 60 ft. Clarifier (2003) – General Layout

Circular clarifiers commonly experience significant damage during major earthquakes. During earthquakes, water sloshing in the clarifiers result in waves that over-top the clarifier and increases the forces applied to the central tower, baffles, and launders. Figure 7 shows the typical clarifier layout and Figure 8 shows the key dimensions. Barring liquefaction under the concrete tanks, the concrete tanks can sustain inertial loads without damage. With sufficient lateral forces due to sloshing, there will be overturning moments applied to the central tower; if the tower cannot sustain these forces, it will be damaged, rendering the clarifier inoperable until repairs are made.

Ways to mitigate the vulnerabilities include:

- Keep one clarifier empty in order to eliminate the sloshing effect.
- Reinforce the central tower by bracing the top of the tower to the outer concrete tank walls. Additional bracing of the baffles may also be required.

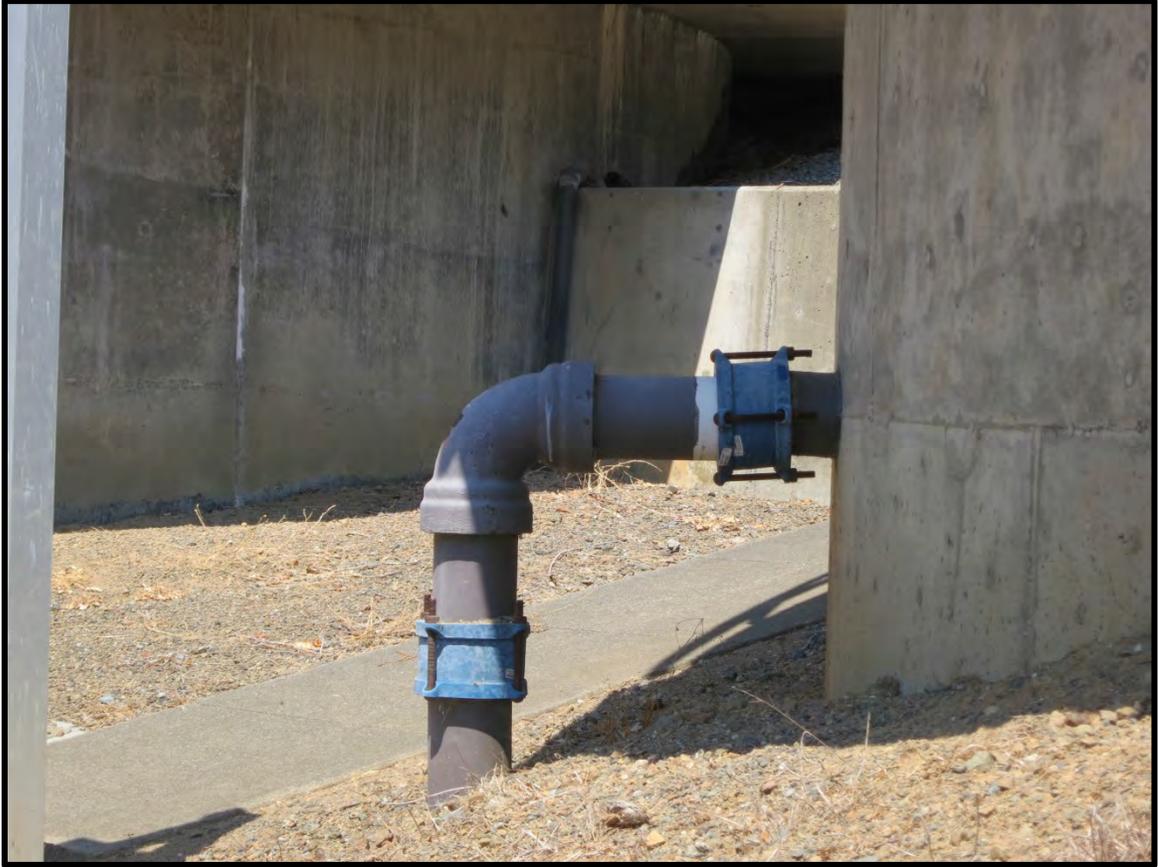
Figure 10: Buried Piping for Clarifier – note offset of top-most coupling

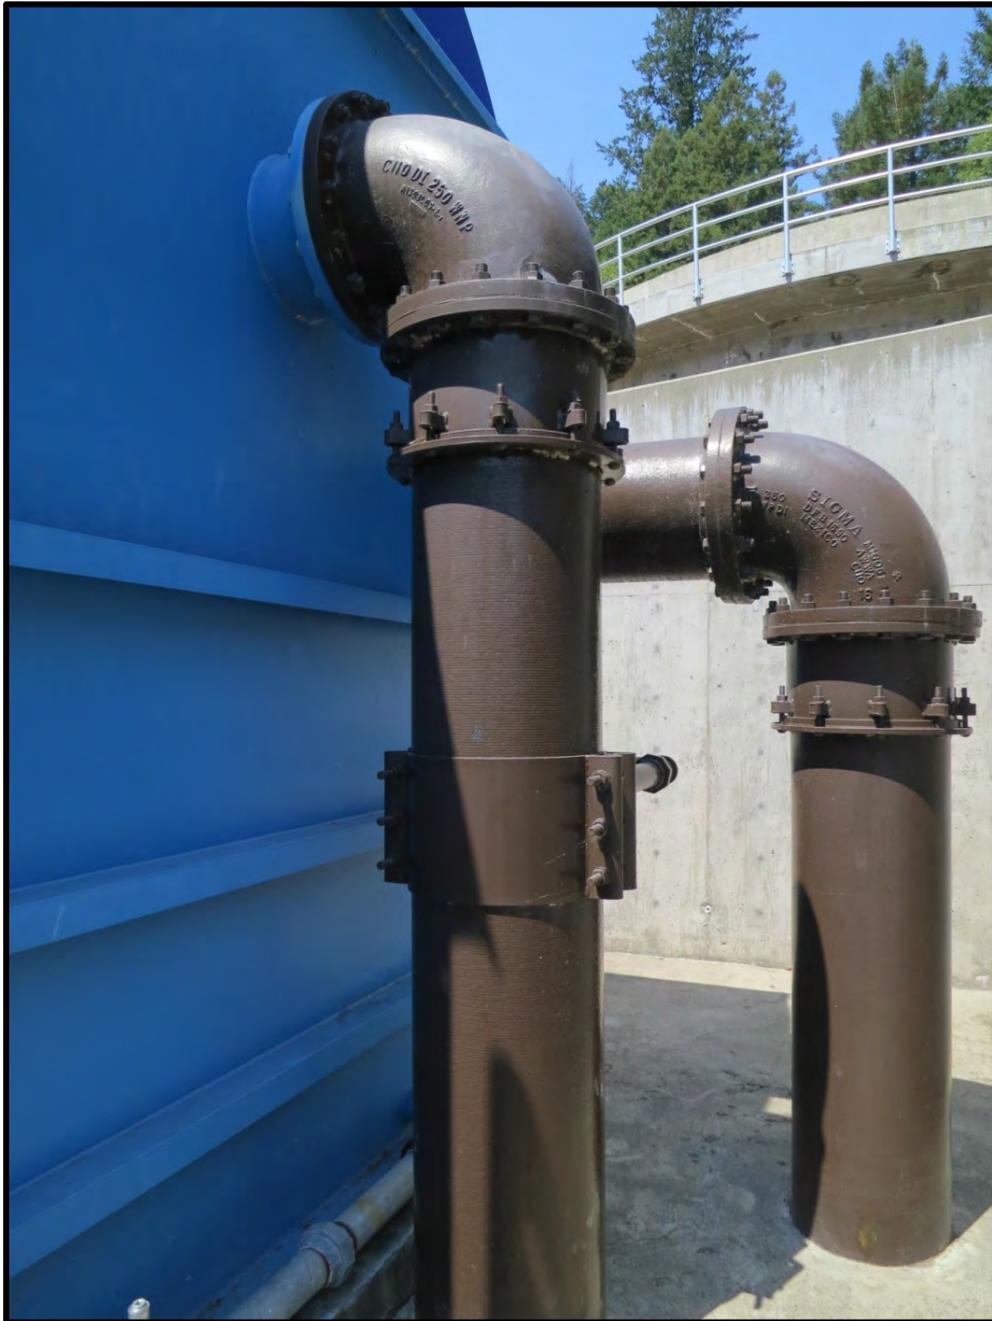
Figure 11: Attached Piping for Filter Tanks (no flexible connections)

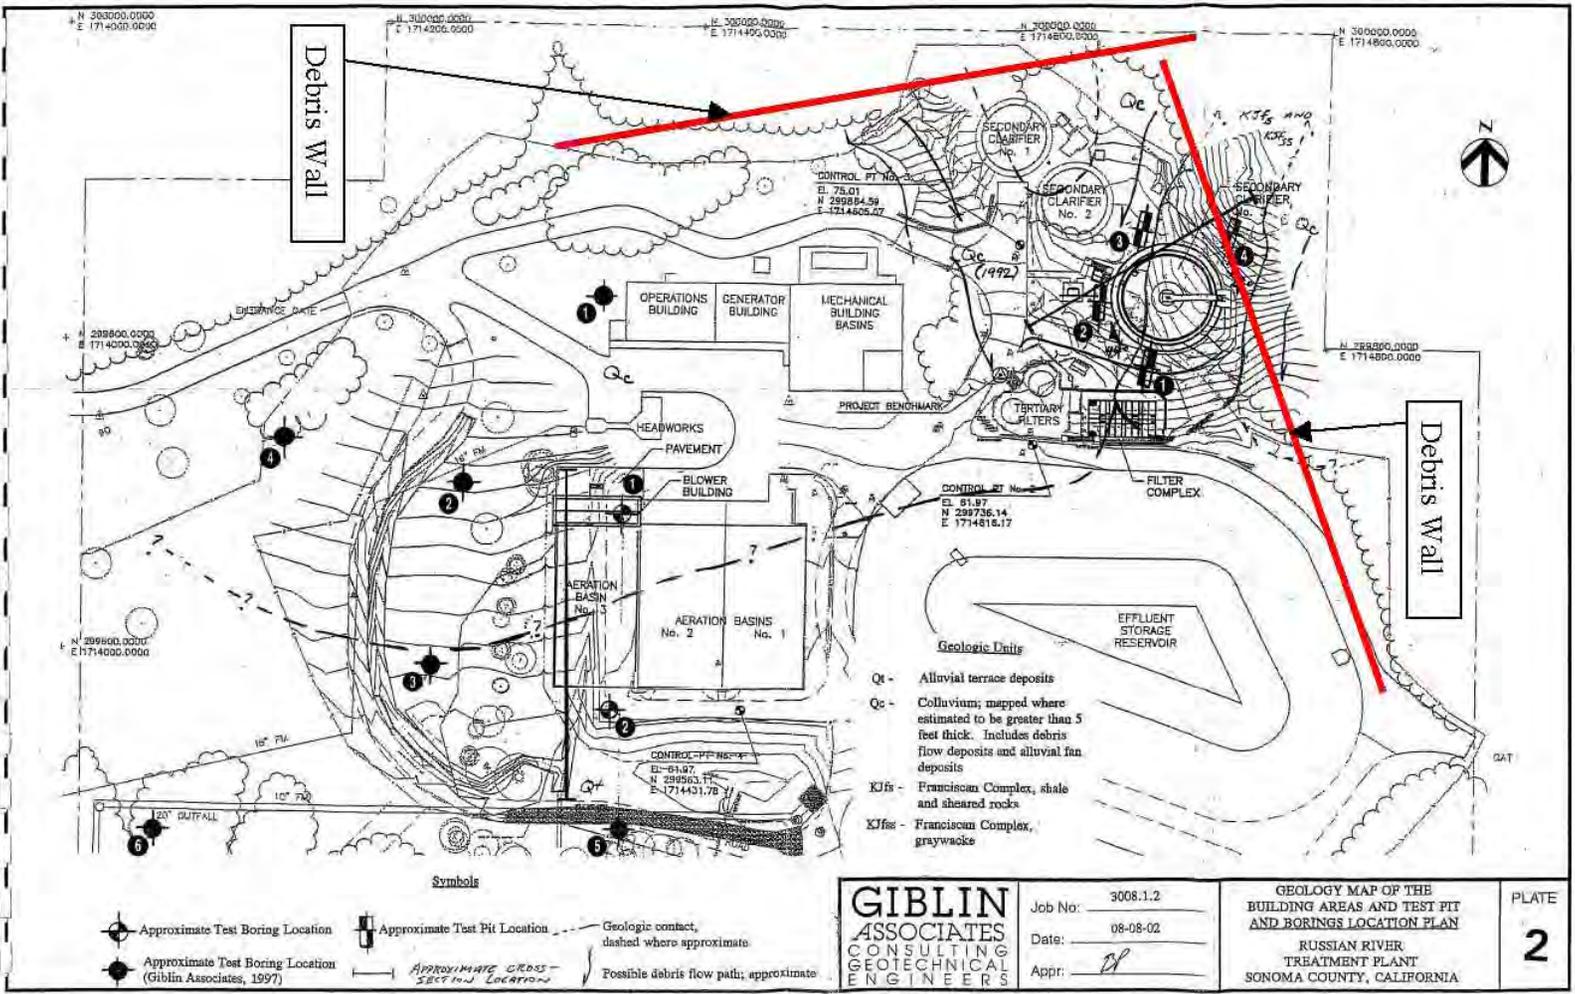
Figure 14: Recommended Debris Diversion Structures at RRCSD WWTP

There is little to no protection from such slope movements to protect the facility at this site. The slopes immediately adjacent and upslope of the site are prone to landsliding, including relatively fast-moving and laterally extensive debris flows. Giblin Associates (2002) performed an evaluation of the site in preparation for the 2003 Third Process Line Project, and reported that debris from earlier flows were approximately 6 feet deep at the site of the 60-foot clarifier. Additionally, a large debris flow in 1992 was triggered by heavy rains when debris extended into the effluent reservoir. The paths of debris flows are shown on Figure 13.

A comprehensive geologic and geotechnical assessment should be performed on these slopes, which include offsite properties, to refine the areas of existing and potential landsliding and development of mitigation alternatives to protect the plant from impact due to landsliding. Design mitigation scheme could include construction of debris diversion/catchment walls or impact fences to protect the essential operations of the treatment plant. See Figure 14. These could be deep-founded structures (possibly soldier-pile walls) intended to deflect the debris away from the primary operational areas of the plant or catchment type fences that prevent the debris from crossing the site or impacting improvements.

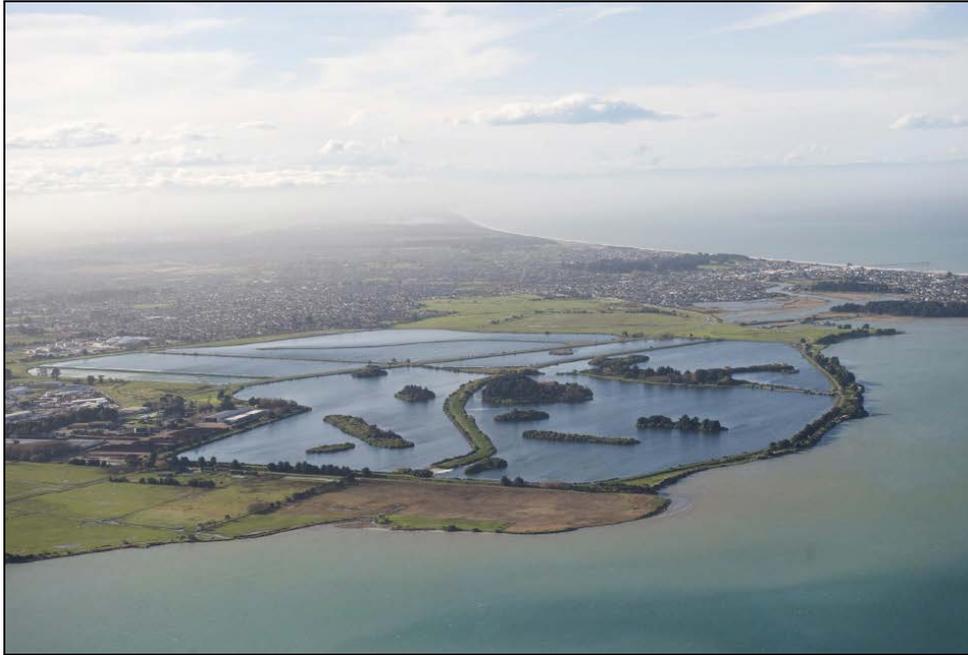
Figure A-2. Christchurch WWTP at Bromley

The primary damage to the WWTP in the September 2010 earthquake was State Highway 71 between Ponds 2 and 4 (Figure A-2) was closed due to 50 cm cracks. The pipe between oxidation ponds 2 and 4 had to be replaced. The levee between Ponds 1 and 2 cracked and

slumped. There were sand boils in many places, with observed PGDs of 30 cm horizontal and 20 cm vertical.

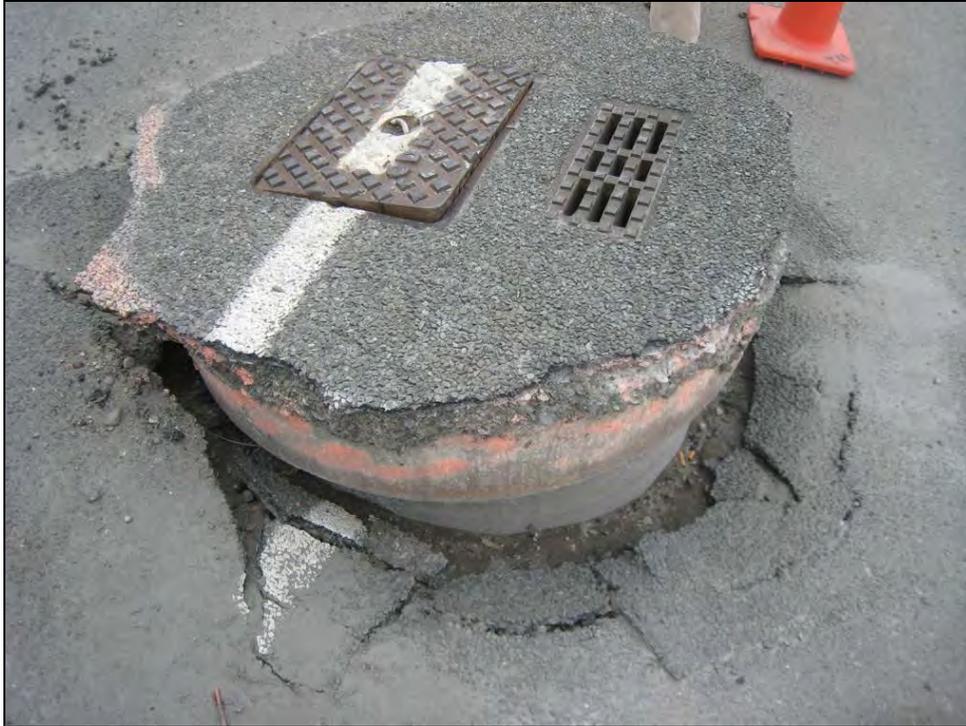
Figure A-7. Floated Sewer Manhole, Brooklands (one of fifteen)

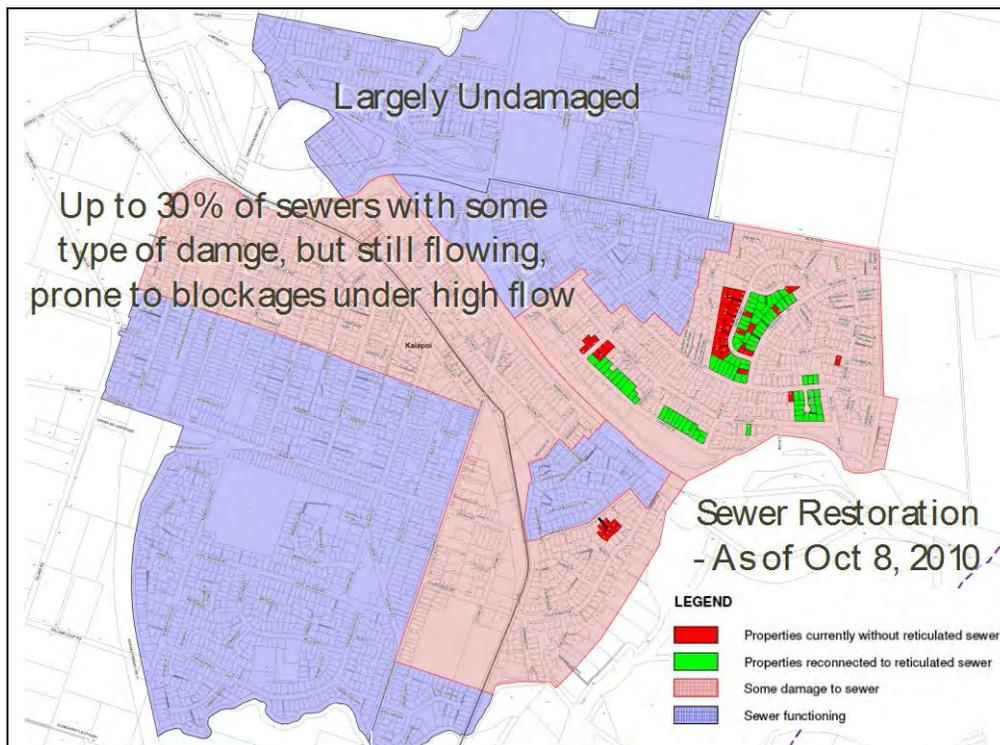
Figure A-13. Map of Sewer Restoration, Kaiapoi, WDC, as of October 8, 2010

Figure A-13 shows a map for Kaiapoi highlighting where the wastewater collection had failed and portable toilets were still in use 6 weeks after the earthquake; more than 200 structures were also so-affected in Christchurch. As of September 29, 2010, there were 150 customers in Kaiapoi and 50 in Pines Beach without any piped sewage service; with the remaining ~95% having piped sewage service.

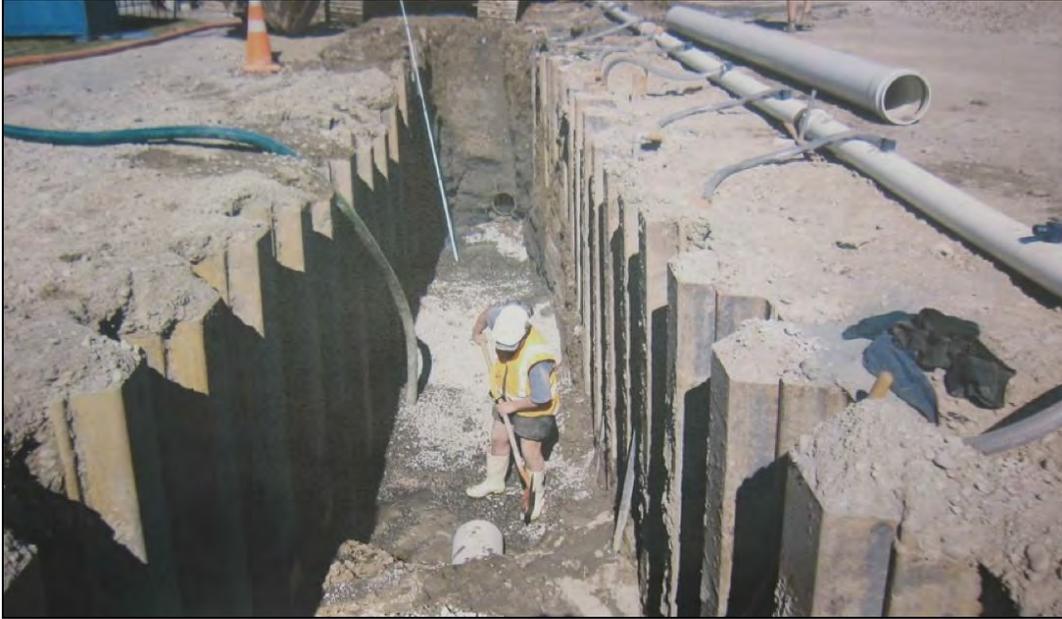
Figure A-15. Repair of Sewer Pipe

Figure A-15 shows a common approach to repairing the damaged sewers. First, the site had to be dewatered. Second, as the pipes are buried deeply (commonly 3 meters of cover), sheet piles (or trench shields) needed to be installed. Finally, the pipe could be repaired / replaced. This is

both a time consuming and expensive effort. Figure A-16 shows a crew working on repair of a deep sewer. Figure A-17 shows a damaged vitrified clay pipe waiting to be repaired.

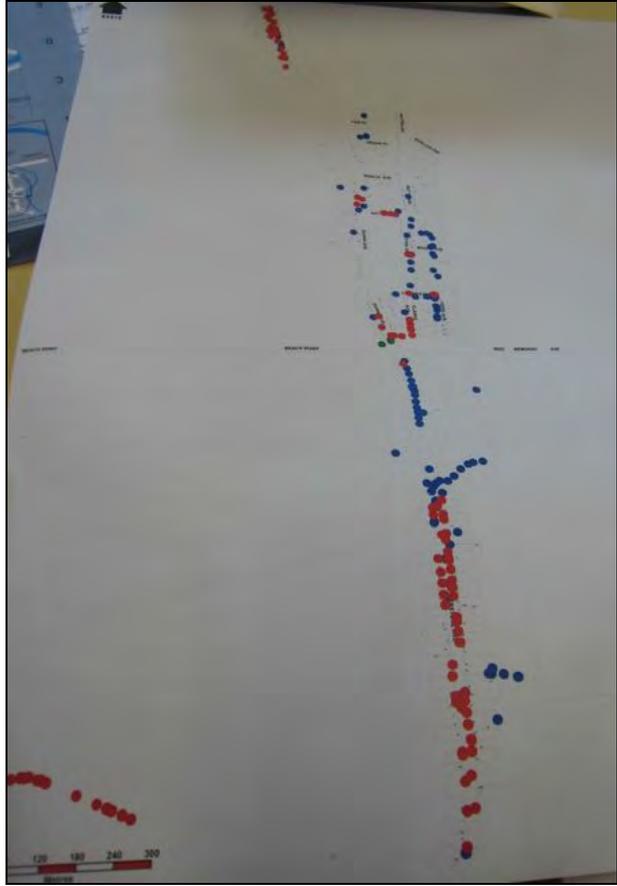
Figure A-18. Pipe Repairs in Pine Beach

Figure A-18 shows a map with the location of repairs made to water (blue dot), wastewater (red dot) or storm water (green dot) pipes in Pine Beach. Much of the Pines Beach community underwent some amount of liquefaction. Figure A-19 shows a similar map for the main urban area of Kaiapoi.

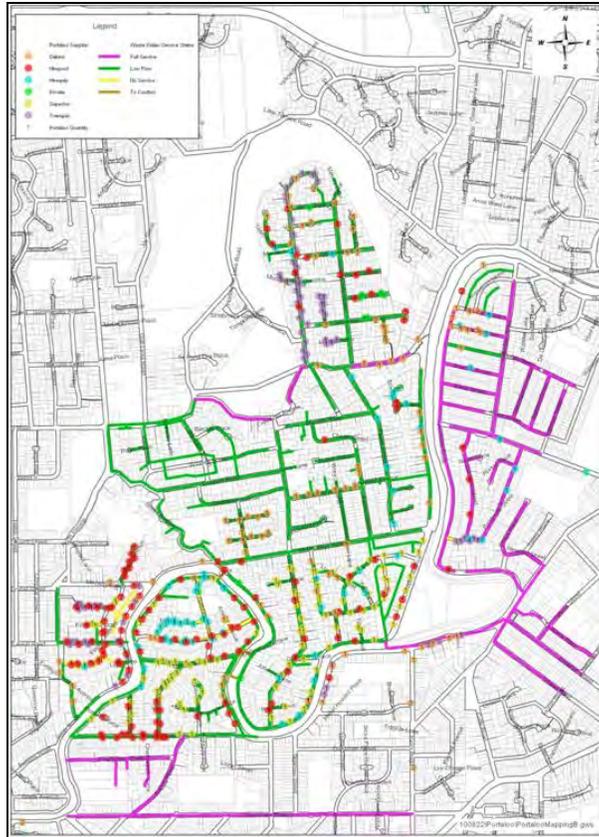
Figure A-20 shows the locations where portaloos were in use as of October 11, 2010, in the Dallington / Avonside / Burwood area of Christchurch. The colored dots reflect the agency that provided the portaloos (numbers indicate the number of portaloos at the site). The color road lines indicate roads where sewage service has been fully restored (blue), partially restored (green) or remained out of service (yellow). Figures A-21 to A-26 show similar information for the Bexley, Brooklands, Halswell, South New Brighton / Southshore, Spencerville and Kainga areas. It would be reasonable to assume that all streets indicated by colored lines in these four maps suffered at least 1 inch, and in many cases several inches, or settlements at depths of the sewers (commonly 3 meters deep).

Figure A-20. Portaloos in Service, October 11, 2010

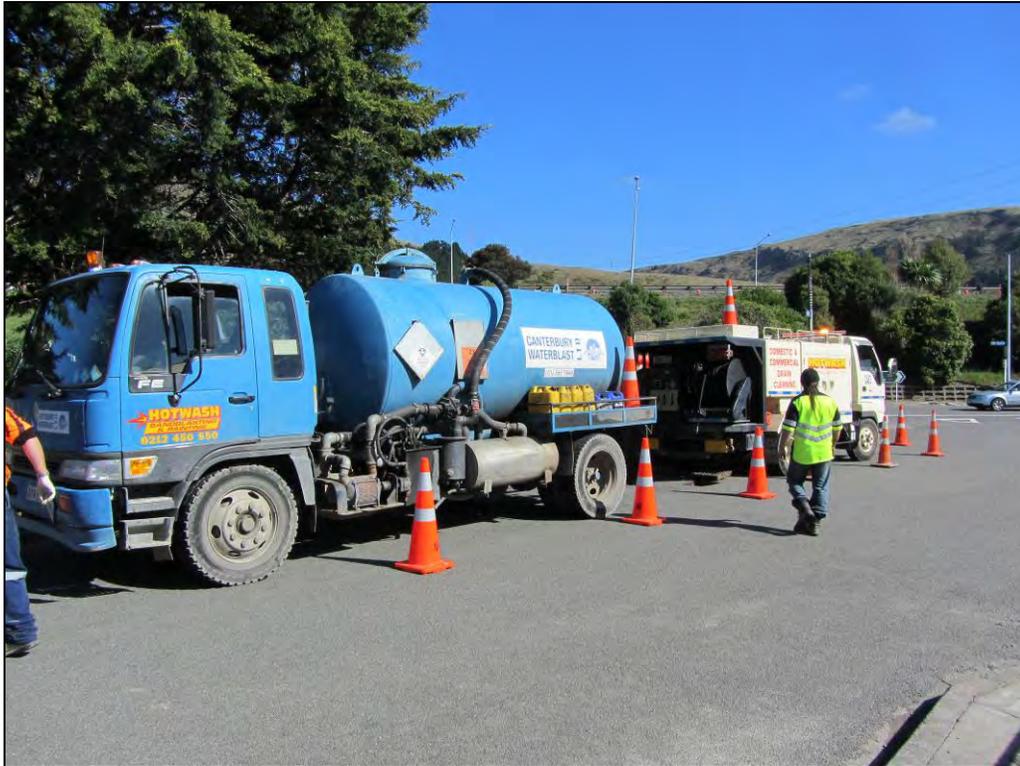
collection pipes, and 11 crews putting cameras through pipes to survey the damage. Figure A-27 shows a crew working to flush sewer pipes with a water jetting method. The jetting cleans the pipes and cameras are deployed after the jetting process to inspect the pipes. Waste from this process is hauled in trucks and disposed at the WWTP. At locations where large sewer pipe breaks occurred, the jetting process sometimes effectively mined the sand from the ground surrounding the pipes and resulted in sink holes in the roadway above. Some cars fell into sink holes. The process was modified to reduce the possibility of creating sink holes by monitoring the rate of progress of the jetting holes, when the rate significantly slows the crews stop the jetting and report a location of potential significant damage.

Figure A-27. Crew flushing sewer pipes.

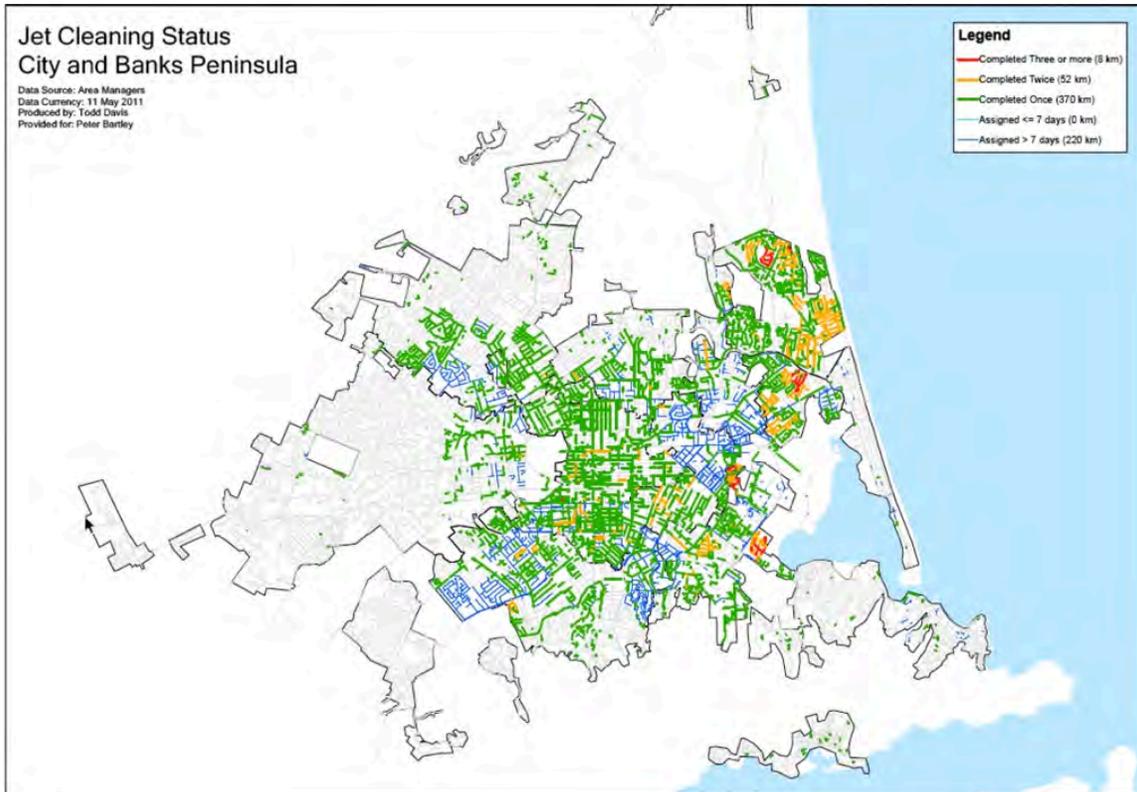
Figure A-28 shows the status of the jet cleaning effort, as of May 11, 2011. The colored pipes correspond nearly one-to-one with portions of the city that has moderate to major liquefaction; and the thin grey pipes are located in parts of the city that had no (or rare) liquefaction). The red lines indicate pipes that had been jet cleaned 3 or more times (8 km); orange lines indicate pipes that had been cleaned 2 times (52 km); and green lines indicate pipes that had been cleaned 1 time (370 km).

Figure A-28. Jet Cleaning of Sewer Pipes (Status as of May 11 2011)

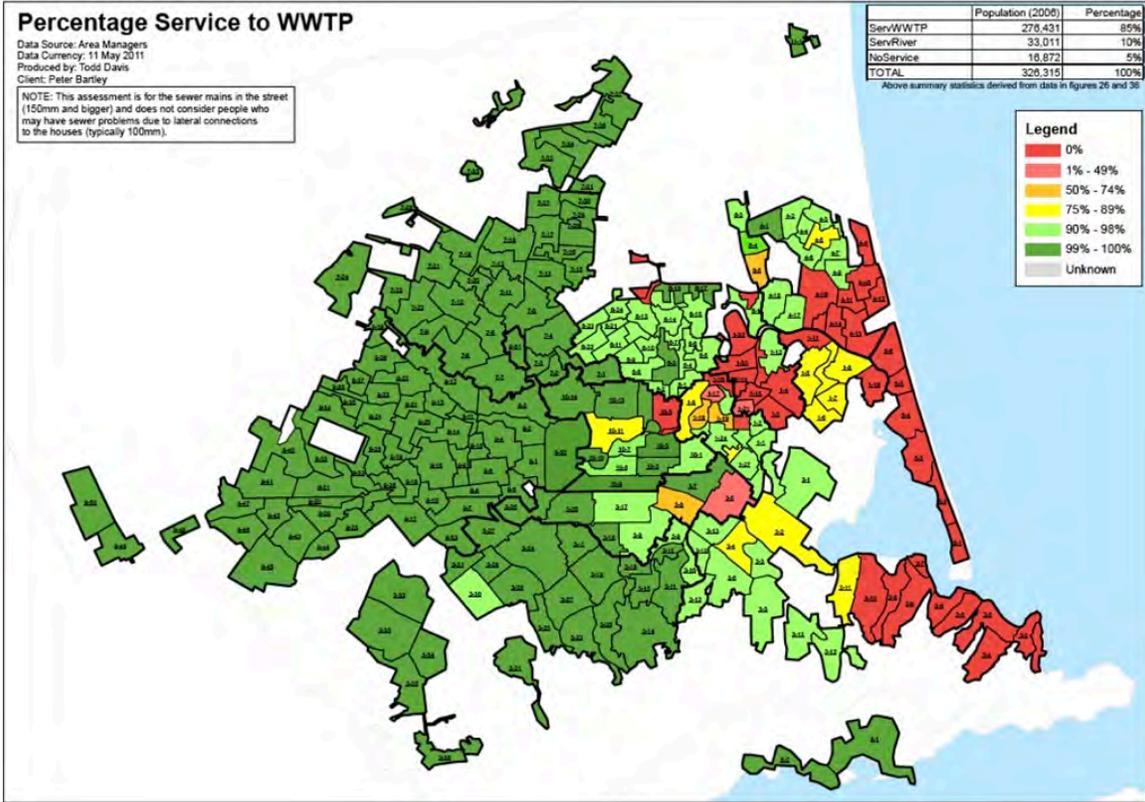
Figure A-29 shows the portions of Christchurch that have functional piped sewer service to the WWTP, as of May 11 2011. This map is based on functioning sewers, 6" and larger, and excludes damage of laterals to mains. Figure A-30 shows a similar map, but highlighting the parts of the city with piped sewer service, except that the sewage is being discharged into local streams, as there remains damage in the sewer mains to the WWTP.

Figure A-29. Portion of Christchurch with Piped Sewer Service to the WWTP (Status as of May 11 2011)

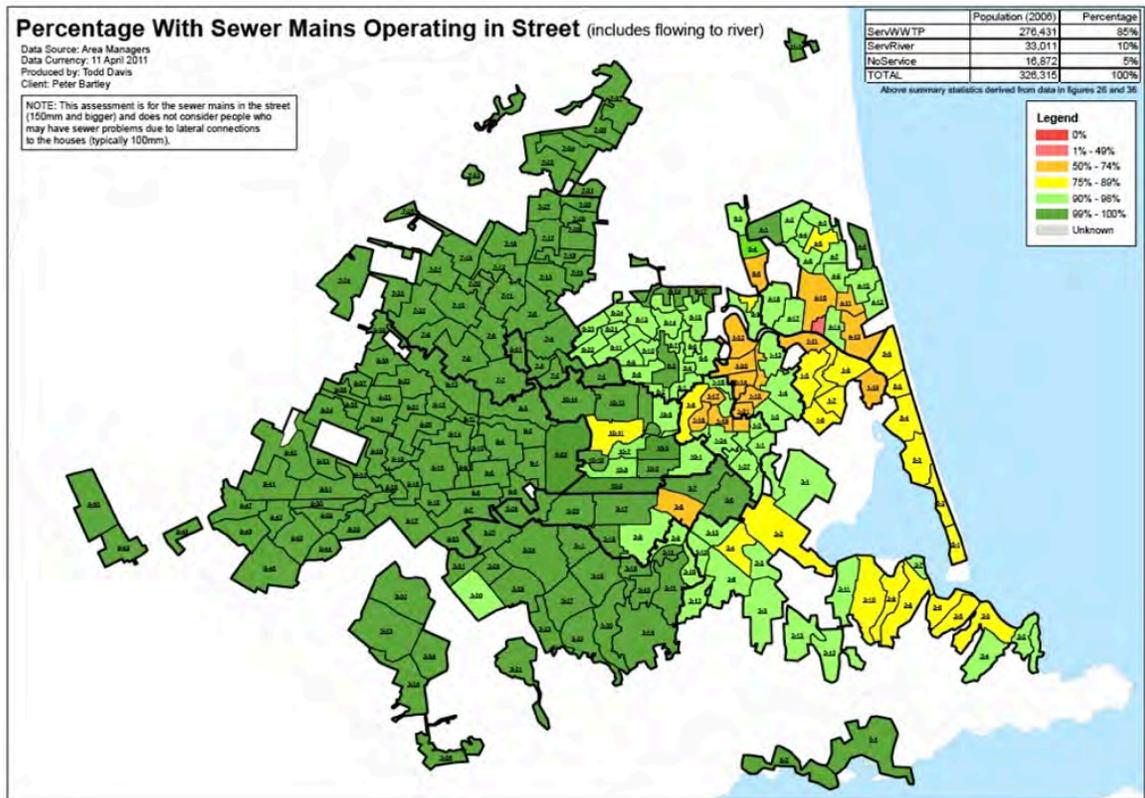
Figure A-30. Portion of Christchurch with Piped Sewer Service, either discharging to local streams or to the WWTP (Status as of May 11 2011)

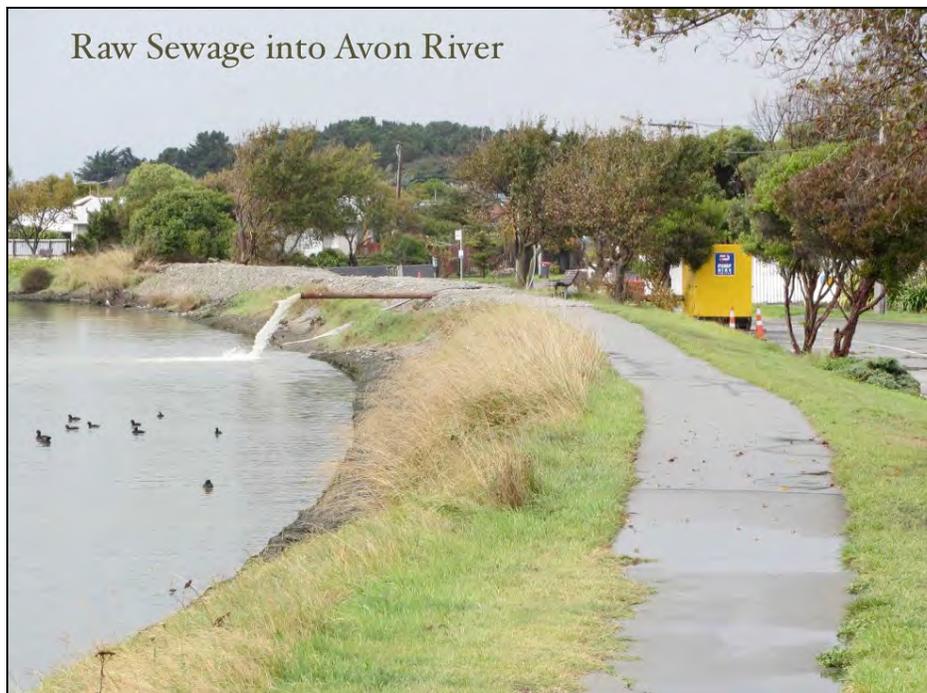
Figure A-33 shows raw sewage being spilled into the Avon River (note the ducks). The sight of solids floating on the river surface has been judiciously cut-out of the images in this report.

Figure A-33. Raw Sewage in Local River, April 2011

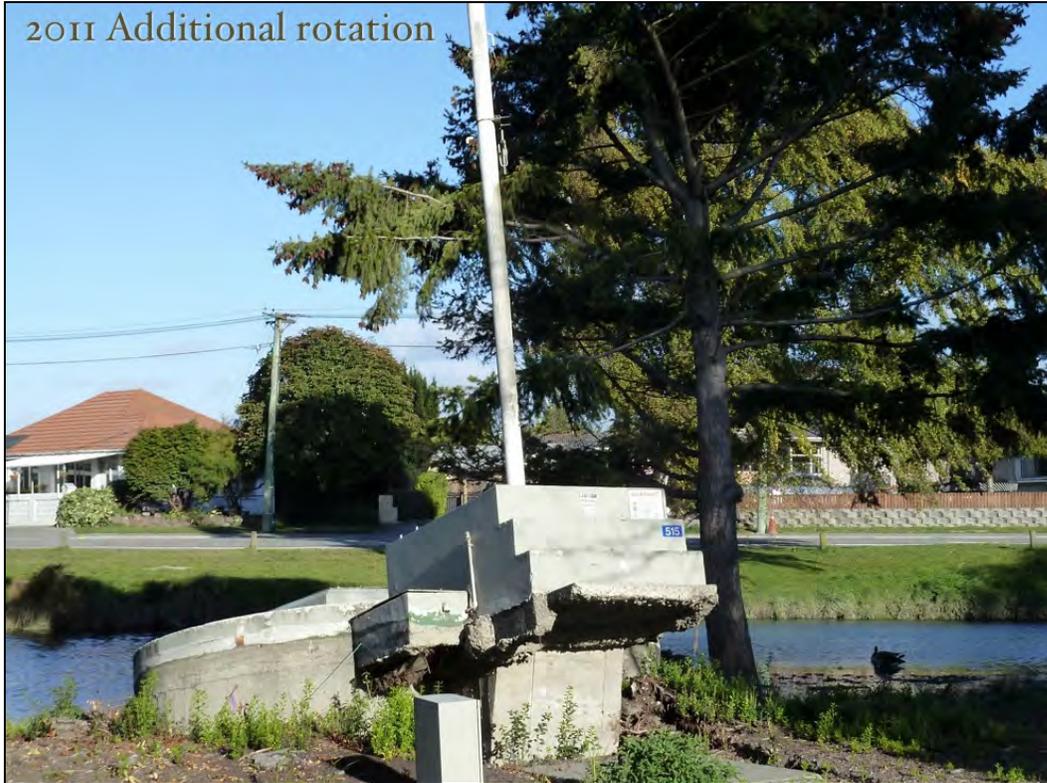
Figure A-34 shows the additional movement of a sewer dry well lift station, due to the February 2011 earthquake. Compare this with the movement of the same lift station from the September 4 2010 earthquake, Figure A-4.

Figure A-34. Rotation and Sewer Lift Station, April 2011 (see Fig A-4 for Comparison)

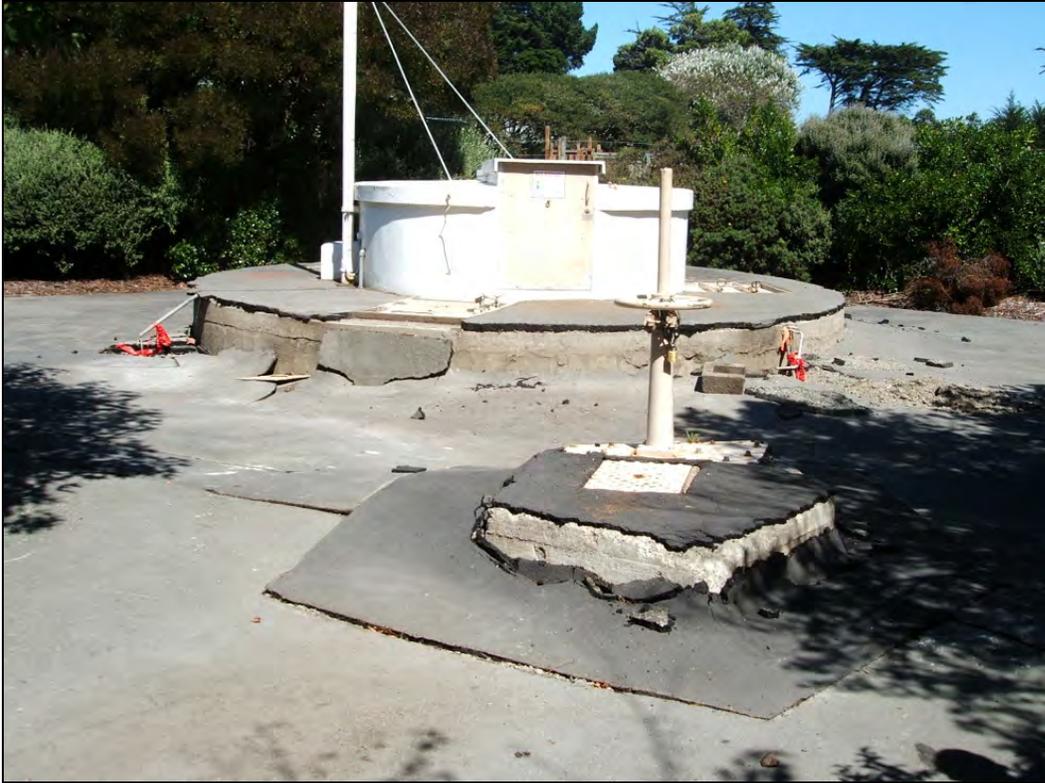
Figure A-35 shows another dry well lift station that floated in the February 2011 earthquake. Several other dry well pumping stations floated during the February, 2011 earthquake due to the more extensive liquefaction. The total uplift between the two earthquakes at some stations was measured at about 0.6 m and could exceed a meter at other stations.

Figure A-35. Flotation of Sewer Lift Station, April 2011

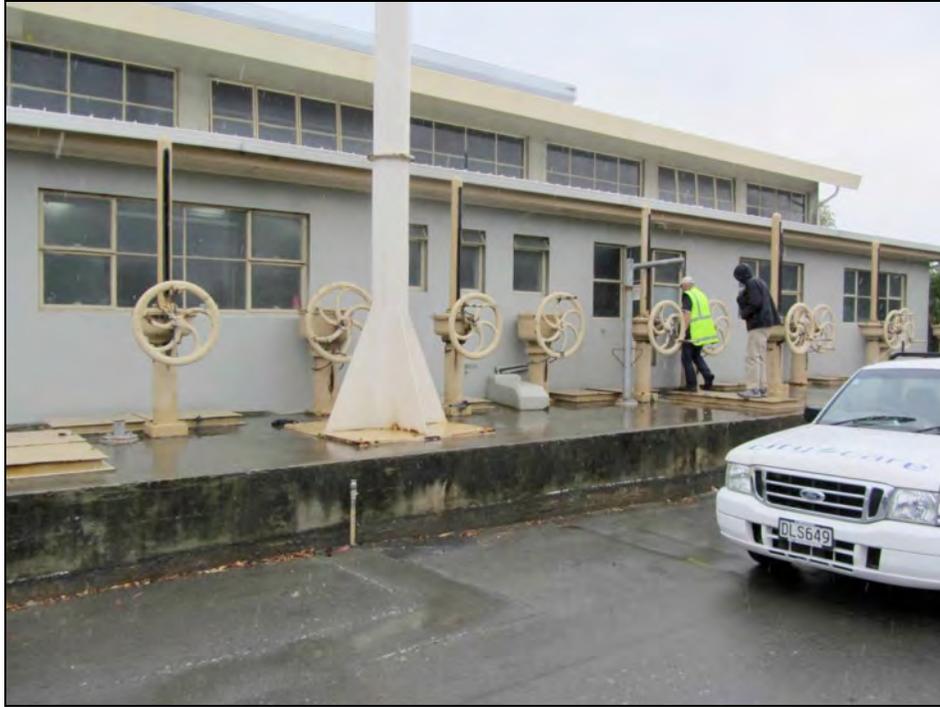
Figure A-36. Pages Road Pumping Station

Figure A-36 shows the Pages Road Sewage Pumping Station. The pump station site suffered severe liquefaction. The suction well floated about 4" to 6" and connections with the sewage pipes broke outside the station, but the pumps and internal piping remained functional. Measurements on the outside indicated differential movements of 4" to 10" across the entire building. There were no flexible connections for piping at this station. Figure A-37 shows the interior wall differential movement.

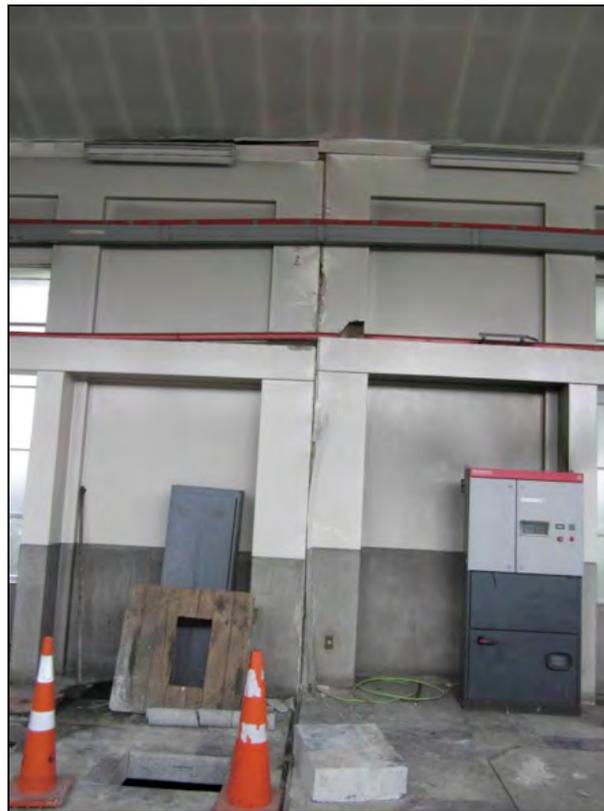
Figure A-37. Pages Road Sewer Pumping Station differential movement

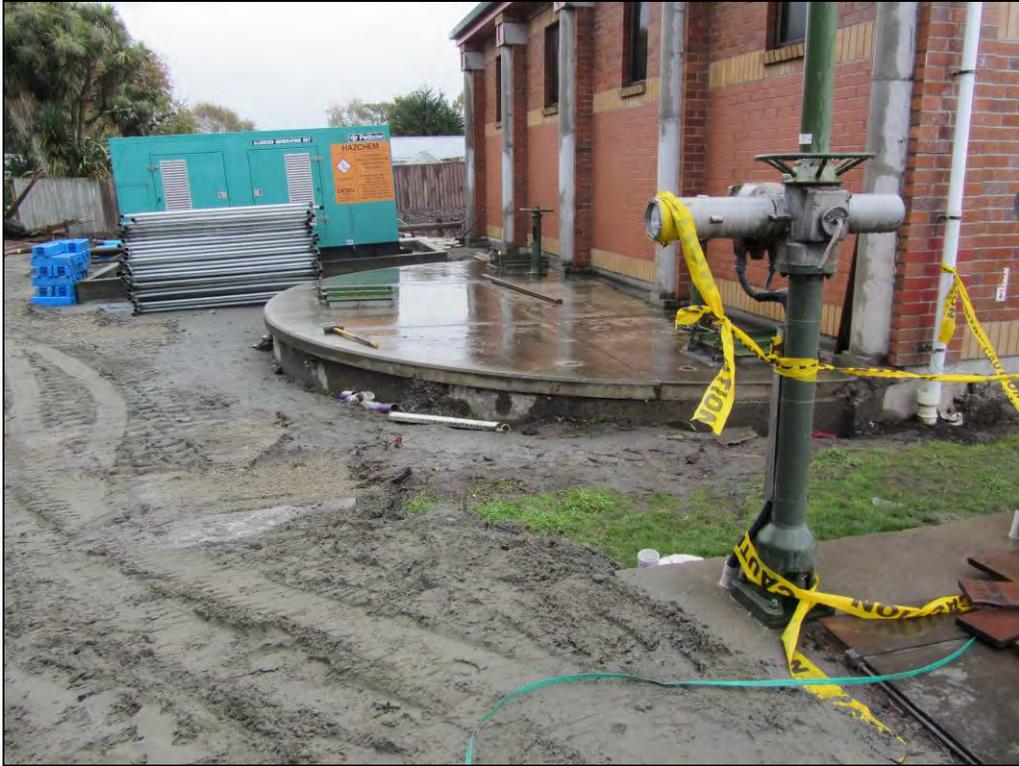
Figure A-38. Sewer Pumping Station No. 36

Figure A-38 shows uplift of the suction well at sewer Pumping Station No. 36. The concrete pumping station was not damaged by the earthquake, but liquefaction in the area damaged the inlet and outlet pipes and kept the station from functioning. CCC began sucking sewage from the wet well to dispose of the sewage in a truck. As they were sucking out the sewage the wet well began to float (should have been no surprise!)

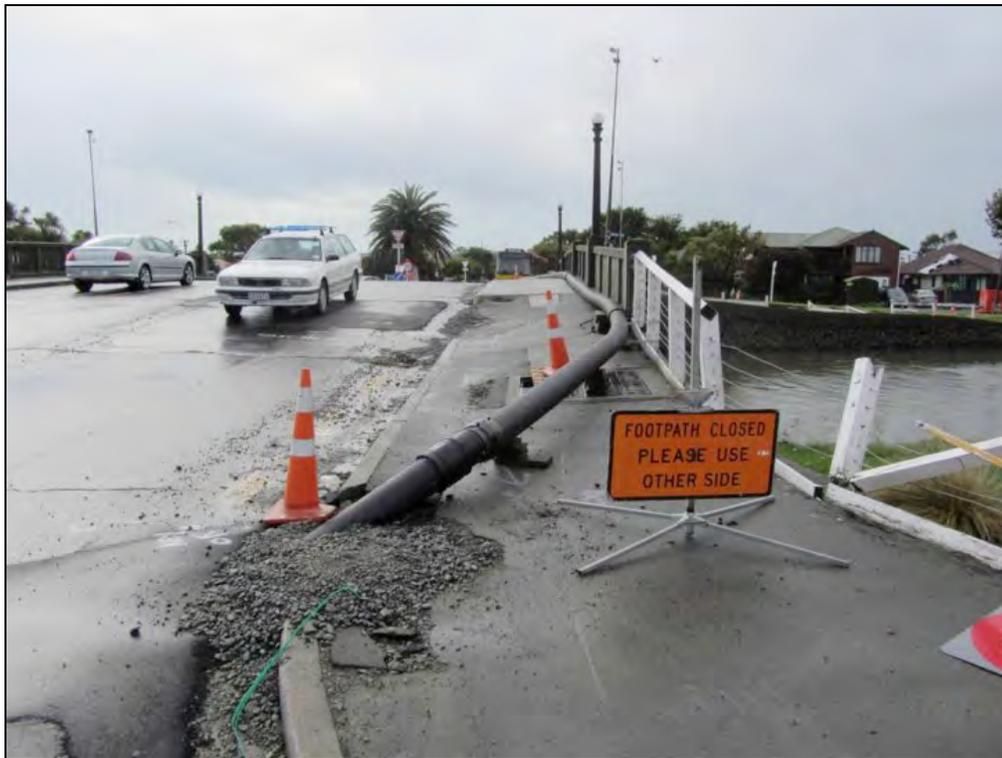
Sewer pipelines were damaged at bridge crossings where the bridge abutments were damaged by lateral spreading. Figure A-39 shows a HDPE pipe used as a temporary bypass line placed overtop of the Brighton Bridge.

Figure A-39. Sewer pipe bypass over the Avon River at Brighton Bridge
