Descriptions of Proposed Project and Enhanced Compliance Action As Part of Settlement of North Coast Regional Board ACL, Prepared By Russian River County Sanitation District Staff, December 2015

Russian River County Sanitation District Natural Hazard Reliability Assessment

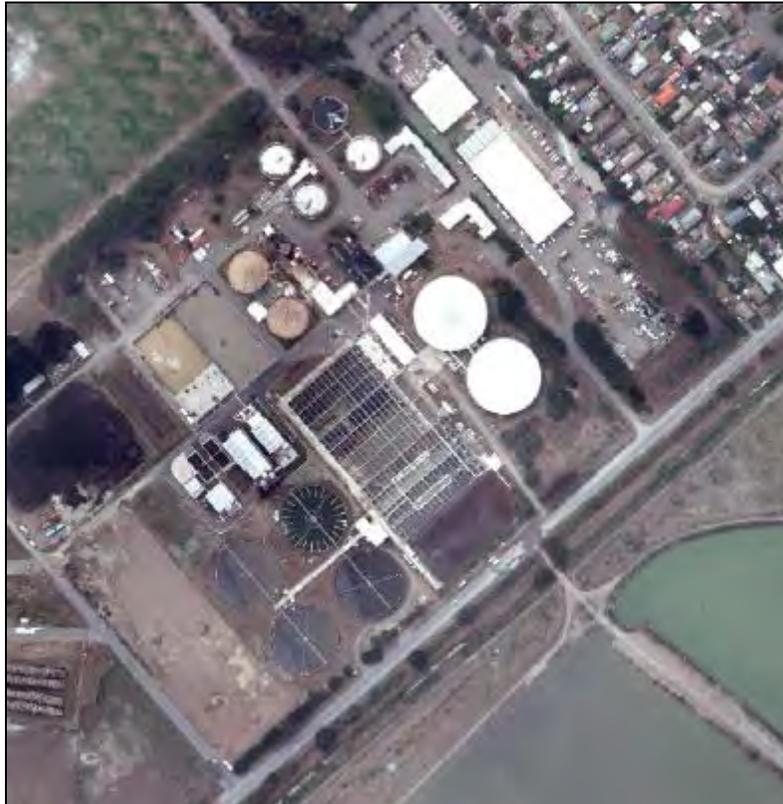
Figure A-40 shows the process flow diagram for the Bromley WWTP. Figure A-41 shows an aerial view of the WWTP following the February 2011 earthquake. Figure A-42 provides a close

Figure A-41. Aerial view of Bromley WWTP following the Feb. 2011 earthquake

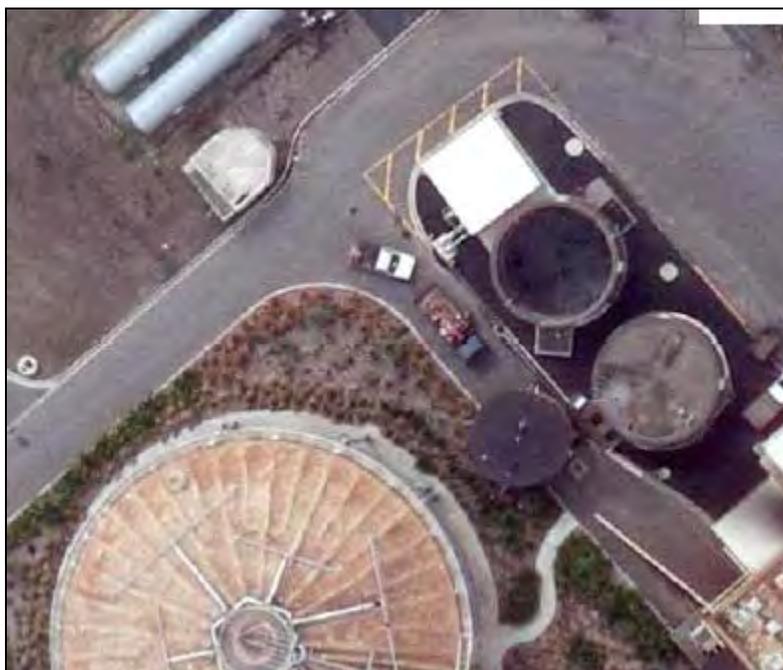
up from the area above the digester tanks showing how one of the two tanks had its roof thrown off during the earthquake.

Figure A-42. Aerial view of digester tanks at Bromley WWTP

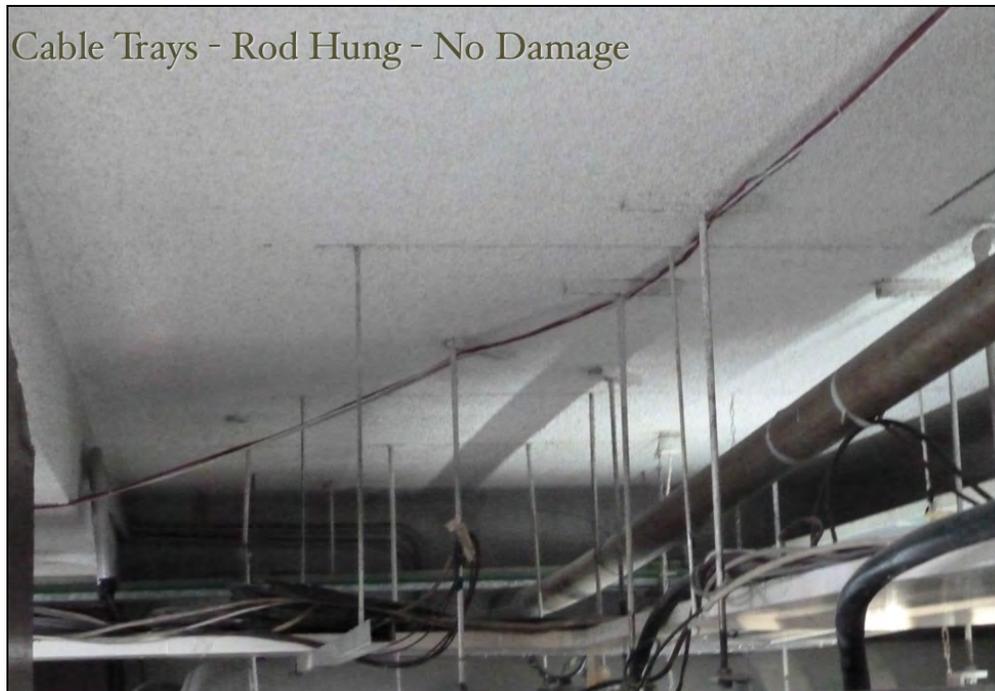
Figure A-44 shows a cable spreading area at the Bromley WWTP. While the facility shook with $PGA = 0.5g$, there was no damage to these rod-supported trays and pipes; showing that intelligent New Zealand engineers have recognized the wastefulness of ASCE 7 2010 and related non-structural code that would require seismic lateral braces in such a situation.

Figure A-44. No Damage to Rod-Hung Cable Trays, Bromley WWTP

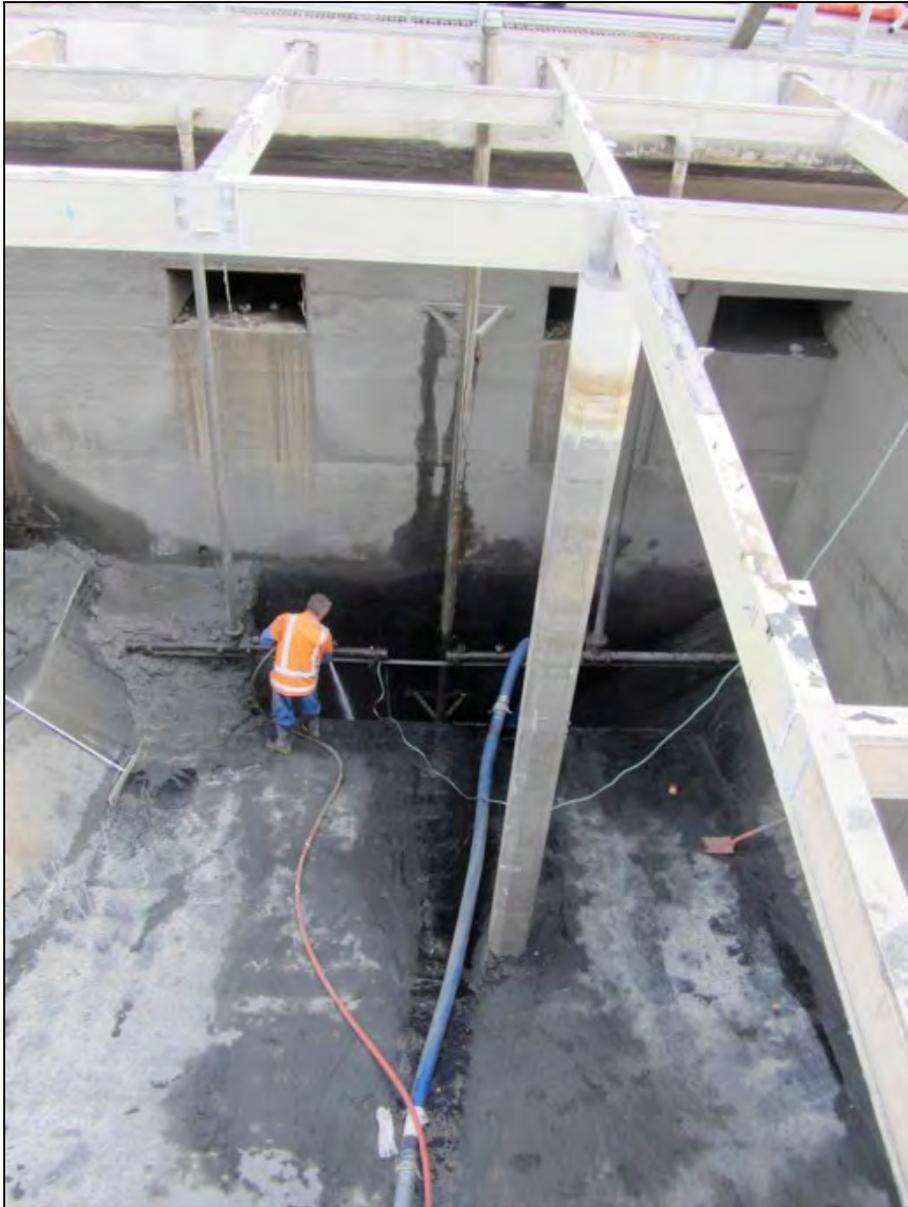
Figures A-46 and A-47 show workers cleaning sand from the grit chambers and the primary settling basins, respectively. These basins were reportedly completely filled with sand and were at the end of cleaning at the time of photos taken in early April 2011. The depth of sand reached about 6 meters, completely filling the grit chamber in Figure A-46 to the top water mark notable near the top of column. One set of grit chambers and primary settling basins were restored within

about 1.5 to 2 weeks after the earthquake. Since then the plant has been working at about 1/3 capacity and the different sets of grit chambers and primary settling basins have been rotated between cleaning of sands and treating of sewage.

Figure A-46. Grit Chamber cleaning, Bromley WWTP

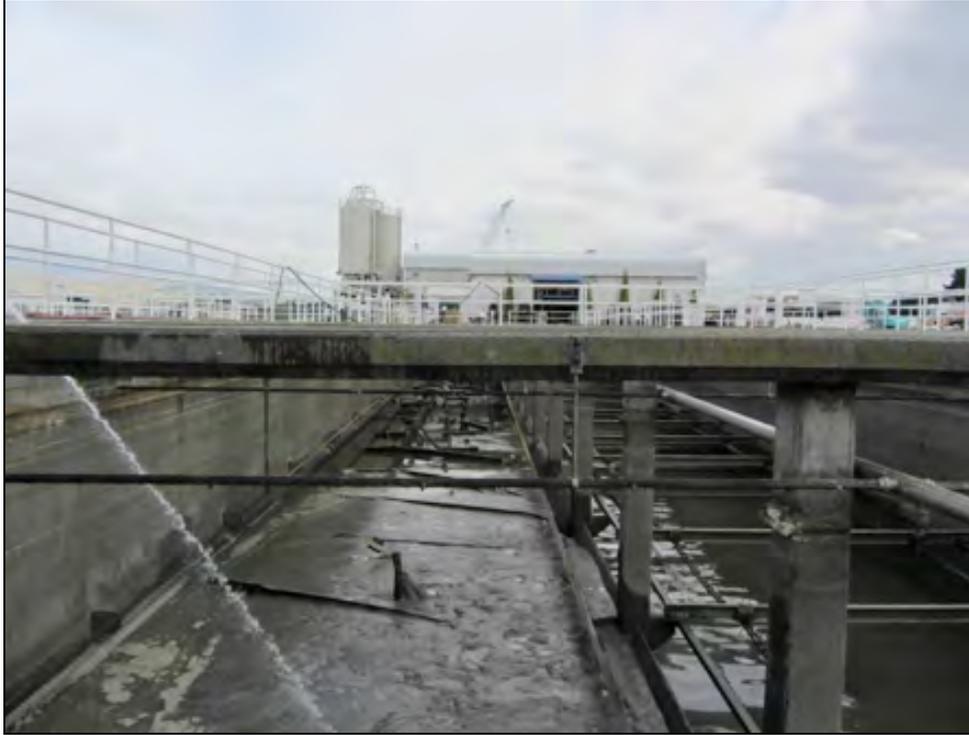
Figure A-47. Primary Settling Basins Cleaning, Bromley WWTP
