**Complaint Inspection Report
Daniel Franklin Property
1-00NTMP-019 MEN/LAK
Lake and Mendocino Counties
WDID No. 1B13159CNME**

Date: April 30, 2014

Subject: May 3, and May 24, 2013 inspections

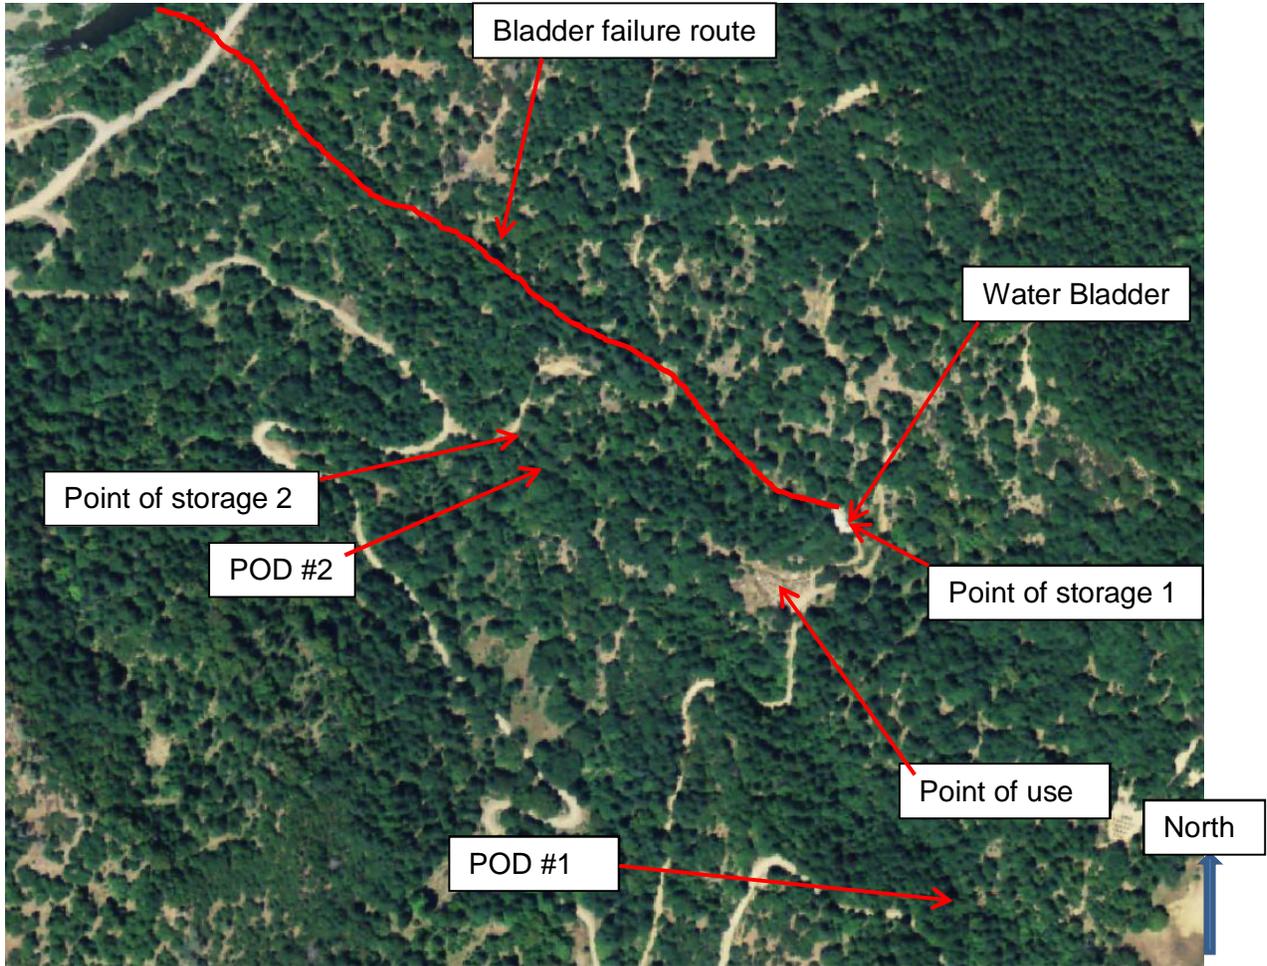
Image 15- NAIP 2012 the areas identified on the map approximate locations observed in the field and discussed above in the report.

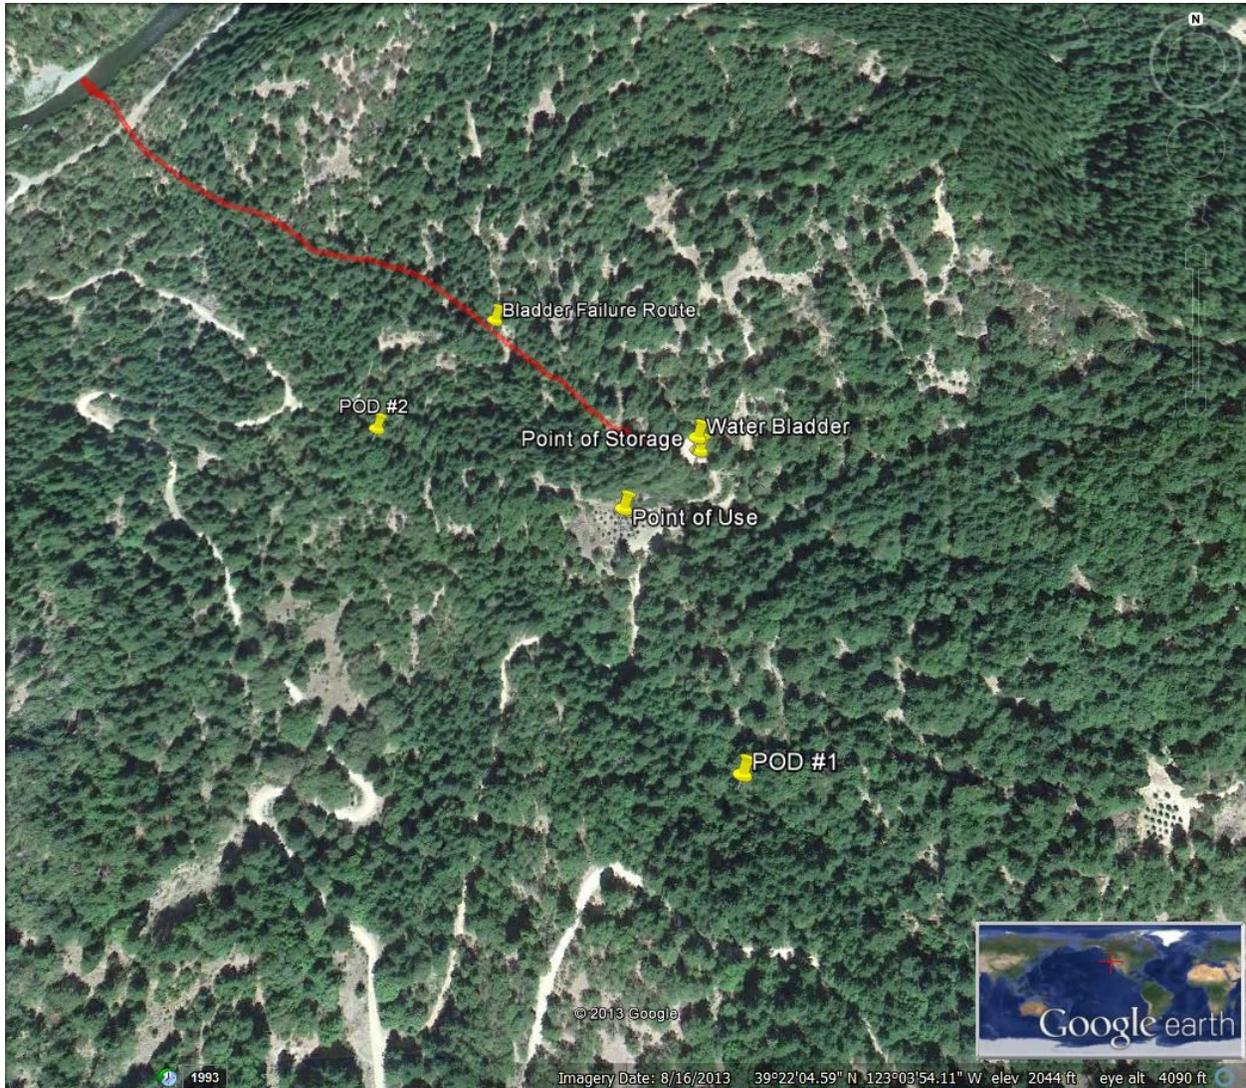
Image 15, Google Earth Image of subject property and locations described within this report. The map points are generated by hand, and are estimated locations on the google image based upon observable landmarks. There is also a point of storage not shown, located directly downstream of POD #2 next to the road.
