State Water Resources Control Board – Office of Enforcement Inspection Report

Inspection Date & Time:	02/01/2016 11:47am –3:11 pm	Inspected By:	<i>State Water Resources Control Board, Office of Enforcement:</i> Dylan Seidner Sr. Environmental Scientist & Bryan Elder Water Resource Control Engineer see Additional Attendees , below
SMARTS WDID:	1 23CN602948	Report By:	Dylan Seidner
Owner/Operator:	Sierra Northern Railway, 341 Industrial Way, Woodland, CA 95776 Mendocino Railway – Skunk Train, Foot of Laurel St., Fort Bragg		
Site Type:	Railway construction - tunnel cave-in repair		
Site Name:	Skunk Train, Tunnel 1 West Portal		
Site Address:	Approximately 39°26'49.55"N, 123°45'46.10"W (Pudding Creek bridge)		
Site Contact:	Robert Pinoli, Vice President, Skunk Train rjp@mcn.org ; 707.964.6371		
Site Staff Present for Inspection:	Robert Pinoli, Vice President, Skunk Train Kennan Beard III, President and CEO, Sierra Northern Railway kbeard@sierrarailroad.com ; 530.666.9646 ext. 101 Teri Jo Barber, Storm Water Consultant, Ridge to River Environmental Services teriijo@ridgetoriver.com ; 707.357.0857 Josh Bumpus, Manager, Maintenance of Way, Sierra Northern Railway jbumpus@sierrarailroad.

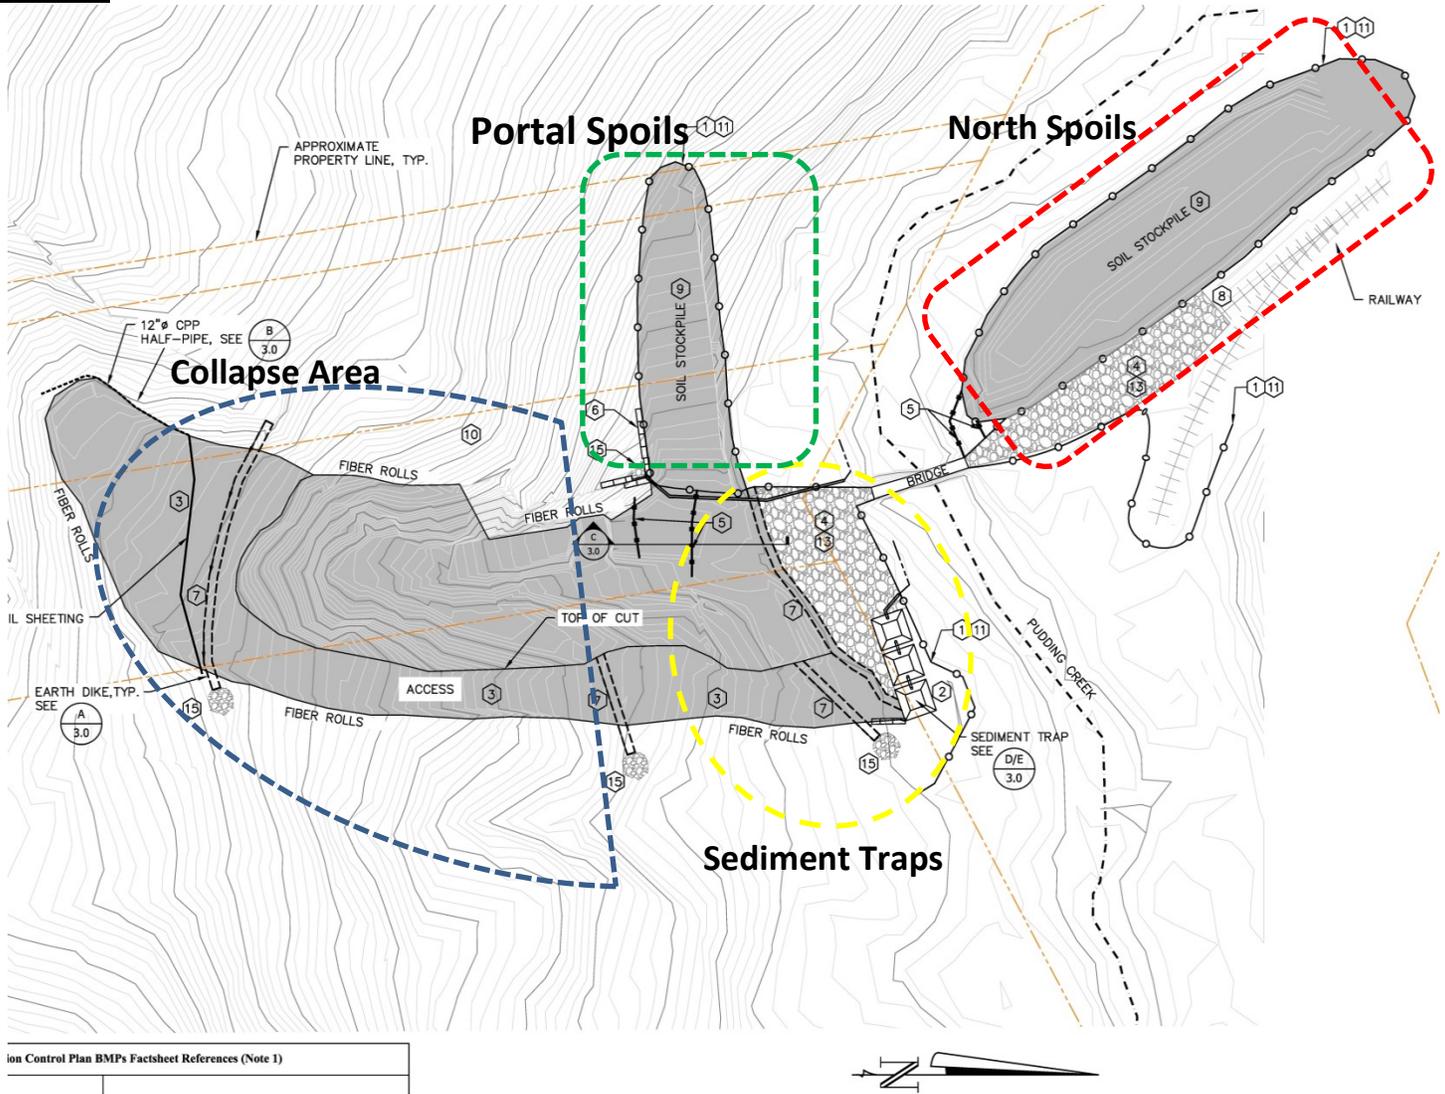
Map 1 - Cropped area of the *BMP Implementation Plan*, part of the *Erosion Control Plan* (dated 11/10/2015) submitted in response to the *Requirement for Information Pursuant to Water Code section 13267*, for *Mendocino Railway, Fort Bragg, Mendocino County* (11/13/2015).

For orientation later in this report, four areas are defined and labelled on Map 1: **Collapse Area** (half circle in blue), **Portal Spoils** (rectangle in green), **Sediment Traps** (circle in yellow), and **North Spoils** (rectangle in red). Pudding Creek and the rail bridge over Pudding Creek are to the left of the **North Spoils** area.
