Re: Transmittal Letter for Subgrade Sampling Results and Report of Remedial
Actions, Compost High-Flow and Low-Flow Ponds, Recology Hay Road, Solano
County, California

**RE: SUBGRADE SAMPLING RESULTS, COMPOST AREA POND, RECOLOGY HAY ROAD,
SOLANO COUNTY, CALIFORNIA**

This report summarizes the remedial actions completed, repairs made to the liner systems, and the associated testing that was performed.

**FIGURE 2
COMPOST AREA PONDS REPAIR PLAN
RECOLOGY HAY ROAD**

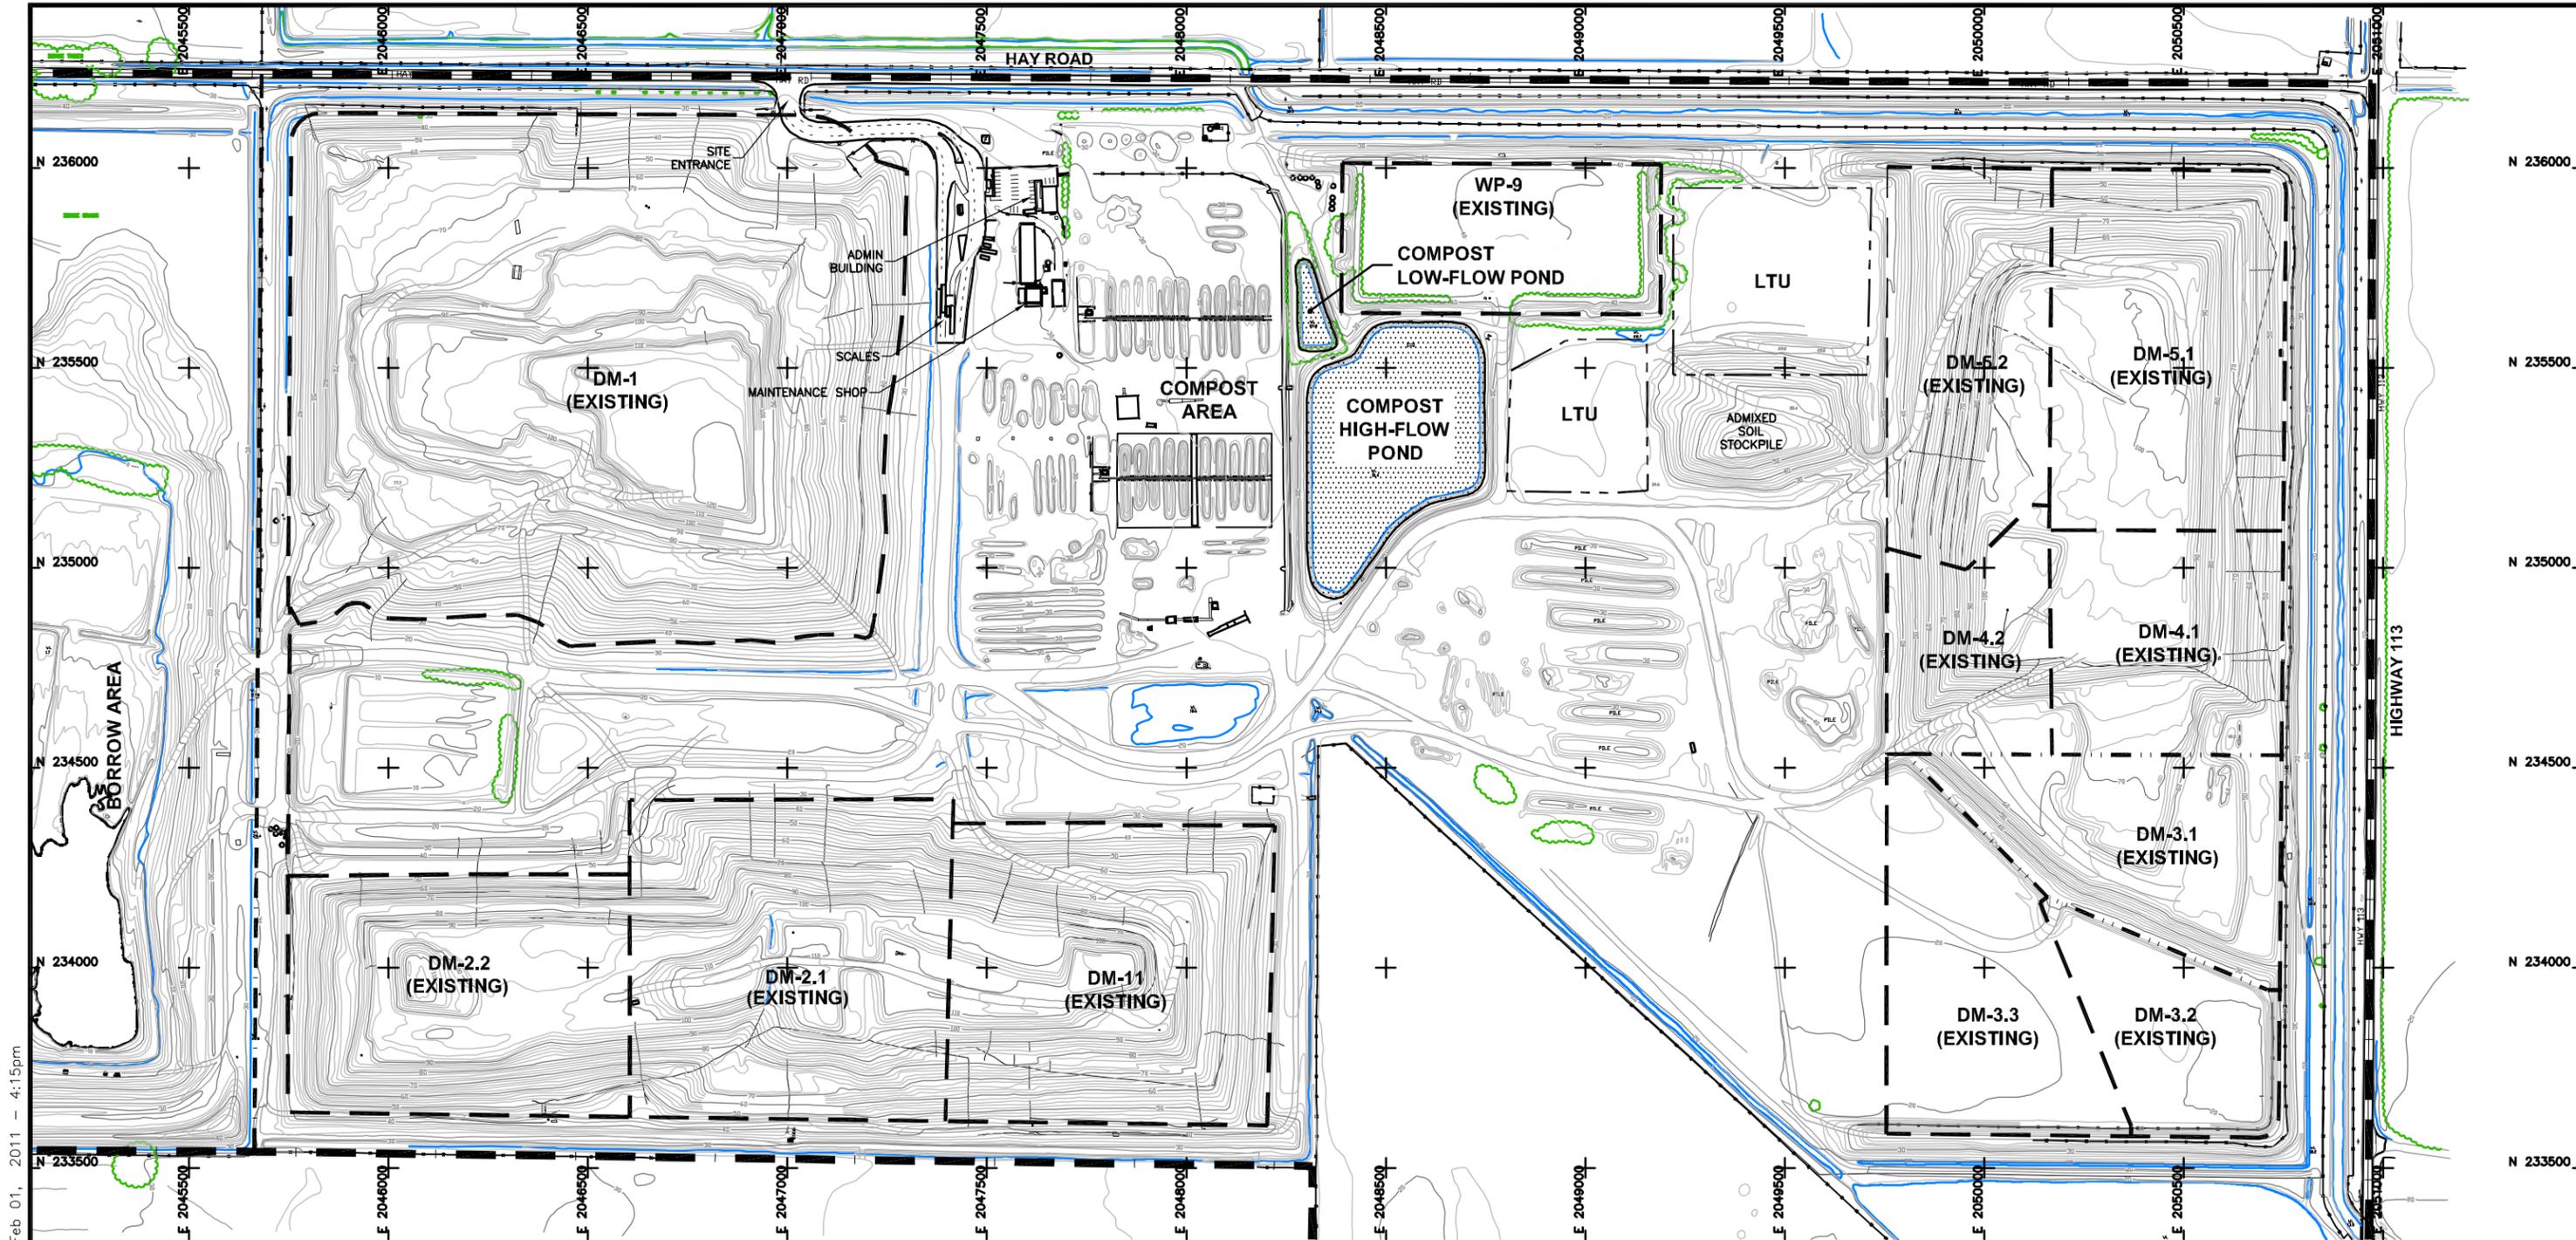
**FIGURE 1
SITE PLAN
RECOLOGY HAY ROAD COMPOST PONDS REMEDIATION**

The composting area and associated stormwater management is operated in accordance with the Waste Discharge Requirements (WDRs) Order No. R5-2008-0188. As discussed previously, the larger, 5-acre Compost High-Flow Pond provides the primary containment of surface water run-off from the composting area to the west. The 0.5-acre, Compost Low-Flow Pond is located northwest of the larger Compost High-Flow Pond and collects compost liquids and surface water during low-flow periods to allow more efficient aeration of these liquids prior to discharge to the larger pond. Figure 1 shows the pond locations.
