CALIFORNIA REGIONAL WATER QUALITY CONTROL BOARD
CENTRAL VALLEY REGION

ADMINISTRATIVE CIVIL LIABILITY COMPLAINT R5-2015-0520
IN THE MATTER OF

CHRISTOPHER CORDES, EDDIE AXNER CONSTRUCTION, INC., AND EDDIE AXNER

ASSESSOR PARCEL 041-300-035-000
SHASTA COUNTY

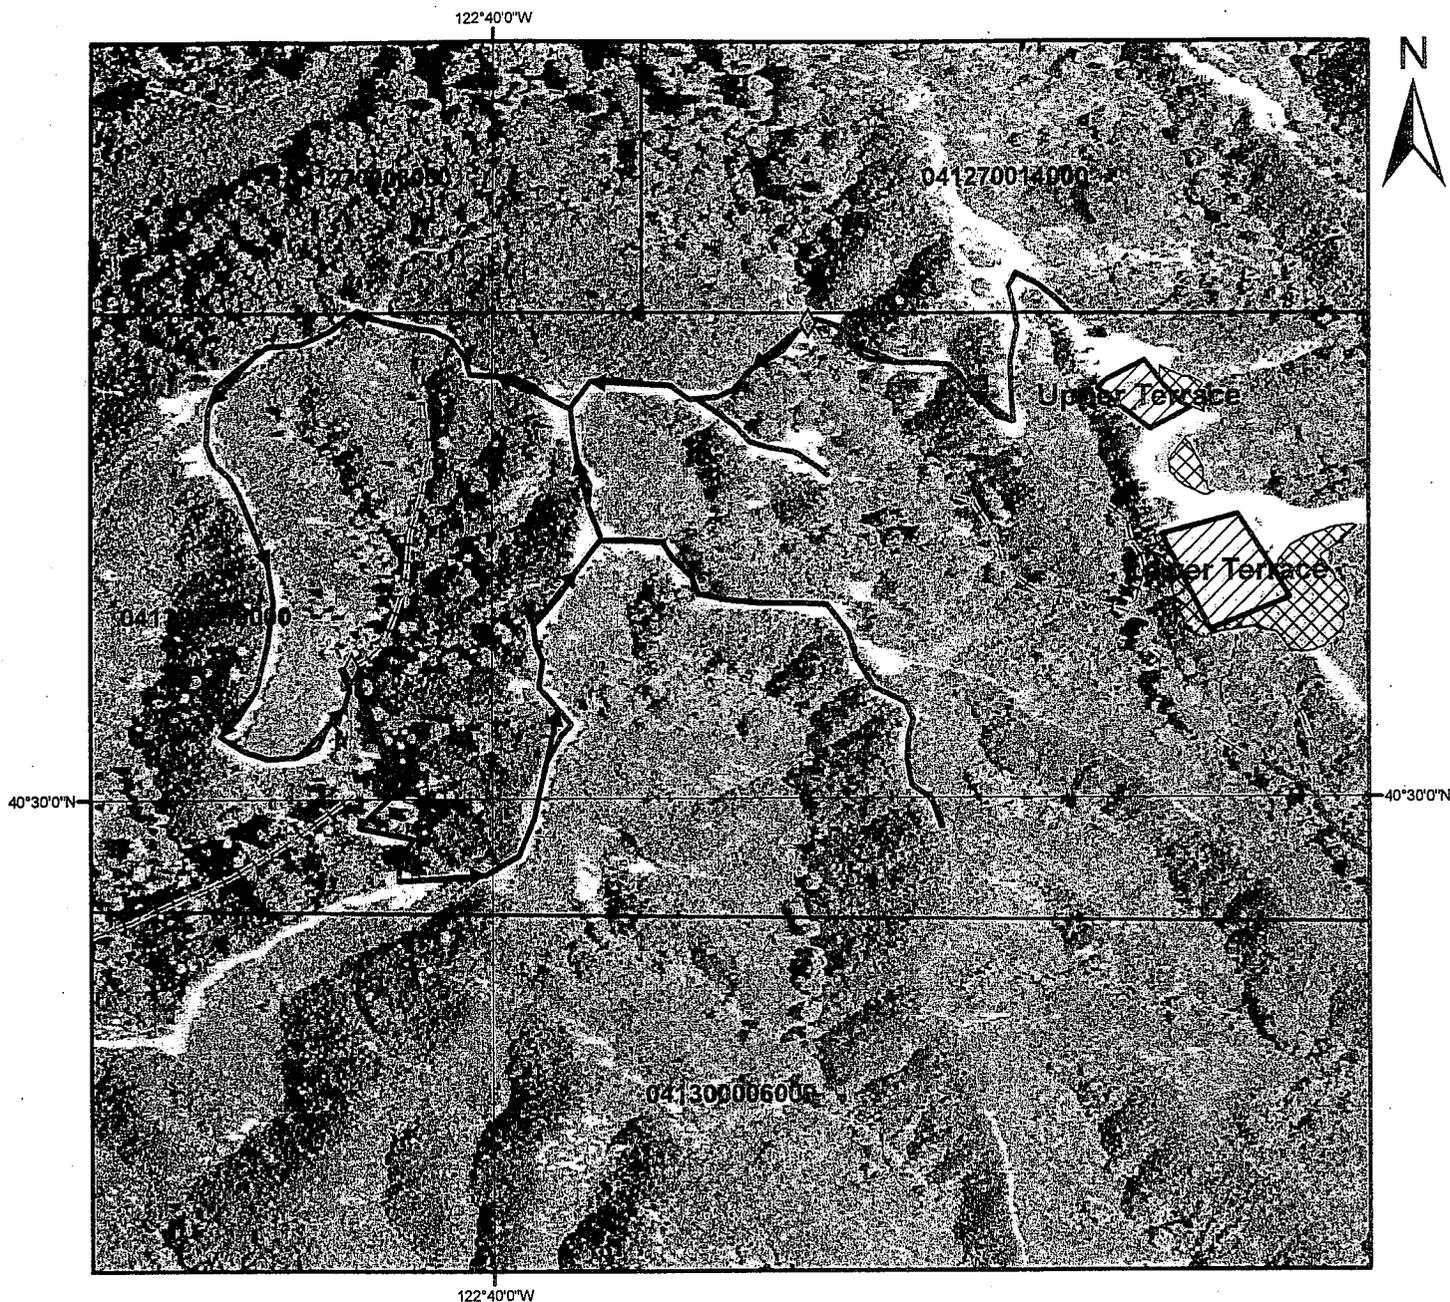
Appendix A – Figure 1

During the 19 November 2014 inspection, Staff found a second un-culverted, non-armored watercourse crossing on the newly constructed section of road. This crossing was constructed by placing more than 4,680 cubic feet of native rock and soil into a streambed and banks of an unnamed tributary of North Fork Cottonwood Creek (Attachment B - 19 November 2014 Baker Ridge Inspection Report, Appendix A, Way Point 2). Staff found and documented evidence that fill material from this watercourse crossing had discharged to the unnamed tributary of North Fork Cottonwood Creek below the crossing (Attachment B - 19 November 2014 Baker Ridge Inspection Report, Appendix B, Photograph #5).

Baker Ridge Rd. Grow: 11-19-14 Inspection on NAIP 2014 Imagery

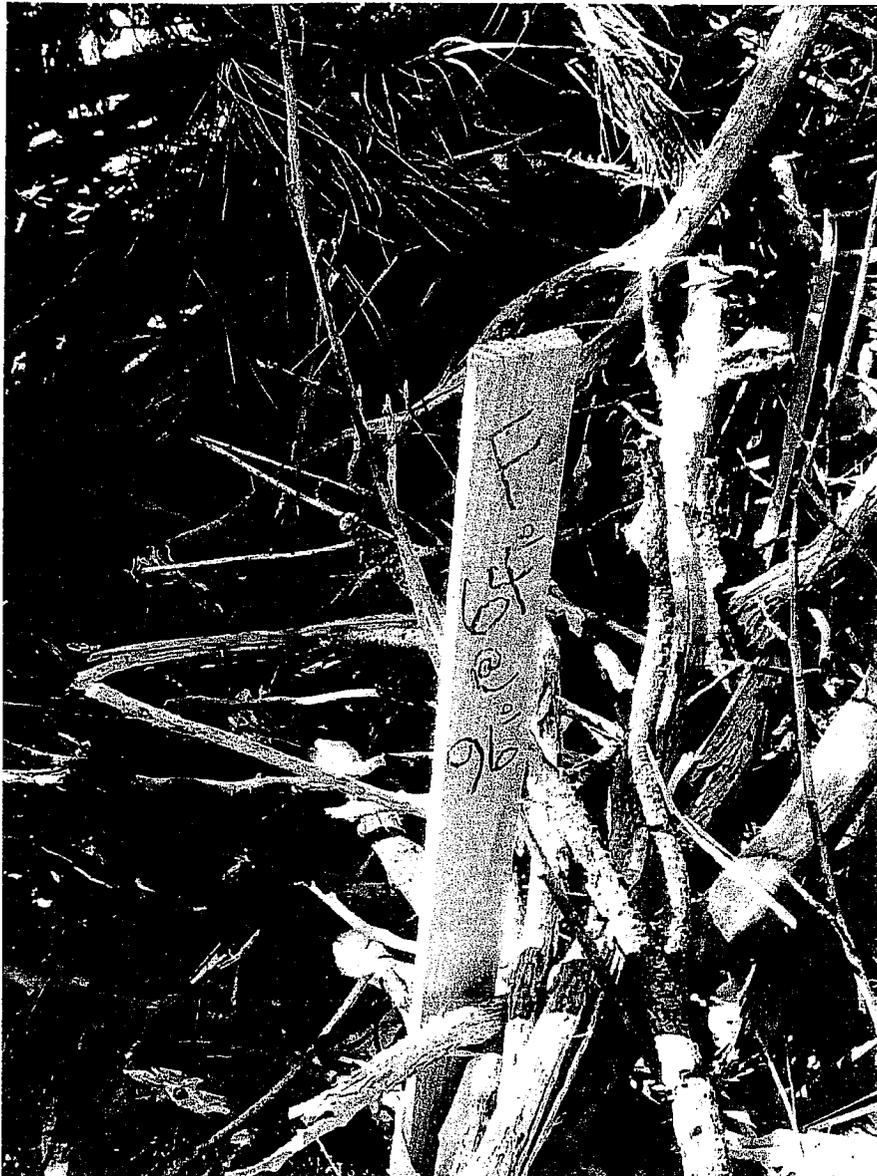
Photograph #6. Eddie Axner Construction grading stake documented during the 28 October 2014 inspection.

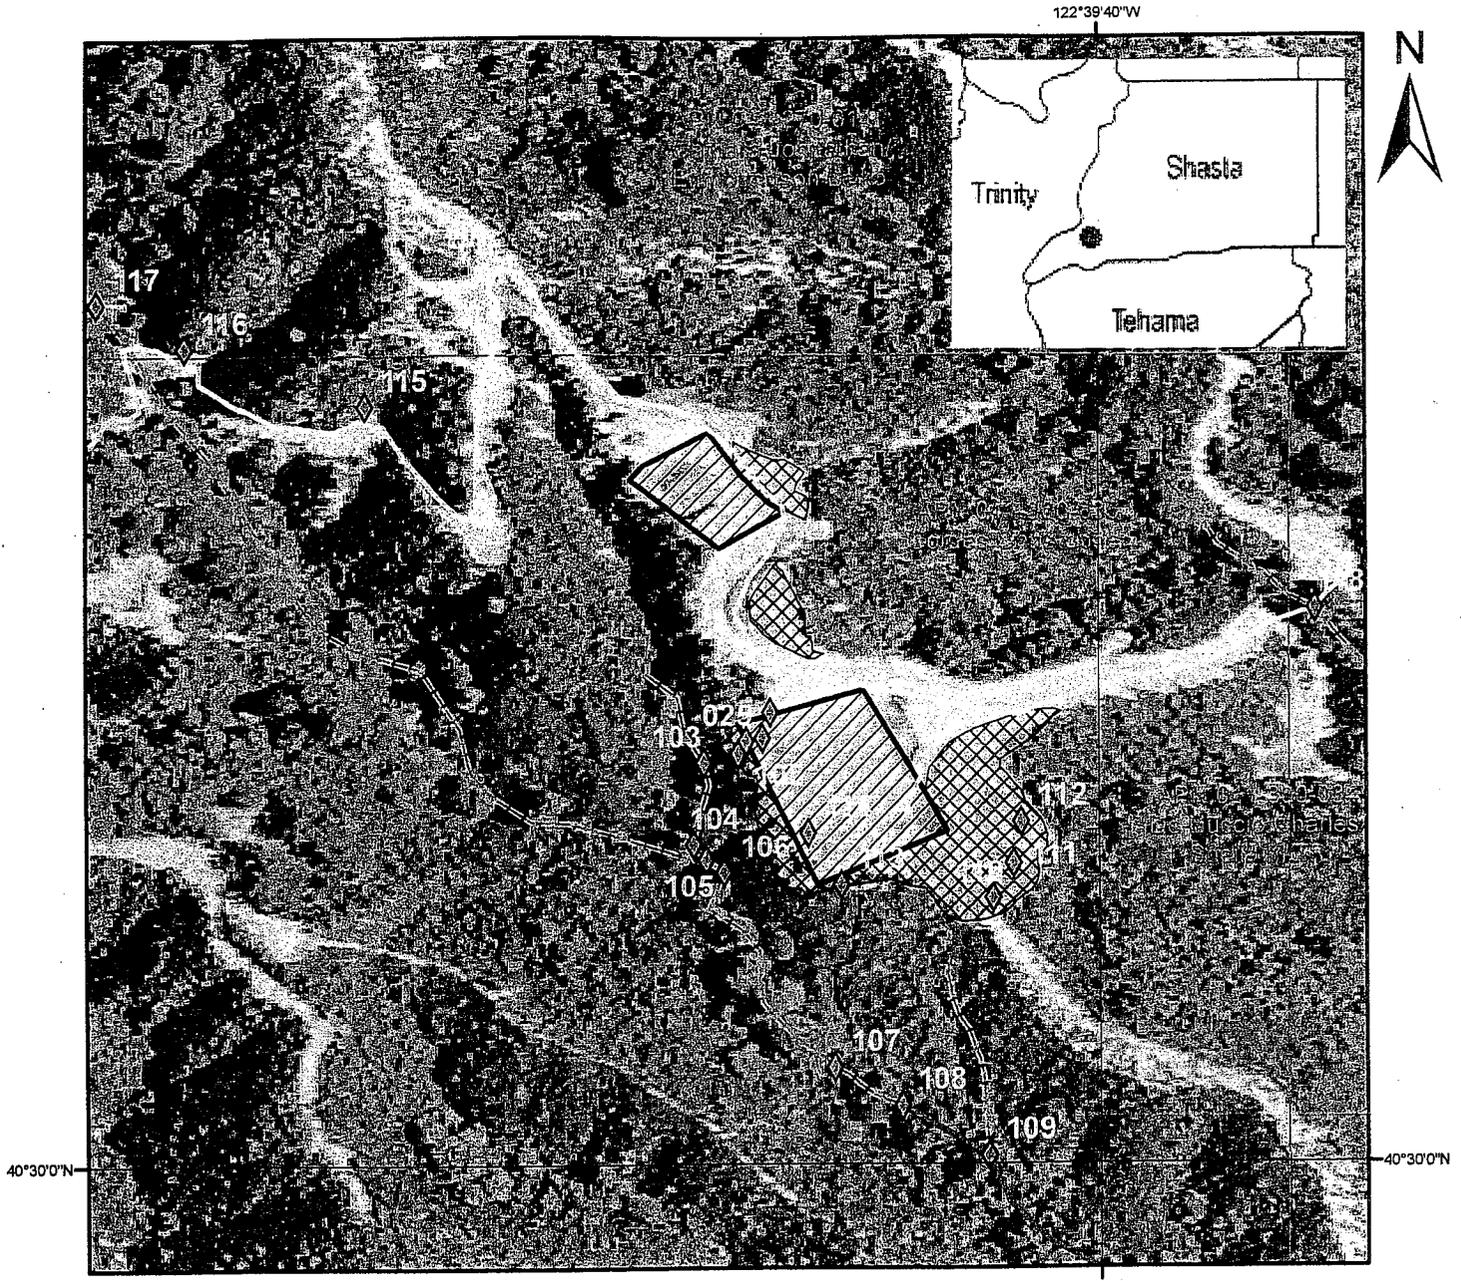
Appendix A – Figures 1 - 3

At approximately 0900 hours, Central Valley Water Board and CDFW staff arrived at the property and entered onto Parcel APN 041-300-035-000. They found the gate to the property open and staff from Eddie Axner Construction working on the Site. Several men (approximately 5) were installing straw erosion control blankets on berms along the road section connecting the upper terrace to the lower terrace, while two other men were operating heavy equipment (a Komatsu PC 200 LC & Caterpillar D4G) on the east fill slope of the lower terrace. The inspection team parked on the lower terrace then Lt. Little informed the working men that the Central Valley Water Board and CDFW were there to conduct an inspection. The Site is composed of two terraces with a native soil surfaced road connecting the upper and lower terraces to Baker Ridge Road. Recent road construction has continued this road from the north side and to the west of the upper terrace. Central Valley Water Board staff collected information at GPS Way Point locations 025 and 100-118 on this parcel (Figures 1 - 3).

Baker Ridge Rd. Grow: 10-28-14 Inspection on NAIP 2014 Imagery

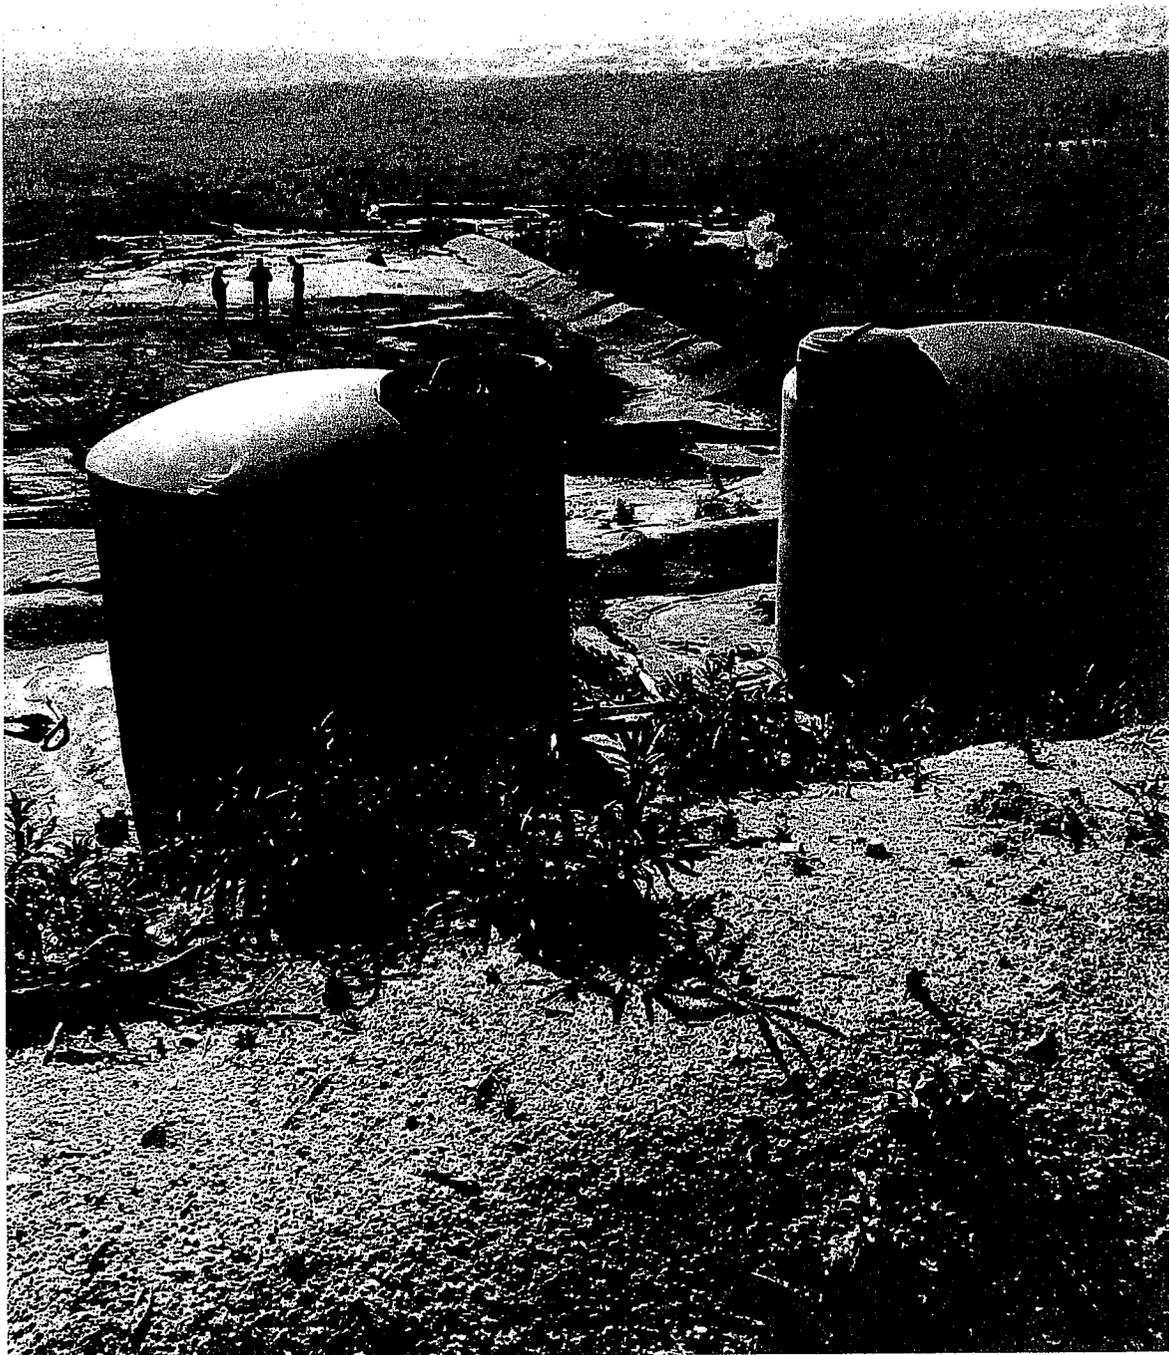
The upper terrace was constructed similar to the lower, by grading material to form a rectangular native soil surface with large berms around the perimeter. Using a GPS, Staff determined that this terrace surface is approximately 0.3 acres in size. Two 3000 gallon water tanks were located upslope and to the north northwest of the upper terrace surface (Photograph #11) and Staff found another area of dumped potting soil on the east fill/side slope of the upper terrace. At the time of the inspection the 1 water tank was full and the other approximately half full and there were no pipes connected to these tanks.

Photograph #11 – Two 3000 gallon tanks in front of upper (foreground) and lower (background) terraces.

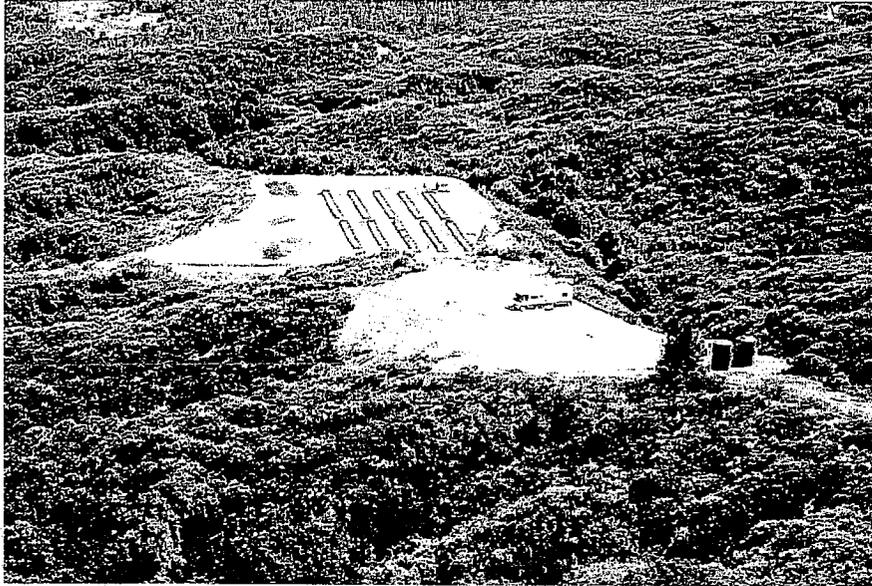
May 22, 2014

In addition, images collected by Shasta County Marijuana Investigations Team Deputies Tom Barner and Ron Smith during subsequent overflights, and later transferred to me, also documented the grading and marijuana cultivation activity on May 22nd and August 19th of 2014. During those overflights, more apparent marijuana infrastructure was added.
