CENTRAL VALLEY REGIONAL WATER QUALITY CONTROL BOARD

INSPECTION REPORT

LOCATION & COUNTY: Berry Street Mall (Aka Finger's) Landfill

INSPECTION DATE: 24 October 2013

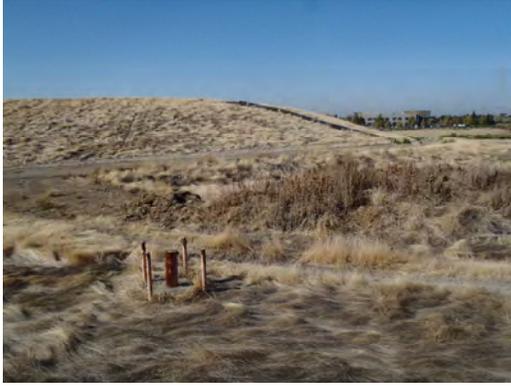
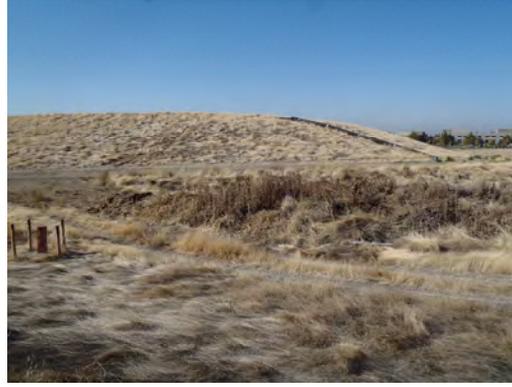
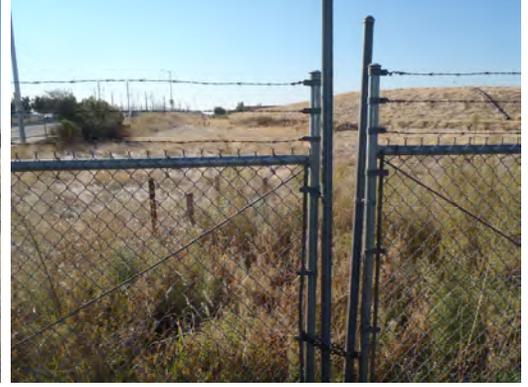
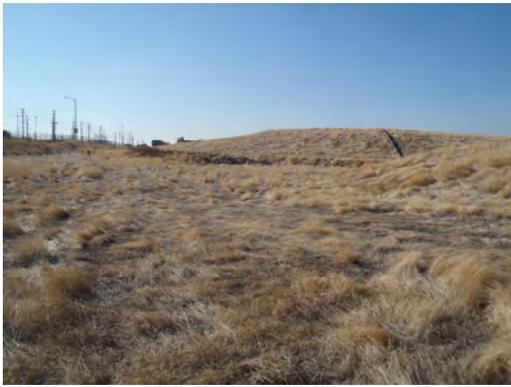
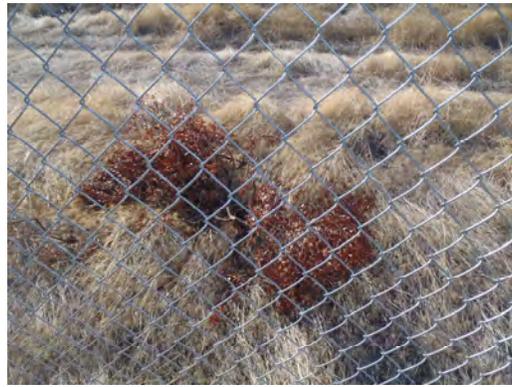
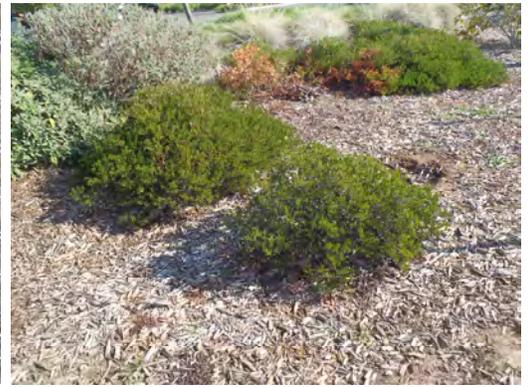
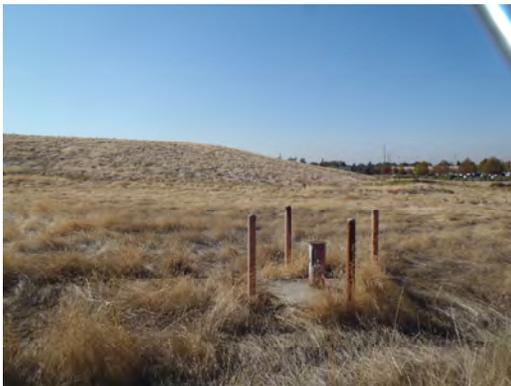
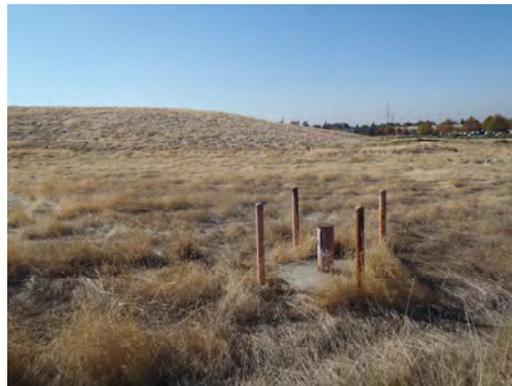
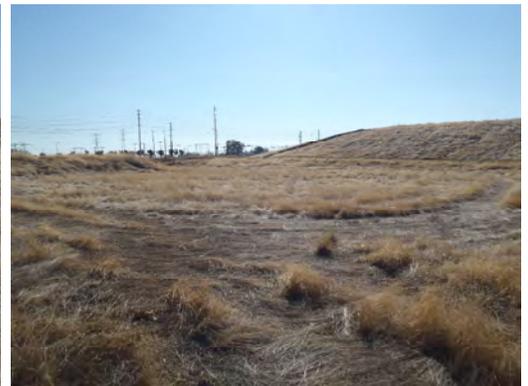
Figure 20

Near the beginning of the storm water sedimentation basin (Figure 19), along the western side of the WMU, there is a large poly tank with a lid atop it (Figure 20). According to historical reports this poly tank is a manhole for the Site's leachate collection system.

Standing in the same location as Figure 19, but looking west at the poly tank, which according to historical reports is a manhole for the Site's leachate collocation system.
