## TECHNICAL MEMORANDUM

# System-wide Evaluation to Identify Restoration Opportunities

**San Bernardino County  
Flood Control District**

January 2011

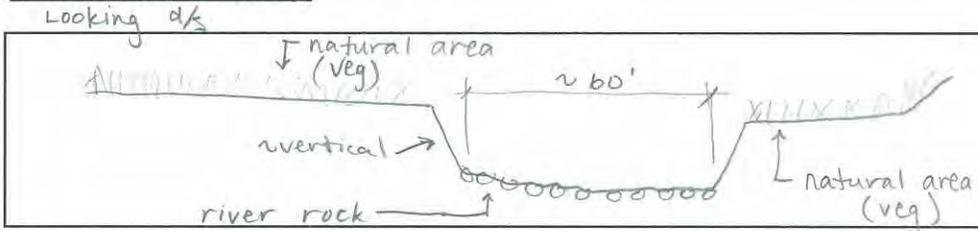
Facility:	Cucamonga Channel
X-Sec #:	Z1-RS2
Comment:	d/s of Chino Corona Rd
Pictures:	6313 - 6315

1. Bank Protection Condition (good or poor)	poor
2. Bank Erosion (yes or no)	y
3. Toe Erosion (yes or no)	y
4. Invert Degradation (yes or no)	y
5. Sediment Source (yes or no)	y

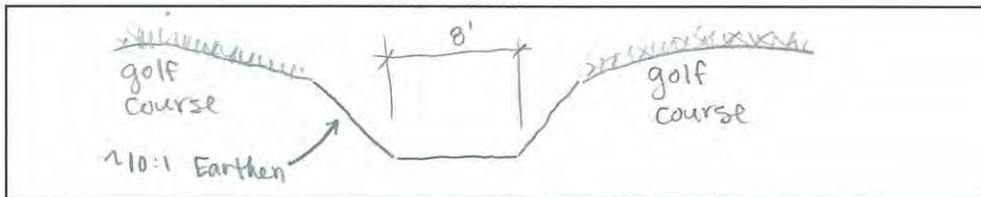
Facility:	Golf Course - Cypress Channel
X-Sec #:	in Chino
Comment:	Pine Ave Bridge
Pictures:	5043 - 5053

1. Bank Protection Condition (good or poor)	poor
2. Bank Erosion (yes or no)	y
3. Toe Erosion (yes or no)	y
4. Invert Degradation (yes or no)	y
5. Sediment Source (yes or no)	y

→ need to verify if Municipal Course (verified)  
 → lots of degradation  
 → plenty of space for restoration  
 → Corp owns land  
 → improvements needed on up- & downstream sides of Pine Ave.

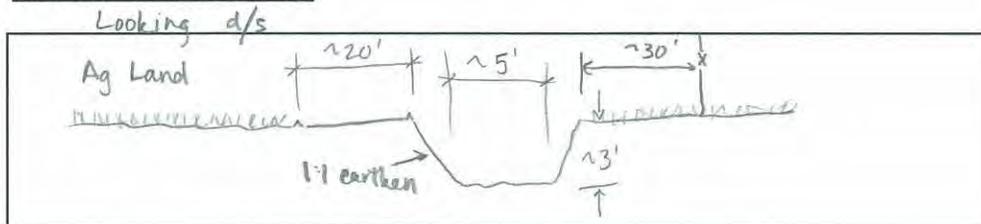
Facility:	Magnolia Channel
X-Sec #:	Z1-CP1
Comment:	at Kimball
Pictures:	5039-5043

1. Bank Protection Condition (good or poor)	poor
2. Bank Erosion (yes or no)	y
3. Toe Erosion (yes or no)	y
4. Invert Degradation (yes or no)	n
5. Sediment Source (yes or no)	y

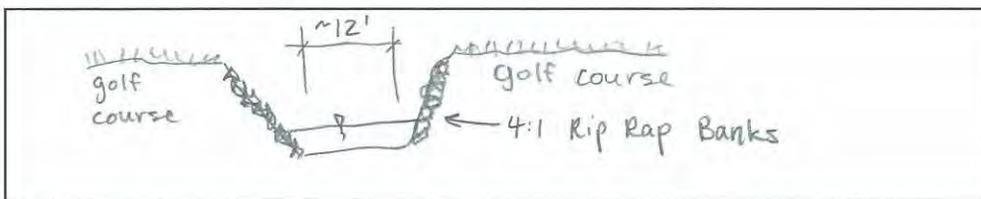
Facility:	Golf Course #2 - San Antonio Channel
X-Sec #:	
Comment:	Pine Ave Arizona Crossing
Pictures:	5053 - 5057

1. Bank Protection Condition (good or poor)	good
2. Bank Erosion (yes or no)	n
3. Toe Erosion (yes or no)	y
4. Invert Degradation (yes or no)	n/a
5. Sediment Source (yes or no)	y

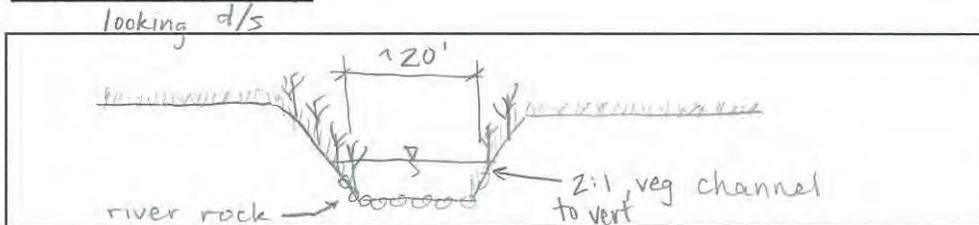
Facility:	San Antonio Channel
X-Sec #:	Z1 - RS1
Comment:	adjacent to El Prado Rd, 1/5 of WWP
Pictures:	6306 - 6309

1. Bank Protection Condition (good or poor)	poor
2. Bank Erosion (yes or no)	n
3. Toe Erosion (yes or no)	y
4. Invert Degradation (yes or no)	y
5. Sediment Source (yes or no)	n

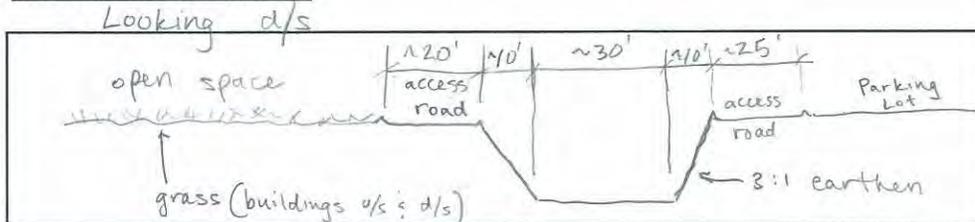
Facility:	Reche Canyon Channel
X-Sec #:	22-R57
Comment:	w/s of Mt Vernon Ave
Pictures:	5031 - 5038

1. Bank Protection Condition (good or poor)	poor
2. Bank Erosion (yes or no)	y
3. Toe Erosion (yes or no)	y
4. Invert Degradation (yes or no)	n
5. Sediment Source (yes or no)	y

→ channel looks recently repaired. Has "unfinished" look.

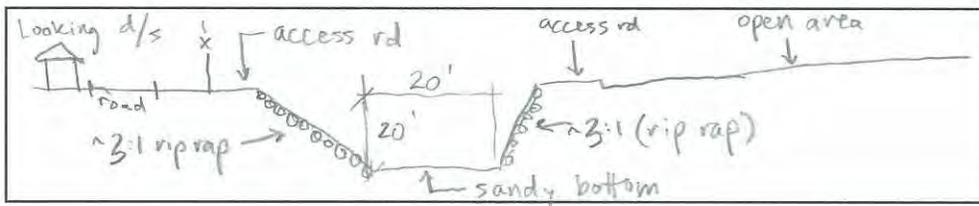
Facility:	Cable Creek
X-Sec #:	Z2-R53
Comment:	d/s of Little League Dr
Pictures:	(100-4847 to 100-4849 d/s section) (100-4850 to 4874 @ site)

1. Bank Protection Condition (good or poor)	good
2. Bank Erosion (yes or no)	no
3. Toe Erosion (yes or no)	y (minor)
4. Invert Degradation (yes or no)	n
5. Sediment Source (yes or no)	y

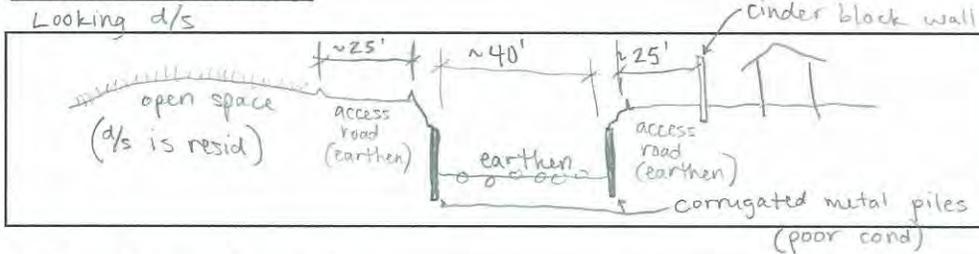
Facility:	Devil Creek Channel
X-Sec #:	
Comment:	University Pkwy Bridge
Pictures:	5060 - 5063

1. Bank Protection Condition (good or poor)	poor
2. Bank Erosion (yes or no)	n
3. Toe Erosion (yes or no)	y
4. Invert Degradation (yes or no)	y
5. Sediment Source (yes or no)	y

→ piles are protecting bank but are in poor condition  
 → to widen an access road would be removed  
 → invert shows scour  
 → downstream there are dorms to the left. There is a cinder block wall at the edge of the access road.

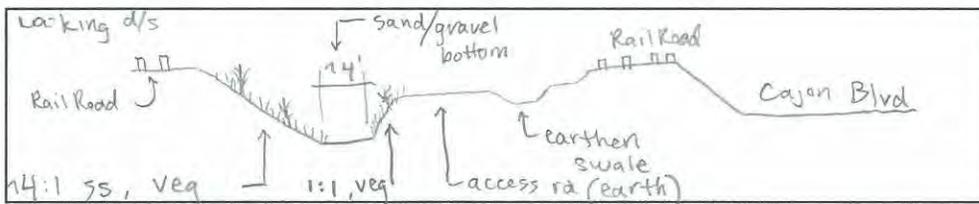
Facility:	Ono Storm Drain
X-Sec #:	22-R52
Comment:	Adjacent to Cajon Blvd & Railroad
Pictures:	4875 to 4885

1. Bank Protection Condition (good or poor)	decent (grass)
2. Bank Erosion (yes or no)	minor
3. Toe Erosion (yes or no)	y
4. Invert Degradation (yes or no)	y
5. Sediment Source (yes or no)	minor

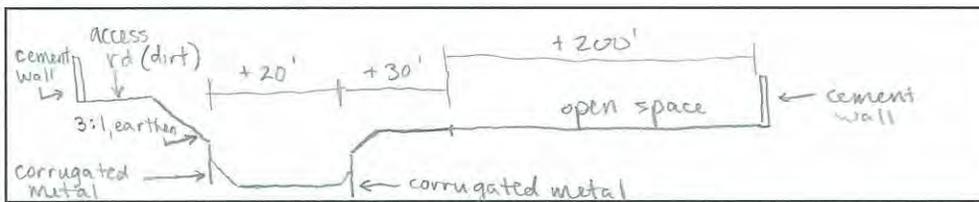
<b>Facility:</b>	Sand Creek
<b>X-Sec #:</b>	Z2-RS4
<b>Comment:</b>	@ end of Citrus
<b>Pictures:</b>	4886 - 4911

1. Bank Protection Condition (good or poor)	poor
2. Bank Erosion (yes or no)	✓
3. Toe Erosion (yes or no)	✓
4. Invert Degradation (yes or no)	no
5. Sediment Source (yes or no)	yes

→ drop structures every ~100' - 200'  
 → Invert looks stabilized  
 → corrugated metal piles are failing  
 → side slopes showing scour up to ~4'  
 → major drops d/s w/ energy dissipators  
 → basin d/s

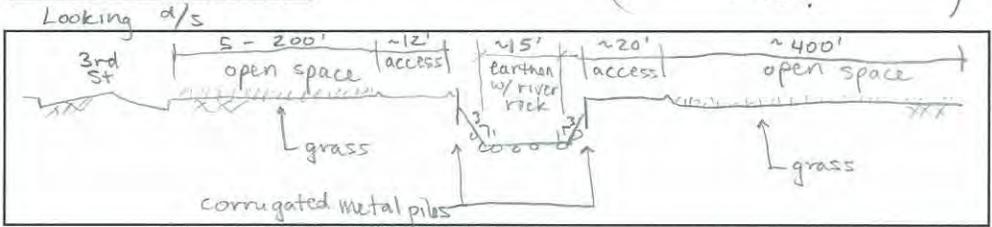
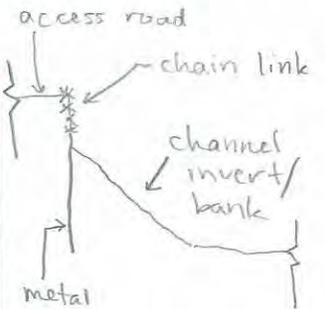
Facility:	City Creek
X-Sec #:	Z2-R56
Comment:	d/s 3rd St
Pictures:	4942 - 4962 (4963 - 4968 across from SBCFCD) (is there enough room here?)

1. Bank Protection Condition (good or poor)	poor
2. Bank Erosion (yes or no)	y (minor)
3. Toe Erosion (yes or no)	y
4. Invert Degradation (yes or no)	n
5. Sediment Source (yes or no)	y

→ invert looks fairly stabilized  
 → corrugated metal piles have chain link fence above (21') to hold back access road (see to right)  
 • starting to fail in some locations  
 → 1/2 channel is 5-10' wider w/ concrete left bank

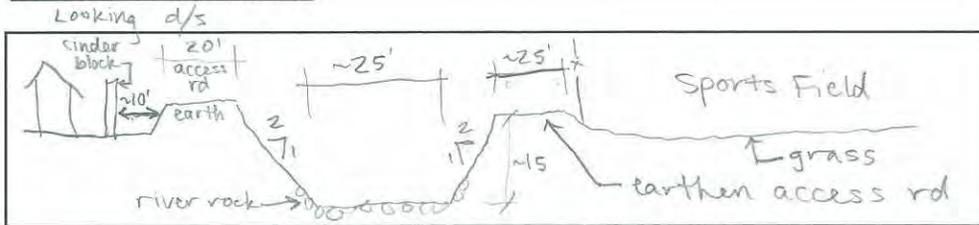
Facility:	Upper Warm Creek
X-Sec #:	22-R55
Comment:	North of Baseline, South of Sports Field
Pictures:	4915 - 4934

1. Bank Protection Condition (good or poor)	poor
2. Bank Erosion (yes or no)	y
3. Toe Erosion (yes or no)	n
4. Invert Degradation (yes or no)	n
5. Sediment Source (yes or no)	y

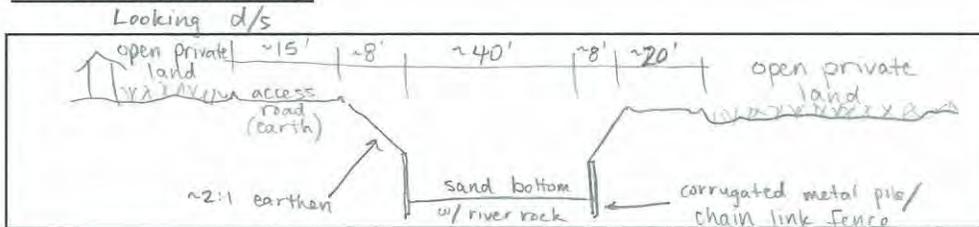
Facility:	Wilson Creek
X-Sec #:	Z3 - R53
Comment:	Ave D
Pictures:	4990 - 5012

1. Bank Protection Condition (good or poor)	poor (eroding)
2. Bank Erosion (yes or no)	n
3. Toe Erosion (yes or no)	n
4. Invert Degradation (yes or no)	n
5. Sediment Source (yes or no)	y

→ drop structures every ~50'  
 → channel is stabilized  
 → corrugated metal piles in some locations & others only has fence. Both are deteriorating  
 → banks above piles/fence are intact and show very little signs of scour  
 → some river rock on invert

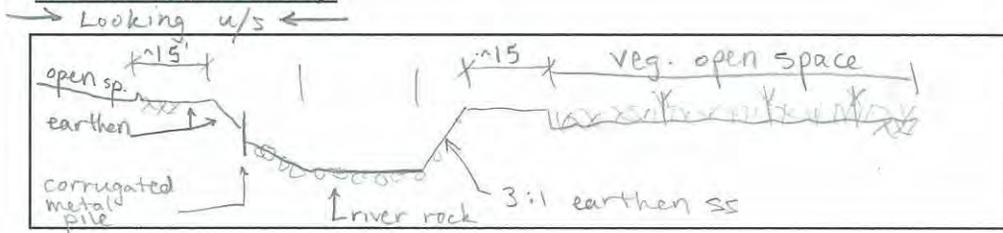
Facility:	Wilson Creek
X-Sec #:	Z3-R55
Comment:	Between Oak Glen Rd & Bryan St
Pictures:	4969 - 4989

1. Bank Protection Condition (good or poor) good
2. Bank Erosion (yes or no) y
3. Toe Erosion (yes or no) n
4. Invert Degradation (yes or no) y
5. Sediment Source (yes or no) y
