# Merkel & Associates, Inc.

May 25, 1995  
M&A# 95-037-01

**Re: Eelgrass Survey of the North Dike of the Chula Vista Wildlife Reserve**

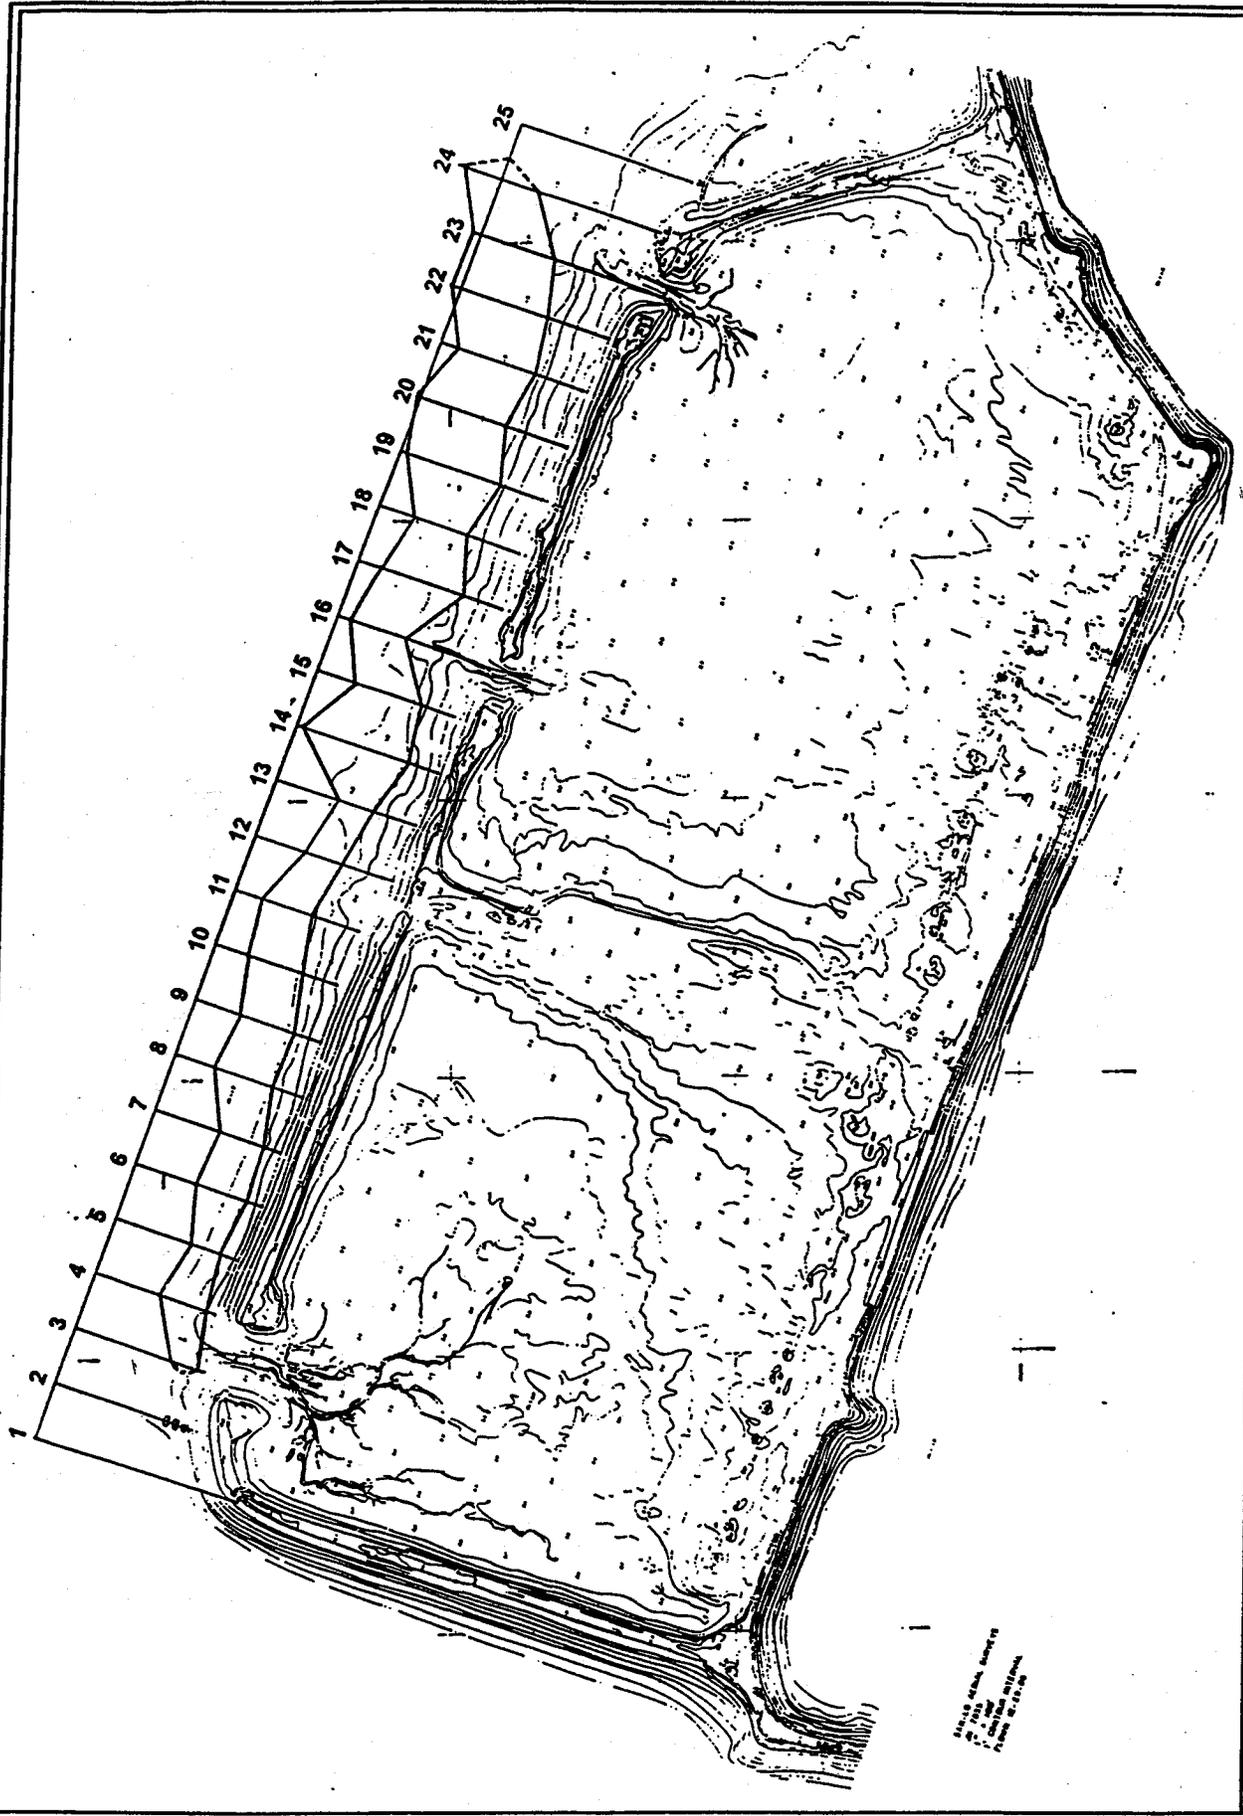
Eelgrass Distribution Along the North Dike of the Chula Vista Wildlife Island  
 May 1994  
 Source: MBC Applied Environmental Sciences (July 1994 Report)
