AN EVALUATION OF EXPERIMENTAL
REHABILITATION WORK,
REDWOOD NATIONAL PARK

TECHNICAL REPORT
JULY 1987

Redwood National Park Watershed Rehabilitation
Technical Report Number 19

National Park Service
Redwood National Park
Arcata, California
July 1987

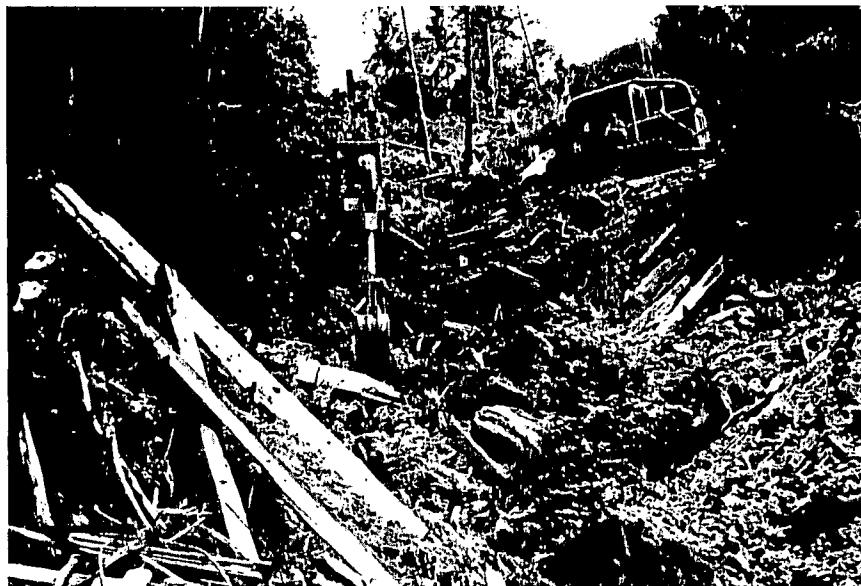
Fig. 5. Tractor and backhoe excavating skid trail stream crossing.

Fill in skid trail crossings was excavated by backhoe and redistributed to stable locations by crawler tractor (Figure 5). The tractor was also used to perform preliminary excavations and to winch and remove organic debris. Total cost for the excavation of skid trail crossings was \$6,400 or \$7.70 per cubic yard (Table 4).

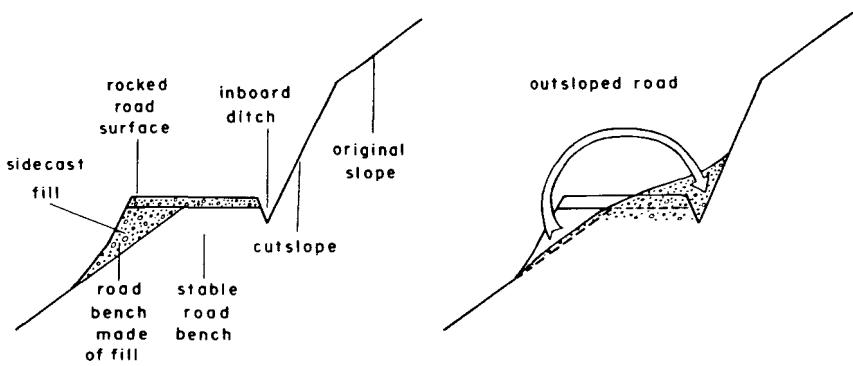
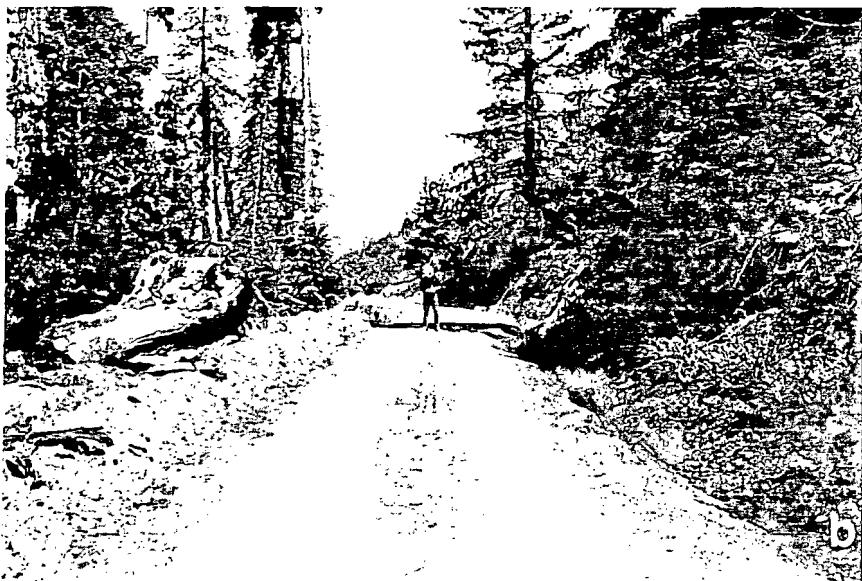
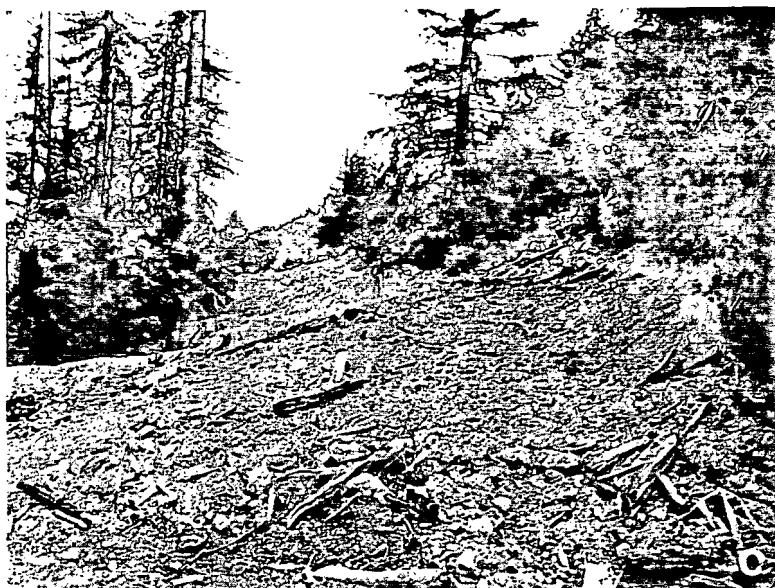
Fig. 6. Outsloping a segment of the L-1-5 road. A) diagrammatic sketch of road outsloping showing excavation of road fill and burial of inboard ditch and cutbank, B) before heavy equipment treatment (May 1979), C) immediately after outsloping and D) two year later (June 1983). All photos taken from the same viewpoint.

Several pieces of equipment were used to outslope the L-1-5 (Figure 6). Before outsloping, a blade-mounted chisel tooth on the tractor was used to decompact the western half of the road to a depth of about 12 inches. Fill material was then removed from the outside edge of the road with a drag-line crane and either loaded into dump trucks or deposited and graded uniformly up the cutbank. Because of insufficient stable storage area, dump trucks were used to end-haul much of the excavated fill to a disposal site (Figure 4). Approximately half of the total length of outsloped road required end-hauling.

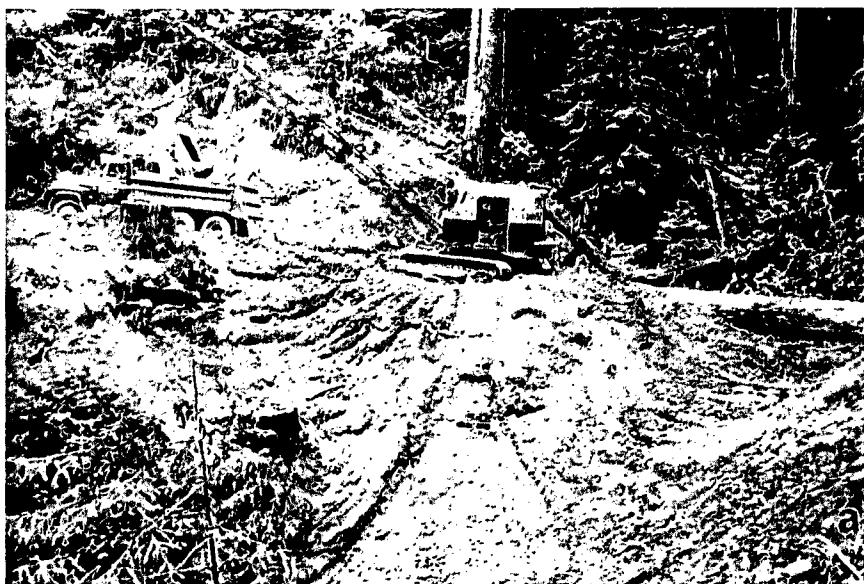
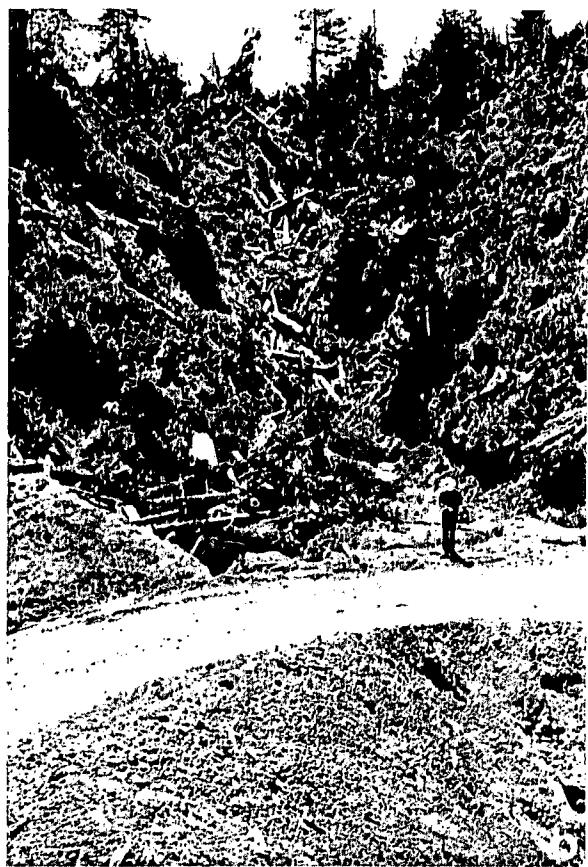
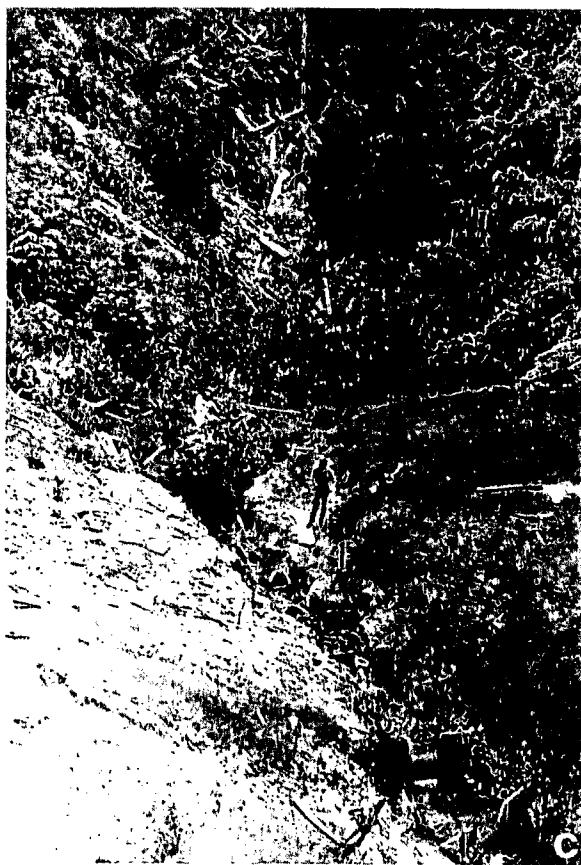
Fig. 7. Stream crossing excavation on the L-1-5 road. A) dragline crane excavates material from the crossing and places it in dump truck for endhauling to nearby storage area, B) before stream crossing excavation and C) after stream crossing excavation. Photos B and C were taken from the same viewpoint.

The four stream crossings on the L-1-5 were excavated by a drag-line crane, with finish work completed by a backhoe (Figure 7). Much of the excavated material had to be end-hauled due to insufficient stable storage area adjacent to the worksites. The amount of fill removed from the crossings ranged from 280 to 500 cubic yards. Costs varied from \$1,200 to \$1,500, averaging \$1,320 per stream crossing (\$3.80 per cubic yard of material removed) (Table 6). Total cost to excavate the four stream crossings was \$5,300.

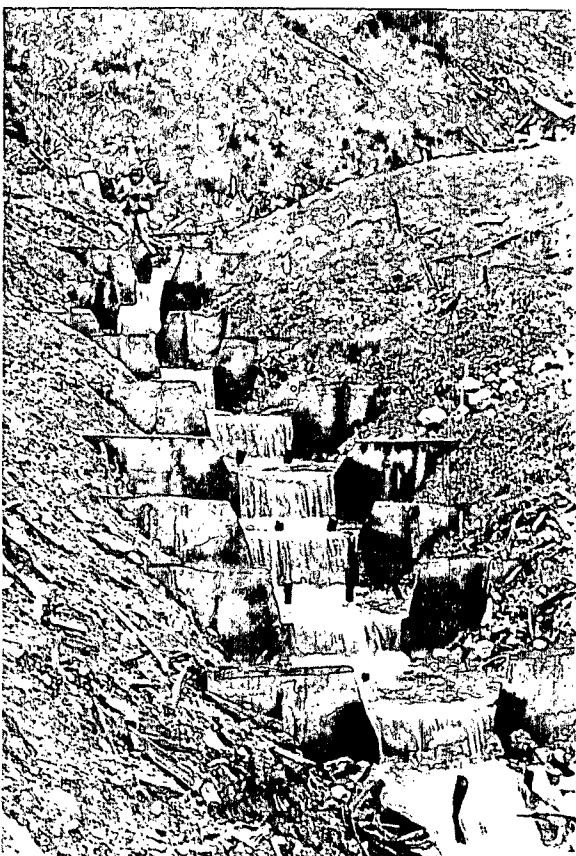
Fig. 8. Redwood board checkdams in an excavated stream crossing, L-1-5 road.

placed in six excavated stream channel crossings (Figure 8). Submerged spillways were installed at three locations. Rock armor, secured with stakes or chicken wire, was used to protect portions of three stream crossings and four drainage ditches (Figure 9).

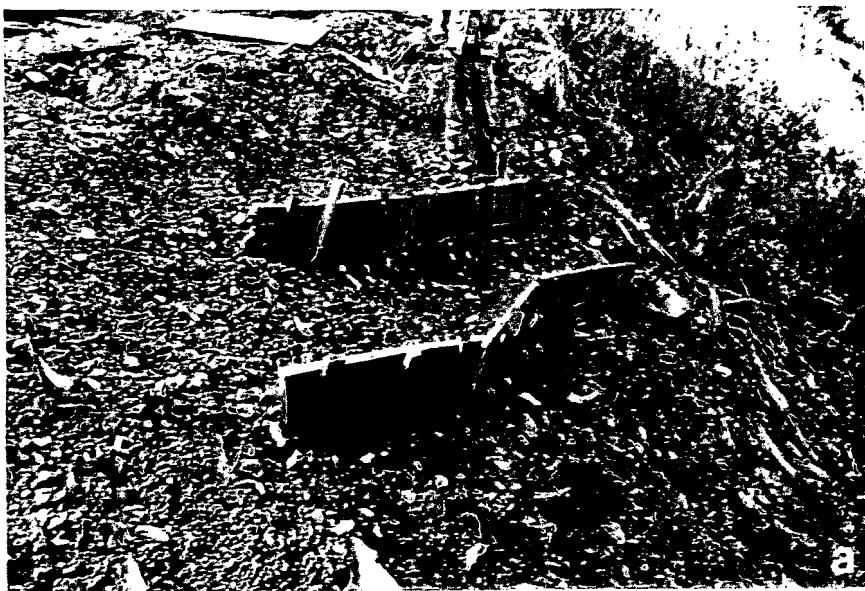
Fig. 11. Physical erosion control devices used to reduce surface erosion from bare soil areas. A) ravel catchers, B) contour trenches and C) wooded terraces.

Physical erosion control techniques used on bare slopes to retard or prevent rainsplash, sheet and rill erosion included wooded terraces, contour trenches and ravel catchers (Figure 11). Contract labor costs for surficial erosion control work were 30 percent for wooded terraces, eight percent for contour trenches and two percent for ravel catchers. The remaining 60 percent was spent on treatments which combined

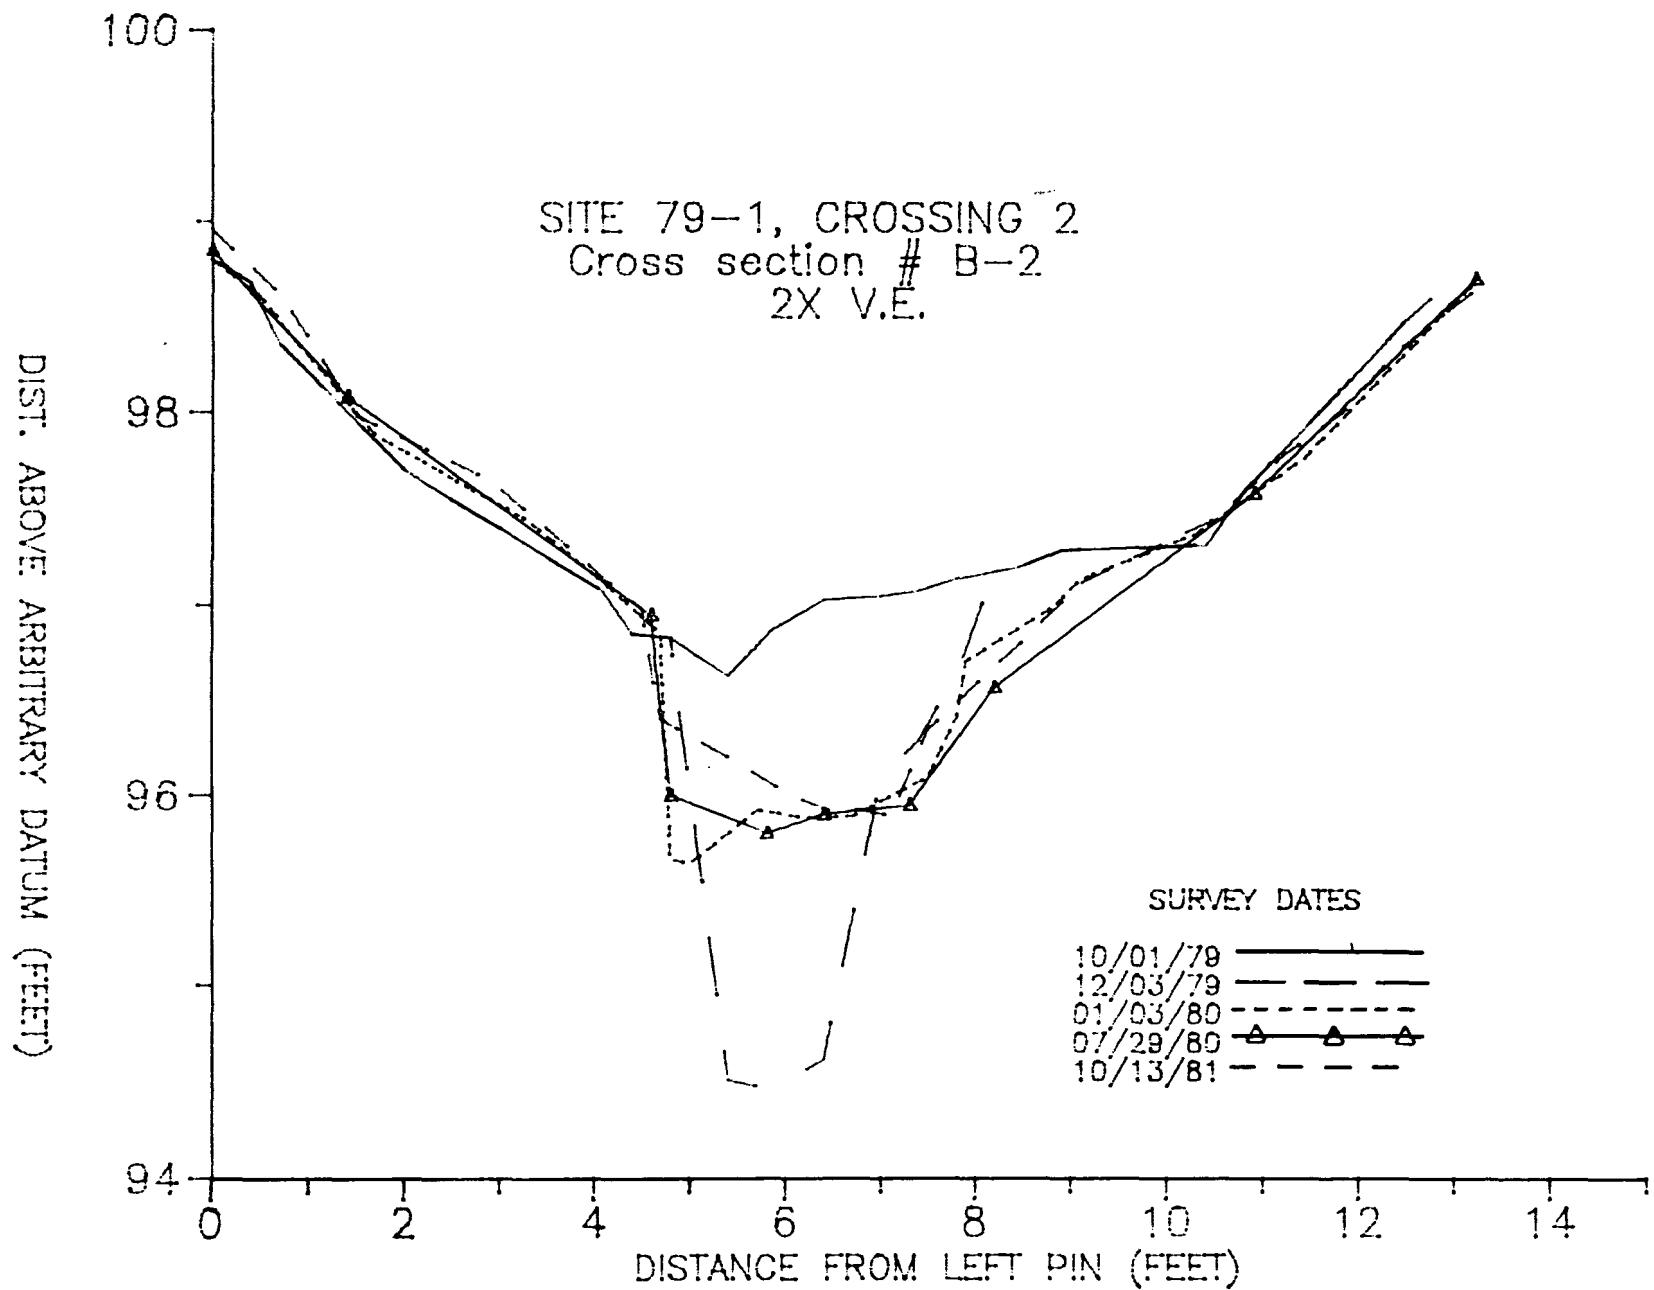
Most techniques used to control stream channel erosion worked well, preventing both downcutting and bank erosion. Checkdams were particularly effective, as demonstrated at worksite R2 (Figure 15). Runoff from early October storms downcut an average of two feet, eroding 22 cubic yards from the unprotected channel. Checkdams were then installed in the actively eroding channel. They succeeded in preventing further erosion and caused local aggradation of the streambed. Representative cross-sections (Figure 16) of worksite R2 demonstrated channel conditions which existed prior to the first winter storms, following the storm runoff and after installation of the checkdams.

Fig. 16. Channel cross-sections of excavated stream crossing R2. Surveys were conducted immediately after crossing excavation (October 1979), after downcutting caused by the first major storm runoff of the 1979 winter (December 1979), following installation of a series of redwood board checkdams designed to stabilize the channel (January 1980) and during two subsequent remeasurements. Note the aggradation and subsequent stability of channel dimensions following construction of the checkdams.

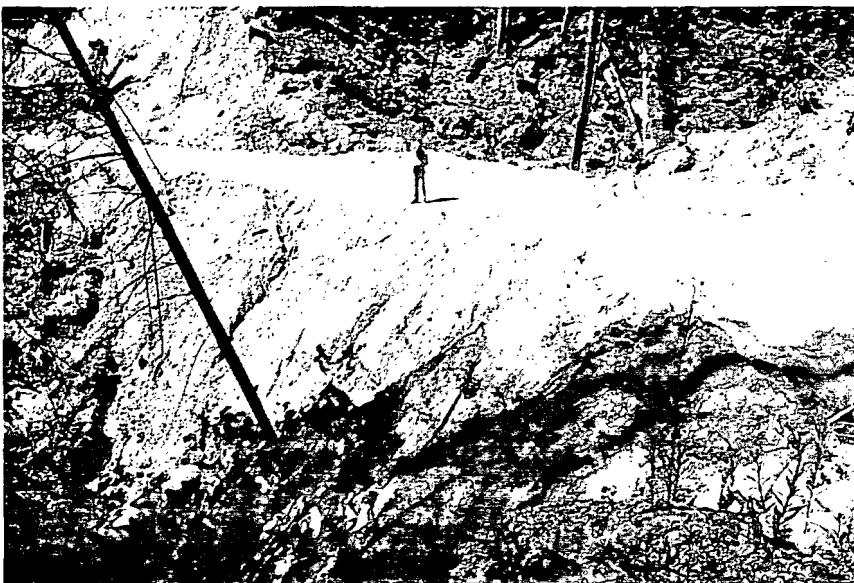
All active erosion problems within this unit were associated with the M-7-5-1 road (Figure 20). No significant erosion was noted on the cable clearcuts. Problems included erosion of roadfill (Figure 21); accelerated movement of wet, naturally unstable hillslopes undercut by road construction; mass failure of road and landing fill material (Figure 22) and minor gullying resulting from concentrated inboard ditch flow culverted onto roadfill or bare soil areas on the slope below the road (Figure 23). All of these erosion problems would have been much more severe had the area experienced average or above average rainfall during the two years between road construction and rehabilitation.

Fig. 21 (above). Gullied fill slope on a stream crossing site, M-7-5-1 road, prior to rehabilitation work.

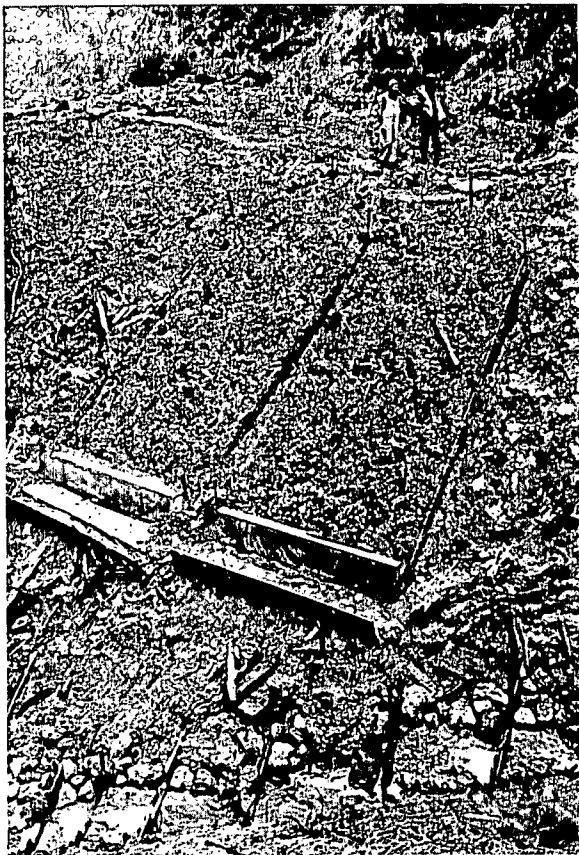
Fig. 24. Sediment trough erosion plots installed on the steep right bank of excavated stream crossing R7. The 10' x 25' plots were established to monitor sediment yield from untreated side slopes at stream crossings. Sediment accumulated in the 1' x 1' x 10' sediment trough while runoff was funneled to 50 gallon drums, and later a large tipping bucket, for measurement.

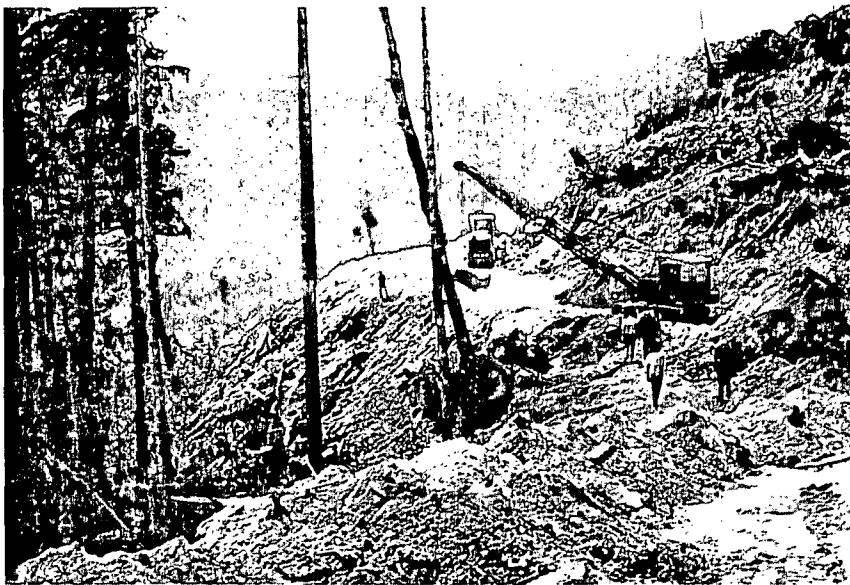
Fig. 25. Initial stages of outsloping on a segment of the M-7-5-1 road using a dragline crane and D-6 crawler tractor.

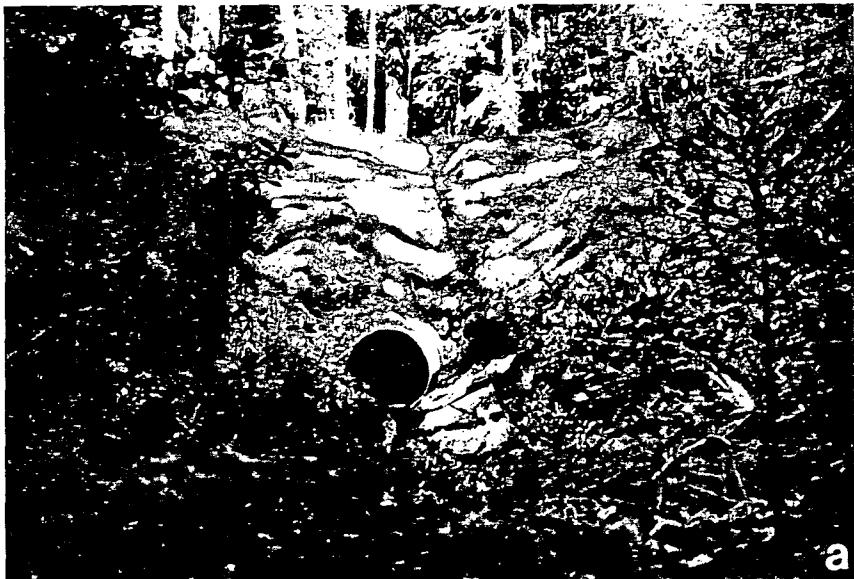
Fig. 26 (above). Excavation of stream crossing R9 at the end of the M-7-5-1 road. The fill material was primarily excavated by dragline crane. To complete the work, a backhoe was lowered to the channel bottom to finish detailed work on the stream bed. A) before treatment, (May 1979), and B) after excavation, (January 1980).

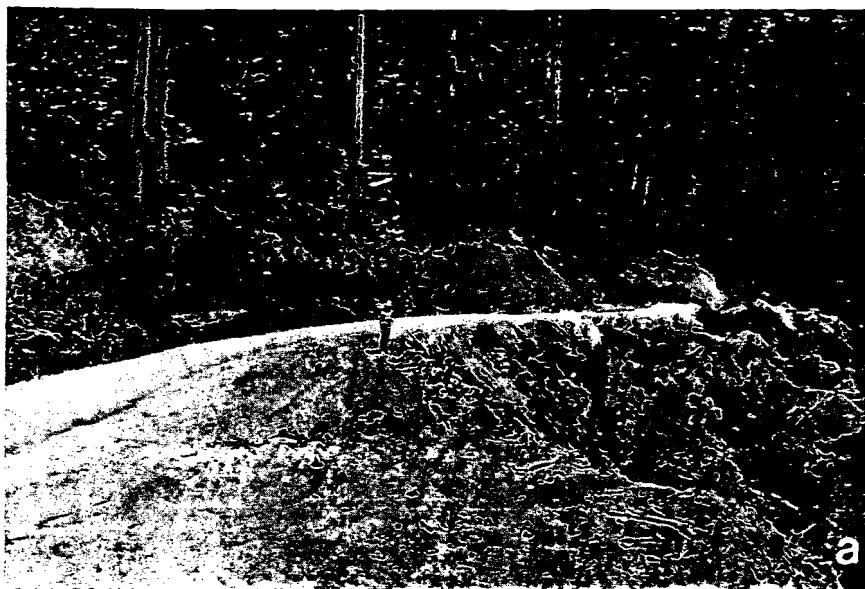
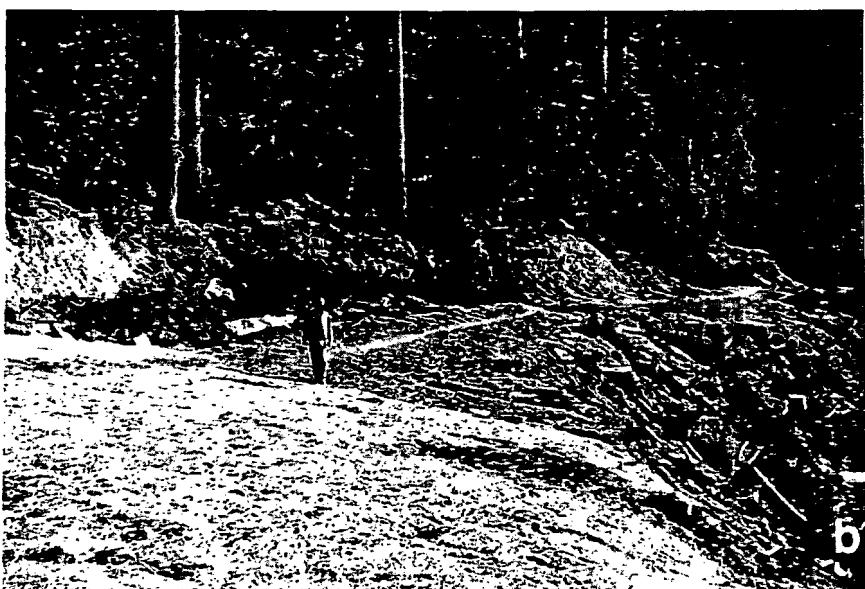
Approximately 1.2 miles of the M-7-5-1 road were slightly outsloped (Figure 28) and cross-road drained by the D-6 crawler tractor and backhoe for \$9,100 (Table 18), representing a unit cost of \$7,600 per mile. A dragline crane outsloped another 0.02 miles or 105 feet for \$1,800. Most of the road outsloping was accomplished by a crawler tractor. A backhoe was used for culvert removal, construction of cross-road drains and to pull back the outboard edge of the road at locations where it was awkward for the tractor to operate. The crane retrieved large concentrations of sidecast material to realign stream courses and remove culverts deeply placed in the road prism.

Fig. 28. Slight outsloping of a segment of the M-7-5-1 road. This was the most common type of treatment applied to logging roads on this unit. A) before outsloping (June 1979); B) after outsloping and application of straw mulch (January 1980); C) natural invasion of alder (June 1981).

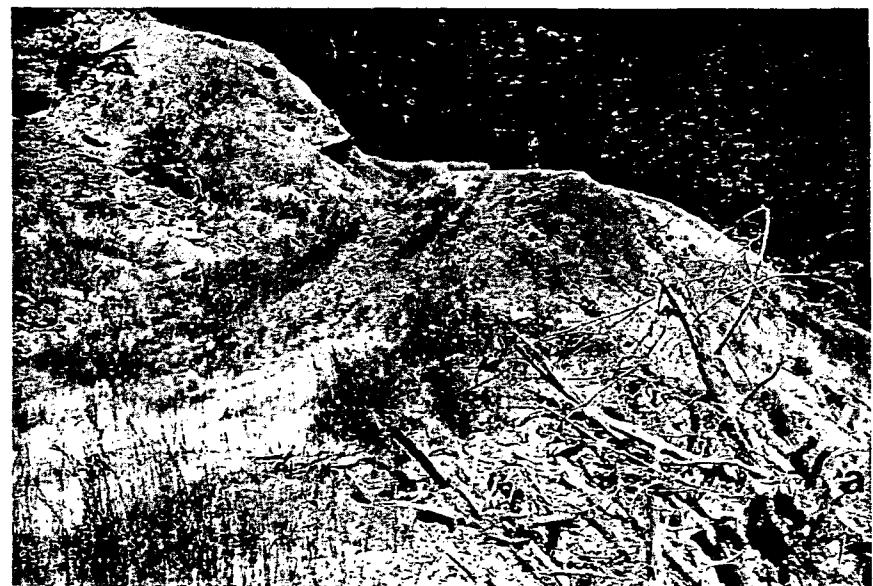
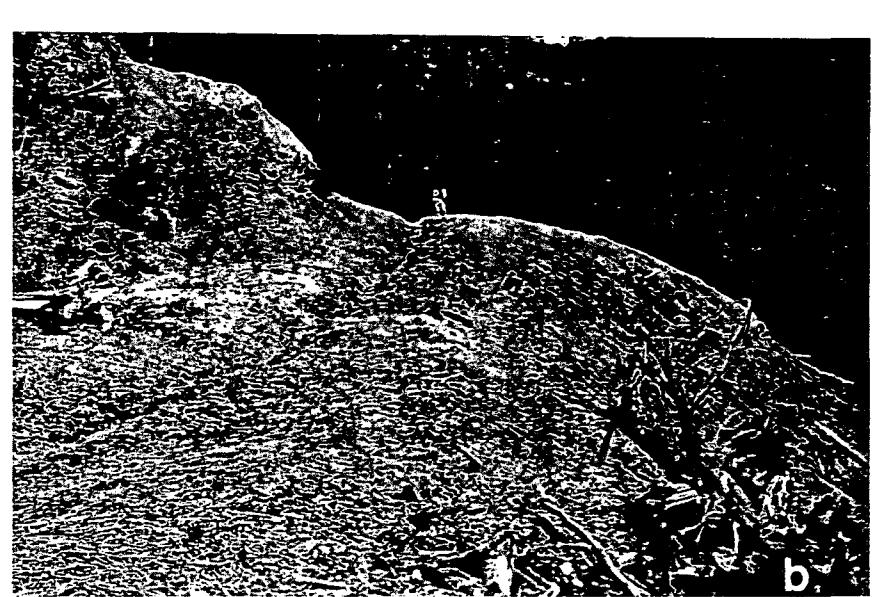
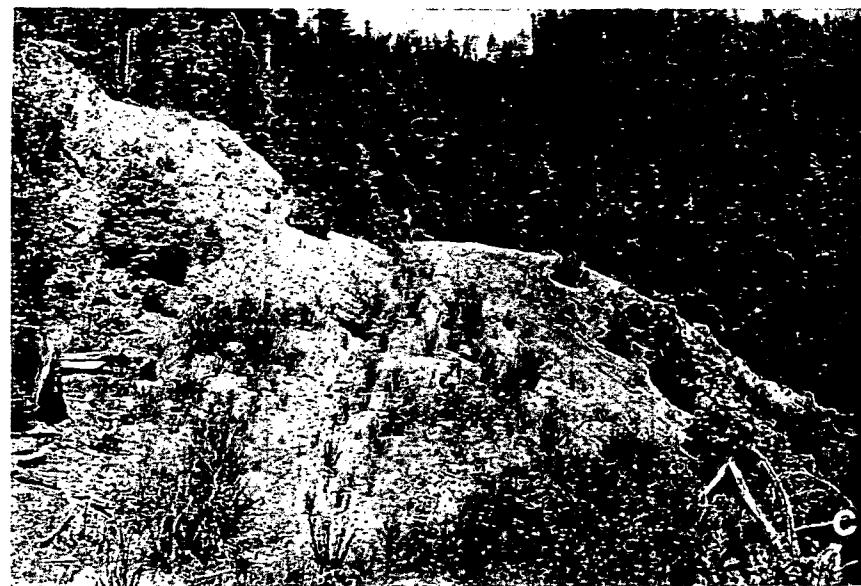
Three yarder pads were ripped, outsloped and drained by the crawler tractor and backhoe (Figure 29) for \$3,400. A ditch system installed between pads 2 and 3 and outsloping of approximately 0.2 miles of access road is included in the cost.

Fig. 29. Treated yarder pad above landing 2. A) before rehabilitation (note sparse revegetation) (June 1979); B) after outsloping and drainage improvements (January 1980); C) natural invasion of rushes and woody shrubs (August 1983).

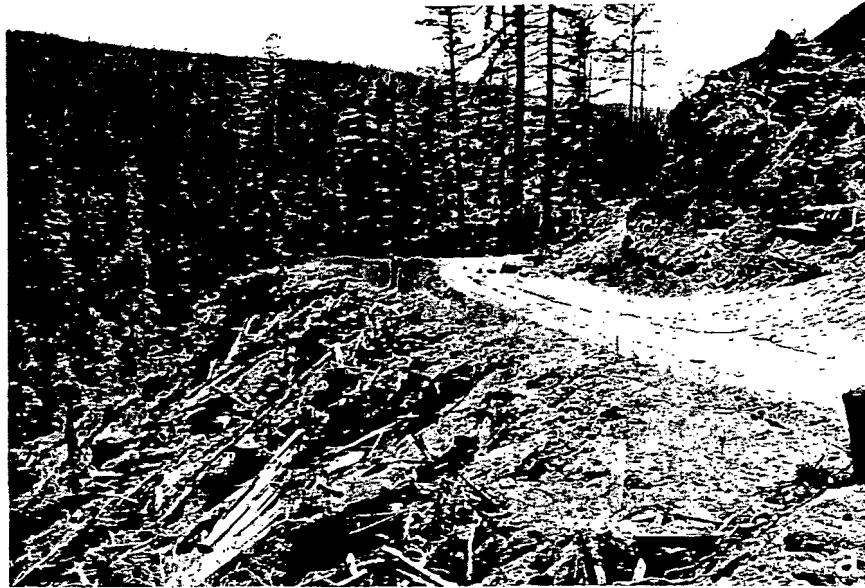
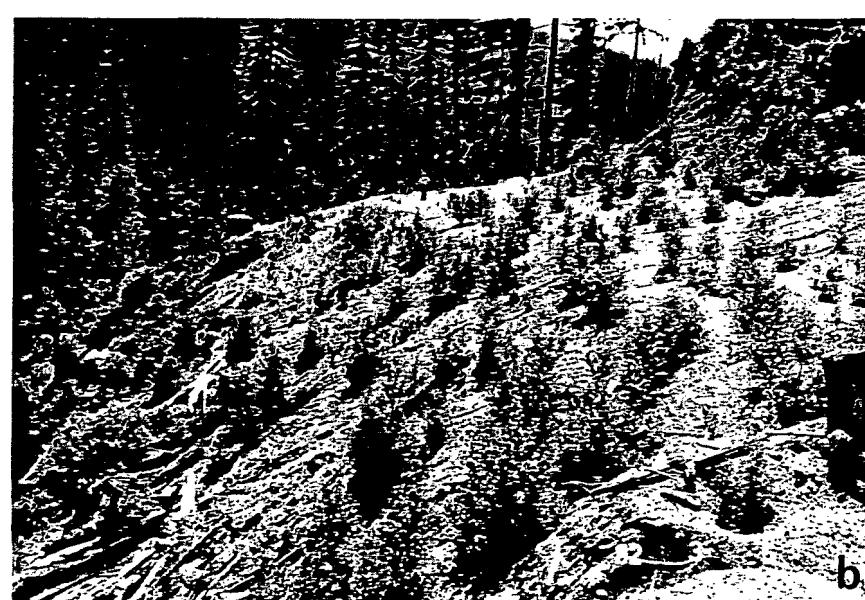
The most expensive and least cost-effective treatments were removal of fill and debris and outsloping landings (Figure 30). These totalled 45 percent of heavy equipment costs (Table 14). Without treatment, much of the landing fill would have failed, but only a portion of this material would probably have directly entered stream channels. Most of the failed material would have been deposited on hillslope benches below the landings (Figure 20). A more cost-effective treatment would have been to excavate fill material in the headwater regions of streams located below the landings and to provide a slightly outsloped surface to drain the remainder of each landing. Based on more recent rehabilitation work, a similar treatment, utilizing a crane or loader and large crawler tractor, would probably have cost about \$5,000 for each landing.

Fig. 30. Serial photographs depicting the treatment and recovery of landing 2. Outsloping and debris removal along several portions of the M-7-5-1 road was expensive but resulted in reduced erosion and rapid revegetation. A) landing 2 before heavy equipment rehabilitation treatment (June 1979); B) after debris removal, outsloping and the natural invasion of alder seedlings approximately 3 years later (July 1982); C) roughly 4 years after treatment (August 1983).

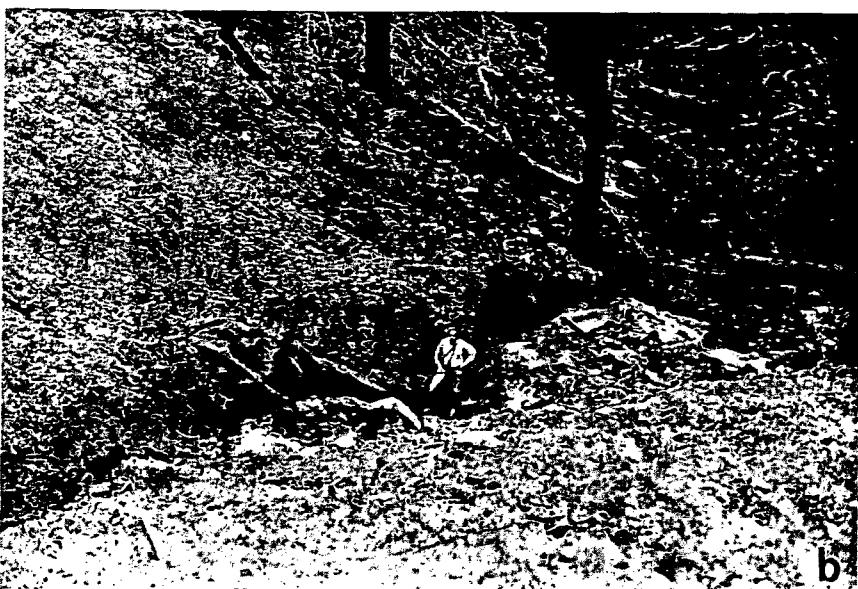
Fig. 32 (left). Excavated stream crossing R6. The two photos show views from A) top left edge of crossing, showing downcutting and terrace development along the right channel bank (rock armor is stranded above the new thalweg) and B) top right bank, showing consequent undercutting of the adjacent channel base. Photos taken October 1979.

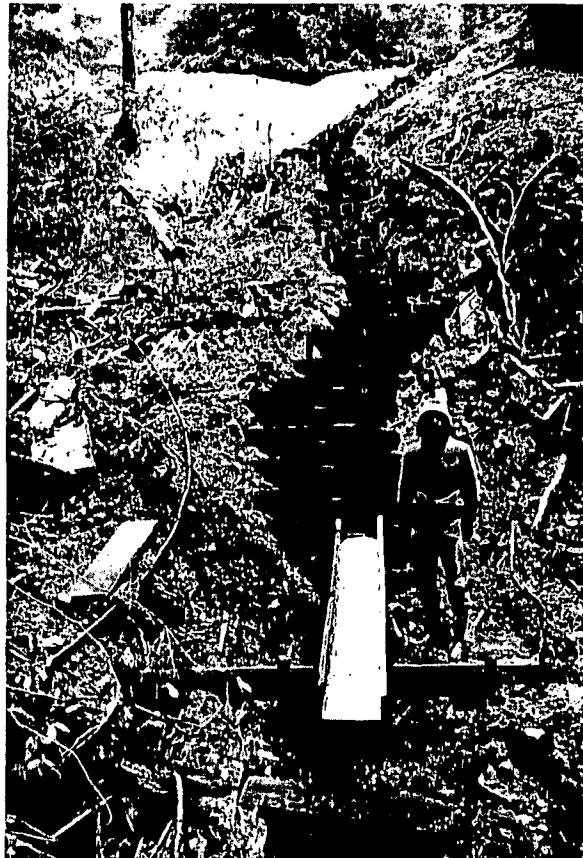
Fig. 35. Protection of a steep, rilled slope near crossing R9 using small checkdams and a flume with energy dissipater. In retrospect, this treatment was judged excessive for the comparatively small amount of runoff and erosion which would have occurred. As with this case, runoff volumes from treated areas and former springs are often difficult to predict.

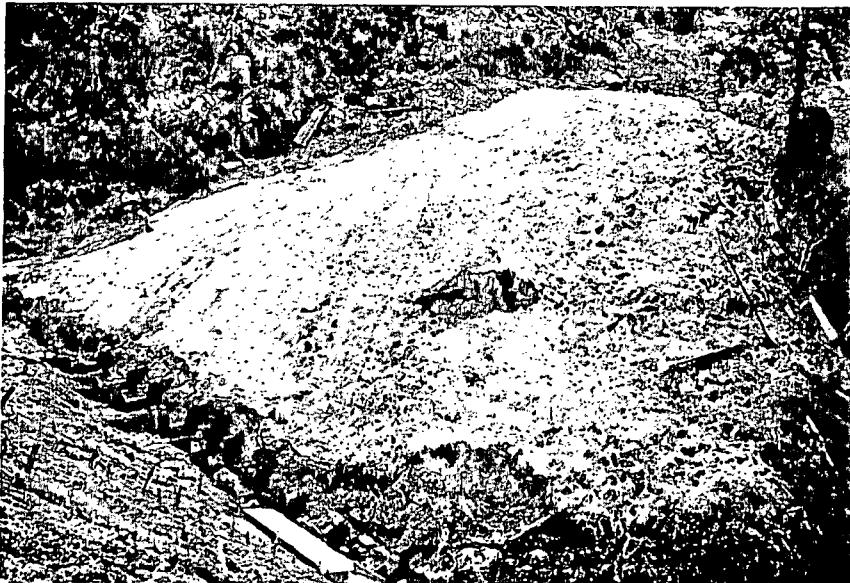
Fig. 36 (left). Surface erosion control on excavated stream crossing R7. The most cost-effective treatment for controlling surface erosion was the liberal application of straw mulch, secured by jute netting on slopes steeper than 70 percent. Photo shows same slope depicted in Figure 34.

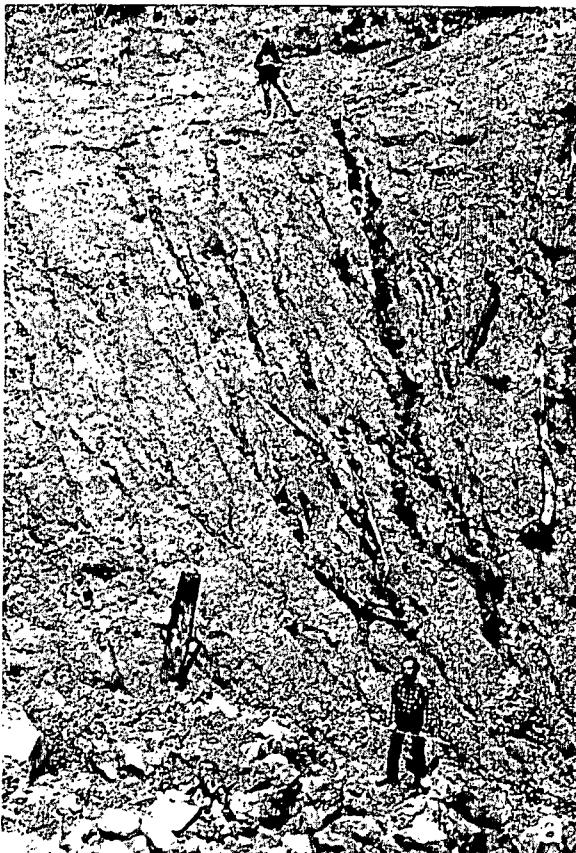
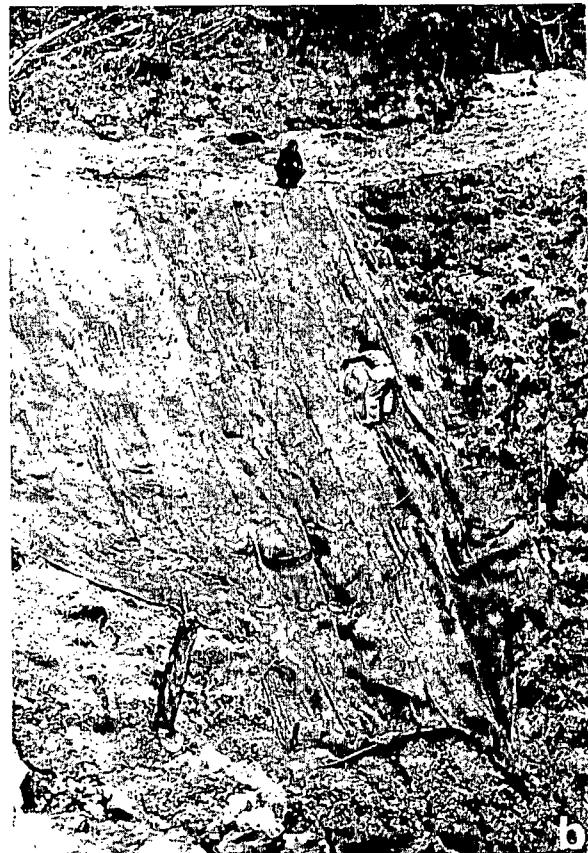
Fig. 37. Photos showing the left bank of excavated stream crossing 8A. A) after 5 inches of rainfall but prior to treatment for controlling surface erosion and B) during final stages of installation of jute netting over straw mulch. Once the original surface had rilled, it had to be manually raked (smoothed) before the jute and straw could be placed. No measureable erosion of the slope has since occurred.

Straw covered by jute was very successful in controlling rilling (Figure 37). However, the size and number of rills which developed on all treated sites were substantially reduced as compared to the same areas before treatment (immediately after the first fall rains). Following each winter, measurements showed that plots 3 and 4 (straw covered by jute and punched straw, respectively) actually trapped sediment which had been eroded from upslope areas. Plot 5 (straw mulch) reduced expected rilling by 85 percent and Plot 1 (wood chips) reduced predicted rilling by 13 percent (Table 23). There was less erosion with straw applied at 6,000 to 8,000 pounds per acre than with the 2,000 to 4,000 pound per acre rate. Wood chips prevented surface erosion on slopes less than 40 percent, but washed away and were ineffective on slopes steeper than 60 percent.

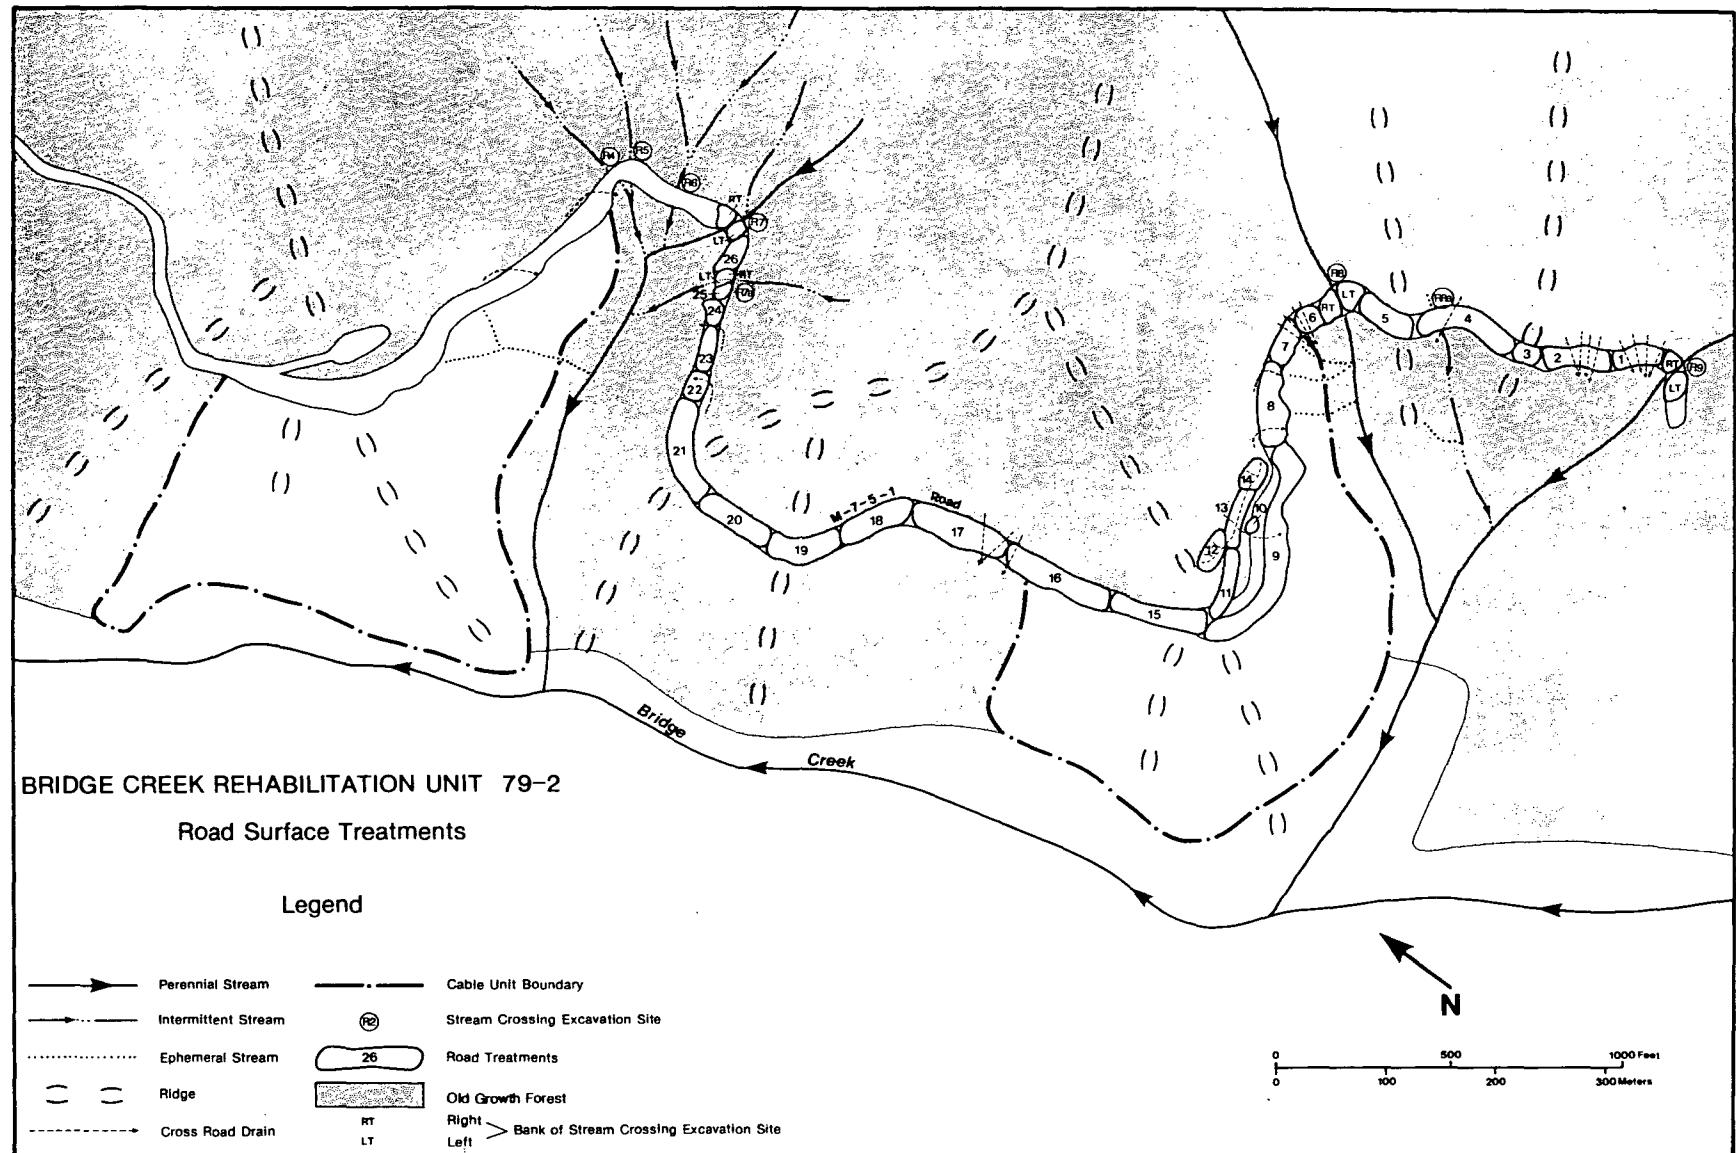
Experimental treatments of grass seed, fertilizer and straw mulch were applied to most of the road surface in November 1979 (Figure 39 and Table 21). Grass seed and fertilizer were also applied at stream crossing excavations R7, R7A, R8 and R9. The RNP grass mixture was applied at 50 pounds per acre and 16-20-0 fertilizer was applied at 250 or 500 pounds per acre.

Fig. 39. Revegetation treatment plots established on the surface of the M-7-5-1 logging road following heavy equipment rehabilitation work. Surface treatments included grass, grass and fertilizer, straw mulch, wood chip mulch and untreated control plots (Table 21).

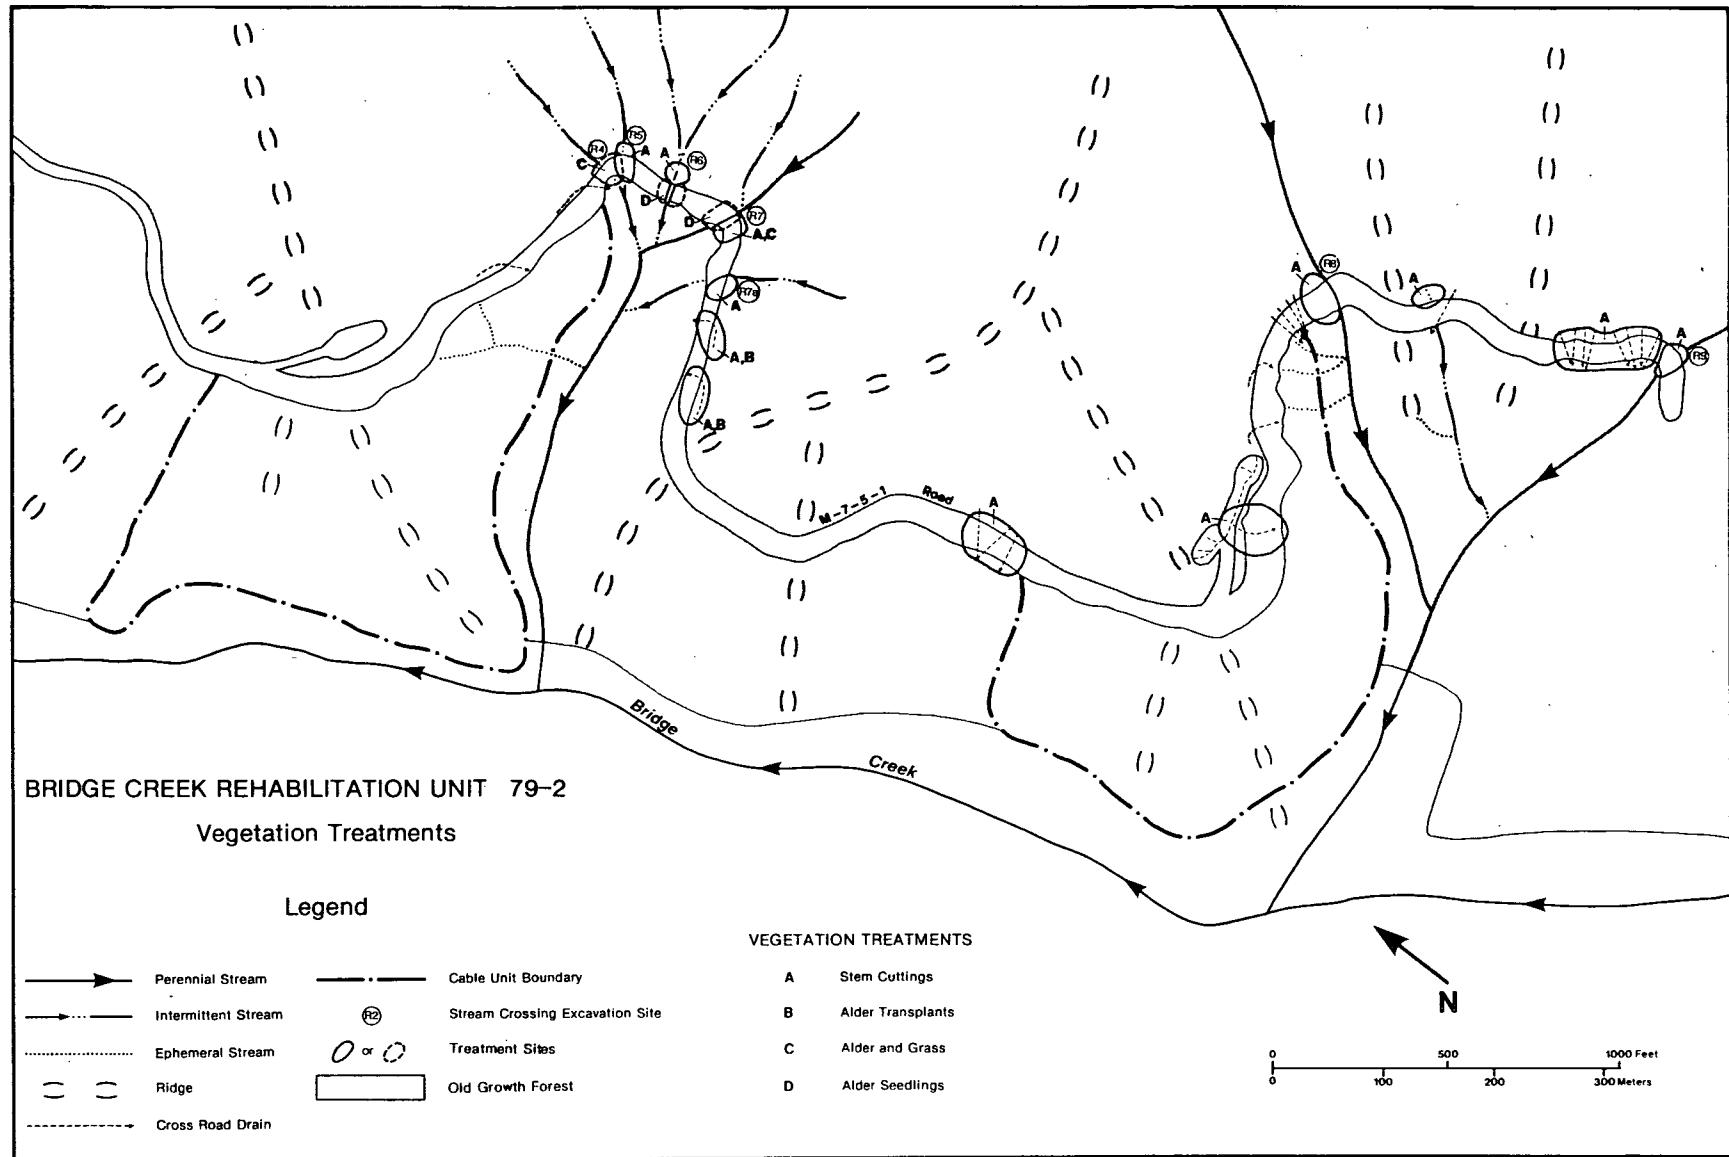
Over one-thousand willow stem cuttings were planted at 14 moist areas (Figure 40). Source for cuttings was near the Redwood Creek trailhead at Orick. On-site alder seedlings were transplanted at two sites. One-year old containerized alder seedlings grown by Simpson Timber Company were planted at R6 and R7. Twenty-six pounds of a grass/alder seed mixture were sown at stream crossings R4 and R7 in April 1980 (Figure 41). The grass/alder seed mixture was composed of 25 pounds "RNP mix" and one pound alder seed.

Fig. 40. Vegetation treatments, M-7-5-1 logging road.
