AN EVALUATION OF EXPERIMENTAL
REHABILITATION WORK,
REDWOOD NATIONAL PARK

TECHNICAL REPORT
JULY 1987

Redwood National Park Watershed Rehabilitation
Technical Report Number 19

National Park Service
Redwood National Park
Arcata, California
July 1987

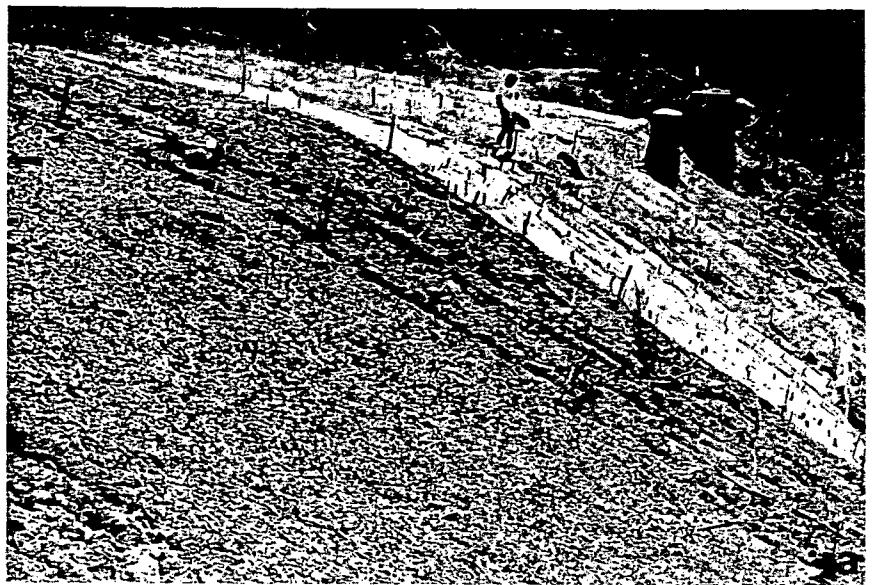
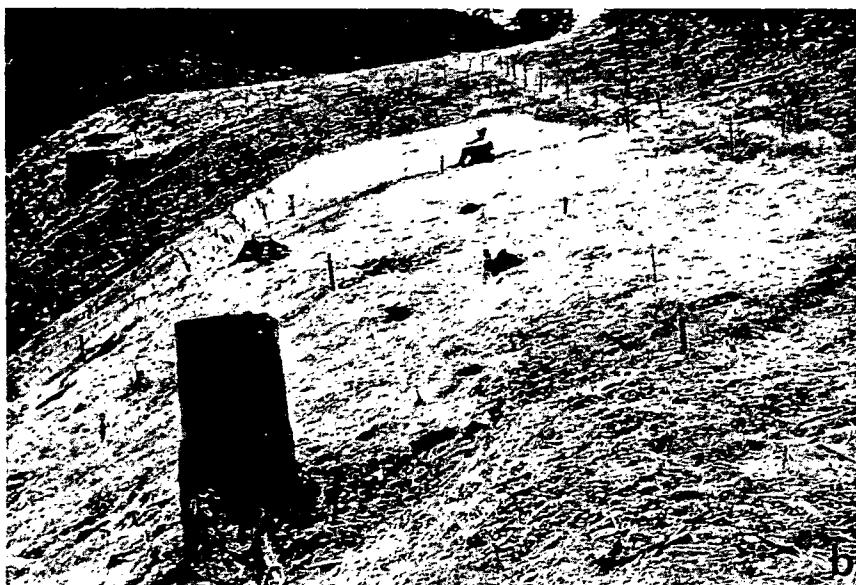
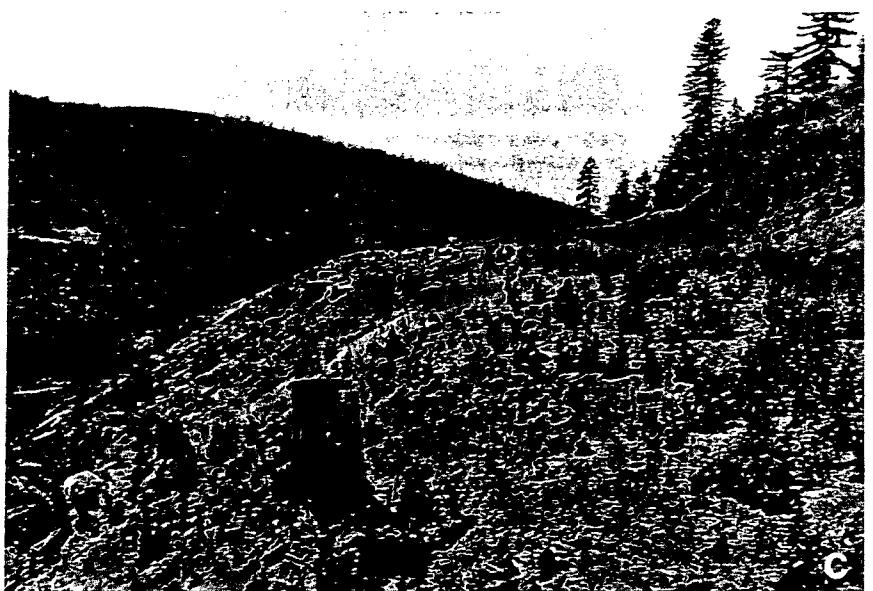
Treatments to control surface erosion included straw mulch, straw mulch covered by jute netting and wood chip mulch. Five (20 foot by 50 foot) side-by-side slope treatment plots were established to compare the effectiveness of these treatments to control rilling (Figure 42). In order of decreasing effectiveness the treatments were: straw mulch (8,000 pounds per acre) covered by jute netting; straw mulch (9,000 pounds per acre) punched into the ground surface with a shovel; straw mulch (9,000 pounds per acre); wood chips (305 cubic yards per acre) and no treatment.

Fig. 42. Slope treatment plots established on the out-sloped section of landing 1. A) plots, from foreground to background, included (1) wood chip mulch, (2) control (no treatment), (3) straw mulch covered by jute netting, (4) straw mulch, punched in by shovel, and (5) unsecured straw mulch. B) closer view of the straw mulch plots, #5 (foreground, beyond stump) to #3 (beyond person sitting on ground near break-in-slope). Photos A and B taken just after application of treatments (December 1979). C) natural invasion of alder two years following treatments (June 1981); note how chip mulch (background) has inhibited alder invasion. D) same view (July 1982).

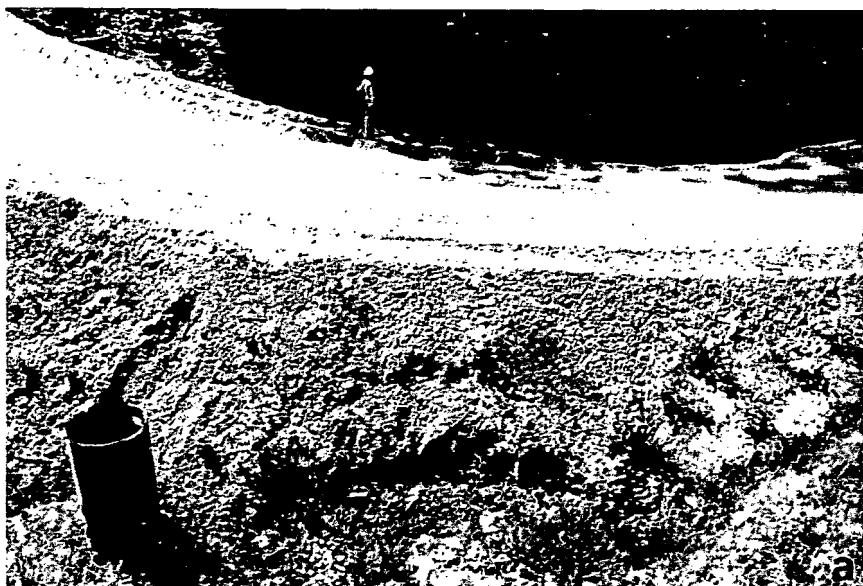
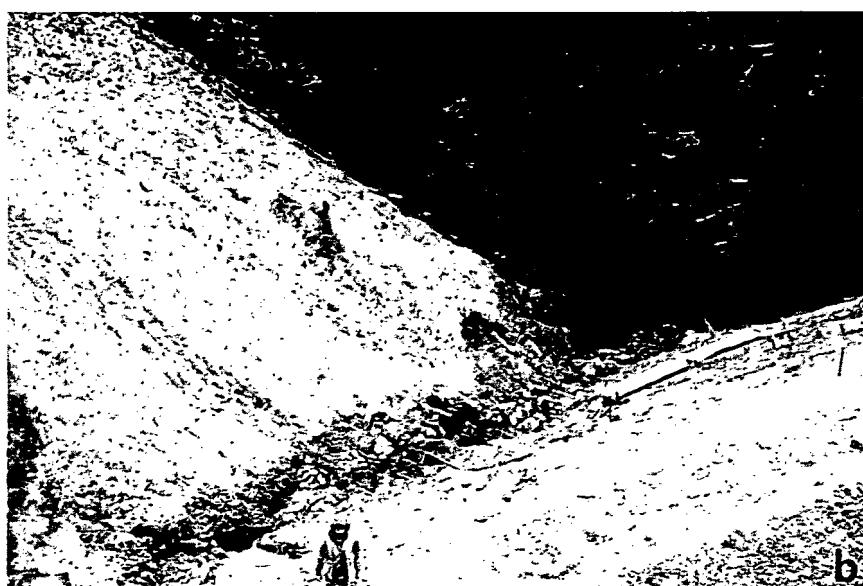
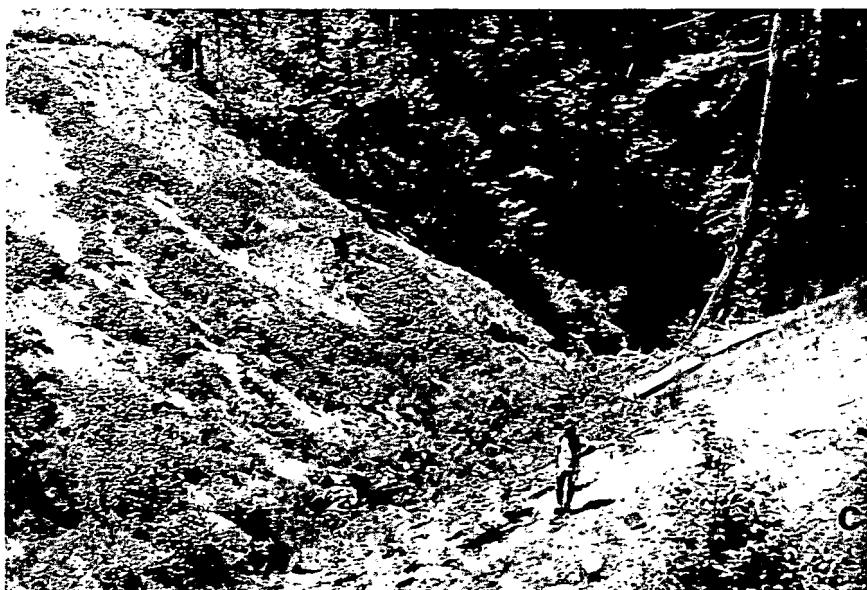
Fig. 43. View of the excavation and revegetation of stream crossing R7, M-7-5-1 logging road. A) M-7-5-1 logging road before rehabilitation and excavation of the stream crossing material (note drop inlet to culvert), May 1979; B) after channel excavation; note straw and jute netting on the left bank, sediment troughs on right bank, and checkdams in channel (January 1980); C) one year, eight months after rehabilitation, showing patchy alder growth from seeding (left bank) and growth of planted alder seedlings and grass (right bank) (May 1981); D) two years, nine months after rehabilitation, showing dramatic alder growth and essentially equal success (in both height and number) of seeded and planted alder at this locality (July 1982); E) three years, ten months after rehabilitation, showing complete closure of new canopy over excavated stream crossing (August 1983).

Grass/alder seed treatments resulted in heavy grass the first year, but alders were well-established the second (Figure 43). The grass did not persist because no fertilizer was used. Natural alder invasion in the unseeded area between stream crossings R5 and R6 resulted in similar alder cover as the seeded area between stream crossings R4 and R5. Grass sown without fertilizer in the spring-seeded areas did not exclude alders as did the fall-seeded grass sown with fertilizer in the road treatments.

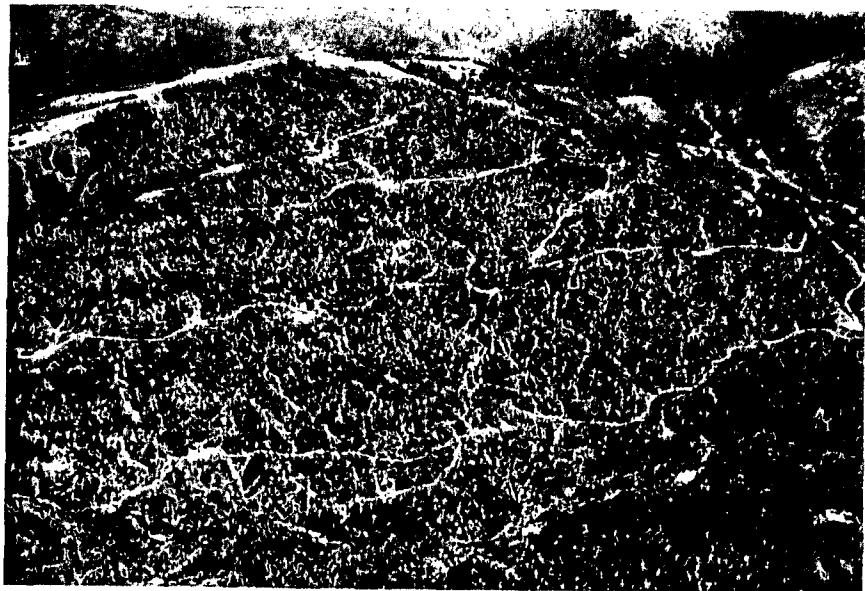
Fig. 46 (above). Oblique aerial photograph of the Copper Creek rehabilitation unit (August 1979). Most areas, except logging roads, major skid trails, landslides and large gullies have revegetated in the decade since the area was last logged.

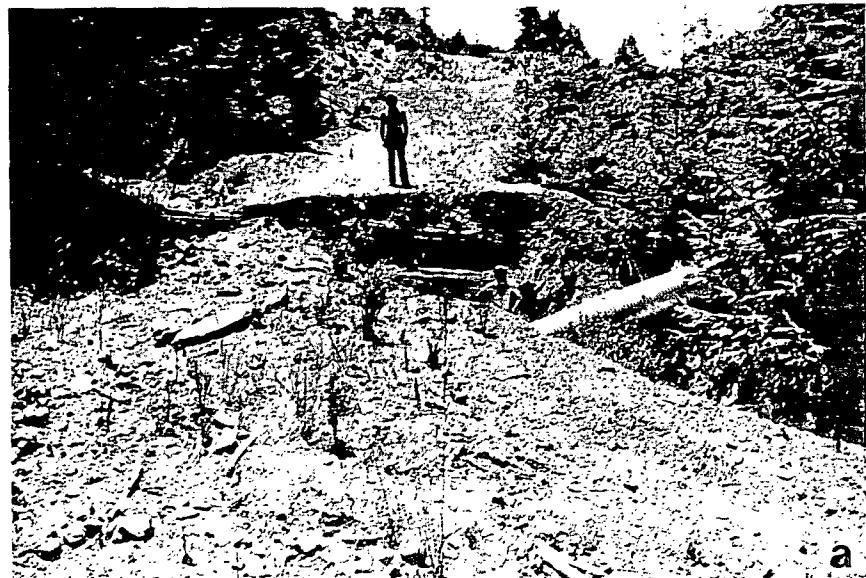
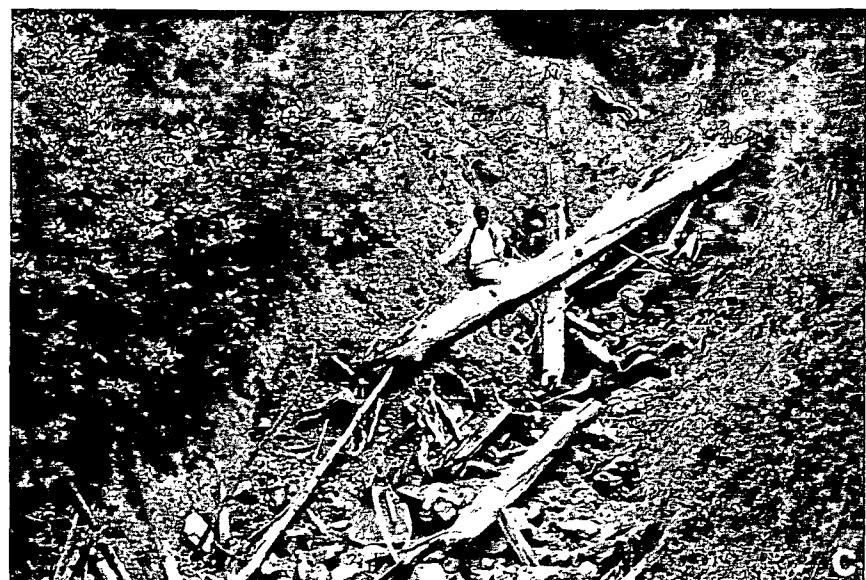
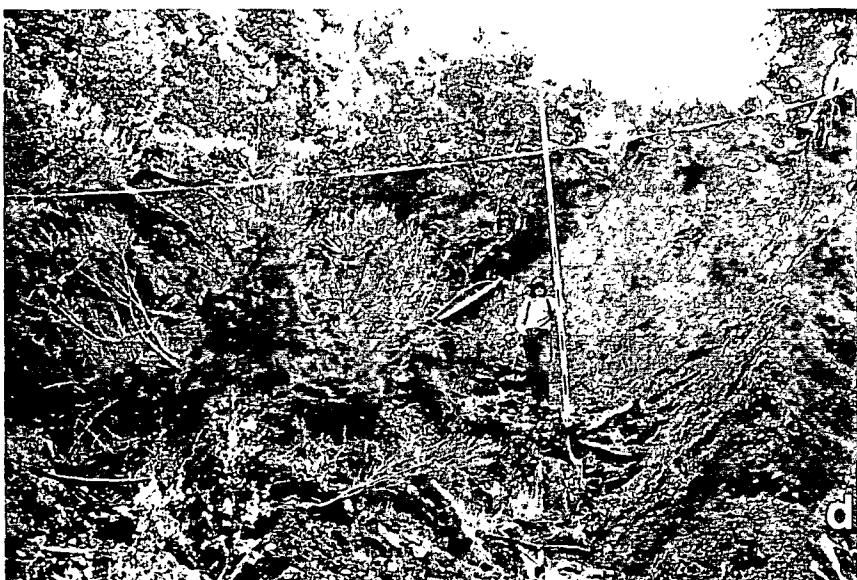
Waterbars or cross-road drains were lacking on most roads and skid trails. Many of these bare areas became severely gullied by concentrated runoff (Figure 49). By 1979, many sections of unstable roads and landings had failed into adjacent stream channels (Figure 50). Approximately 163,000 cubic yards of sediment were eroded and lost from the area between 1964 and 1979 (Weaver and others, 1982).

Fig. 49. Examples of gully erosion on the Copper Creek rehabilitation unit. A) partially eroded stream crossing. B) severely gullied skid trail. C) gully headcut on hillslope and D) large gully formed by stream flow diverted out of its natural channel at an upslope logging road stream crossing.

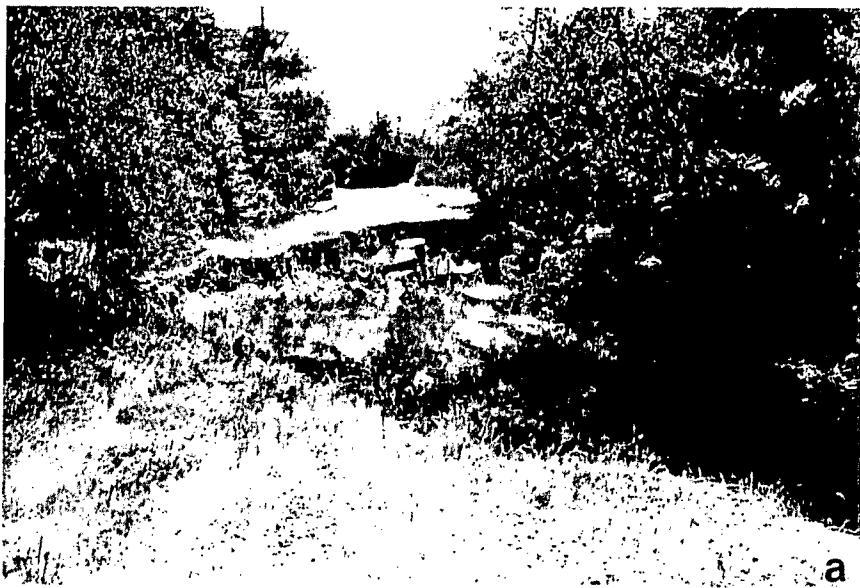
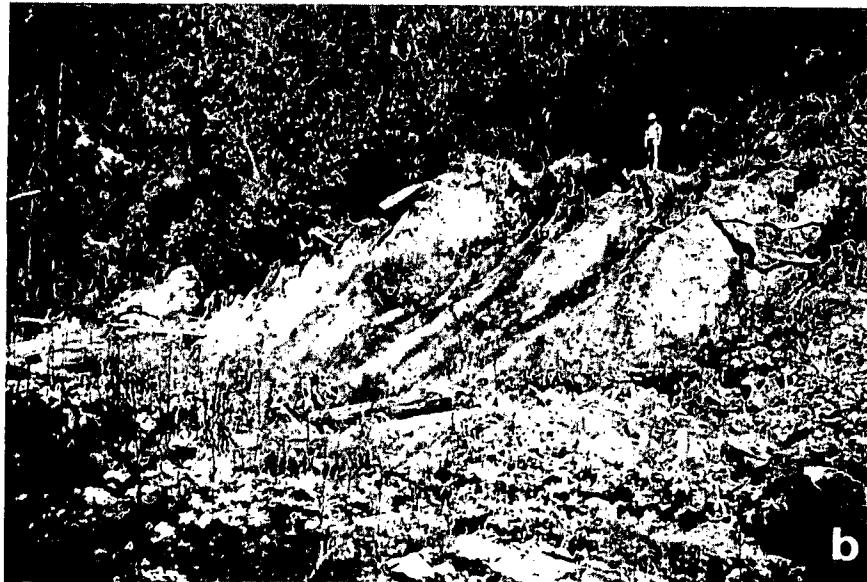
Fig. 50. Examples of hill-slope failures on the Copper Creek rehabilitation unit. A) slump, B) debris slide.

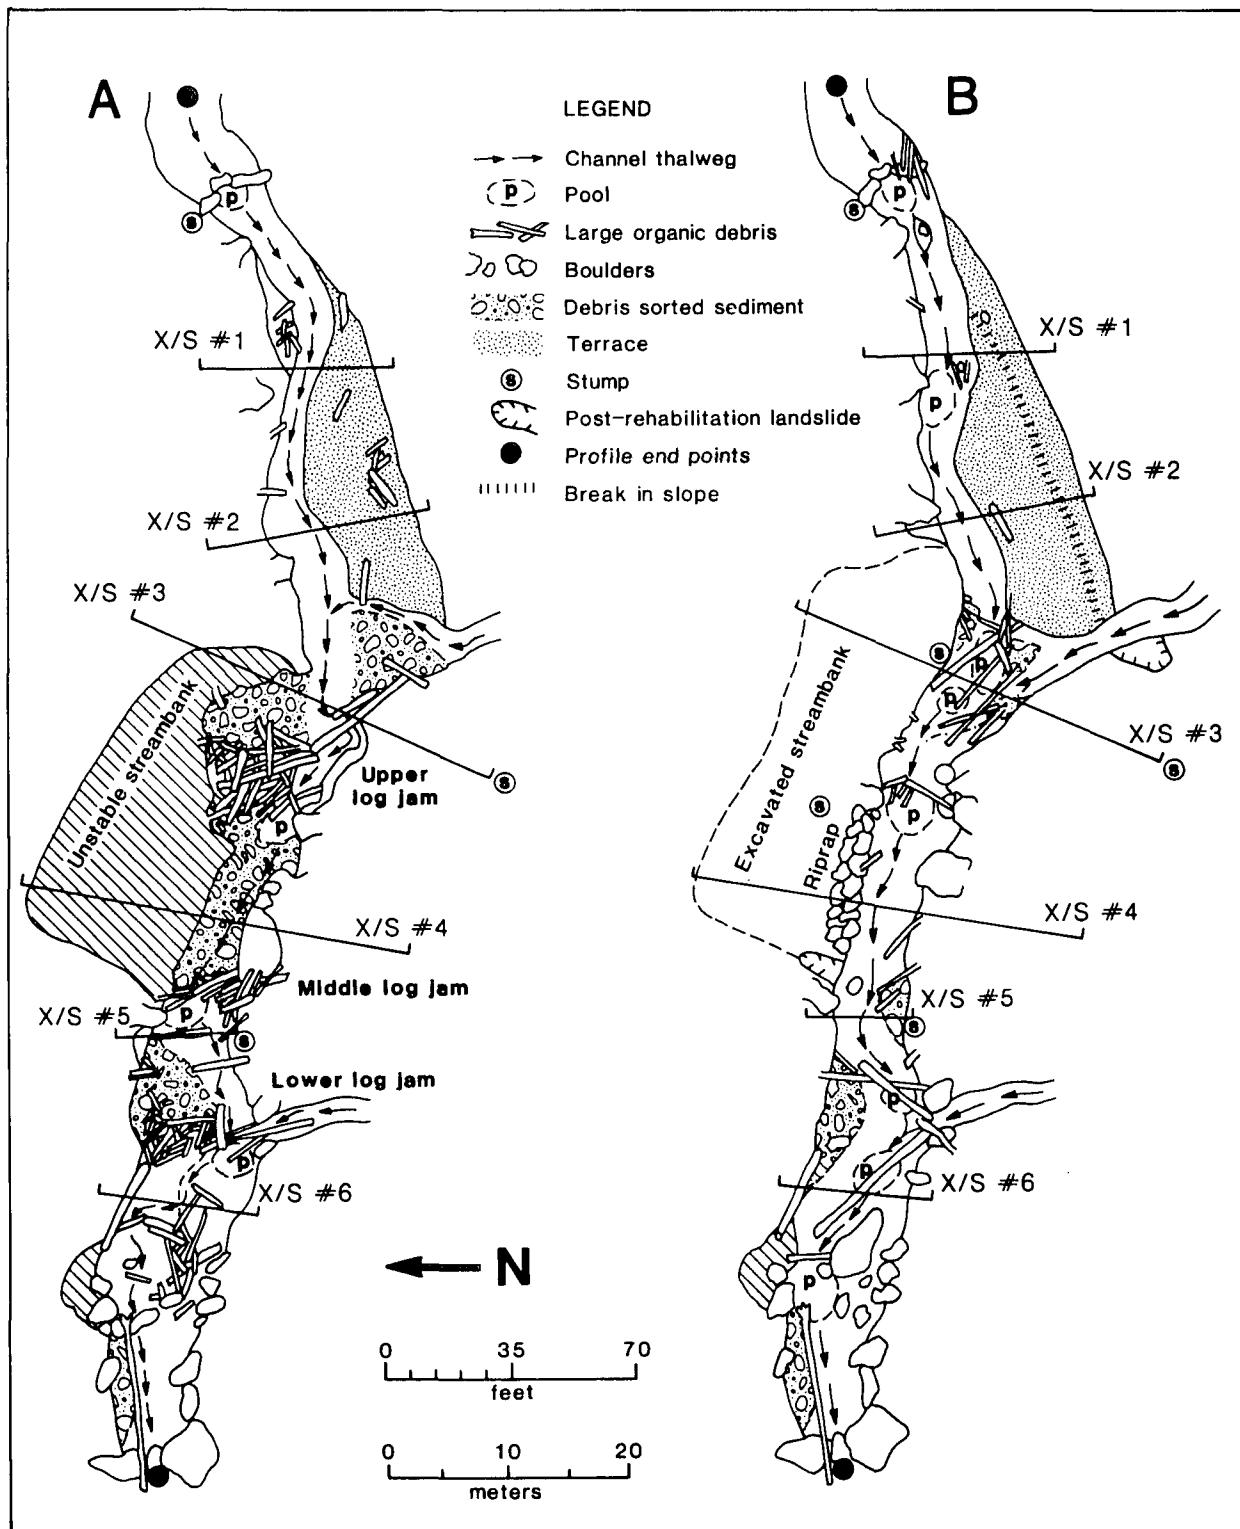
Fig. 58. Morphologic maps of Copper Creek in the vicinity of the log jam. A) before rehabilitation (September 1979), showing the distribution of stored sediment, organic debris and locations of bank erosion, B) after rehabilitation (August 1982) showing the channel adjustments which had occurred in the subsequent winter.

Organic debris and log jams commonly alter the hydraulics of a stream reach causing changes in channel morphology (Pitlick, 1981; Keller and Talley, 1979; Swanson and Lienkaemper, 1978). An abrupt step in the longitudinal profile may form at the log jam with an associated upstream decrease in gradient and increase in channel width. These effects were seen at the Copper Creek log jam worksite. The log jam also caused local hillslope failure by diverting flow into banks and undercutting the toe of an adjacent slope (Figure 58).

Five percent of the total heavy equipment costs were incurred in removing three log jams in Copper Creek. The log jams were composed of partially rotted saw logs (predominantly Douglas-fir) which were likely to fail and release the sediment stored behind them (Figure 56). Unstable sideslopes were also excavated and the toe of the unstable right bank between the upper and middle log jams was protected with riprap. Excavation and endhauling was done by crane, excavator, both crawler tractors, loader and dump truck (Figure 57). Figure 58 shows morphologic maps of the log jams prior to treatment and three years later.

Approximately 600 cubic yards of sediment was excavated during log jam removal at a cost of \$7,760. The excavator and tractors removed an additional 850 cubic yards of unstable material along the channel sideslopes at a cost of \$805. Ripraping the toe of the unstable right bank with boulders cost \$1,680, including quarry and transportation costs. All material excavated from the log jams and side banks was placed in a stable location on the 1910 road between the log jams and R47 (Figure 51). The total heavy equipment cost associated with log jam excavations was \$10,250.

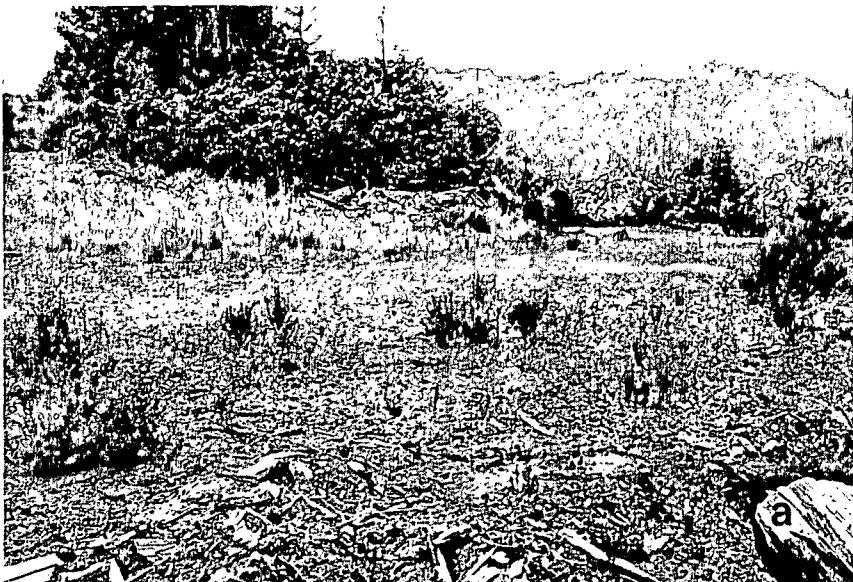
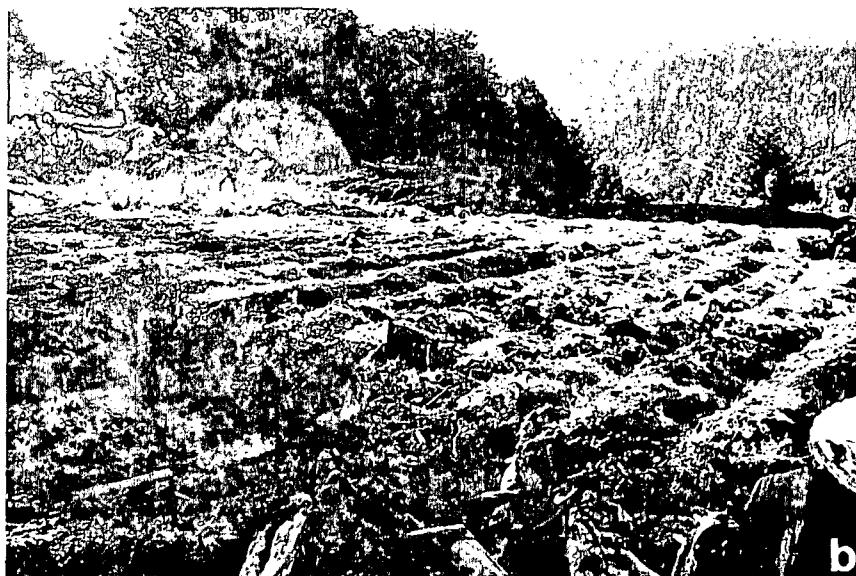
Fig. 60. Ripping a log landing on the Copper Creek rehabilitation unit. A) before disaggregation (May 1979) — note the sparse vegetation invasion of the compacted road surface in the ten years since the road had last been used; B) after ripping and the application of a straw mulch (December 1979).

Approximately 6.7 miles of road and 38 landings, totalling 28.2 acres, were ripped (disaggregated) to a depth of 24 inches. Ripping was done by the TD-25 crawler tractor with a pair of hydraulically operated ripper or chisel teeth (Figure 59). Roads and landings were ripped to increase infiltration of water into the road surface and to promote revegetation of formerly compacted areas. Ripping was done throughout the heavy equipment phase of rehabilitation and, to avoid recompaction, shortly preceding final road removal efforts. Total cost was \$8,280 or an average of \$700 per mile of road and \$125 per acre of landing (Figure 60).

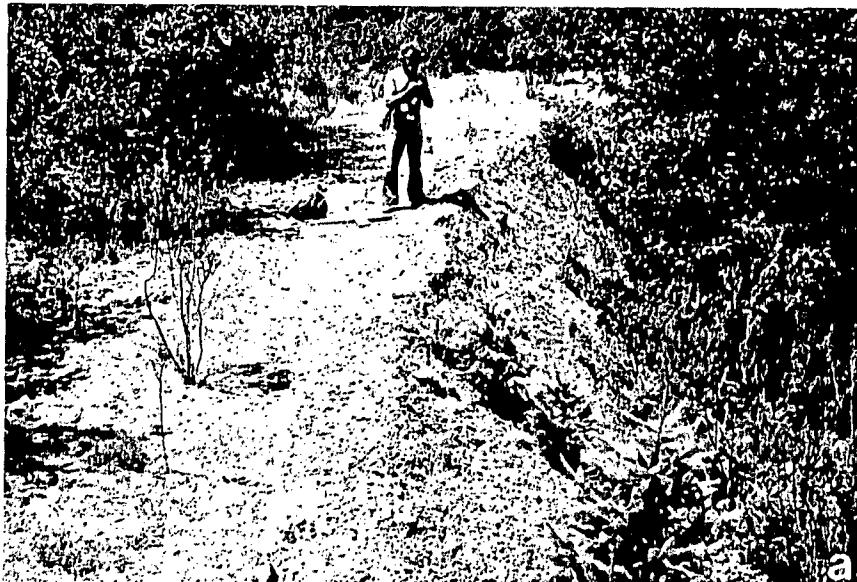
Fig. 61. Rehabilitation of a secondary logging road. A) after ten years of abandonment, but prior to rehabilitation treatments — note lack of re-vegetation on the road surface; B) immediately following road ripping and construction of cross road drains. Decom-pacted road has also been lightly mulched with straw.

Backhoes, crawler tractors and the excavator constructed 291 cross-road drains, drains across landings, and slope ditches at a cost of \$13,330. Average costs per drain are misleading since drain dimensions varied greatly from 30 feet long to 200 feet long. Ditches and drains were constructed to route surface flow into less erodible areas and to disperse water which collected on the road surface (Figure 61). The

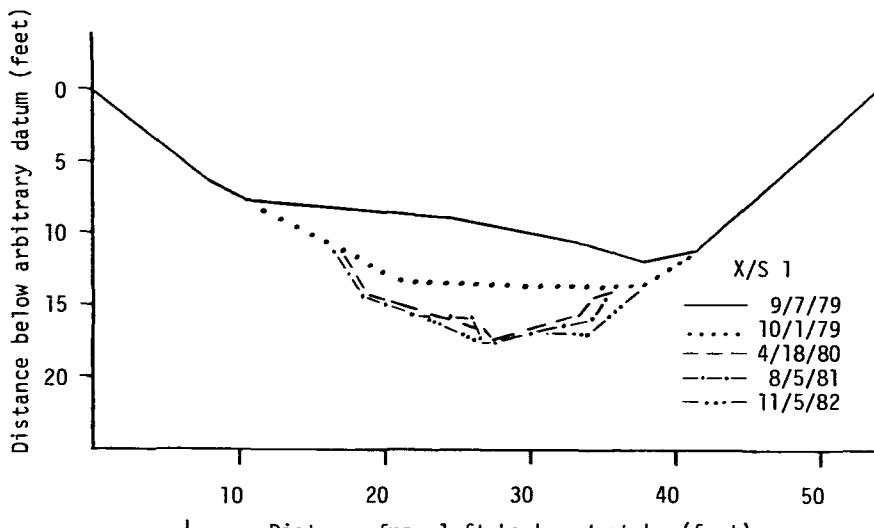
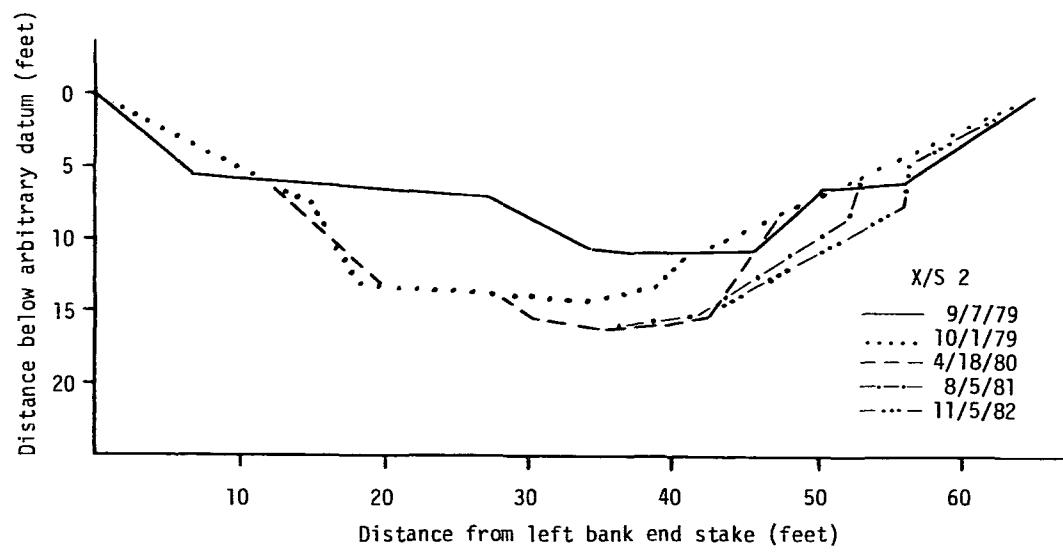
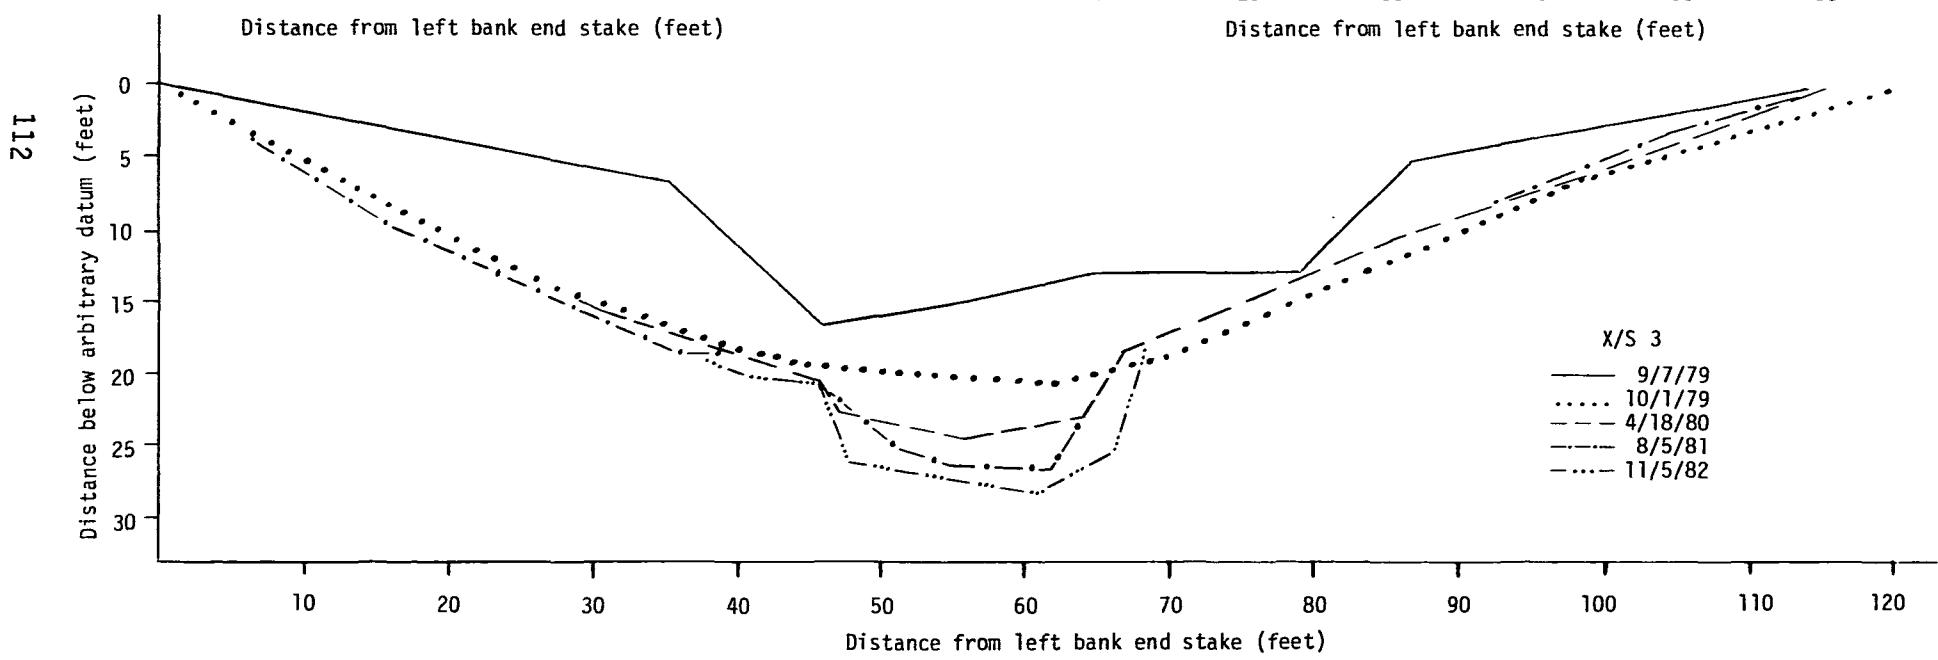
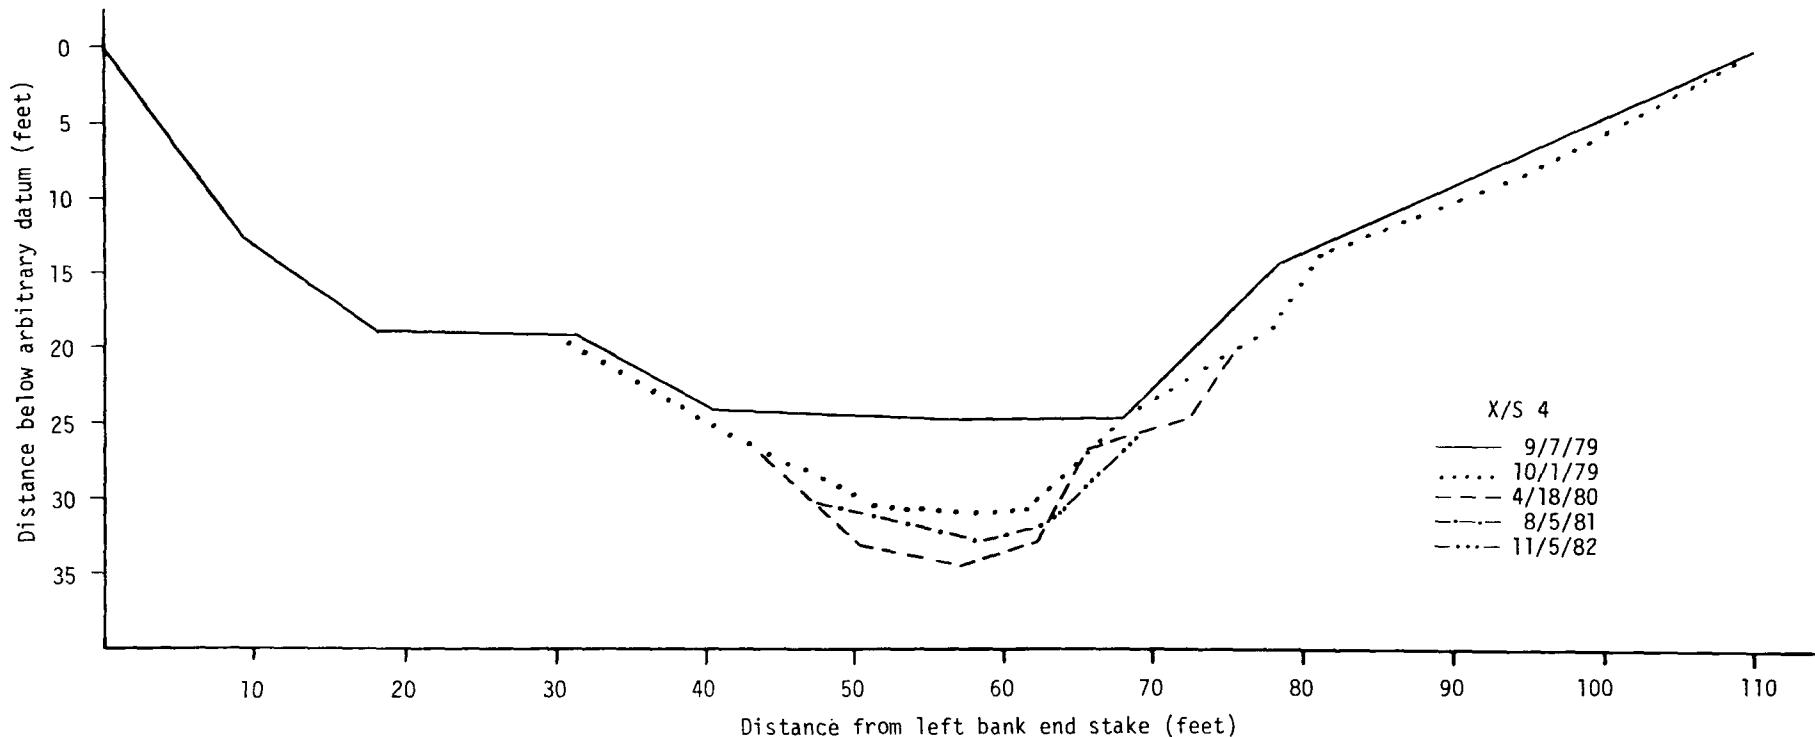
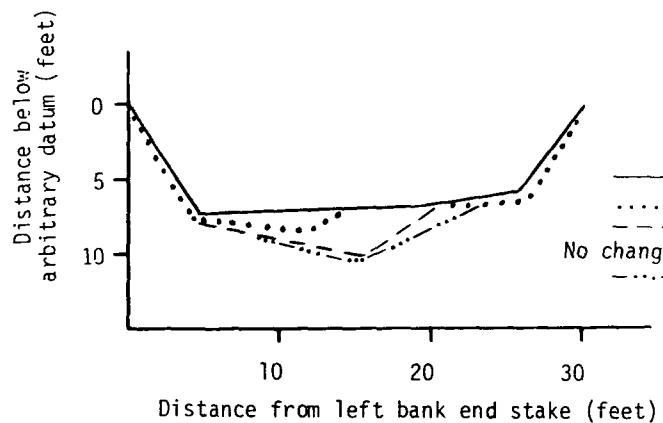
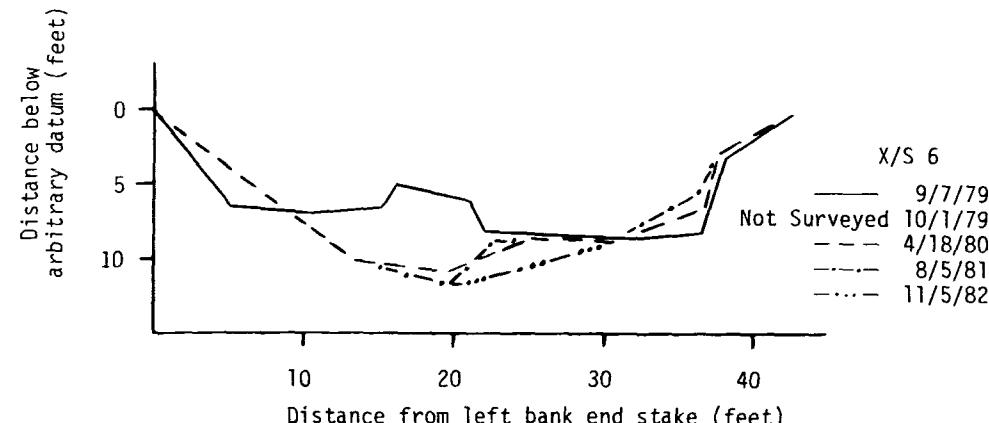
Fig. 67. Six channel-cross-sections of Copper Creek at the site of the excavated log jam. Cross-sections were measured prior to log jam removal (September 1979), immediately following heavy equipment operations (October 1979) and once during each of the following three years (April 1980, August 1981, November 1982).

As a result of the 1980 winter storms, an additional 560 cubic yards were eroded from the site. Most of the bedload loss was associated with channel scour from increased flow velocities on the unprotected loose sediment within the excavated stream reach. During the following winter (1981) an additional 60 cubic yards were eroded (Figure 69). Most of this occurred near cross-sections 2 and 3 where an average of 2 - 4 feet of bank erosion was detected (Figure 67).

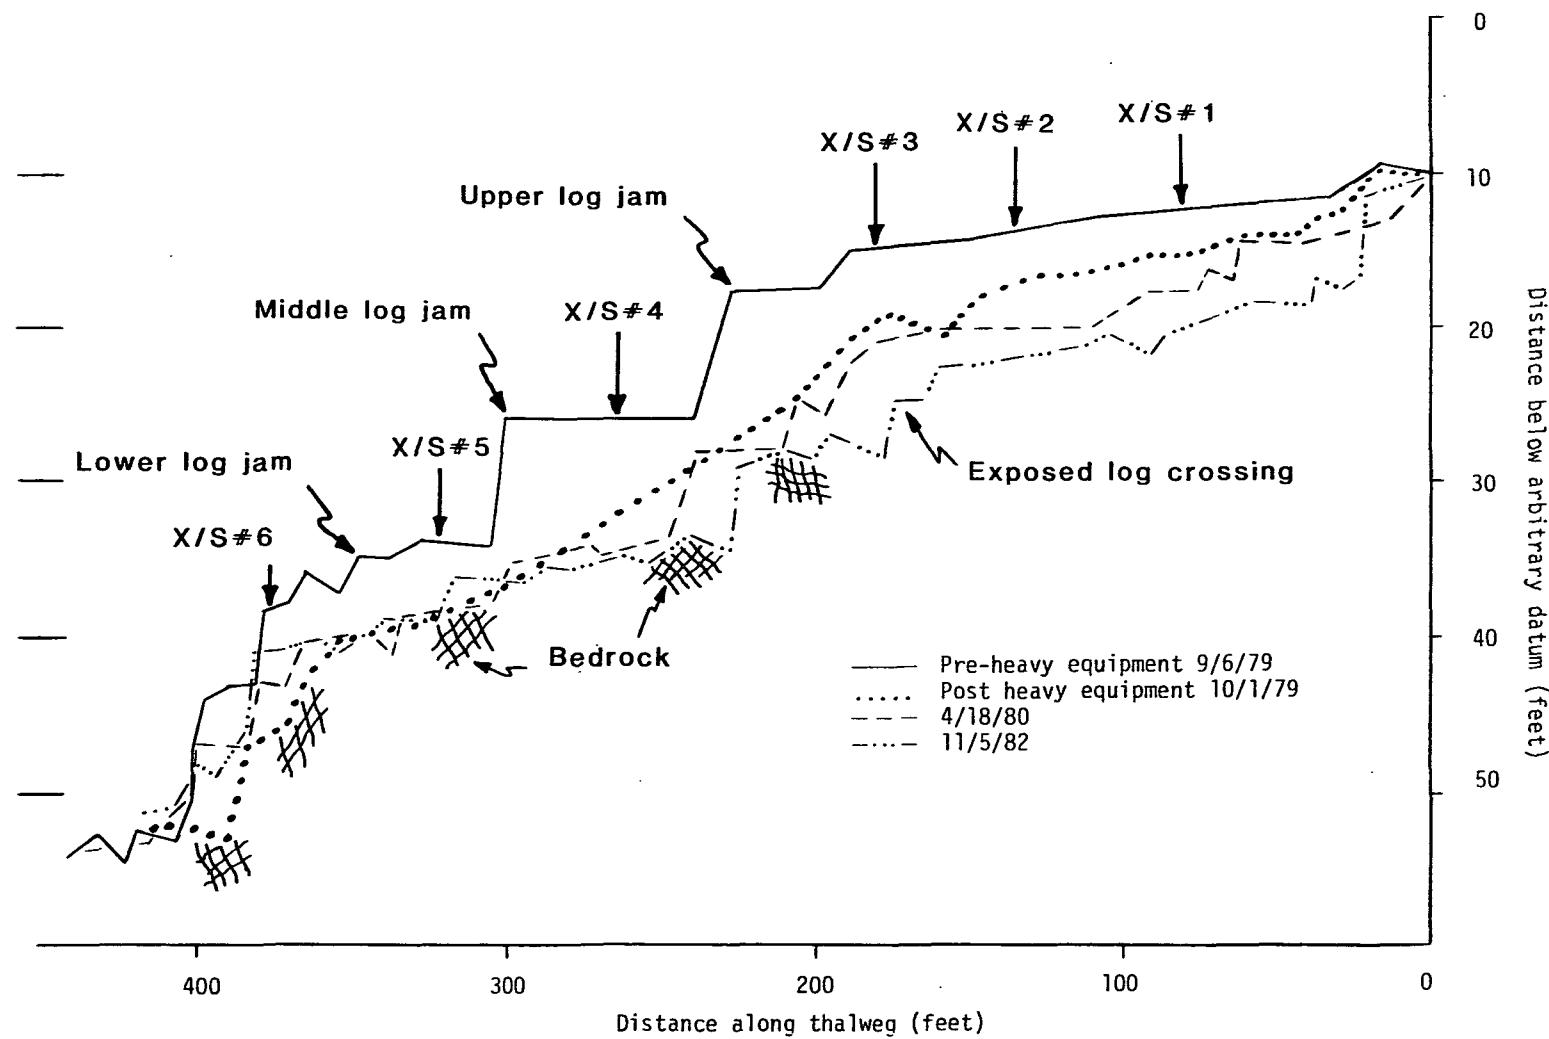
Fig. 68. Longitudinal profiles of Copper Creek at the log jam removal site. The four profiles show the trace of the channel thalweg before log jam removal, immediately following heavy equipment work and once during each of the following two years.

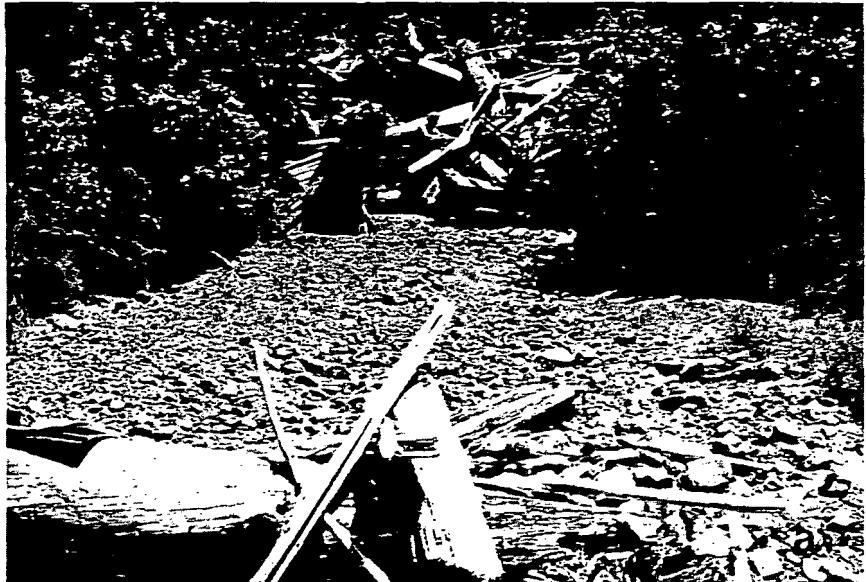
Fig. 69. Channel view from the top of the middle log jam step, looking upstream at the upper log jam step. A) before treatment, large quantities of sediment stored in the channel behind the middle step (foreground) have partially buried the base of the upper log jam; B) same view following the first winter after treatment, note the rip rap placed against the right bank (left of photo) and the nickpoint forming where additional organic debris is being exhumed; C) three years following log jam removal (September 1983) note the persistent step in the channel profile created by the remaining organic debris (this step is graphically shown at station 250 feet on Figure 68).

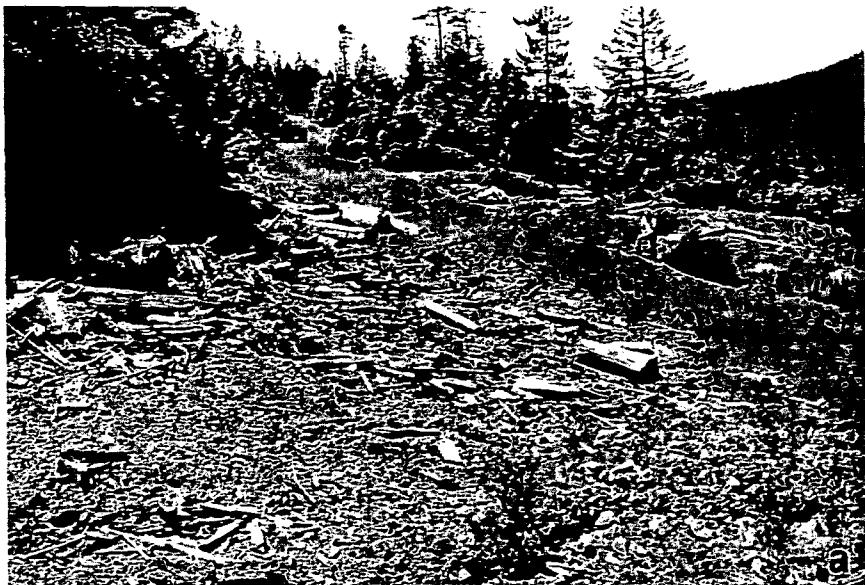
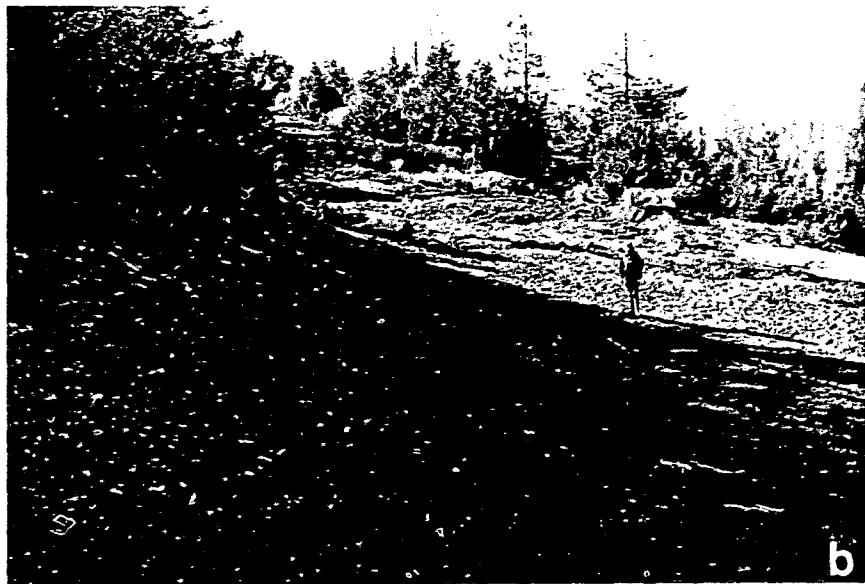
Fig. 74. Natural revegetation of a decompacted road surface. A) before rehabilitation, the former road surface showed little natural revegetation in the 10 years following its abandonment; B) same area immediately following decompaction and outsloping (November 1979); C) four years later (September 1983) the site has been covered with naturally invading coyote brush. Revegetation of this hot, dry southwest facing slope contrasts sharply with the cool moist areas in Bridge Creek (unit 79-2) which were invaded by rapidly growing alder.

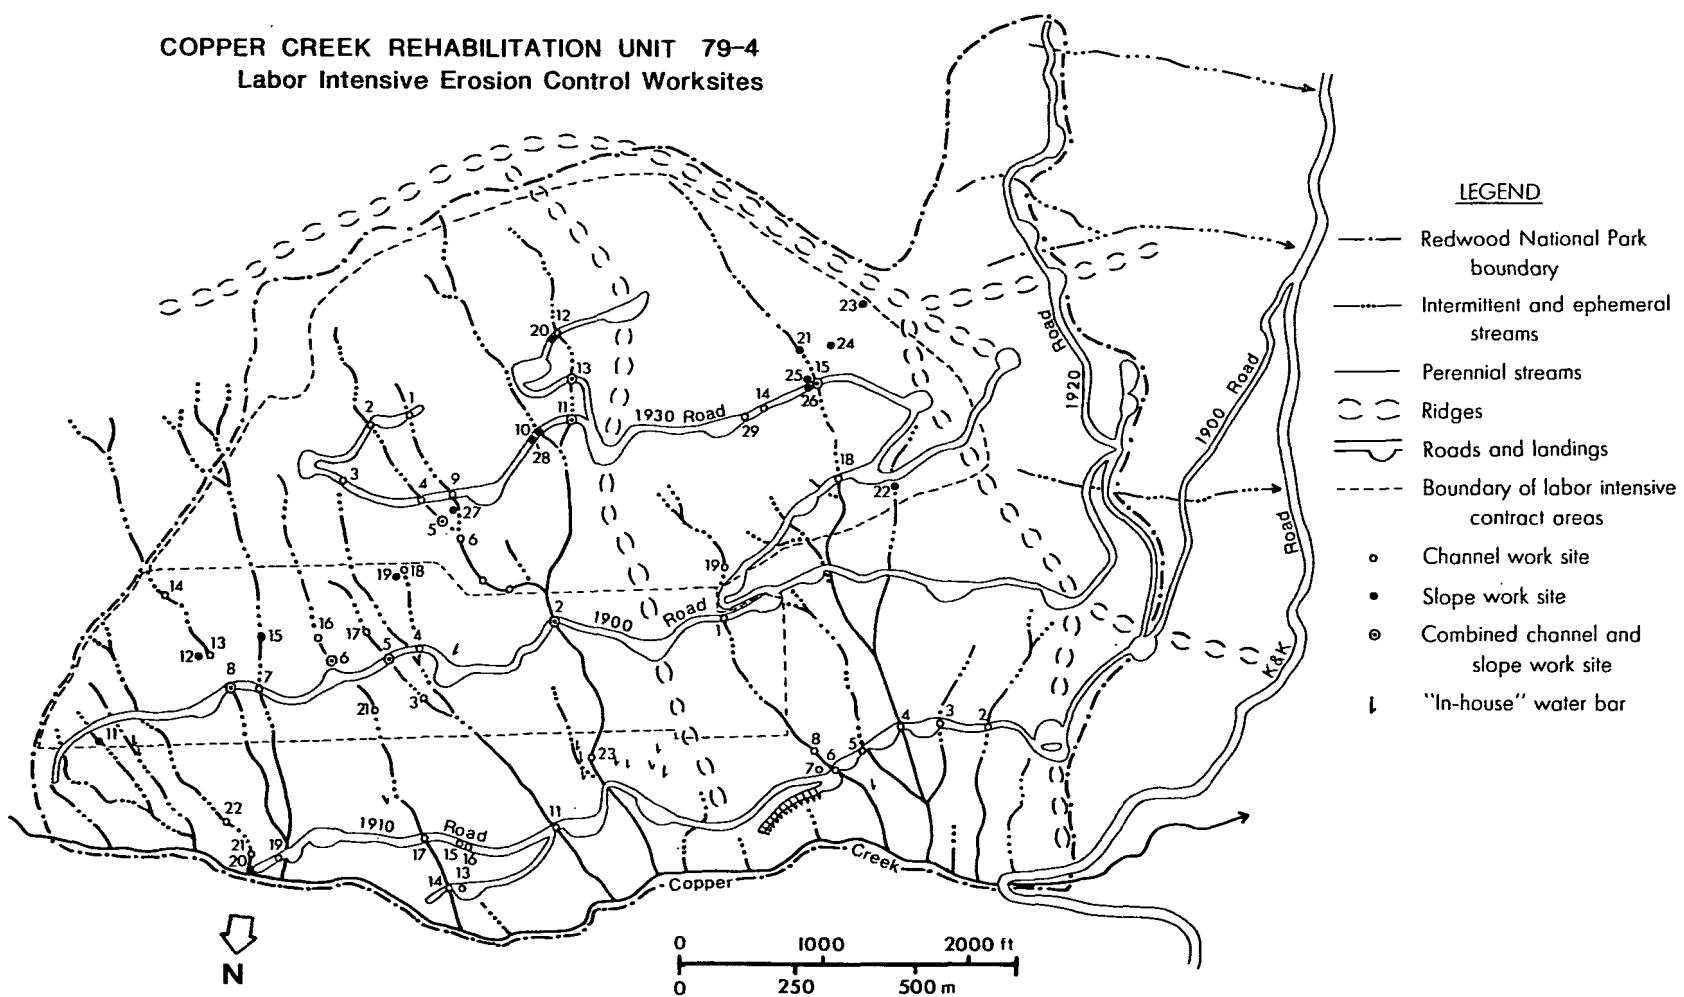
Fig. 72. Labor intensive erosion control work sites on the Copper Creek rehabilitation unit. Note the dashed lines which delineate the upper, middle and lower contract areas.
