AN EVALUATION OF EXPERIMENTAL
REHABILITATION WORK,
REDWOOD NATIONAL PARK

TECHNICAL REPORT
JULY 1987

Redwood National Park Watershed Rehabilitation
Technical Report Number 19

National Park Service
Redwood National Park
Arcata, California
July 1987

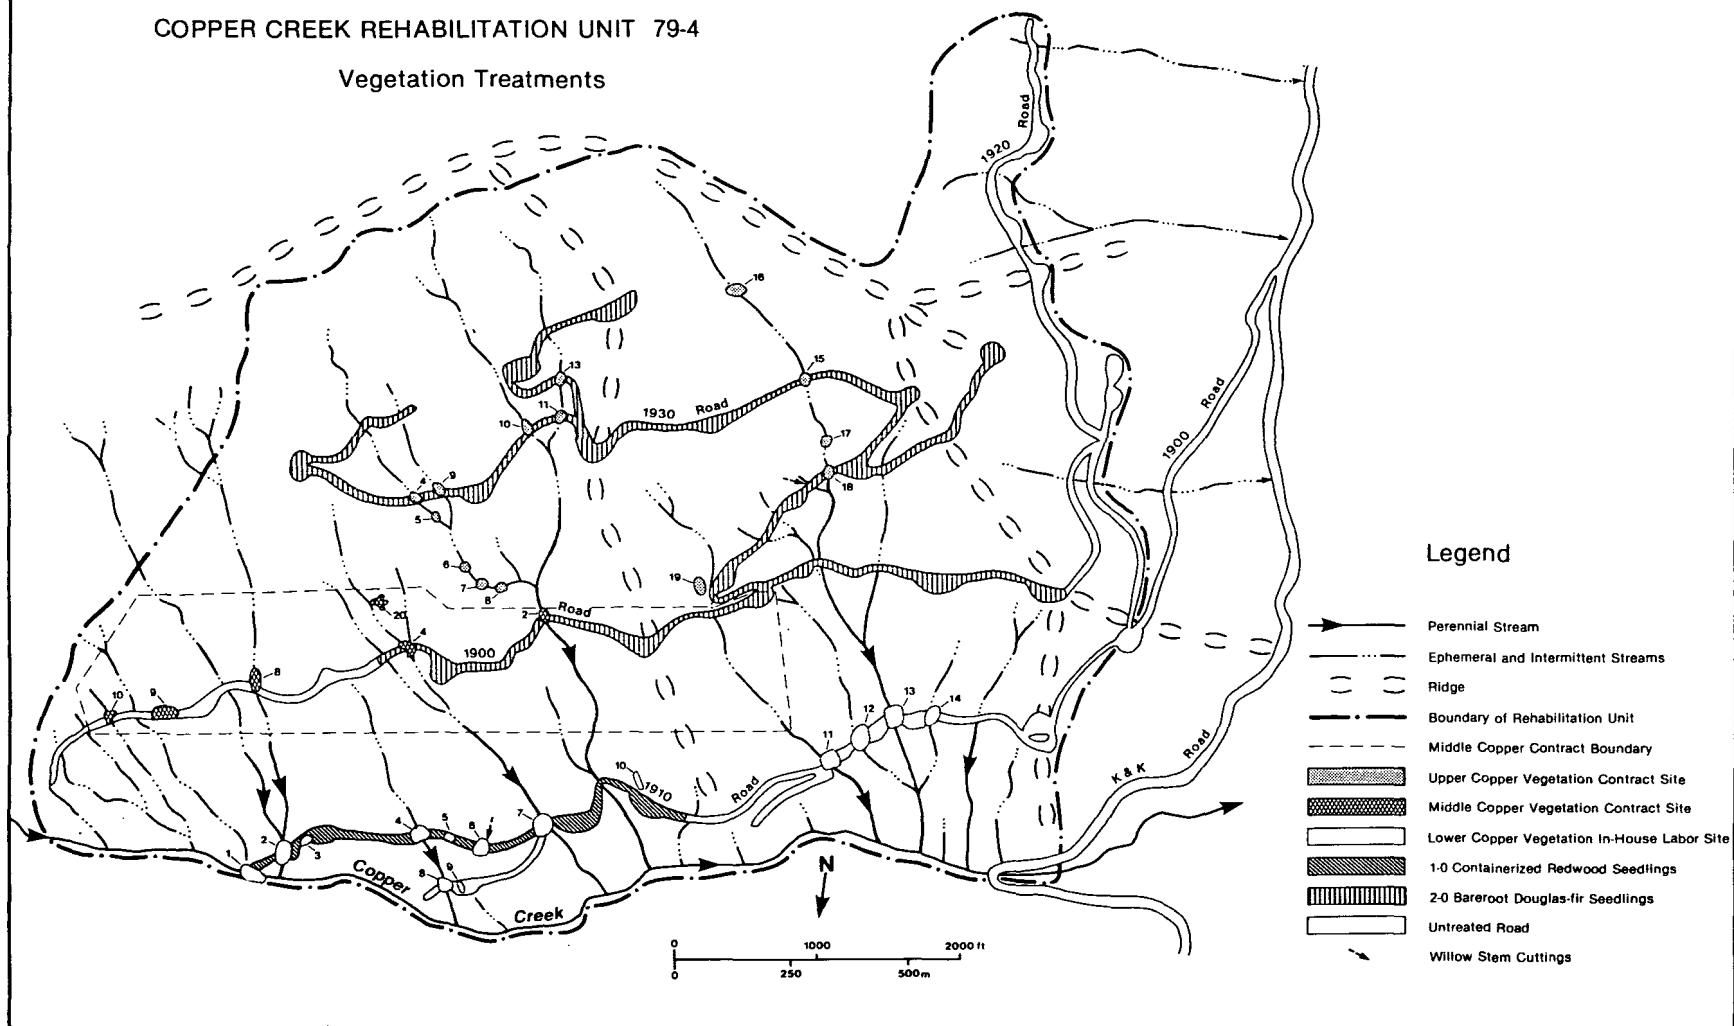
Fig. 73. Vegetation treatments on the Copper Creek rehabilitation unit.

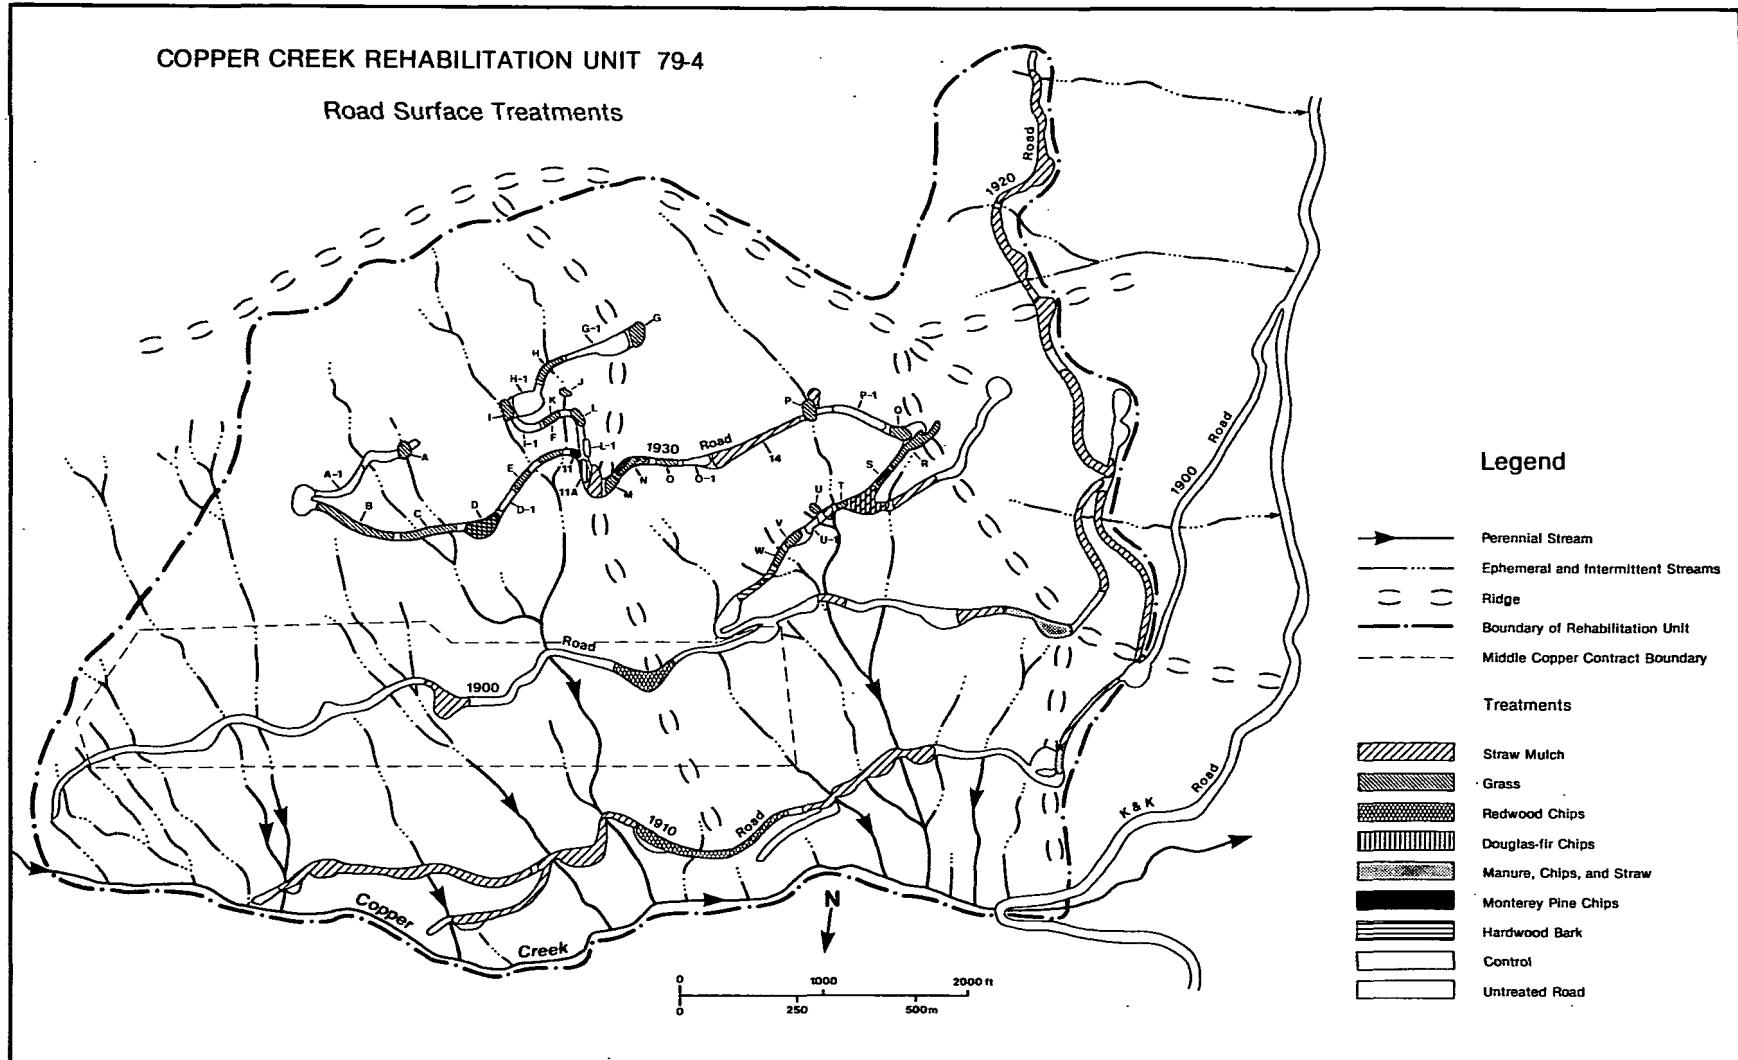
Fig. 74. Road surface treatments (mulching and grass seeding) on the Copper Creek rehabilitation unit.

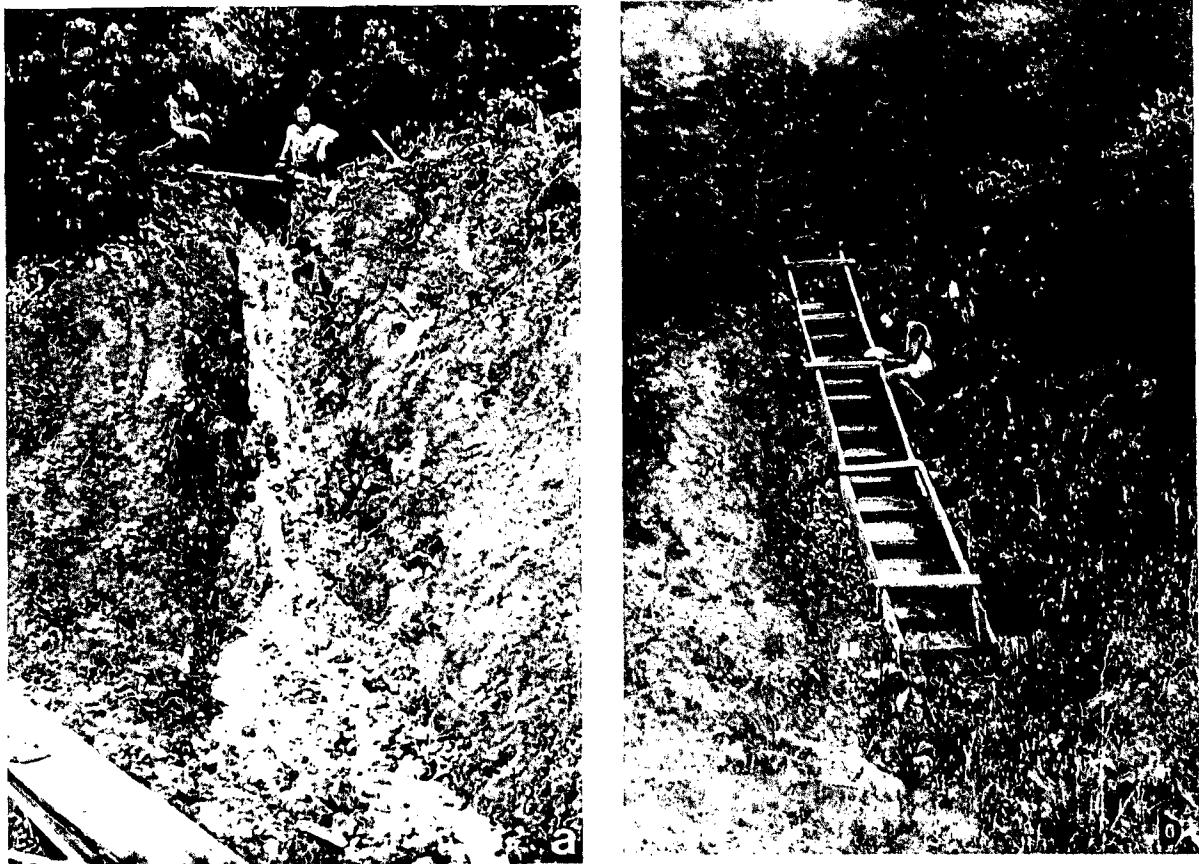
Fig. 75. Water ladder constructed at worksite 9, on the 1930 road, in the upper Copper Creek contract area (see Figure 72). A) before construction, runoff flowing down a former skid trail and over a steep cut bank was causing gully erosion and filling the inboard ditch of the abandoned logging road; B) since the water could not be diverted off the trail, a water ladder was constructed to carry the flow over the erodible bank.

Other in-channel treatments. In-channel treatments other than rock armor totalled four percent of the labor intensive costs. Notched logs, knickpoint plugs and the waterladder were still functioning properly after four winters, but all will deteriorate and eventually fail. Checkdams and waterladders are comparatively cost-ineffective (Weaver and others, 1982) for correcting erosional problems but are used as temporary measures while vegetation is becoming established.

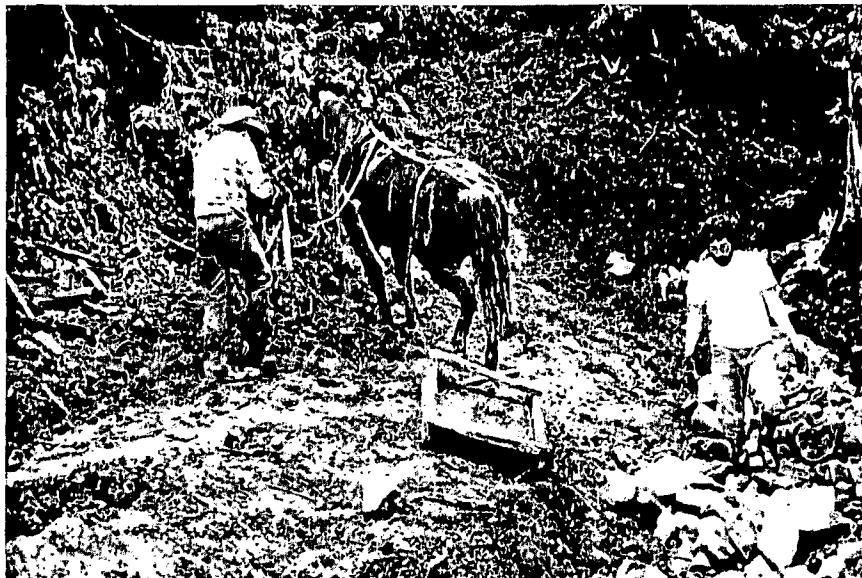
Fig. 76. Horses and sleds moving rock for stream crossing armoring in the middle Copper Creek contract area. The rocks were then placed in the channel by hand. In the smaller streams, hand-placed rock armor was generally successful in controlling post-rehabilitation erosion.

Rock Armoring. Forty-seven percent of the total labor intensive cost was for rocking newly excavated stream channels (Table 37 and Figure 76). A qualitative comparison of the effectiveness of rock armoring by heavy equipment and by hand is shown in Table 38. Evaluations were based on whether or not rock armor was necessary (if applied), needed (but not applied) and effective in preventing erosion.

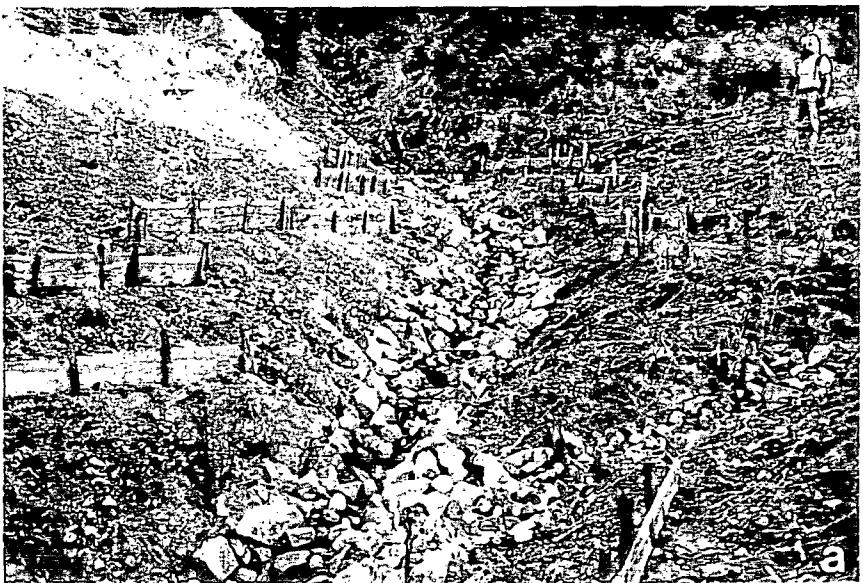
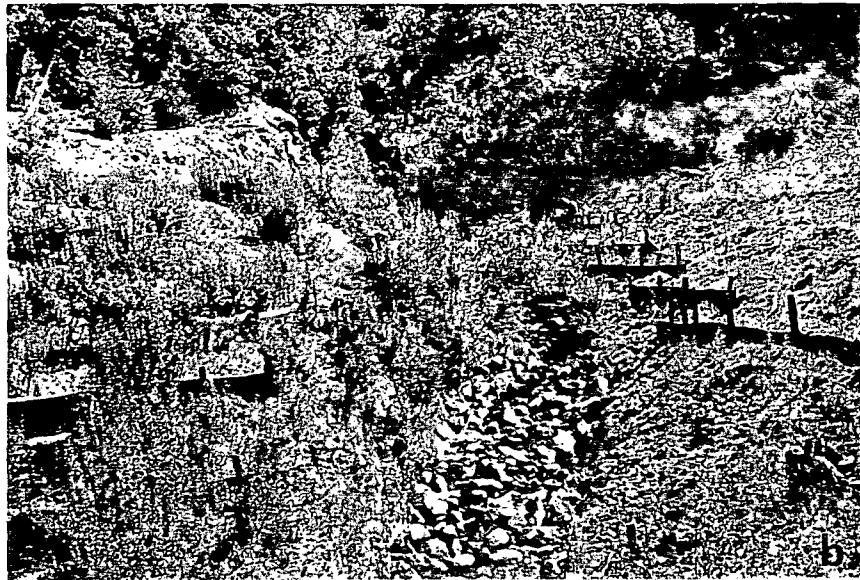
Seventy-four of the 92 crossings showed little post-treatment erosion (Figure 77). These were either excavated down to the original channel or to a stable base level, or they were adequately protected with rock armor. The remaining 18 crossings showed substantial erosion (>5 percent of the excavated volume) which could have been prevented (Figure 78). Seven of these crossings had not received any secondary in-channel protection (Table 38).

Fig. 77. Recovery of an excavated, rock armored stream crossing. A) the hand placed rock armor in this channel covered not only the channel bottom but also extended sufficiently far up the channel banks to protect the channel during higher flows; B) three years following treatment (September 1982), coyote brush has successfully invaded the site and little channel erosion has occurred; C) vegetation is now well established on the channel banks and within most of the channel bed (September 1983).

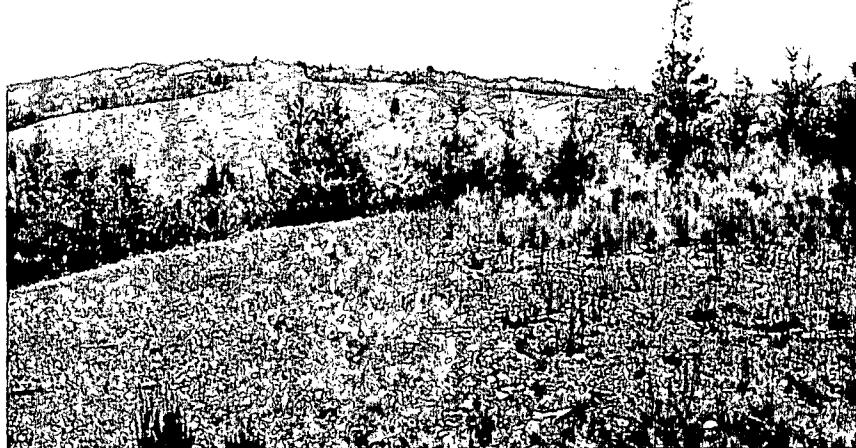
Where the RNP mix was seeded and fertilized, grass persisted with sufficient cover (>60 percent) to exclude significant natural invasion (Figure 81). Coyote brush, the main woody colonizer, was relatively sparse on areas seeded with the RNP mix but abundant in unseeded areas and areas seeded with barley. The areas seeded with barley were nearly indistinguishable from untreated areas.

Fig. 81. Shrub invasion in unseeded (right) and grass seeded areas (left) on treated landing in Copper Creek. Competition with grass on the left half of the landing totally inhibited natural invasion of coyote brush and other shrubs.

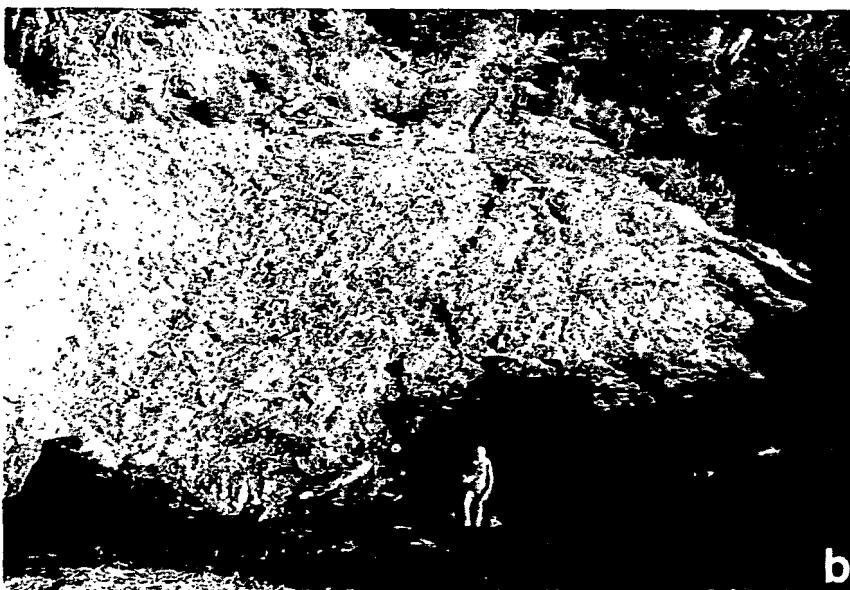
The most widely used mulch was straw. Average straw cover the first year was 90 percent, but declined to <5 percent by the third year. Heavy natural invasion by coyote brush and herbaceous species was seen on many unseeded, strawed areas (Figure 82). Several areas mulched with

Fig. 82. Natural revegetation of excavated stream crossing with straw mulched side slopes, Copper Creek. A) Partially washed out stream crossing displays unstable banks and minimal natural revegetation eight years following road abandonment (July 1979); B) several months after excavation of fill (December 1979) showing straw mulch and rilling on side slope following first winter rains; C) four years after rehabilitation (September 1983), note abundant natural invasion of coyote brush on right bank.

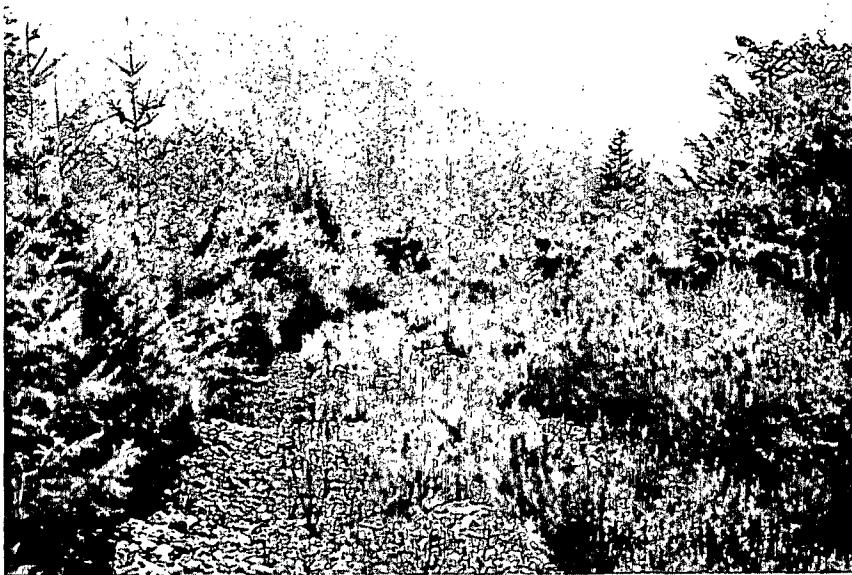
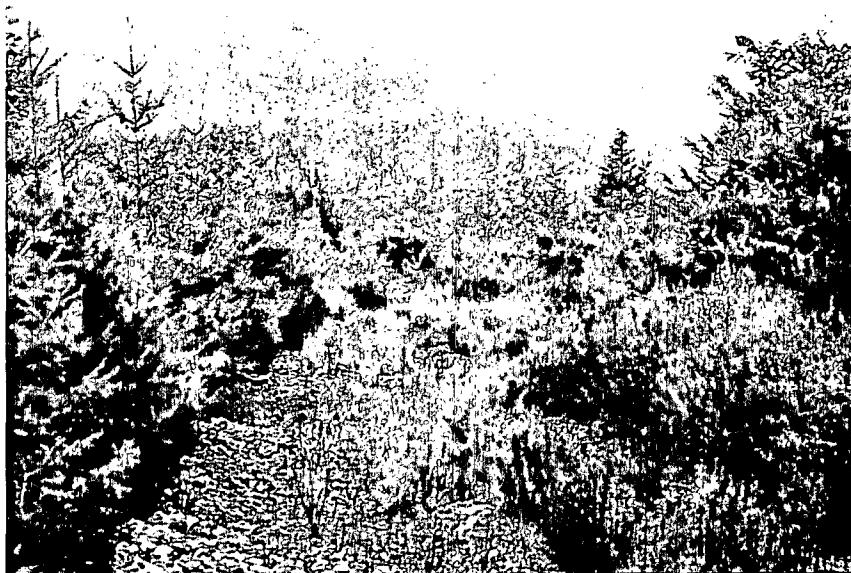
Fig. 86. Natural invasion of coyote brush. Unlike the Bond and Bridge Creek units, where alder was the principal early colonizer, the hot, dry, rocky skid trail and road surfaces of Copper Creek were quickly invaded by coyote brush.

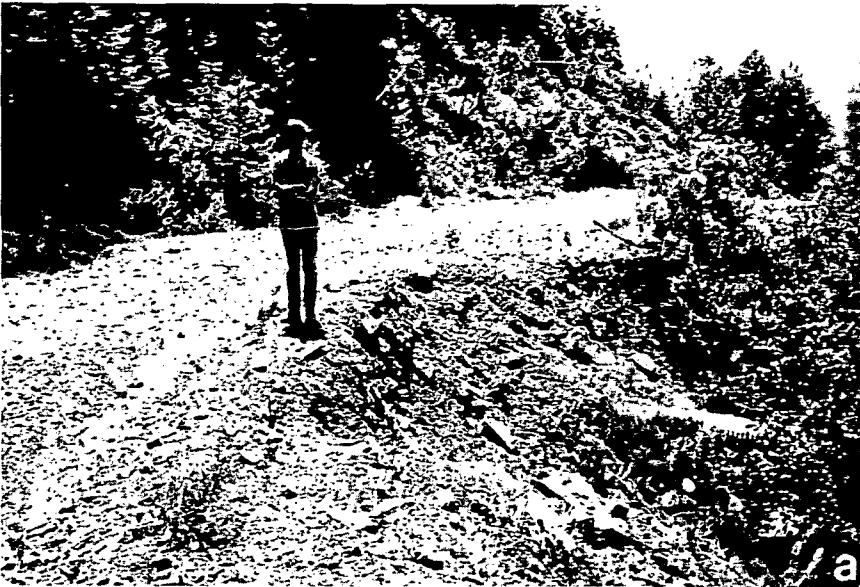
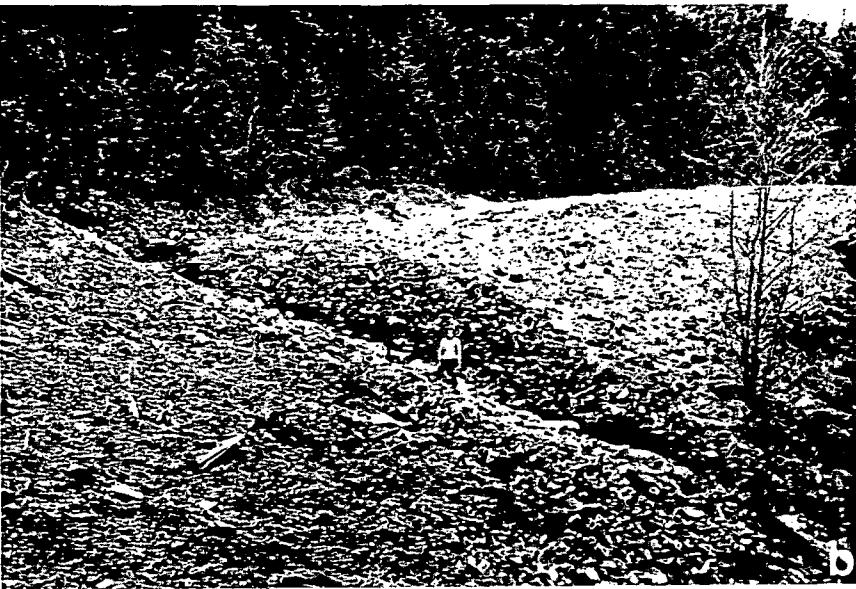
Fig. 87. Natural revegetation of an excavated stream crossing on the 1910 road. Although soils are also rocky in many of the lower hillslope areas, moister conditions favor the invasion and establishment of red alder near watercourses. A) before stream crossing excavation (June 1979), B) following excavation (January 1980; note high rock content of soils) and C) four year following rehabilitation (September 1983).

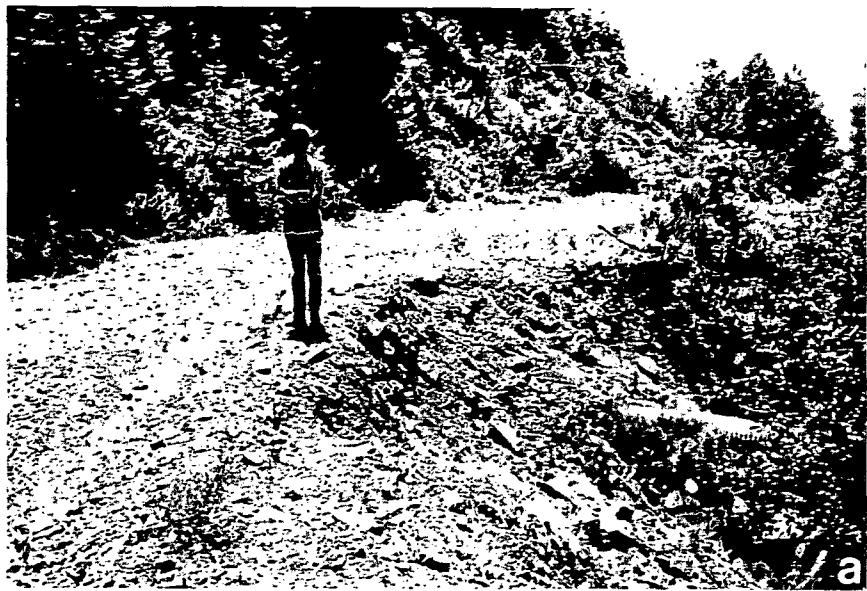
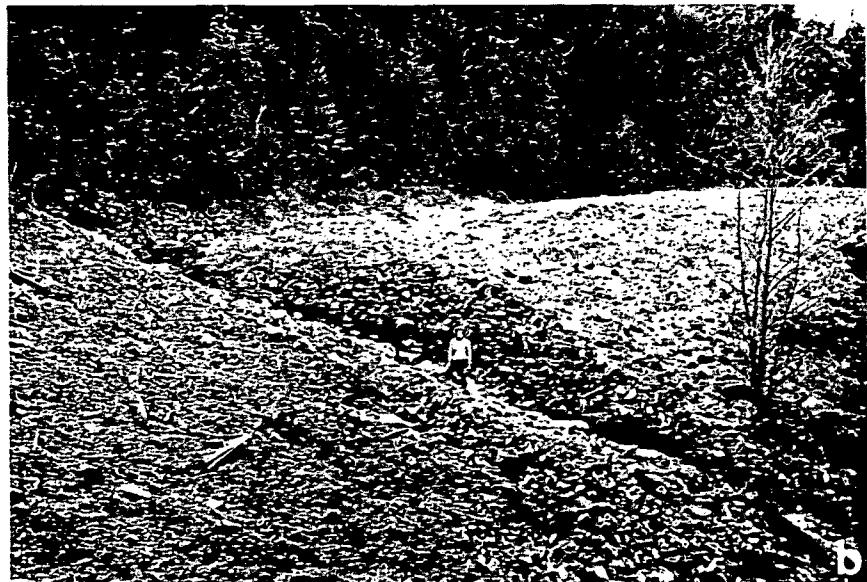
At the time of rehabilitation, much of the unit was bare with many skid trails in evidence. Natural and planted revegetation was slowly changing the appearance of the unit. Madrone and blueblossom seedlings were rapidly colonizing some of the rockier, drier stretches of road. Some tanoak and madrone were becoming established on skid trails, but the dominant colonizer was still coyote brush (Figure 86). In much of the unit, coyote brush and aerially seeded Douglas-fir were so dense that passage was difficult. Alder, established on the lower road, was altering the microhabitat to be more conducive to conifer establishment (Figure 87).

Fig. 87. Natural revegetation of an excavated stream crossing on the 1910 road. Although soils are also rocky in many of the lower hillslope areas, moister conditions favor the invasion and establishment of red alder near watercourses. A) before stream crossing excavation (June 1979), B) following excavation (January 1980; note high rock content of soils) and C) four year following rehabilitation (September 1983).

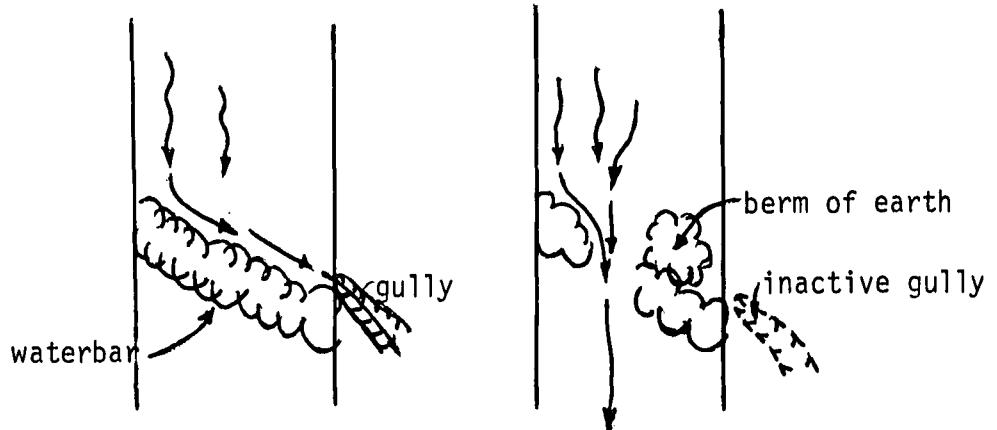
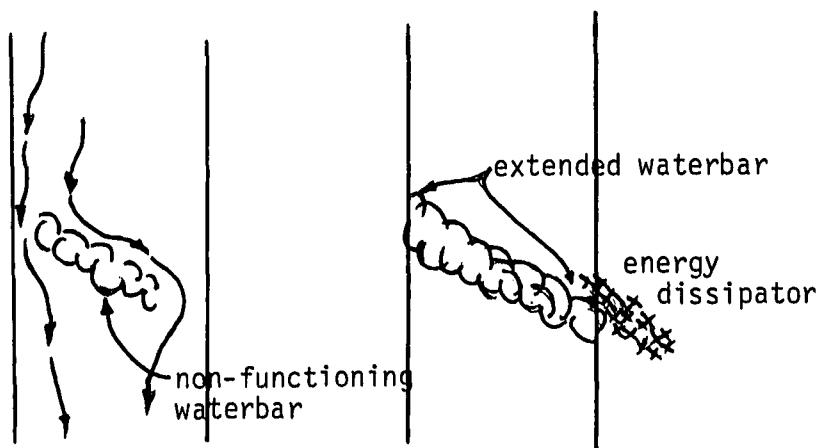
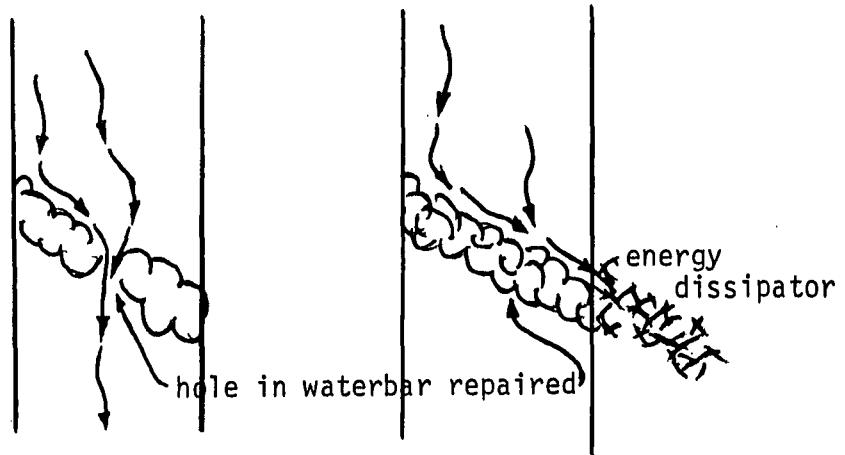
Figure B-4. Three typical repair procedures to waterbars.

A. BREACH WATERBAR

B. EXTEND END(S) OF WATERBAR

C. REPAIR BREACHED WATERBAR

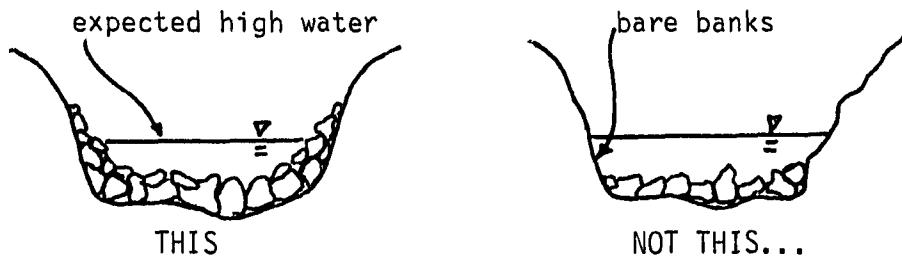
3. When the S.O.W. calls for channel excavation and rockng channel bed, the channel will be excavated in such a way that the bed is slightly concave, and rocks will be placed far enough up the channel banks to contain anticipated heavy flow. This is an effort to prevent failures due to flat-bottomed, rocked channels, where bank cutting can occur during high water (see sketch below):

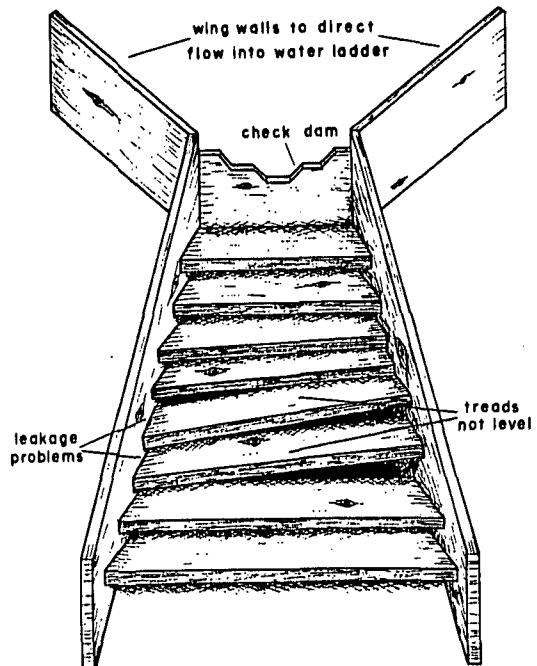
Type 1 - Split board water ladder (Figure B-14). This water ladder begins with a checkdam at the top to integrate with upstream channel stabilization structures. Note how uneven, non-level treads could cause flow concentration, leakage and eventual failure of the structure.

Figure B-14. Type 1 water ladder.
Treads should be constructed level
to prevent leakage.

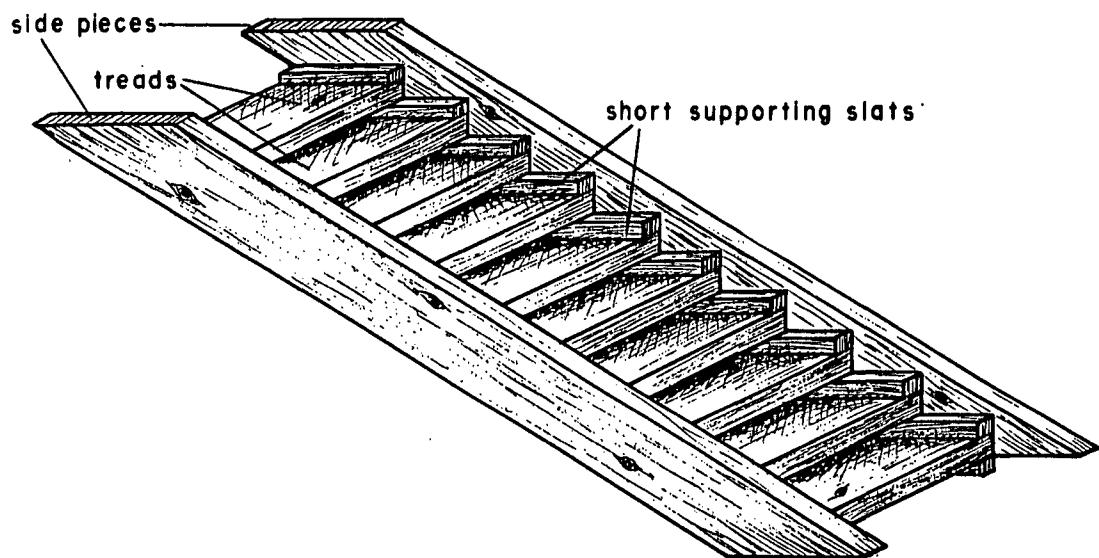
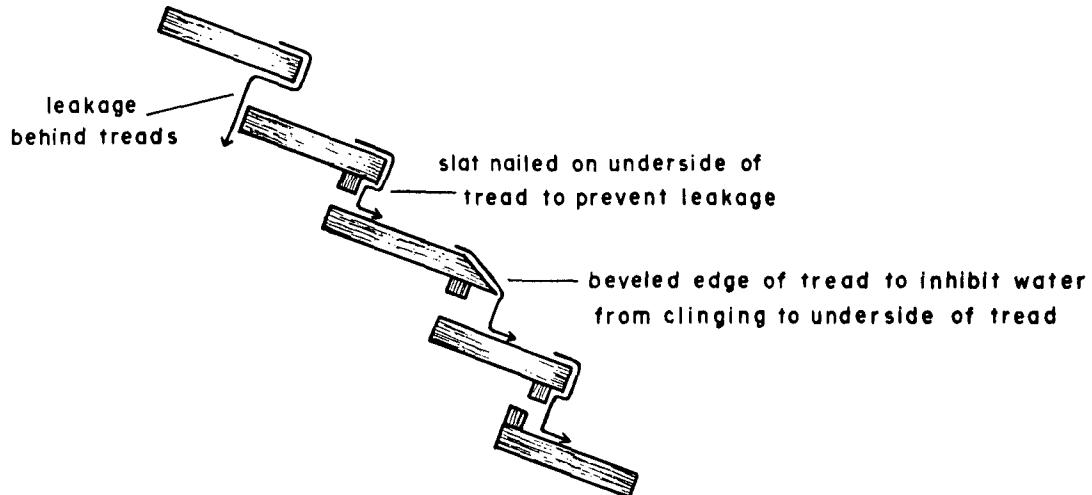
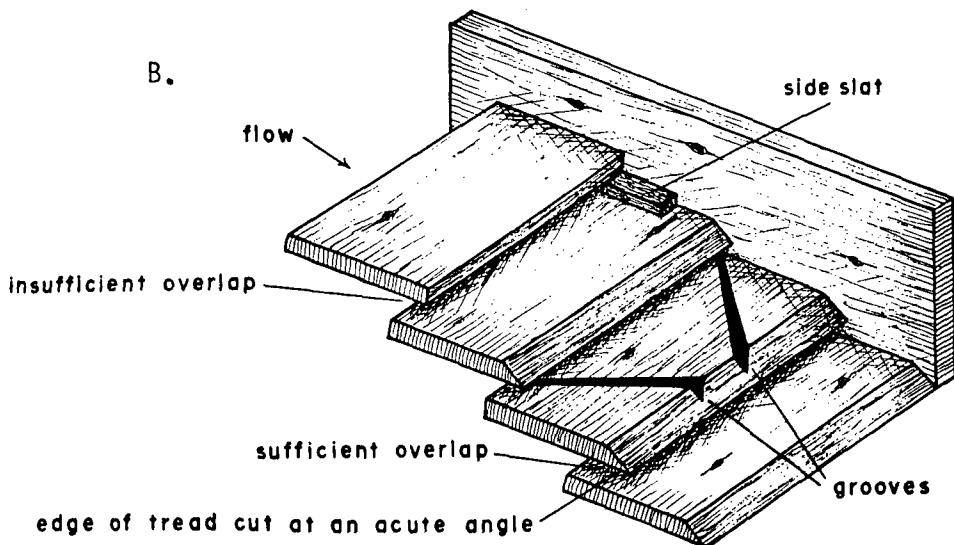
Type 4 - Milled wood ladder (Figure B-17). Ladder is constructed from milled slabs and boards. Treads are supported on stair-stepped slats. Leakage was prevented by providing sufficient tread overlap and by utilizing slats, shims and groves to improve the fit between boards and to direct the flowing water (Figure B-18).

Figure B-18. Side view (A) and oblique view (B) of water ladder treads. Note causes of and solutions to common leakage problems.
