WATERSHED REHABILITATION IN THE AIRSTRIP CREEK BASIN

Harvey M. Kelsey
Geologist
Redwood National Park
Arcata, California

National Park Service
Redwood National Park
Arcata, California
February 1981

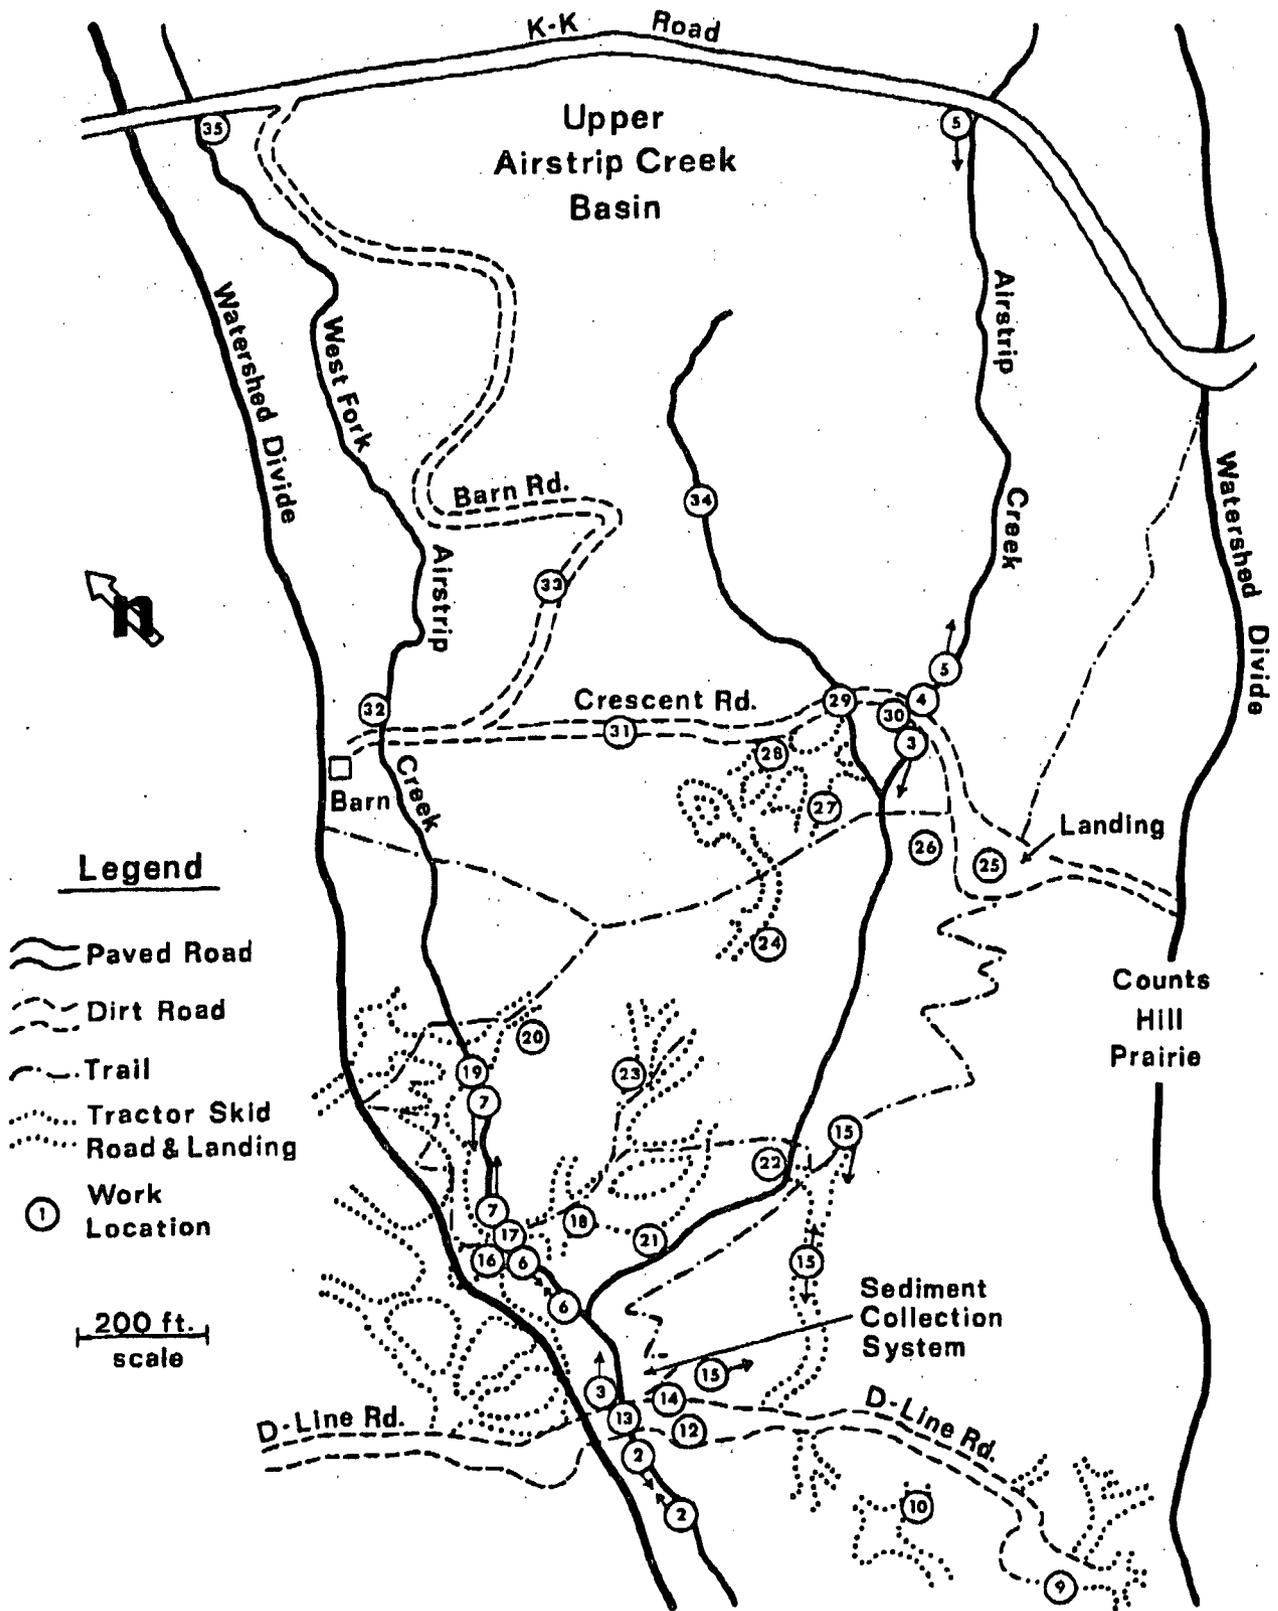
Figure 3

Schematic map of the Airstrip Creek rehabilitation unit showing drainage pattern, road network, and work site locations.

Hand dug waterbars (drainage troughs for diverting water off gullied roads or tractor trails) were a minor part of contract work. The contractor selected all waterbar locations. In total, 28 waterbars were built or rebuilt from existing tractor constructed waterbars (See Figure 3; Sites 31, 33).

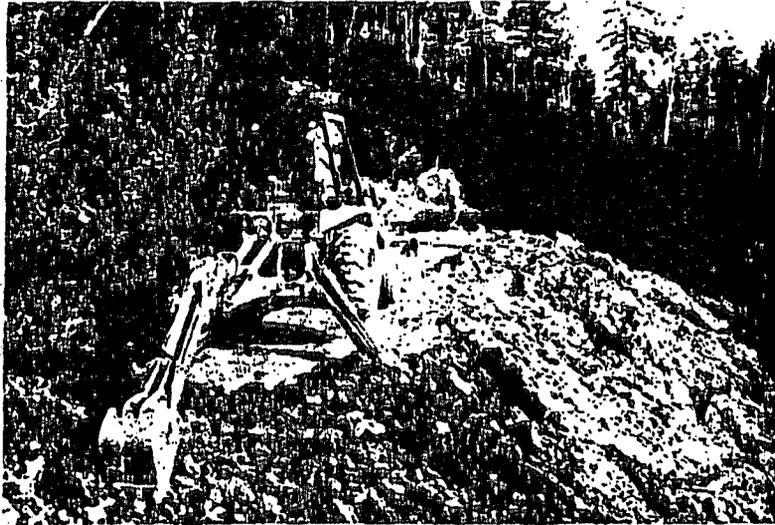
Figure 4

A rubber-tired Caterpillar 580-C backhoe with extendable arm excavated fill from the majority of the stream crossings on the Airstrip Creek rehabilitation unit.

Debris removal from eight stream crossings was the major task of the contract and the only one which used heavy equipment extensively. At six major tractor crossings (Sites 13, 17, 19, 29, 30, 34), a backhoe excavated the channel to the approximate original channel shape. The contractor rented two different backhoes plus operators for the excavations. The first backhoe was track mounted and did not have an extendable arm on the bucket. It worked for 49.5 hours, or five days, at four tractor crossings. The second backhoe, a rubber tired Case 580-C Extendahoe (Figure 4), worked for 58.0 hours, or seven days, at all six crossings, including the four crossings that were insufficiently excavated by the first backhoe.

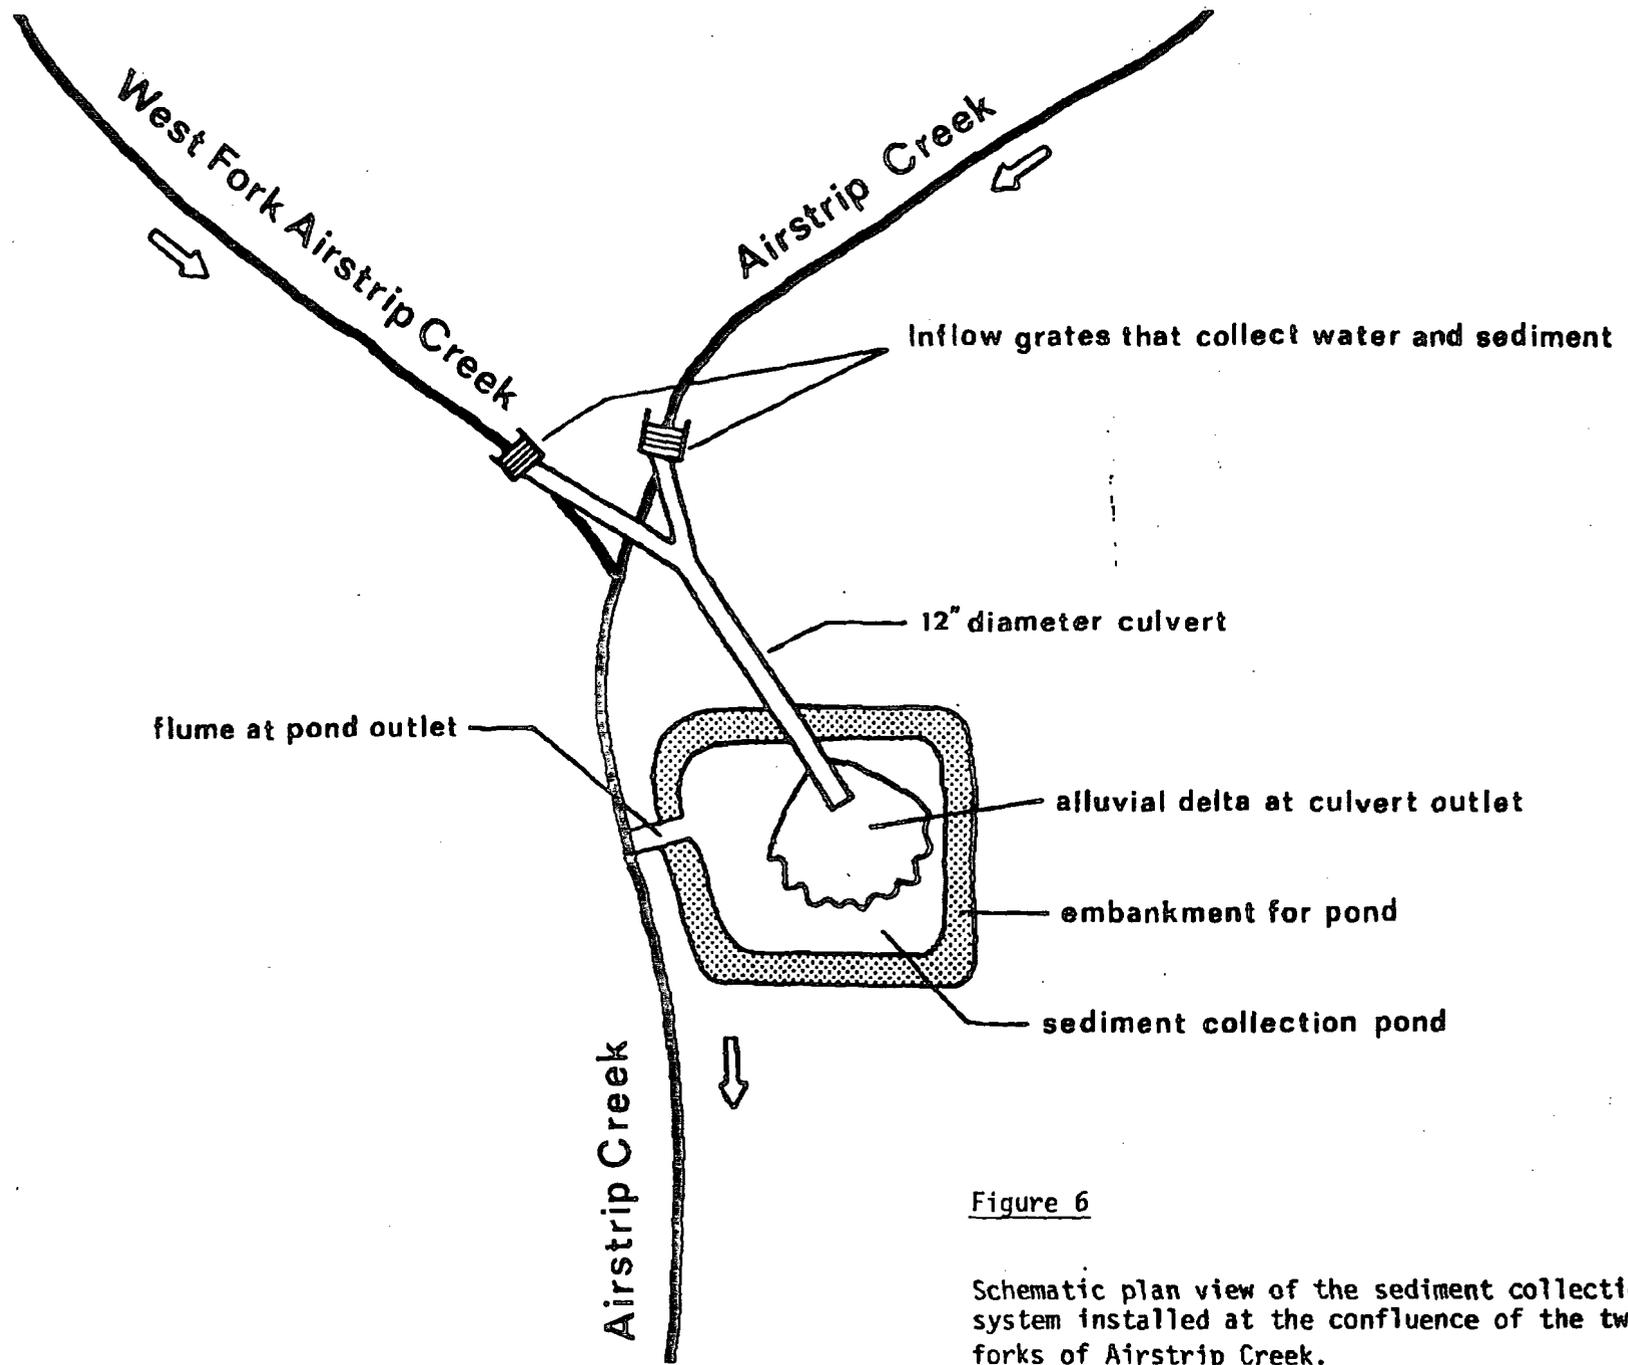
Figure 6

Schematic plan view of the sediment collection system installed at the confluence of the two forks of Airstrip Creek.

A sediment collection system was installed at the confluence of the two forks of Airstrip Creek (Figure 6). The purpose of the collection system was to capture and divert a portion of the bed load material of the stream and store this material in a collection pond built on a former log landing next to the stream. A D-8 Caterpillar tractor and operator, rented by the contractor, constructed the collection pond. In each fork of Airstrip Creek, a collection box with an adjustable grate captured a portion of the streamflow and bed load material (Figure 7). The water and sediment diverted from each fork travelled down a 200 foot, 12 inch diameter culvert collection pipe into a 205 cubic yard capacity sediment settling pond (Figure 8). A wooden flume conducted the outflow from the pond back into Airstrip Creek.

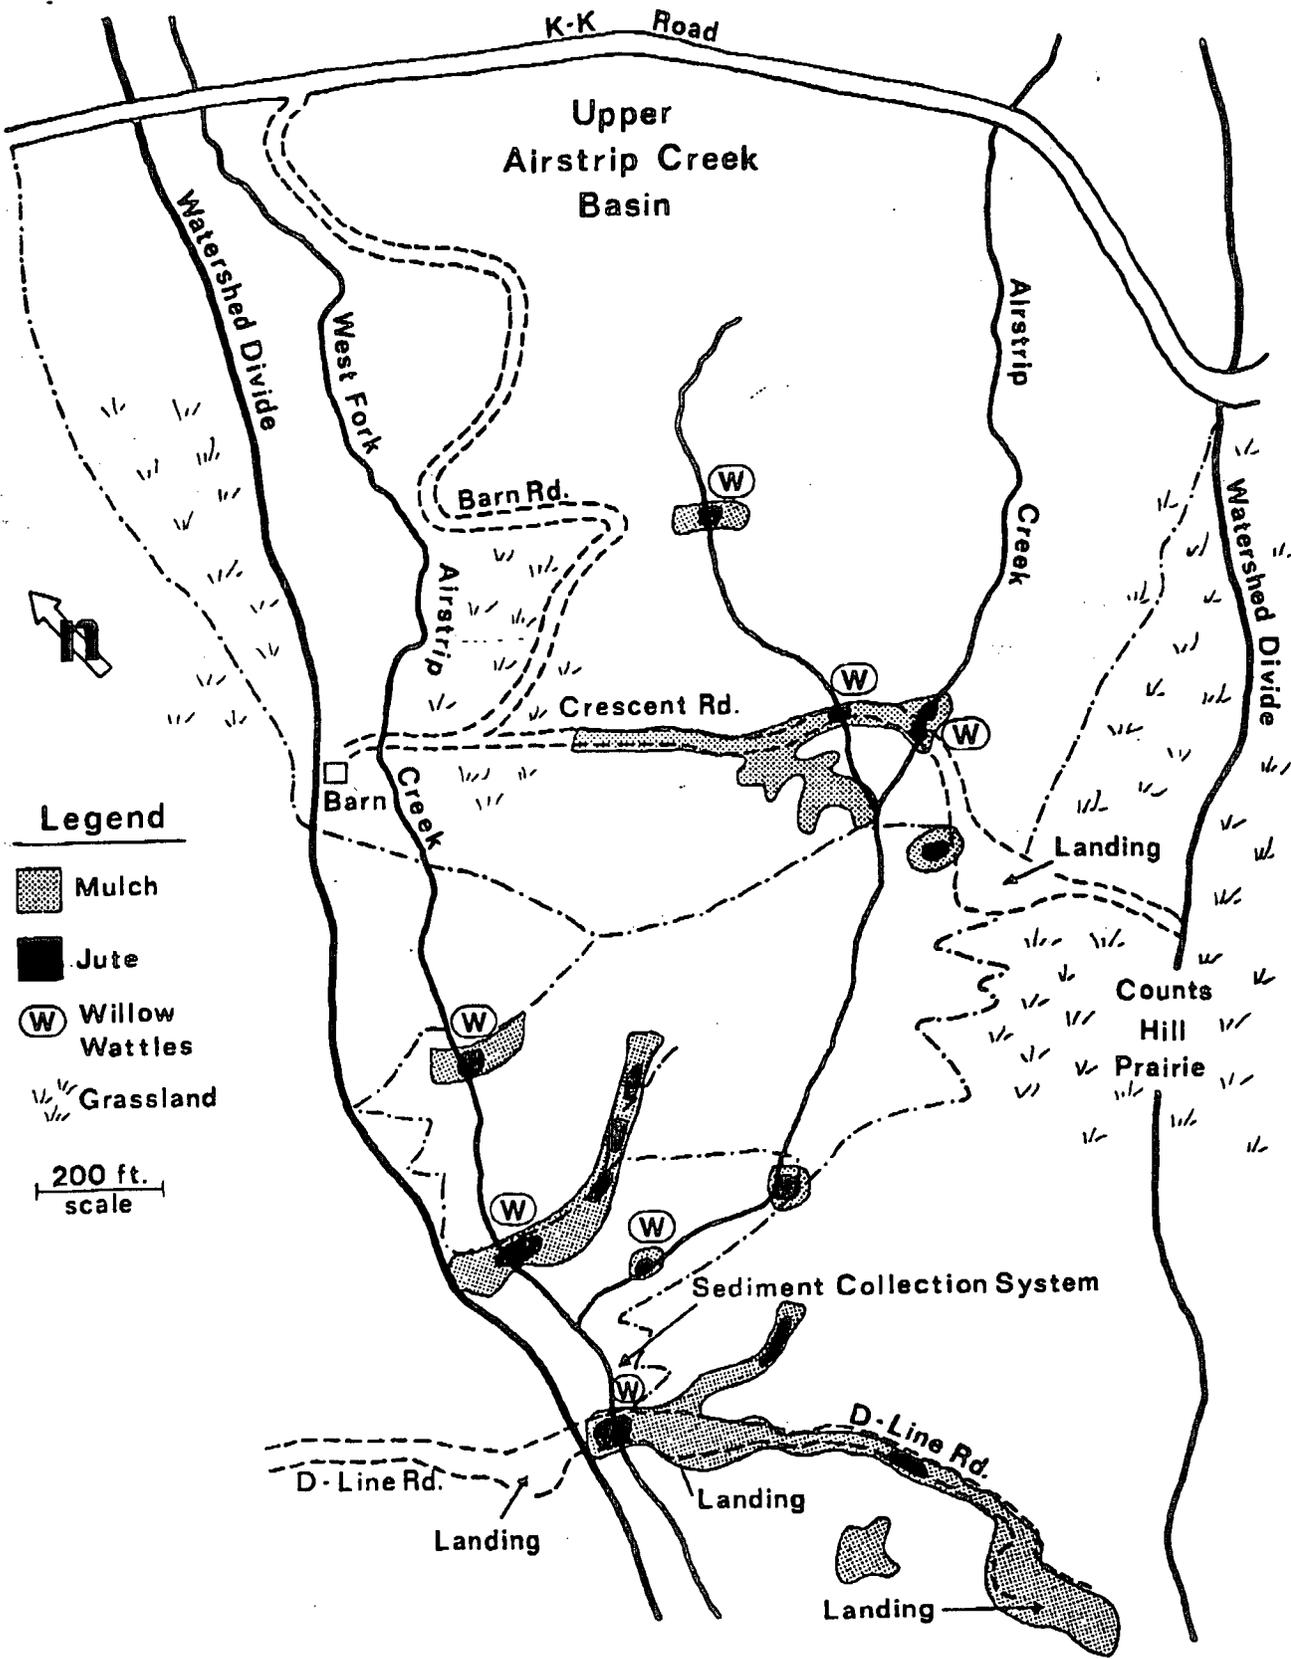
Figure 9

Location of mulch, jute netting and willow wattles on the Airstrip Creek rehabilitation unit.

On sideslopes of excavated stream crossings, the contractors used straw covered by jute netting as a ground cover for erosion control (Figure 9). This combination of straw mulch and jute net provided extremely effective slope protection against both rain-drop impact erosion and rilling. The straw-jute net cover kept fine soil particles in place on the surface, preventing the formation of a compact surface crust and pebble pedestals that characteristically result from high intensity rain falling on bare, recently disturbed soil. The preservation of a loose, open framework soil surface, plus the retention of moisture beneath the mulch, may aid in revegetation.

Heavy jute netting, composed of biodegradable hemp, was applied in a single layer on the sideslopes adjacent to the excavated channels and on a few bare tractor trails (Figures 9 and 10). The jute was laid down after the areas were seeded and mulched. Jute netting provides additional protection from rainsplash and rill erosion on steep, bare slopes, and jute helps hold down the mulch. The jute rolls were four feet wide and 225 feet long. The jute was staked in place with eight inch metal staples. The total area covered with jute was approximately 22,500 ft².

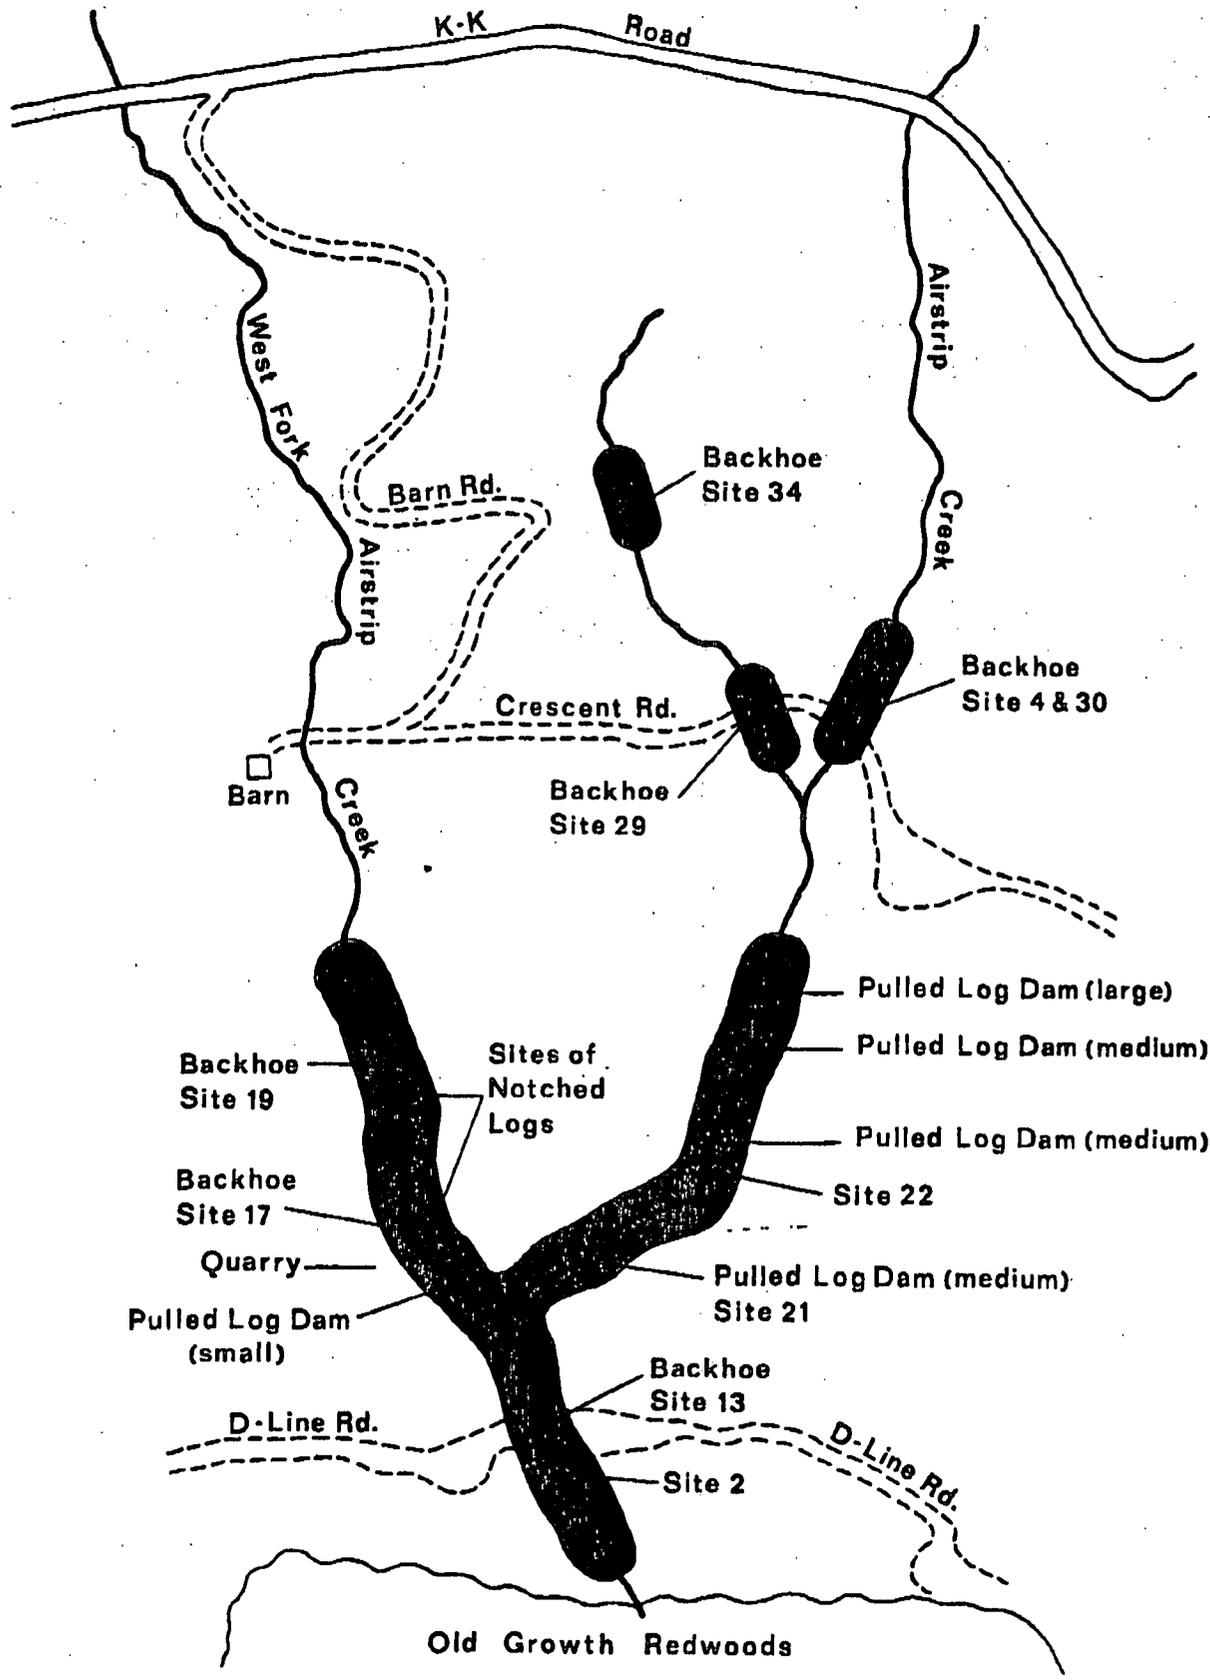
FIGURE 11

Location map of stream clearance sites and backhoe channel excavation sites.
Airstrip Creek rehabilitation unit.

Debris removal from the six major tractor road stream crossings (Figure 11) was the single most effective rehabilitation measure in terms of minimizing the chances for continued severe erosion due to past logging disturbance. Prior to rehabilitation, fills in all crossings were partially eroded. Although the fills were partially vegetated, they had steep sided gullies with bare banks that were a sediment source at high streamflows. Most of the fills contained large logs, and water piped through the fills at low flows.

The contractor cleared a total of 4,200 feet of stream channel along the two forks of Airstrip Creek within the rehabilitation unit (Figure 11). Stream clearance was concentrated in the lower portion of the unit where the two forks flow through the more recently logged hillslopes. Airstrip Creek in this part of the basin is an intermittent stream, and clearance work was completed in the fall before the channel started to carry water from the winter rains.
