**HABITAT INVENTORY AND INITIAL ASSESSMENT OF  
ANTHROPOGENIC SEDIMENTATION OF  
UPPER MARK WEST CREEK,  
SONOMA COUNTY, CALIFORNIA**

**PREPARED FOR:  
New-Old Ways Wholistically Emerging  
7768 St. Helena Road  
Santa Rosa, California 95404**

**PREPARED BY:  
STACY K. LI, PH.D.  
AQUATIC SYSTEMS RESEARCH  
1210 SPENCER AVENUE  
SANTA ROSA, CALIFORNIA 95404  
AND  
DOUGLAS PARKINSON  
DOUGLAS PARKINSON AND ASSOCIATES  
960 L STREET  
ARCATA, CALIFORNIA**

**JUNE 27, 2009**

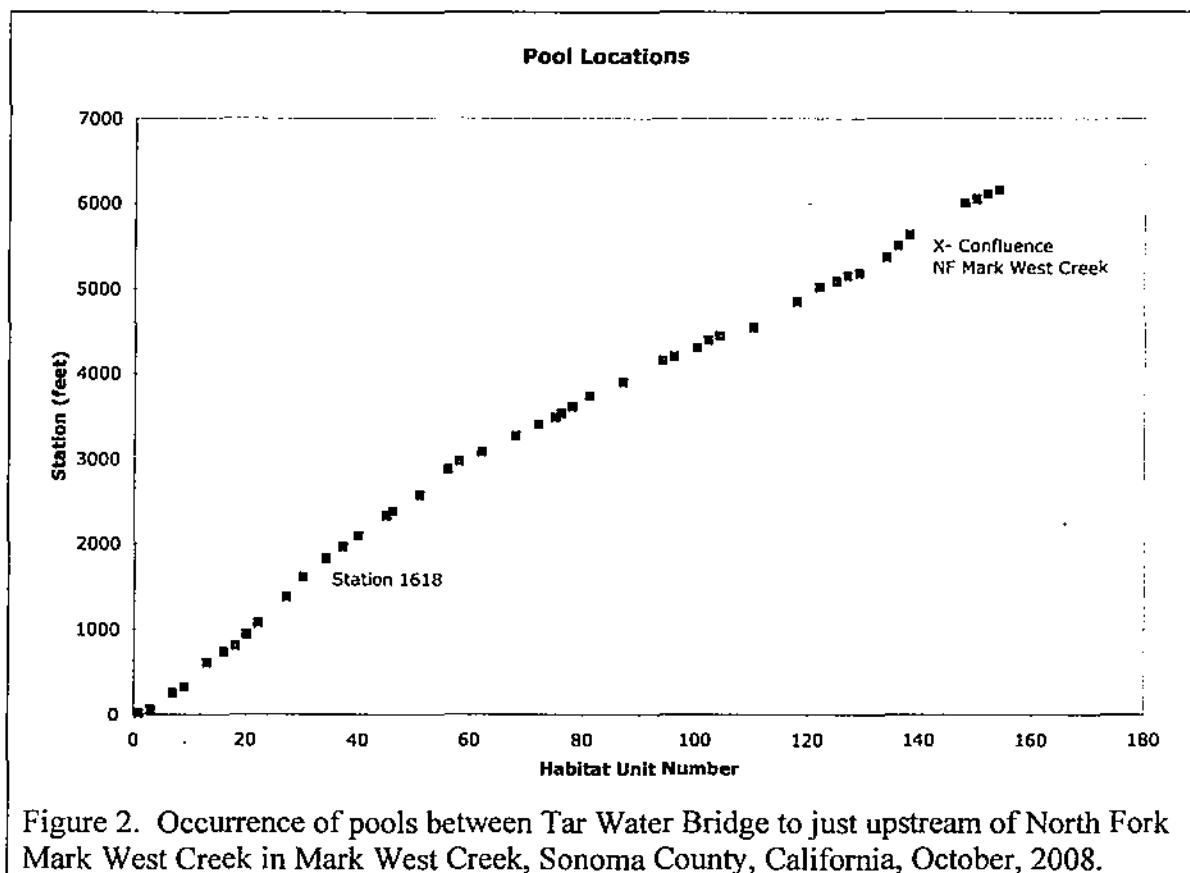
Pools were the dominant flat-water habitat in upper Mark West Creek. They were the most abundant habitat type in frequency or cumulative length. Pools were one of the longer (mean 52.87 feet), and deeper (mean 0.95 feet) habitat types. They were wider than any of the other habitats (mean 9.67 feet), and were also the deepest (2.2 feet), based on maximum depth measurements in pools and step-pools. Pools occurred throughout the surveyed reach from Tar Water Bridge upstream beyond the confluence with NF Mark West Creek (Figure 2). Pools had 19 different substrate combinations that ranged in size from sand to bedrock, reflecting the depositional character of pools during low streamflow conditions. Pools provide living space for steelhead, but do not produce much fish food. This lack of food production occurs because the invertebrates that live in pools are within the substrate and generally unavailable. In addition, the majority of aquatic invertebrates normally used as fish food require current to exist.

Figure 2. Occurrence of pools between Tar Water Bridge to just upstream of North Fork Mark West Creek in Mark West Creek, Sonoma County, California, October, 2008.

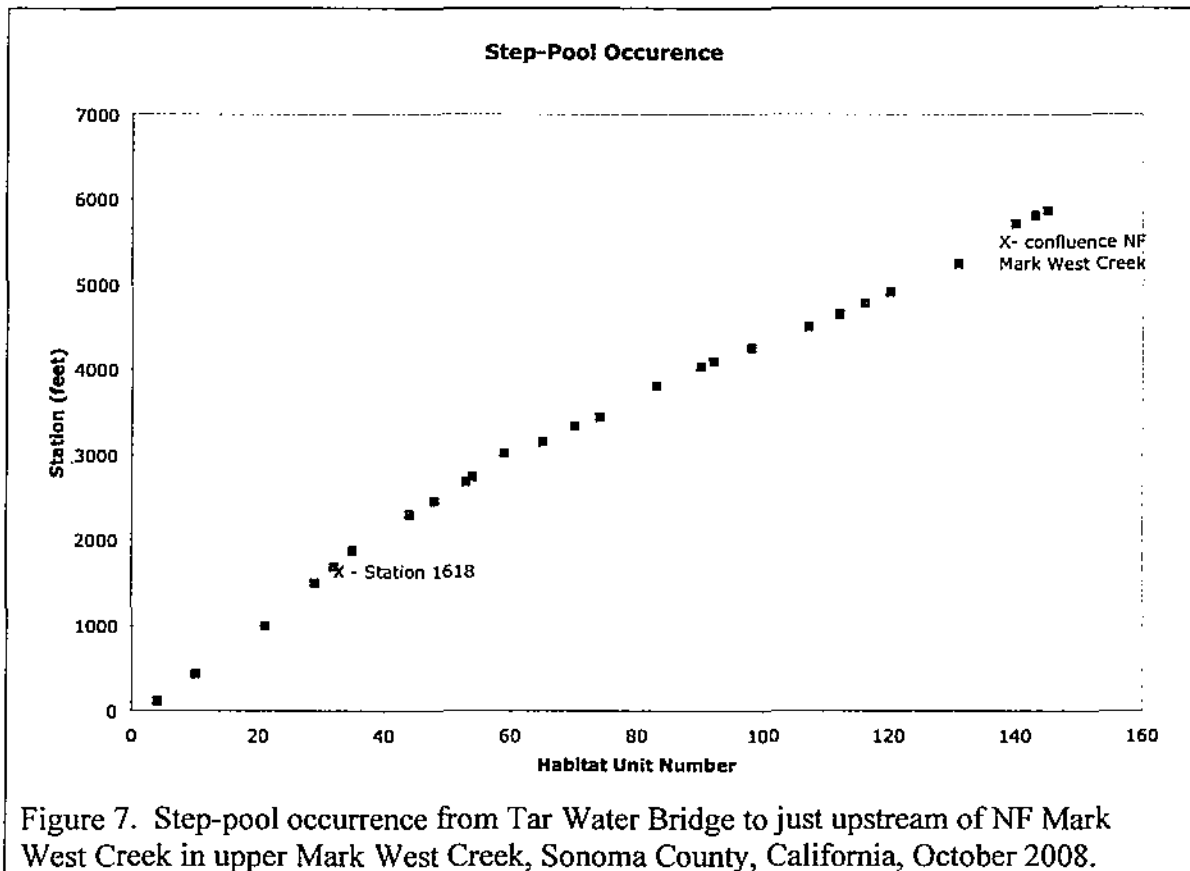
Figure 7. Step-pool occurrence from Tar Water Bridge to just upstream of NF Mark West Creek in upper Mark West Creek, Sonoma County, California, October 2008.

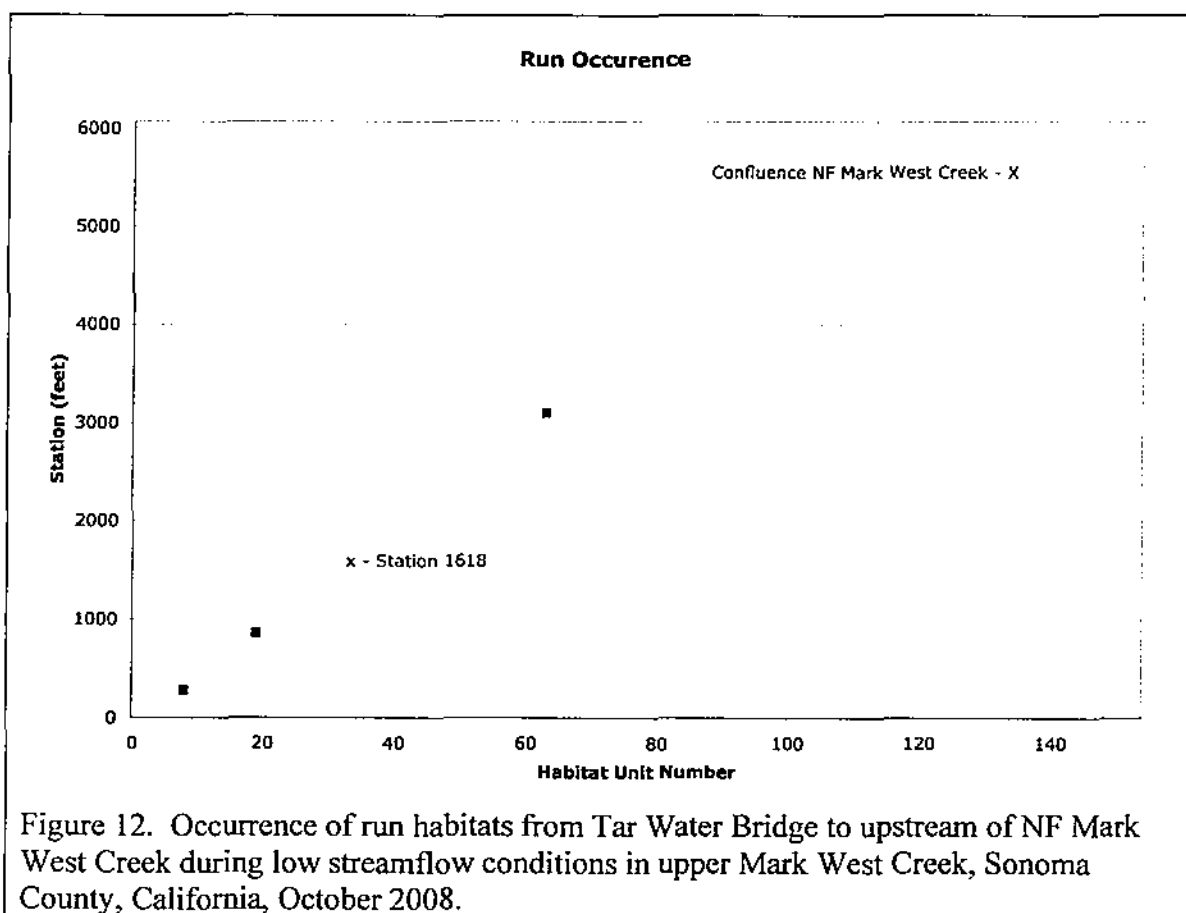
Figure 12. Occurrence of run habitats from Tar Water Bridge to upstream of NF Mark West Creek during low streamflow conditions in upper Mark West Creek, Sonoma County, California, October 2008.

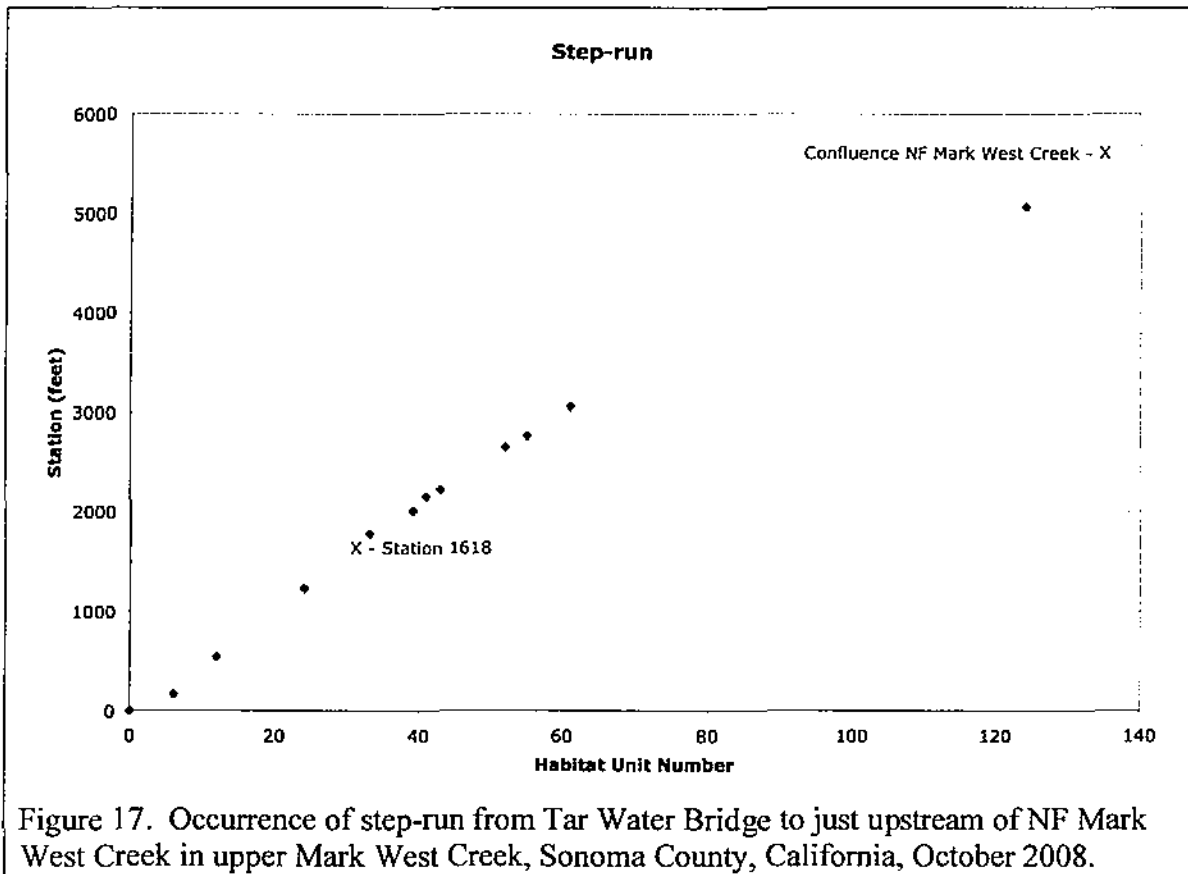
Figure 17. Occurrence of step-run from Tar Water Bridge to just upstream of NF Mark West Creek in upper Mark West Creek, Sonoma County, California, October 2008.

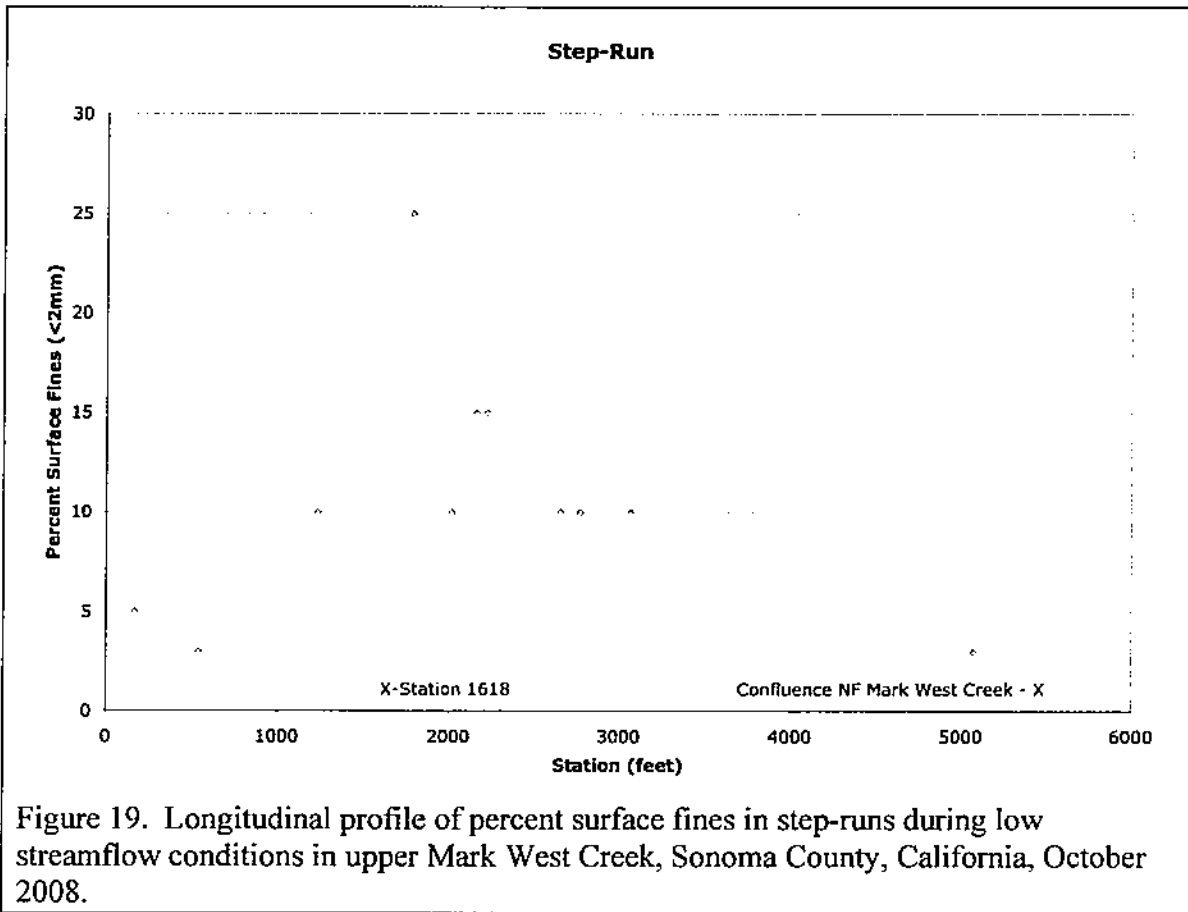
Percent surface fines (<2mm) was typically higher upstream of Station 1618 (Figure 19).

Figure 19. Longitudinal profile of percent surface fines in step-runs during low streamflow conditions in upper Mark West Creek, Sonoma County, California, October 2008.

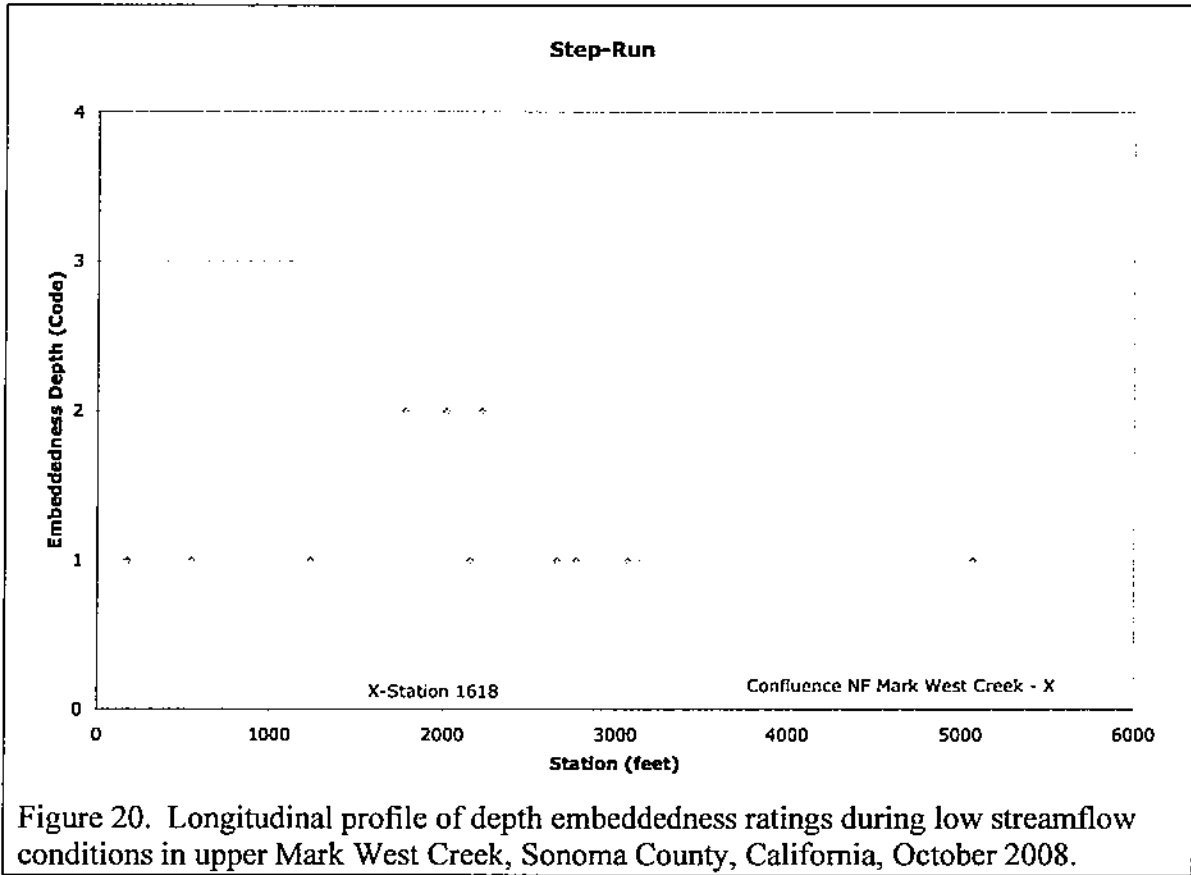
There was an increase in depth embeddedness upstream of Station 1618 (Figure 20).

Figure 20. Longitudinal profile of depth embeddedness ratings during low streamflow conditions in upper Mark West Creek, Sonoma County, California, October 2008.

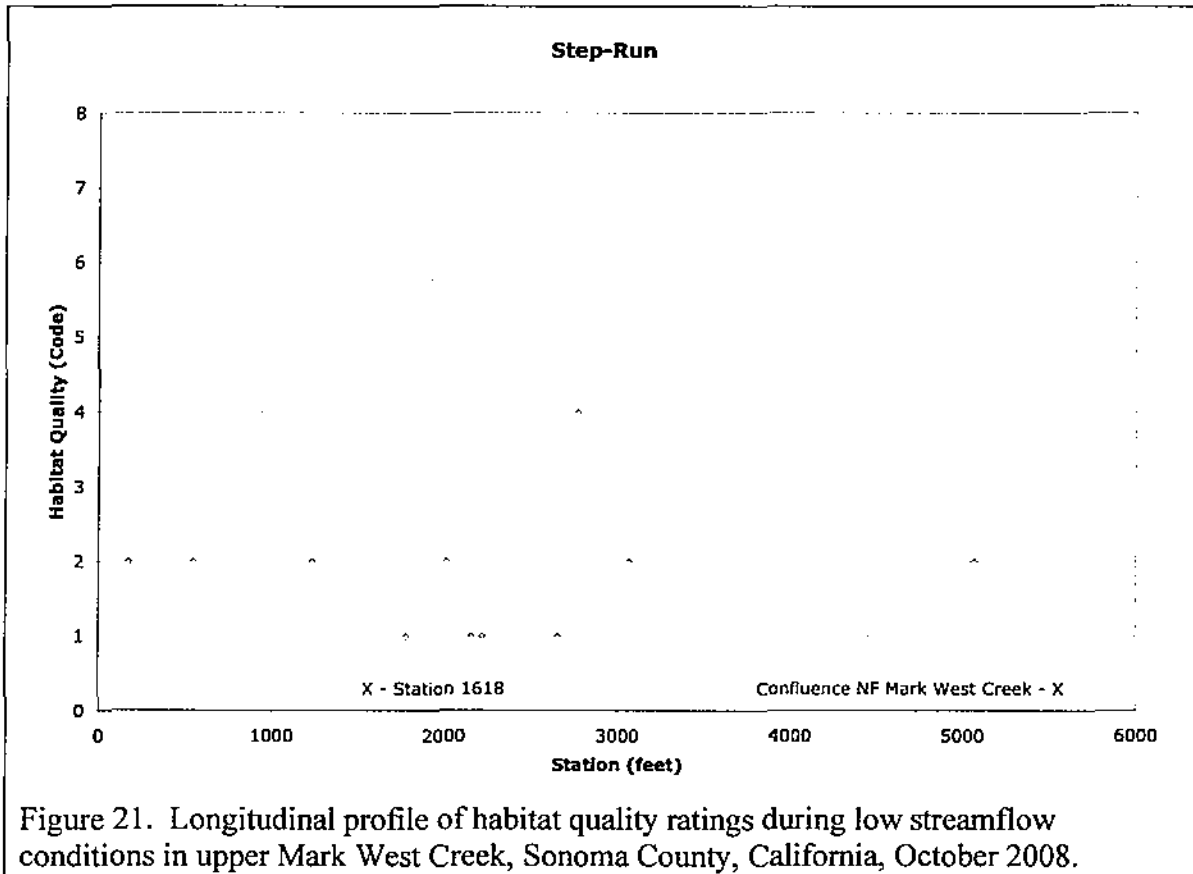
Step-run habitat quality was fair (Figure 21).

Figure 21. Longitudinal profile of habitat quality ratings during low streamflow conditions in upper Mark West Creek, Sonoma County, California, October 2008.

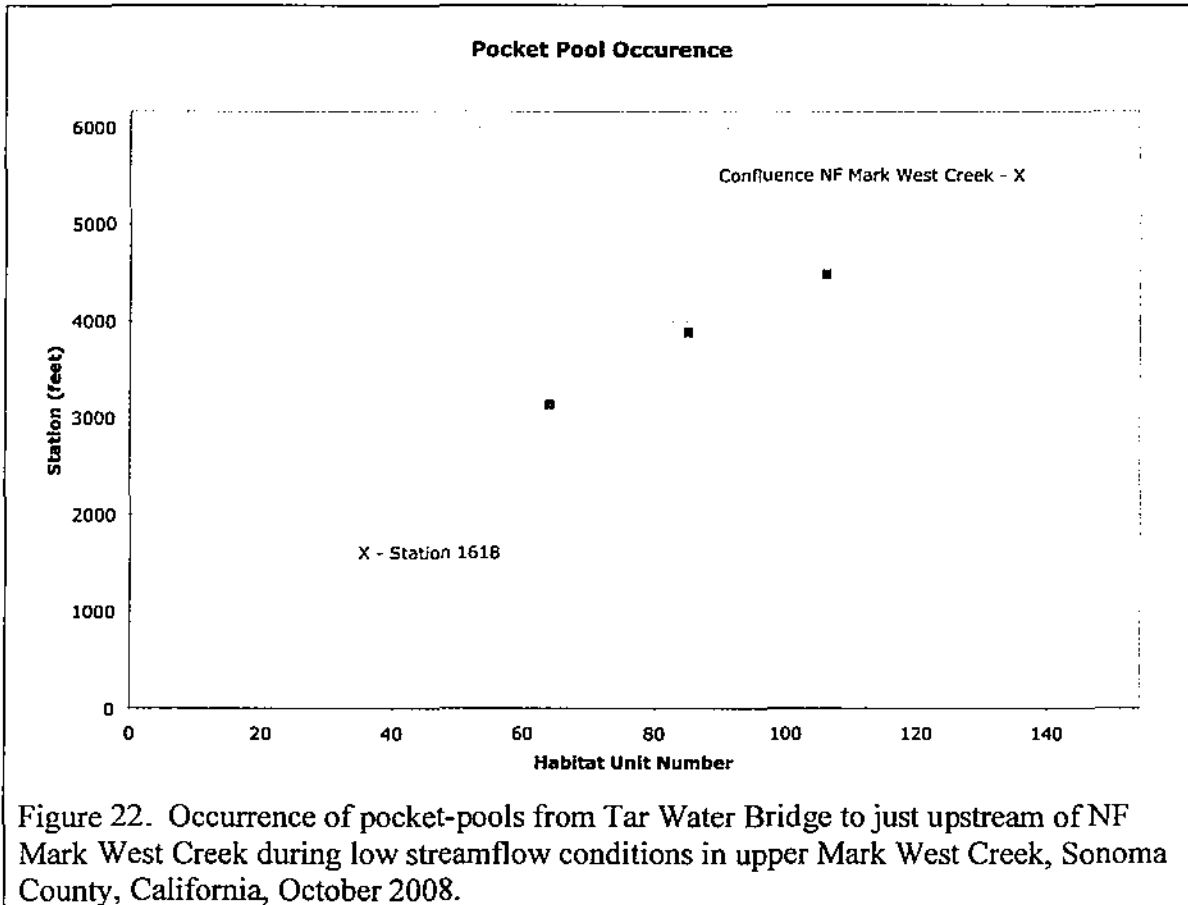
Figure 22. Occurrence of pocket-pools from Tar Water Bridge to just upstream of NF Mark West Creek during low streamflow conditions in upper Mark West Creek, Sonoma County, California, October 2008.

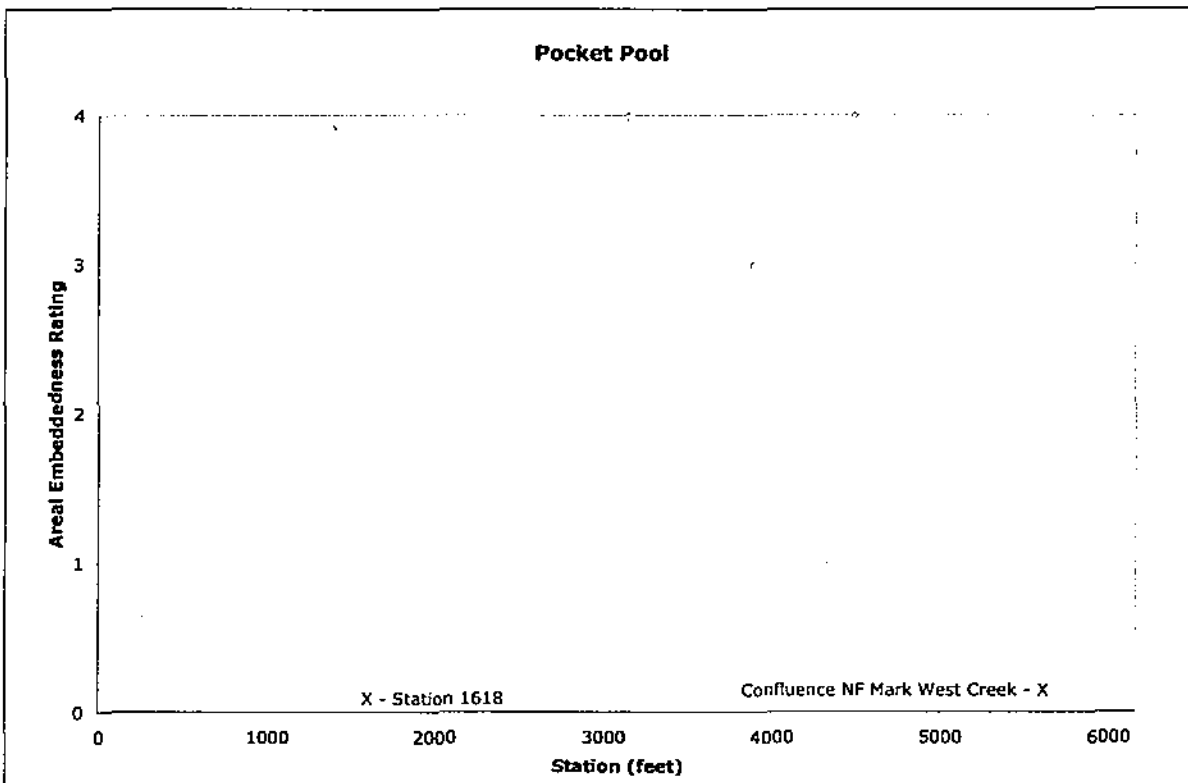
All pocket pools were within the 10,000-yard sediment plume; consequently, their area embeddedness was high (Figure 23).

Figure 23. Longitudinal profile of area embeddedness in pocket-pools during low streamflow conditions in upper Mark West Creek, Sonoma County, California, October 2008.

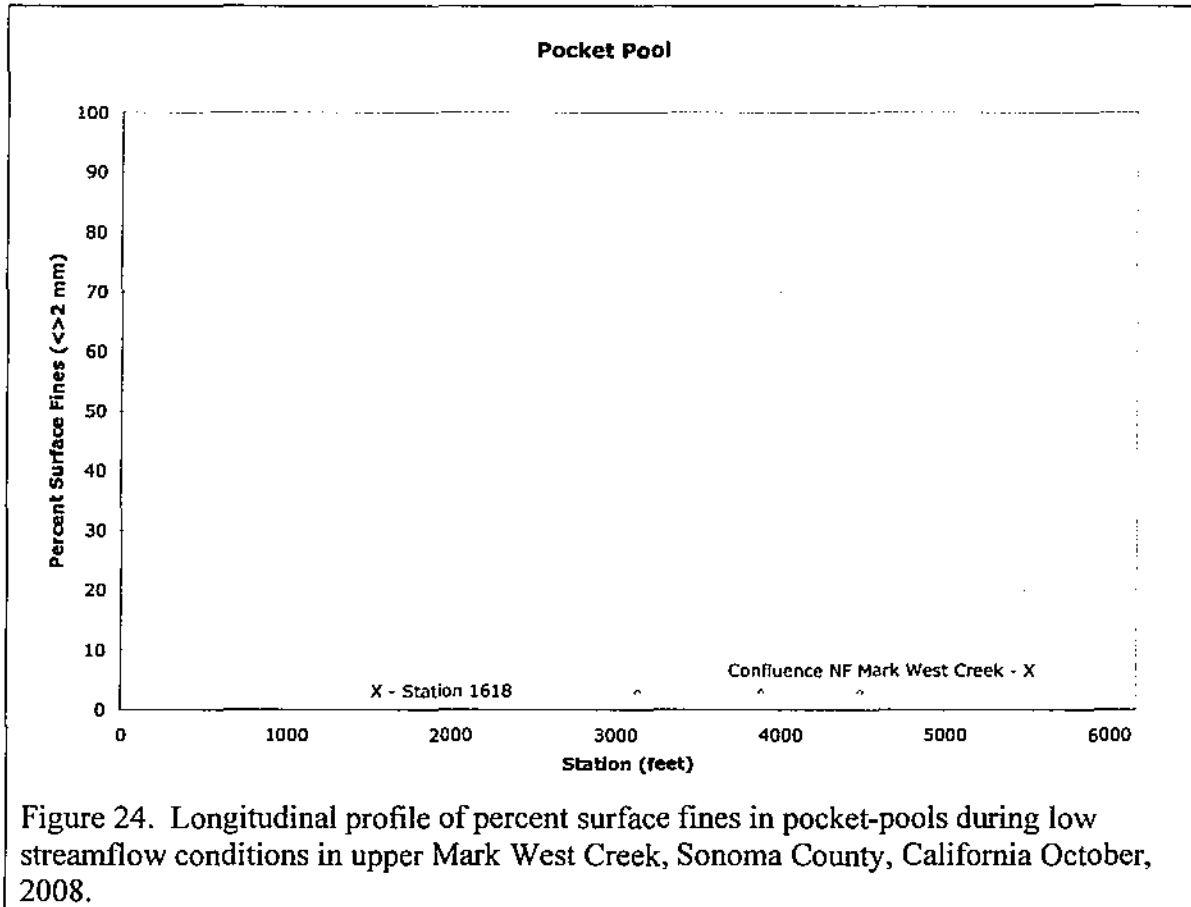
Percent surface fines in pocket-pools were small (Figure 24).

Figure 24. Longitudinal profile of percent surface fines in pocket-pools during low streamflow conditions in upper Mark West Creek, Sonoma County, California October, 2008.

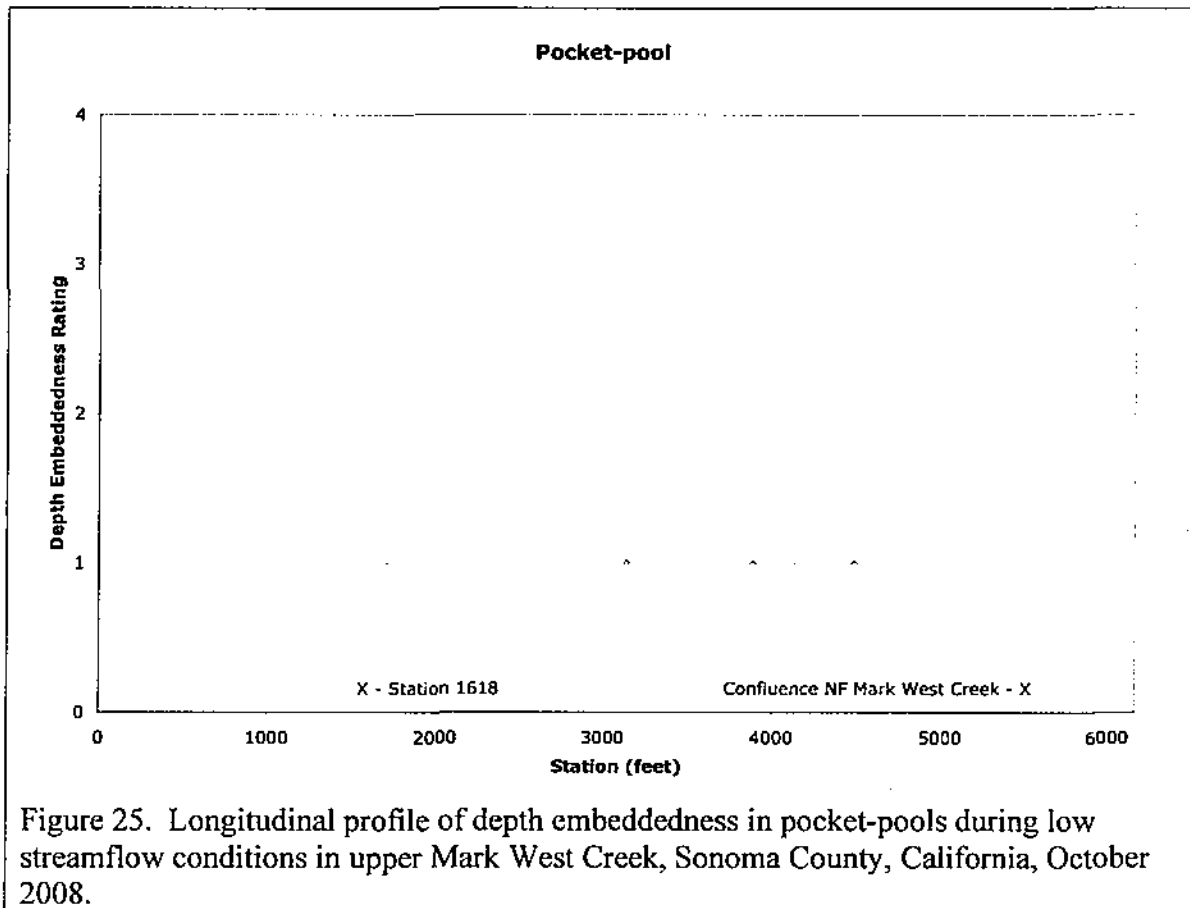
Pocket-pool depth embeddedness was light (Figure 25).

Figure 25. Longitudinal profile of depth embeddedness in pocket-pools during low streamflow conditions in upper Mark West Creek, Sonoma County, California, October 2008.

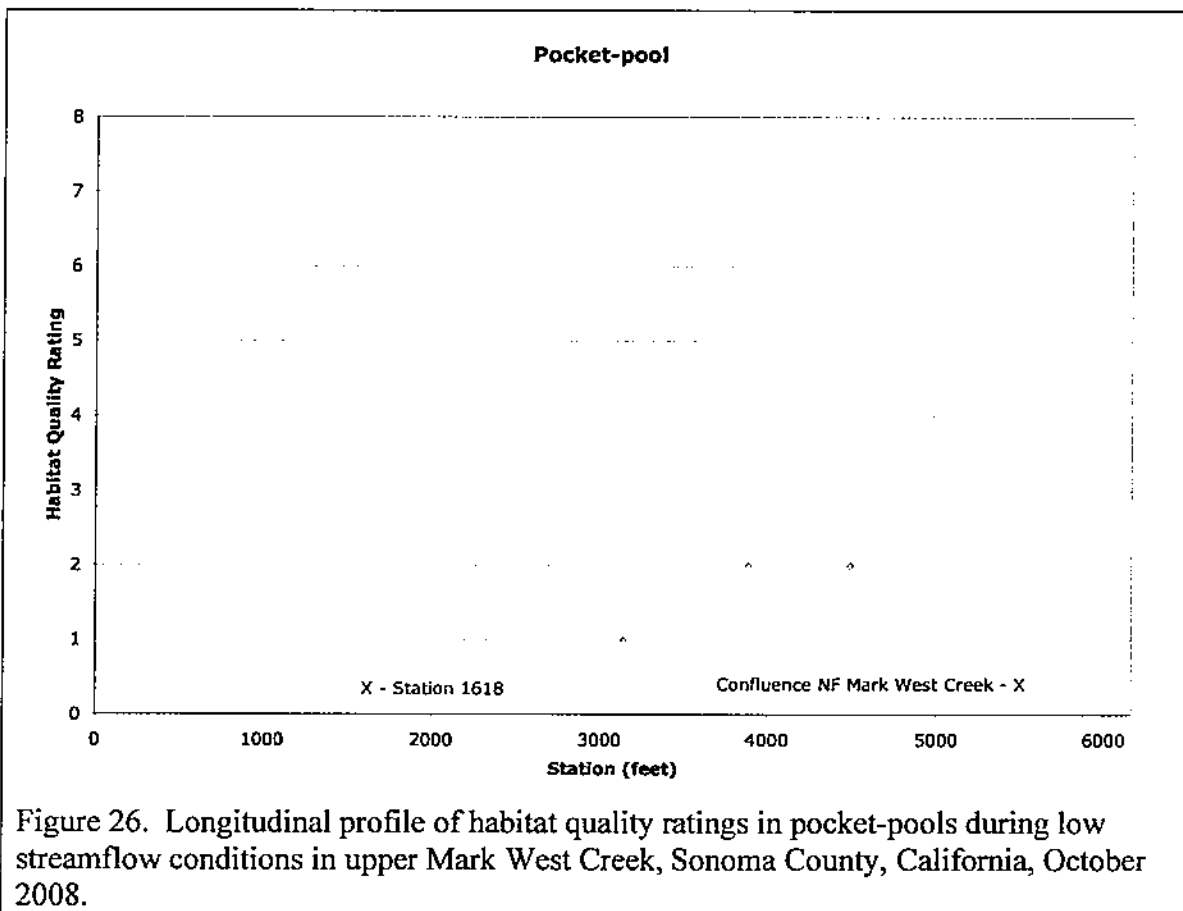
Habitat quality in pocket-pools was poor to fair (Figure 26).

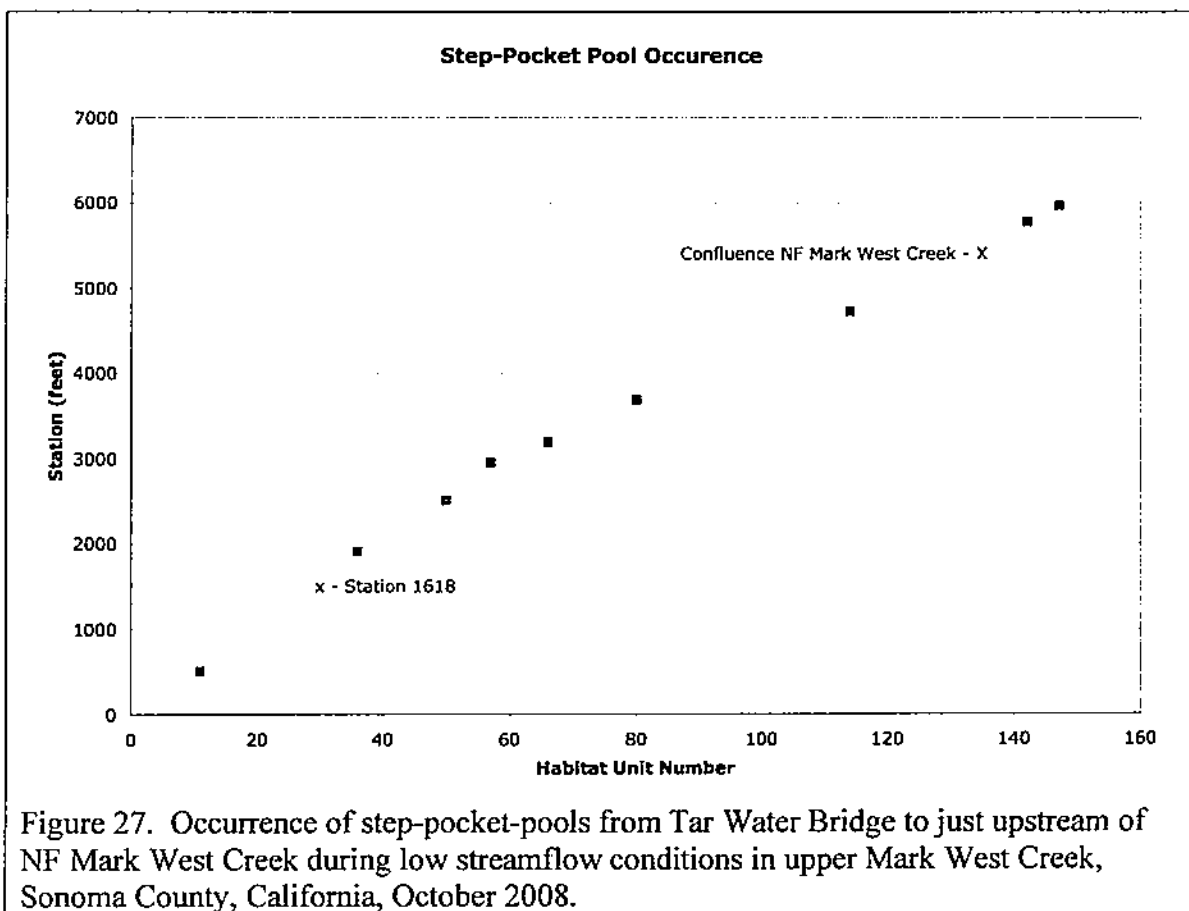
Figure 27. Occurrence of step-pocket-pools from Tar Water Bridge to just upstream of NF Mark West Creek during low streamflow conditions in upper Mark West Creek, Sonoma County, California, October 2008.

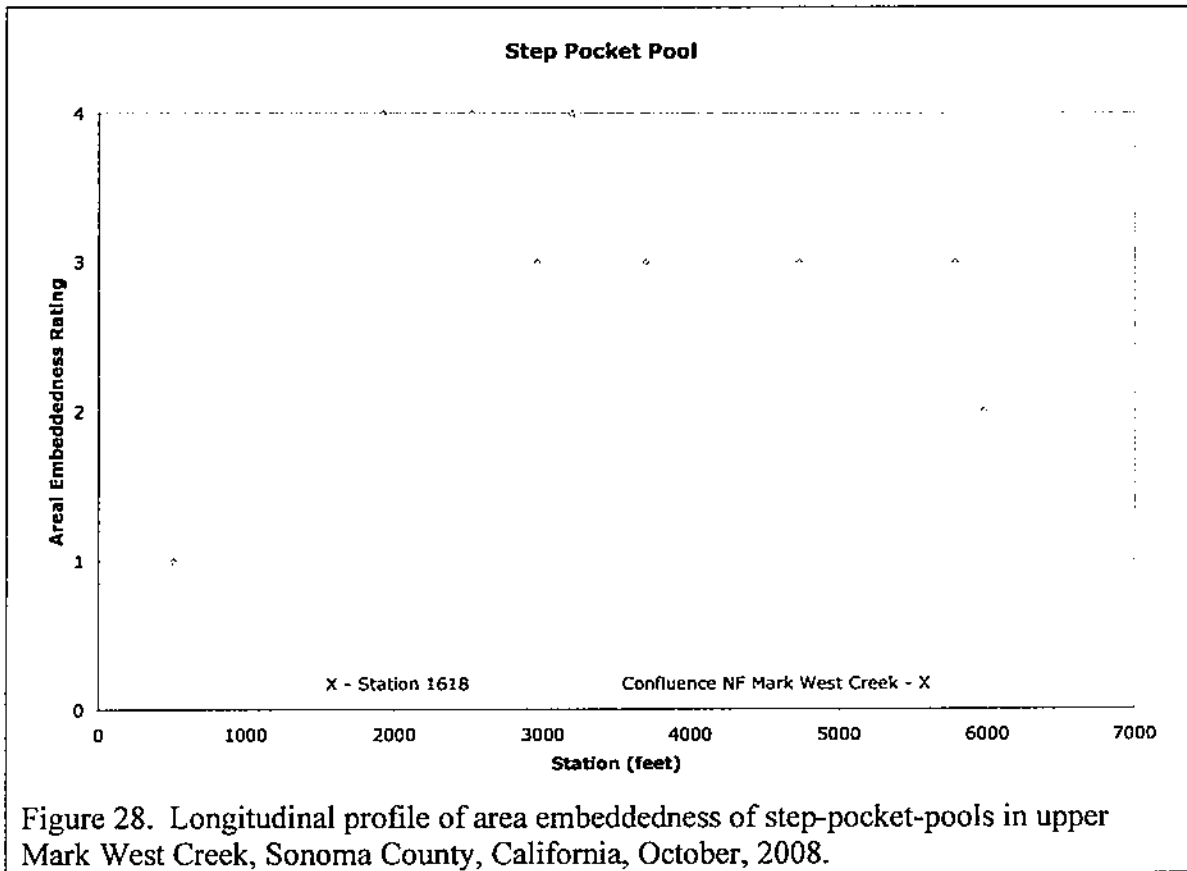
Step-pocket-pools show the effects of the 10,000 cubic yard sediment plume; there is elevated area embeddedness upstream of station 1618 (Figure 28).

Figure 28. Longitudinal profile of area embeddedness of step-pocket-pools in upper Mark West Creek, Sonoma County, California, October, 2008.

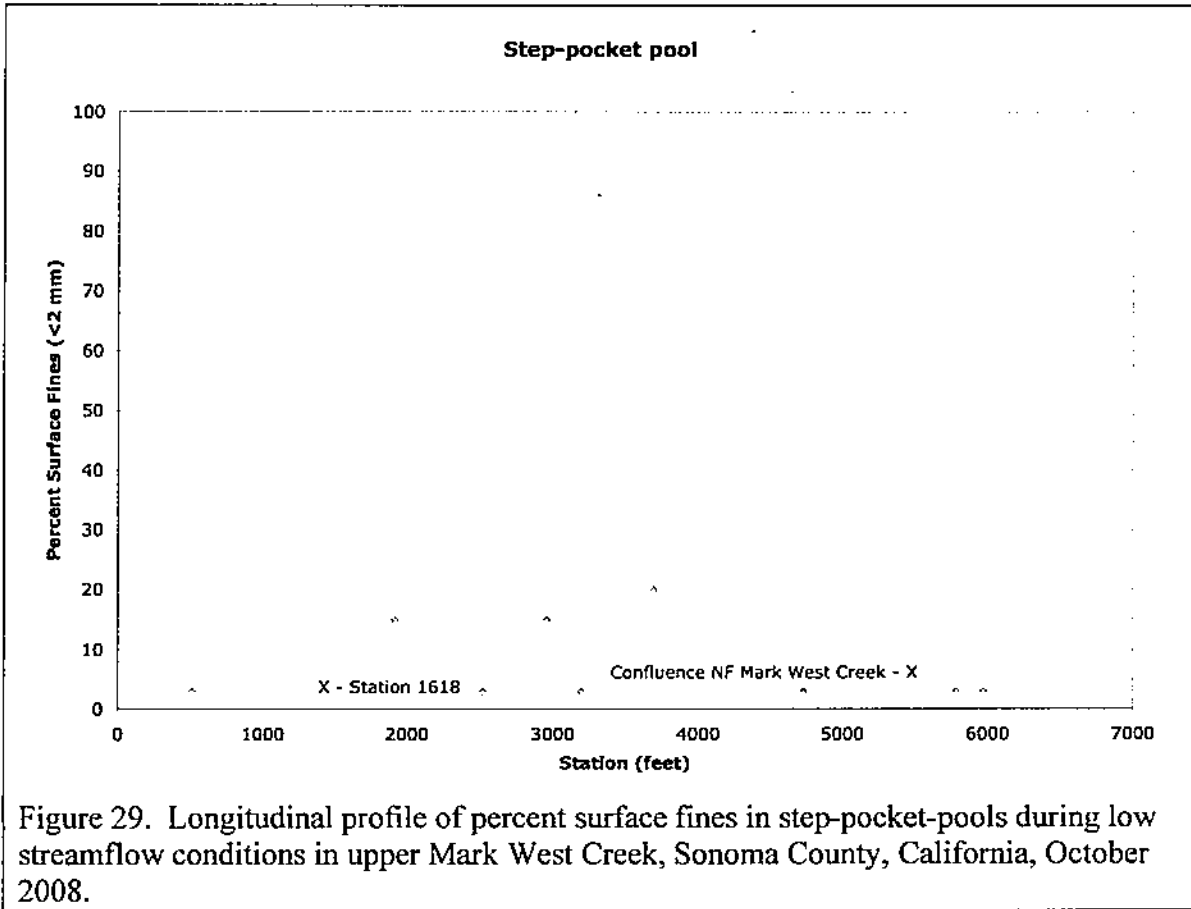
Percent surface fines were relatively light in step-pocket-pools (Figure 29).

Figure 29. Longitudinal profile of percent surface fines in step-pocket-pools during low streamflow conditions in upper Mark West Creek, Sonoma County, California, October 2008.

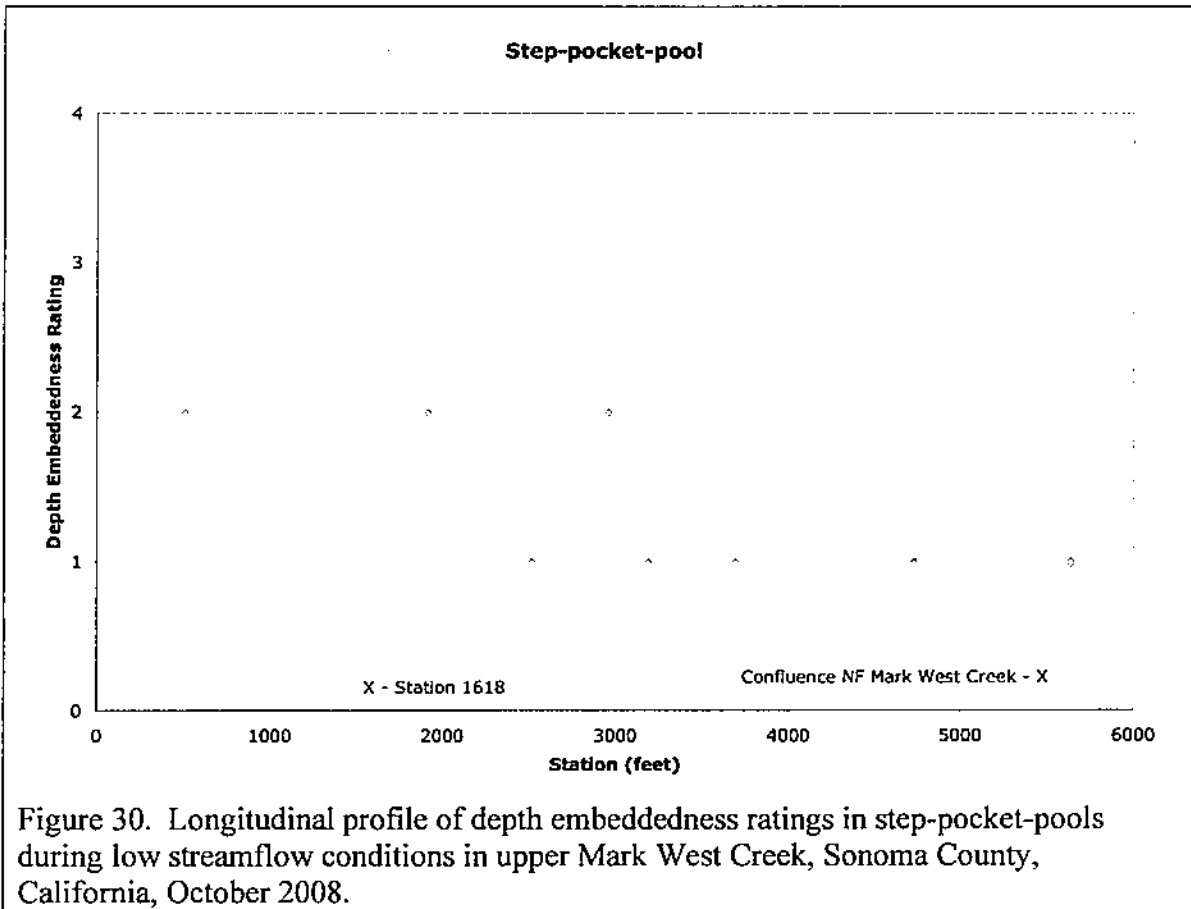
Step-pocket-pool depth embeddedness ratings were light to moderate (Figure 30).

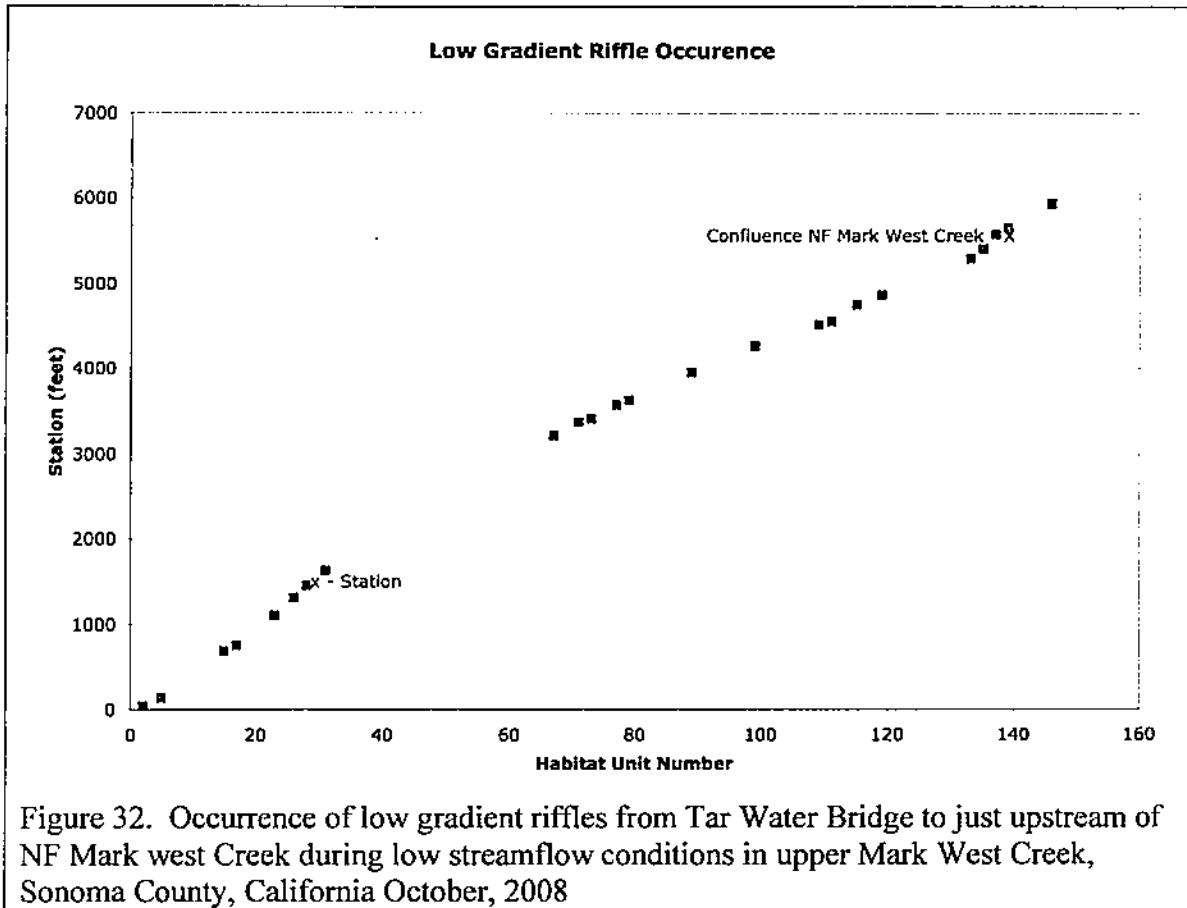
Figure 32. Occurrence of low gradient riffles from Tar Water Bridge to just upstream of NF Mark west Creek during low streamflow conditions in upper Mark West Creek, Sonoma County, California October, 2008

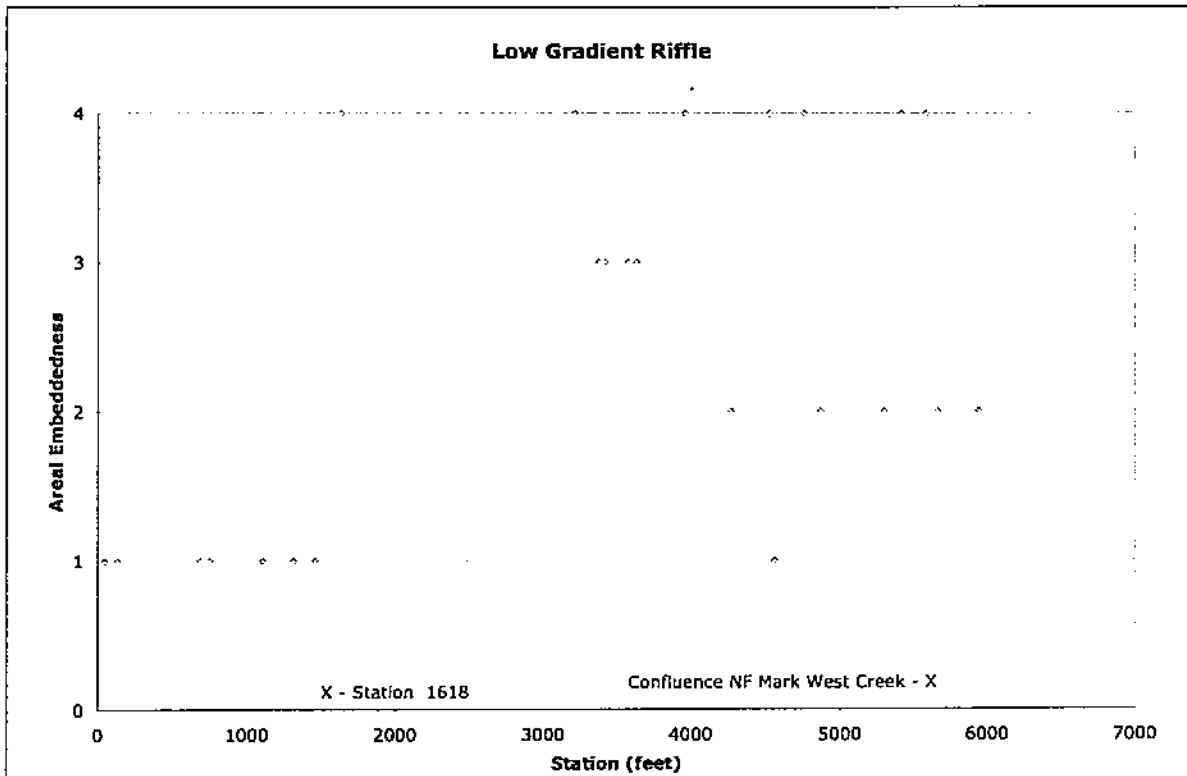
Low gradient riffles downstream of Station 1618 had low area embeddedness, while those upstream of Station 1618 had high area embeddedness (Figure 33).

Figure 33. Longitudinal profile of area embeddedness in low gradient riffles during low streamflow conditions in upper Mark West Creek, Sonoma County, California, October 2008.

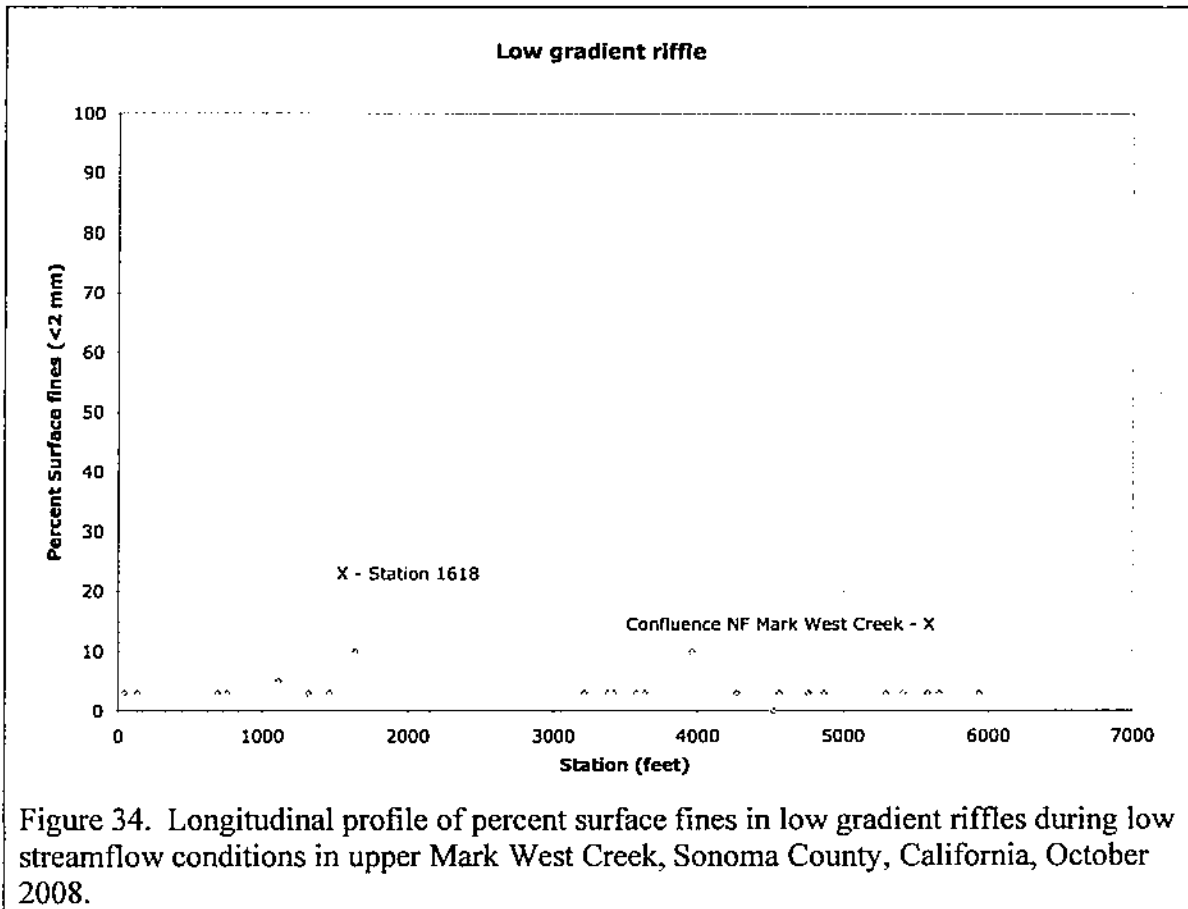
Low gradient riffles generally had low percent surface fines (Figure 34).

Figure 34. Longitudinal profile of percent surface fines in low gradient riffles during low streamflow conditions in upper Mark West Creek, Sonoma County, California, October 2008.

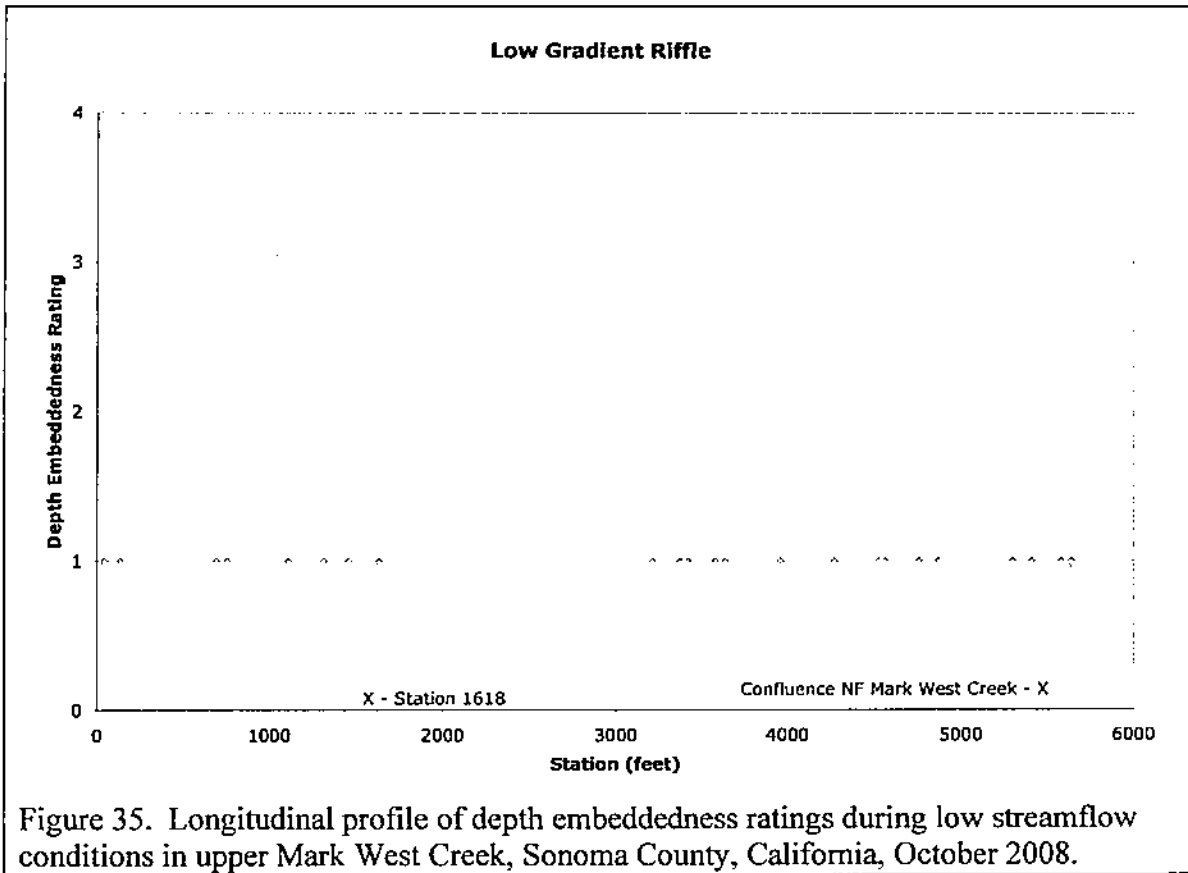
Depth embeddedness was light (Figure 35).

Figure 35. Longitudinal profile of depth embeddedness ratings during low streamflow conditions in upper Mark West Creek, Sonoma County, California, October 2008.
