**HABITAT INVENTORY AND INITIAL ASSESSMENT OF  
ANTHROPOGENIC SEDIMENTATION OF  
UPPER MARK WEST CREEK,  
SONOMA COUNTY, CALIFORNIA**

**PREPARED FOR:  
New-Old Ways Wholistically Emerging  
7768 St. Helena Road  
Santa Rosa, California 95404**

**PREPARED BY:  
STACY K. LI, PH.D.  
AQUATIC SYSTEMS RESEARCH  
1210 SPENCER AVENUE  
SANTA ROSA, CALIFORNIA 95404  
AND  
DOUGLAS PARKINSON  
DOUGLAS PARKINSON AND ASSOCIATES  
960 L STREET  
ARCATA, CALIFORNIA**

**JUNE 27, 2009**

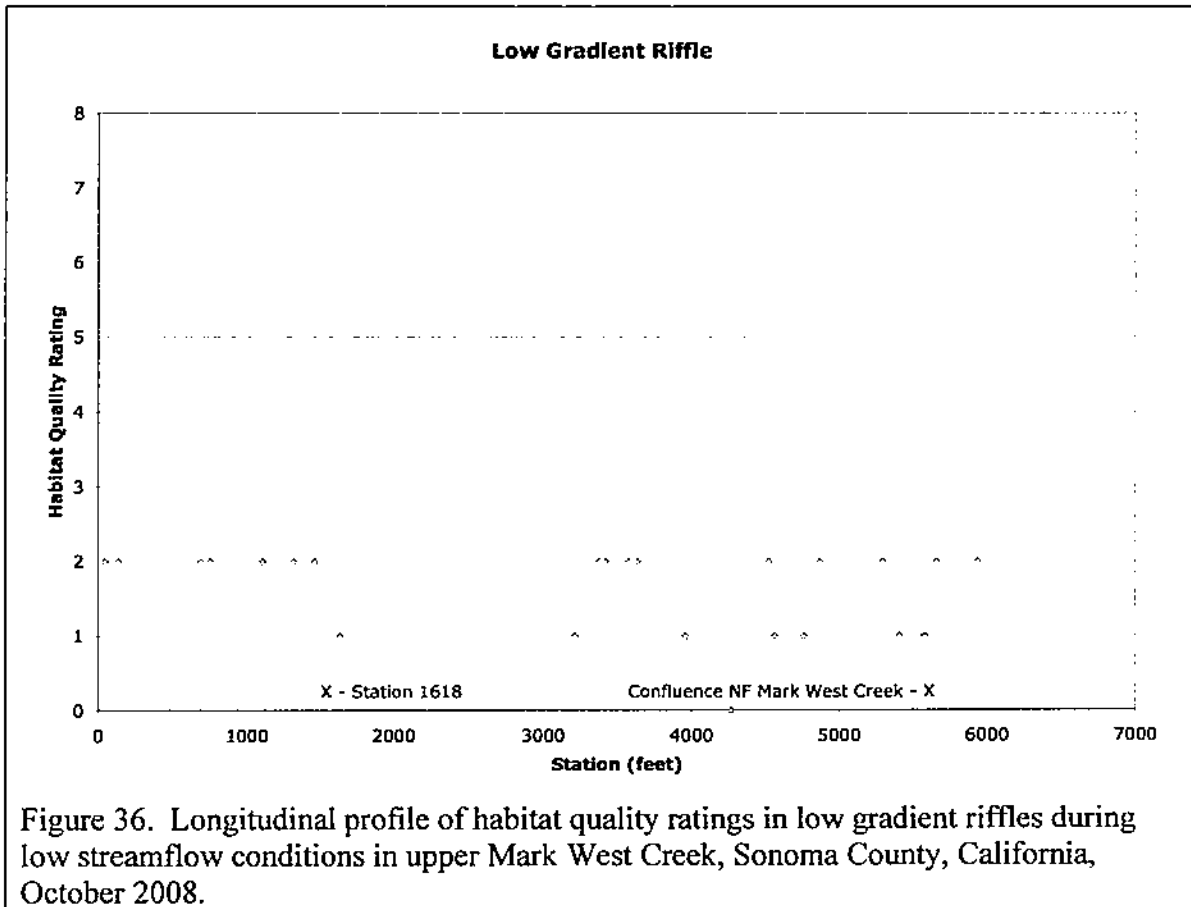
Low gradient riffle habitat quality was poor to fair (Figure 36).

Figure 36. Longitudinal profile of habitat quality ratings in low gradient riffles during low streamflow conditions in upper Mark West Creek, Sonoma County, California, October 2008.

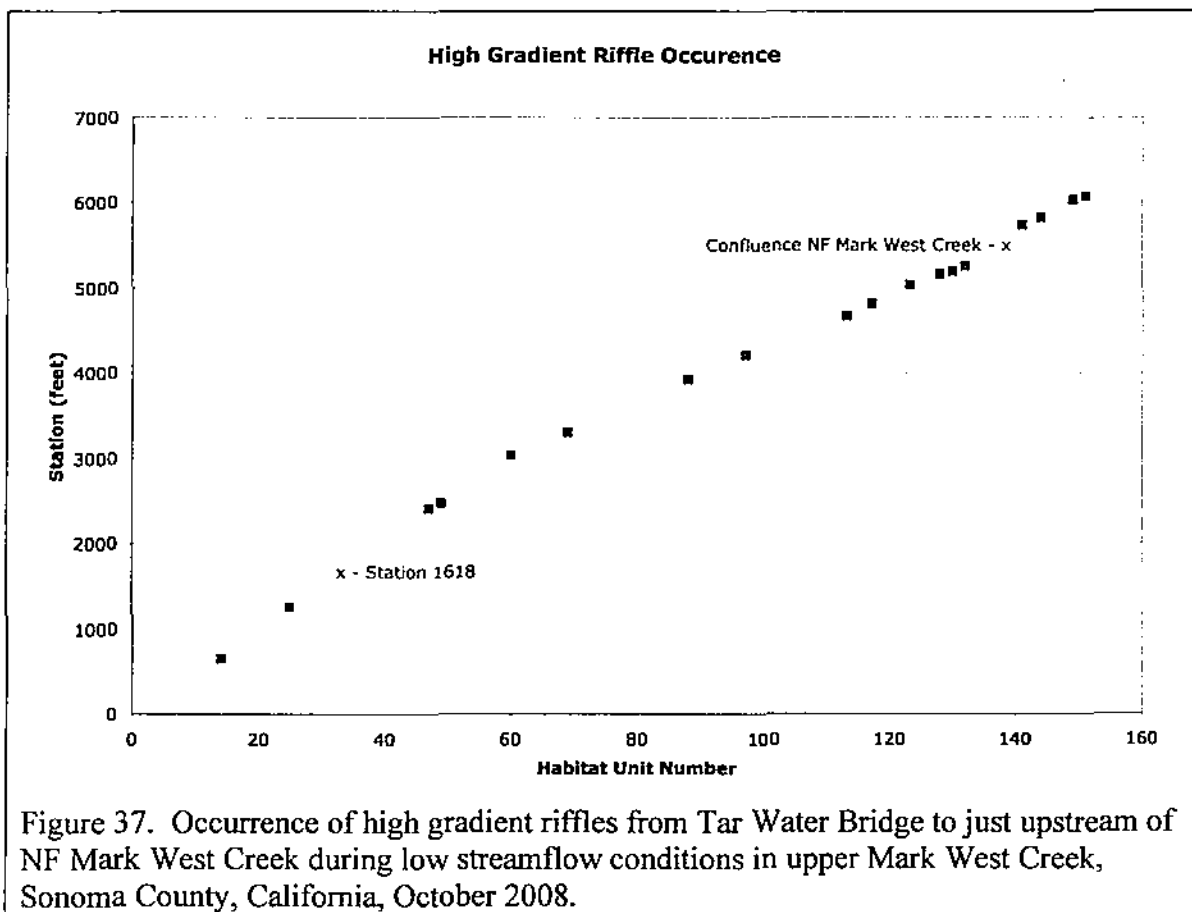
Figure 37. Occurrence of high gradient riffles from Tar Water Bridge to just upstream of NF Mark West Creek during low streamflow conditions in upper Mark West Creek, Sonoma County, California, October 2008.

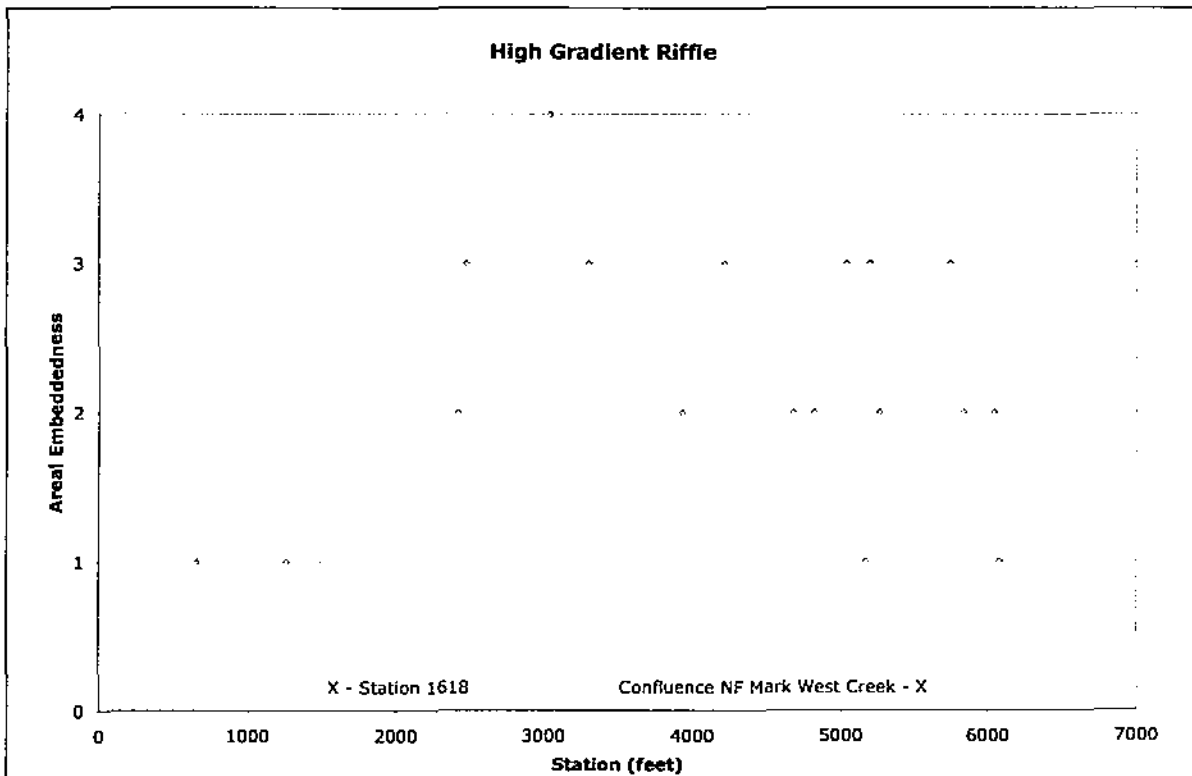
There was low area embeddedness downstream of Station 1618 and higher embeddedness upstream, but there was also low embeddedness upstream (Figure 38).

Figure 38. Longitudinal Profile of area embeddedness in high gradient riffles during low streamflow conditions in upper Mark West Creek, Sonoma County, California, October, 2008.

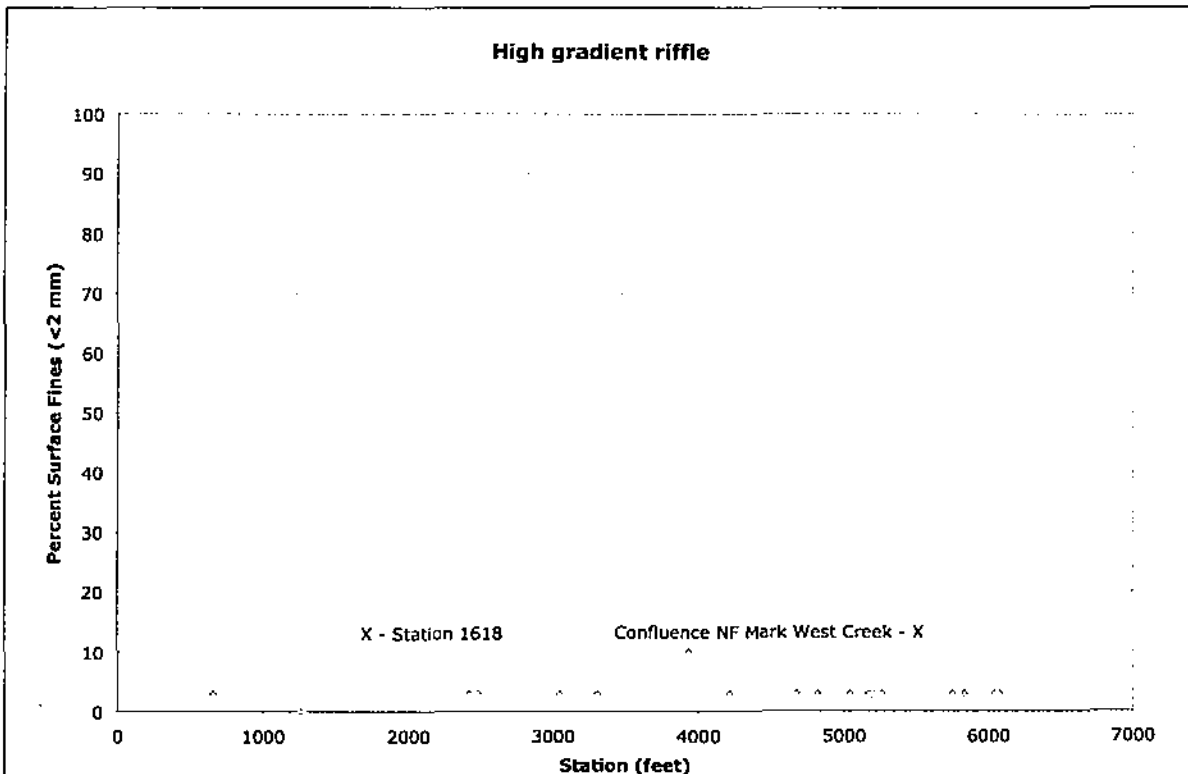
Percent surface fines for high gradient riffles was generally low (Figure 39).

Figure 39. Longitudinal profile of percent surface fines in high gradient riffle during low streamflow conditions in upper Mark West Creek, Sonoma County, California October, 2008.

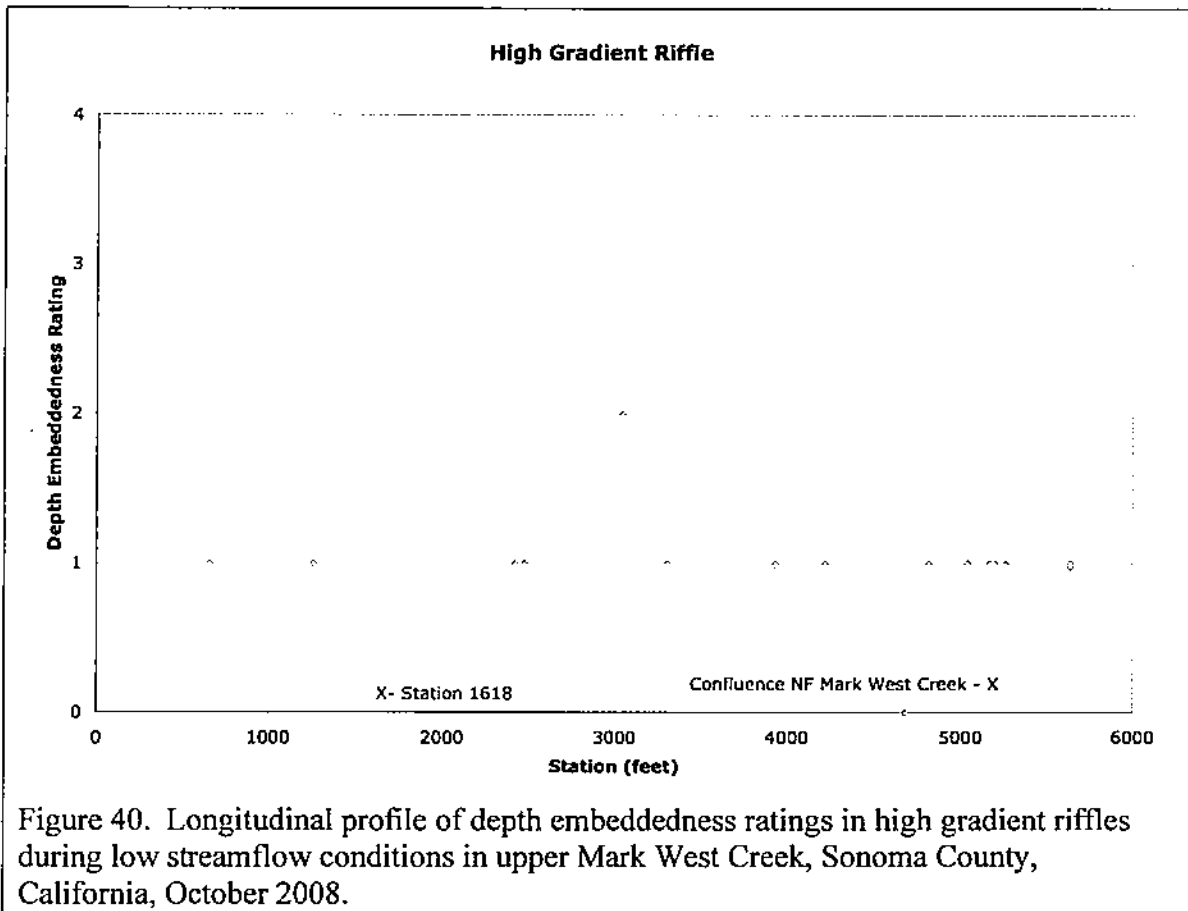
Depth embeddedness was generally light (Figure 40).

Figure 40. Longitudinal profile of depth embeddedness ratings in high gradient riffles during low streamflow conditions in upper Mark West Creek, Sonoma County, California, October 2008.

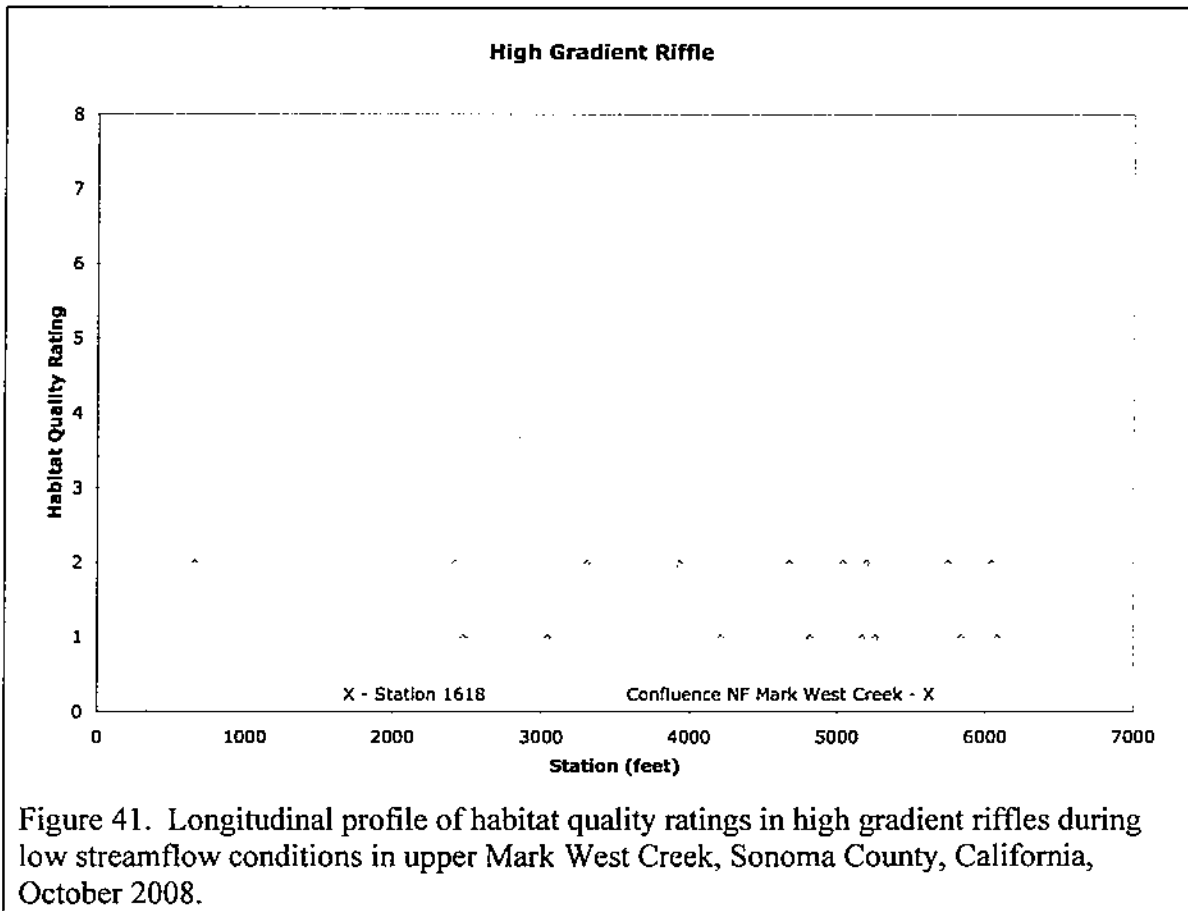
High gradient habitat quality was poor to fair (Figure 41).

Figure 41. Longitudinal profile of habitat quality ratings in high gradient riffles during low streamflow conditions in upper Mark West Creek, Sonoma County, California, October 2008.

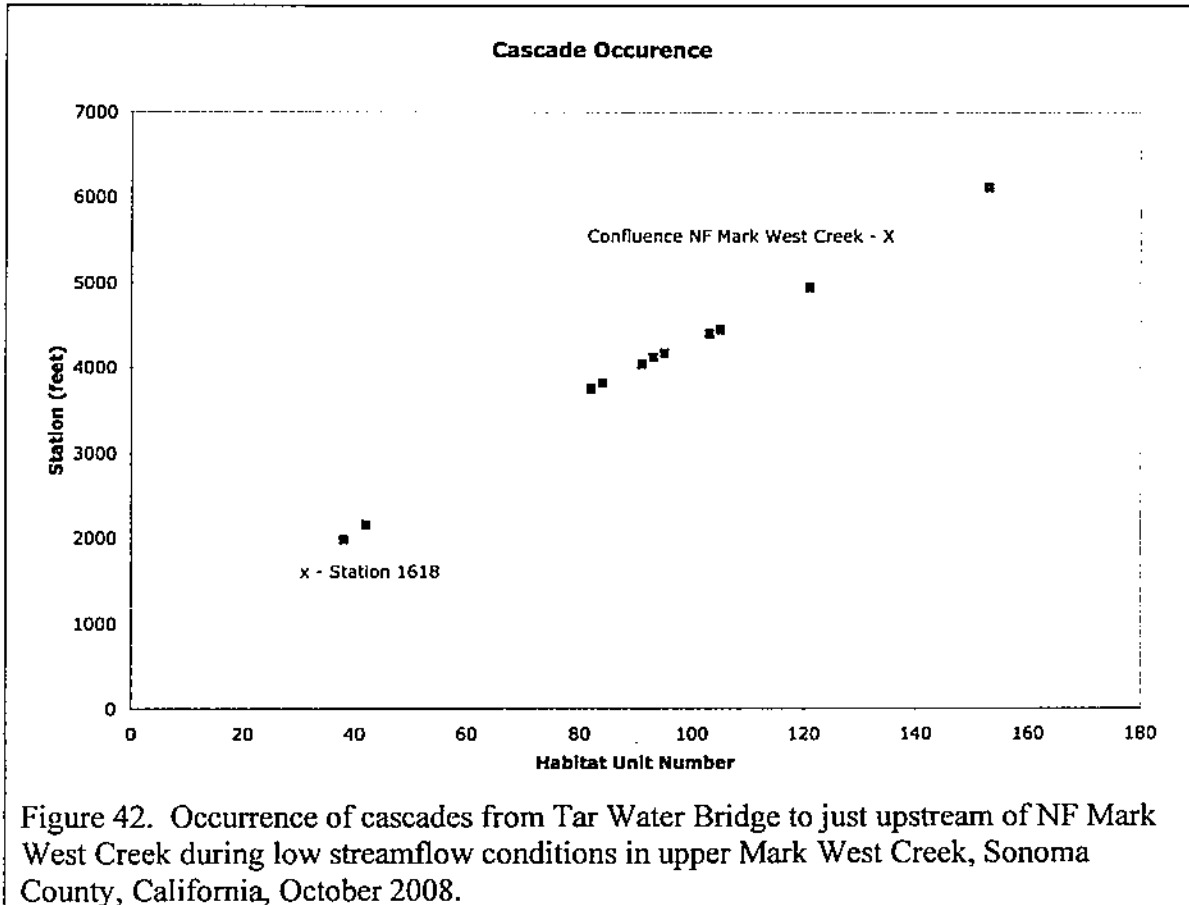
Figure 42. Occurrence of cascades from Tar Water Bridge to just upstream of NF Mark West Creek during low streamflow conditions in upper Mark West Creek, Sonoma County, California, October 2008.

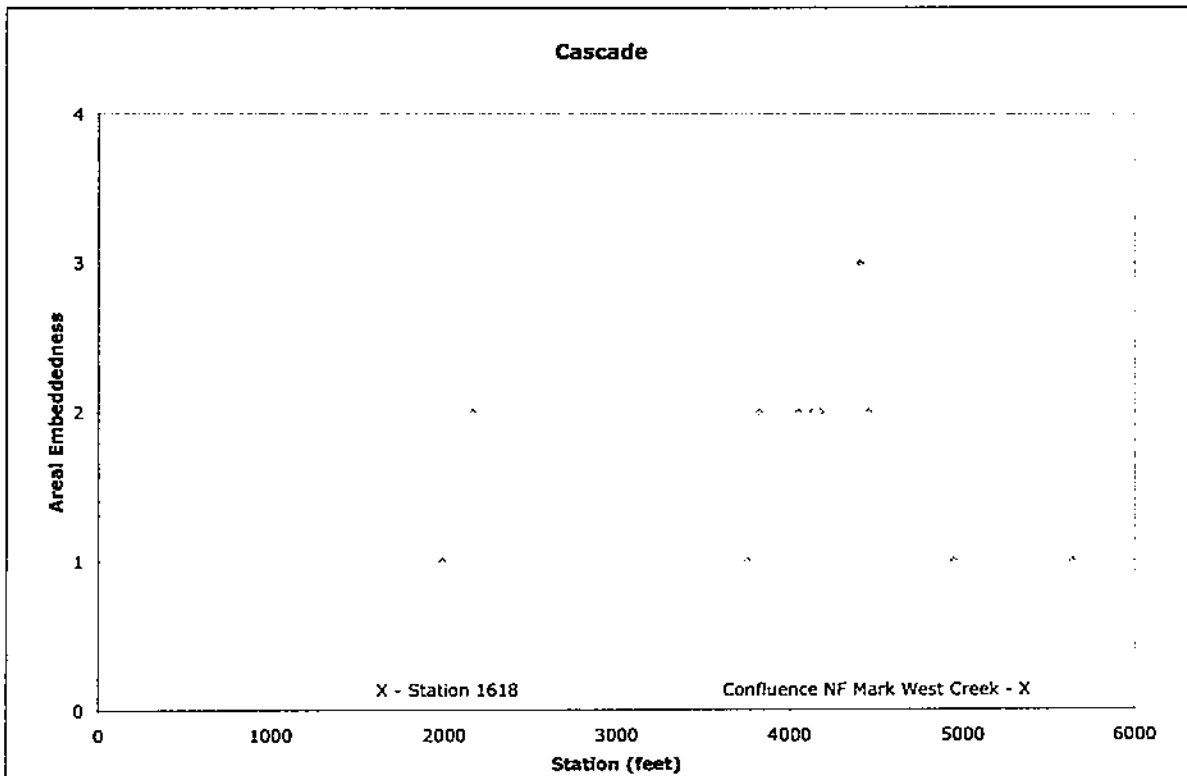
Cascades had low to moderate area embeddedness (Figure 43).

Figure 43. Longitudinal profile of area embeddedness in cascades during low streamflow conditions in upper Mark West Creek, Sonoma County, California, October 2008.

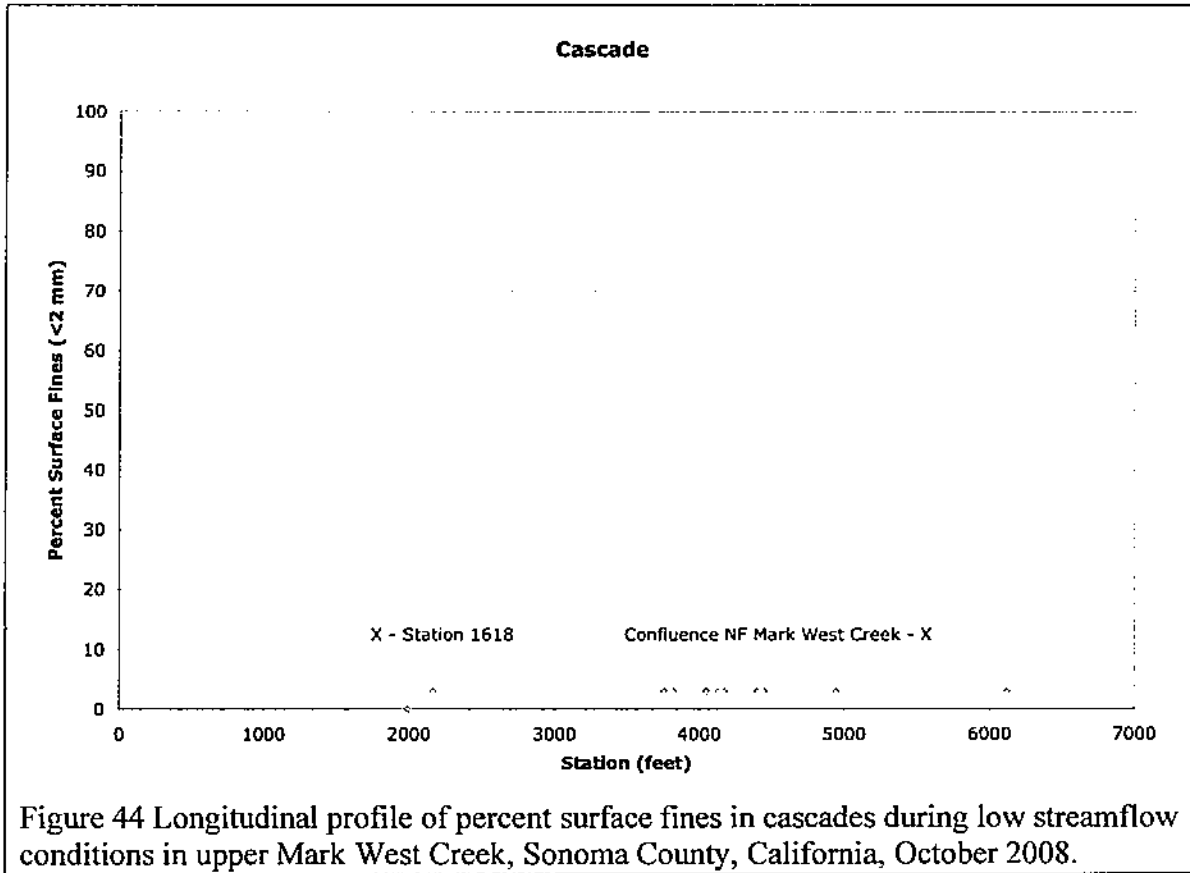
Percent surface fines in cascades was low (Figure 44).

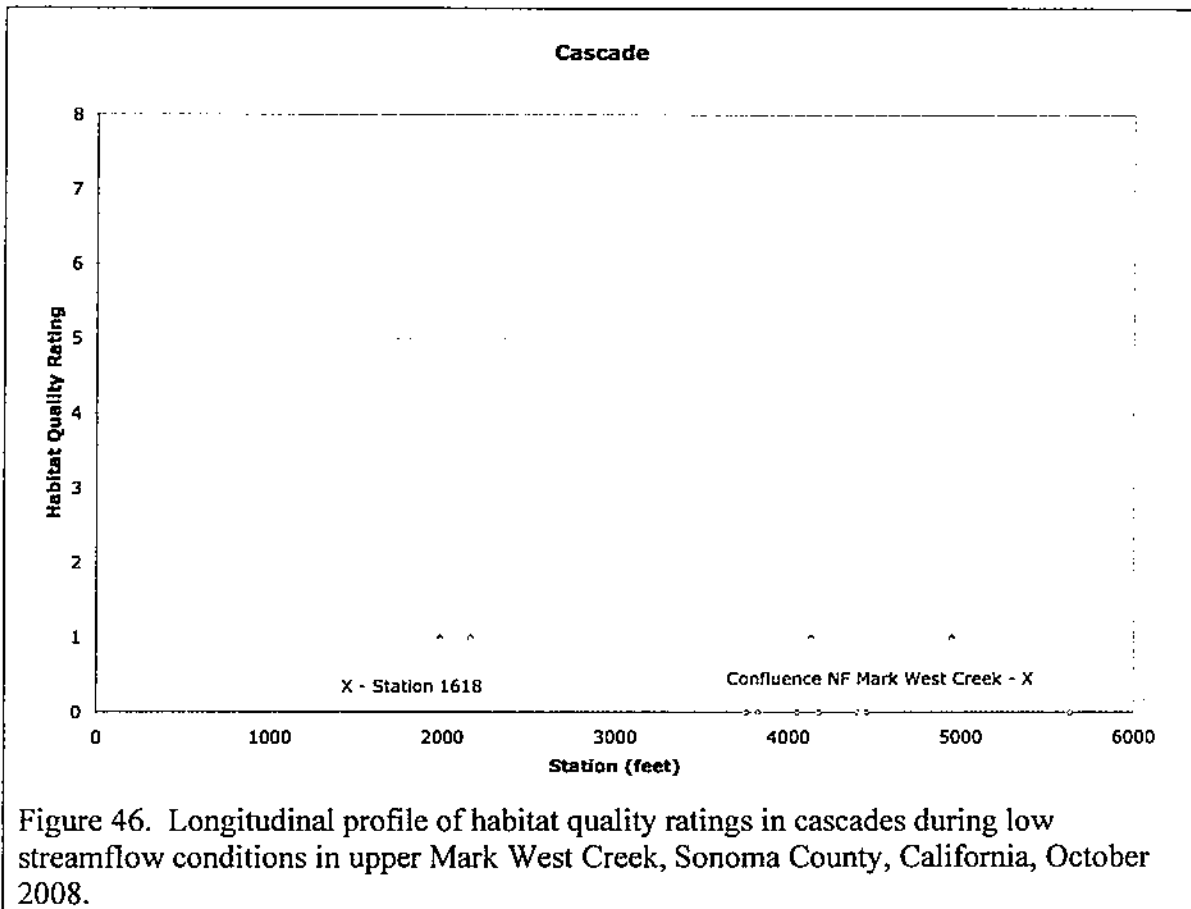
Cascade habitat quality was poor to none (Figure 46).

Figure 46. Longitudinal profile of habitat quality ratings in cascades during low streamflow conditions in upper Mark West Creek, Sonoma County, California, October 2008.

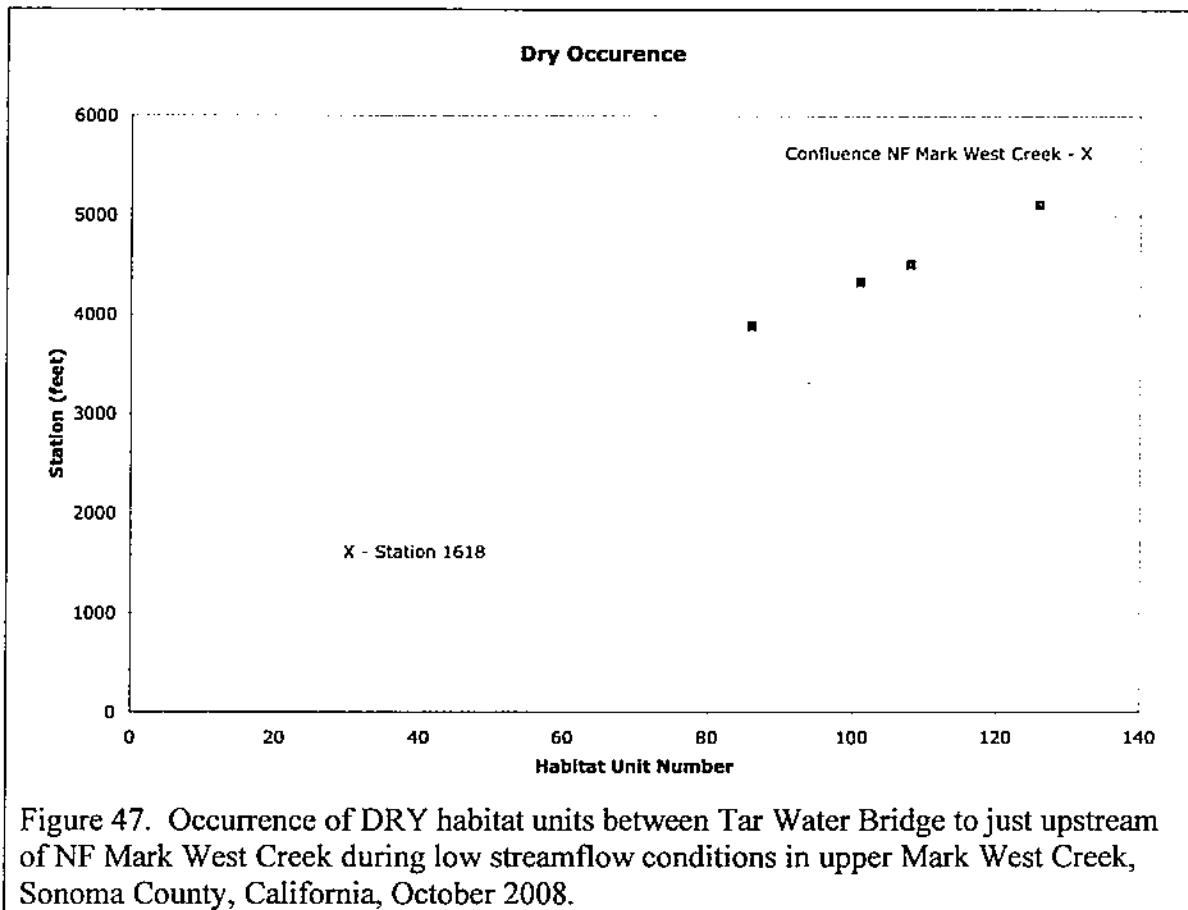
In October 2008, under low streamflow conditions, Li and Parkinson observed that there were four habitat units where sediment deposition caused the interruption of continuous surface streamflow. They called these units DRY. In three instances, the sediment deposition was associated with the tail of a pool, which is where sediment deposition occurs during flow recession. Flow discontinuity occurs when the elevation of the sediment deposition exceeds the water surface elevation of the declining streamflow. The fourth DRY unit occurred between a low gradient riffle upstream and a pool downstream. The base of the riffle consisted of large boulders that created boulder shadows for sediment deposition. All DRY habitat units were in the upper reach of the surveyed creek (Figure 47). DRY units cannot support aquatic invertebrates or fish. DRY units also interrupt the energy flow and fish movement. In all cases, the DRY habitat units were complete migration barriers.

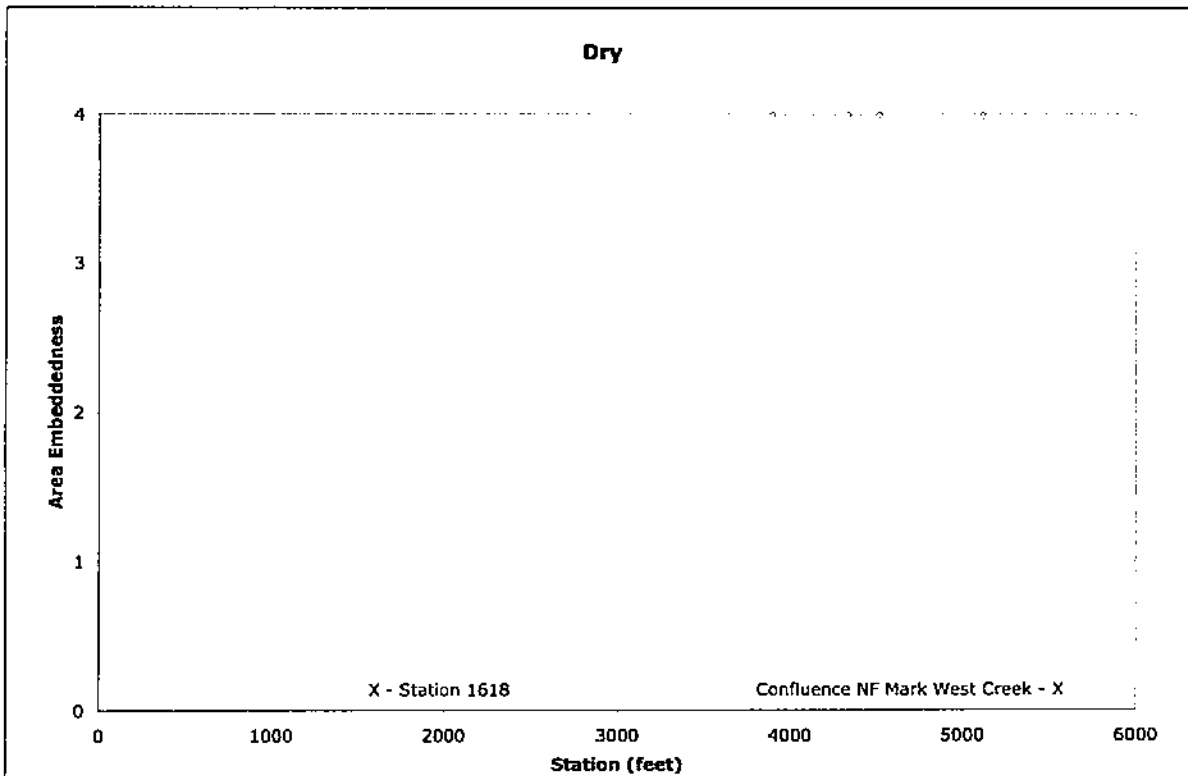
Area embeddedness in DRY habitat units was high (Figure 48).

Figure 48. Longitudinal profile of area embeddedness in DRY habitat units during low streamflow conditions in upper Mark West Creek, Sonoma County, California, October 2008.

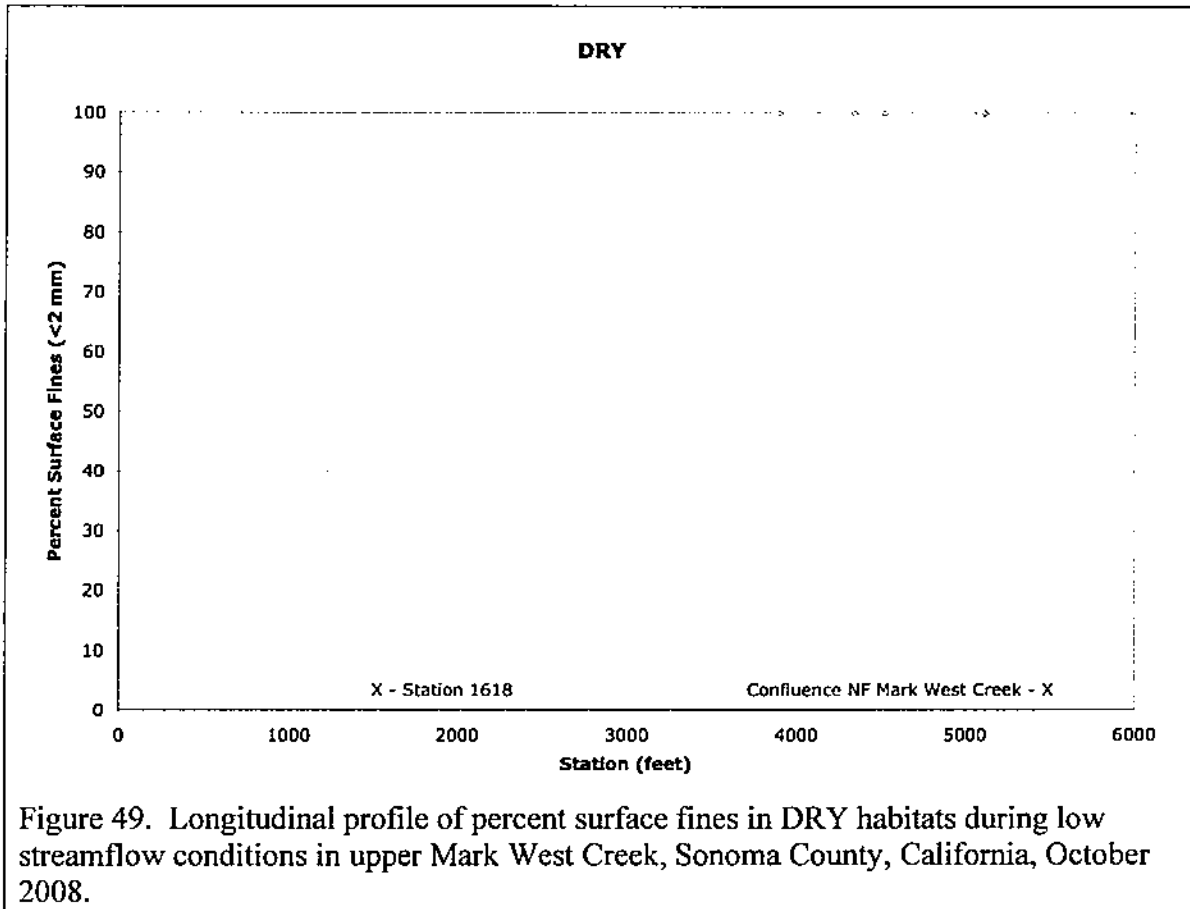
Percent surface fines were maximized in the upper reaches of Mark West Creek (Figure 49).

Figure 49. Longitudinal profile of percent surface fines in DRY habitats during low streamflow conditions in upper Mark West Creek, Sonoma County, California, October 2008.

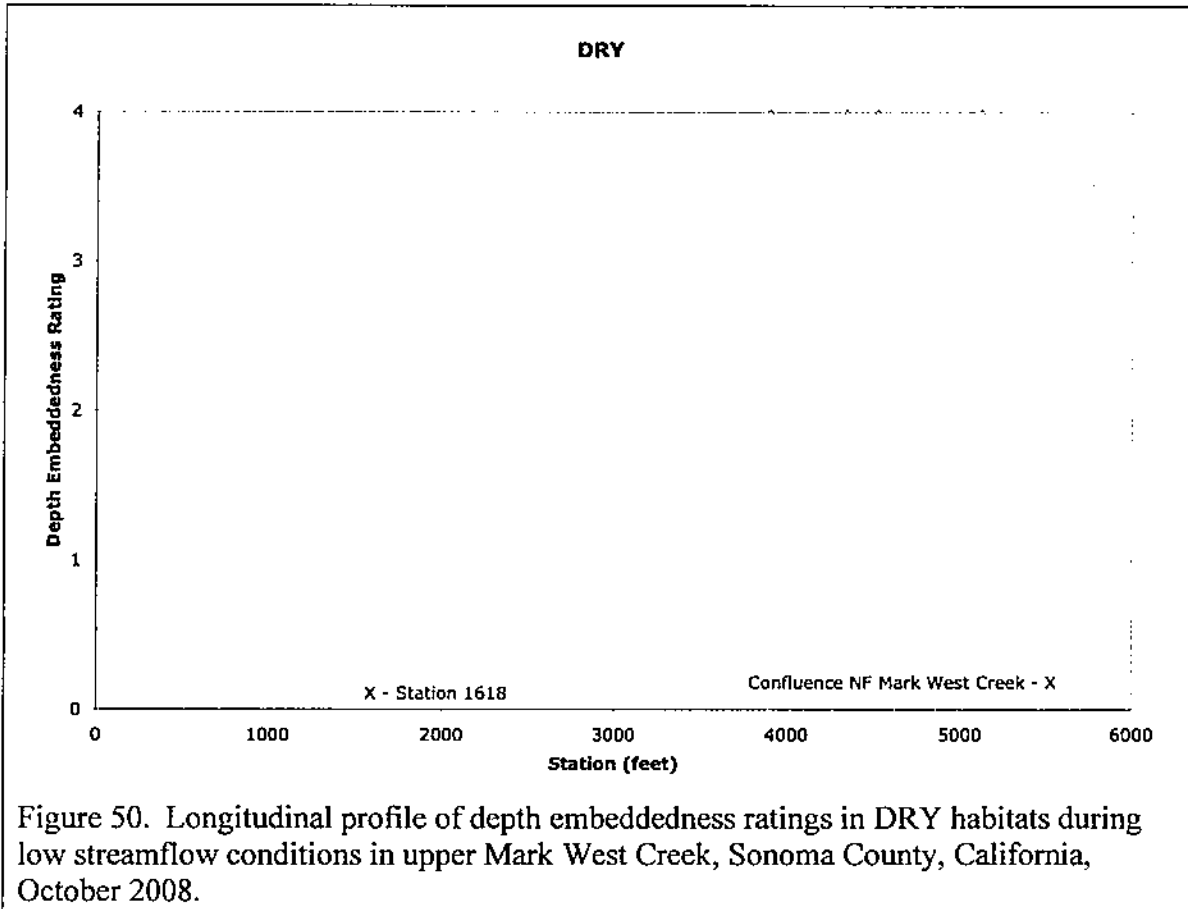
Depth embeddedness was high in DRY habitats (Figure 50).

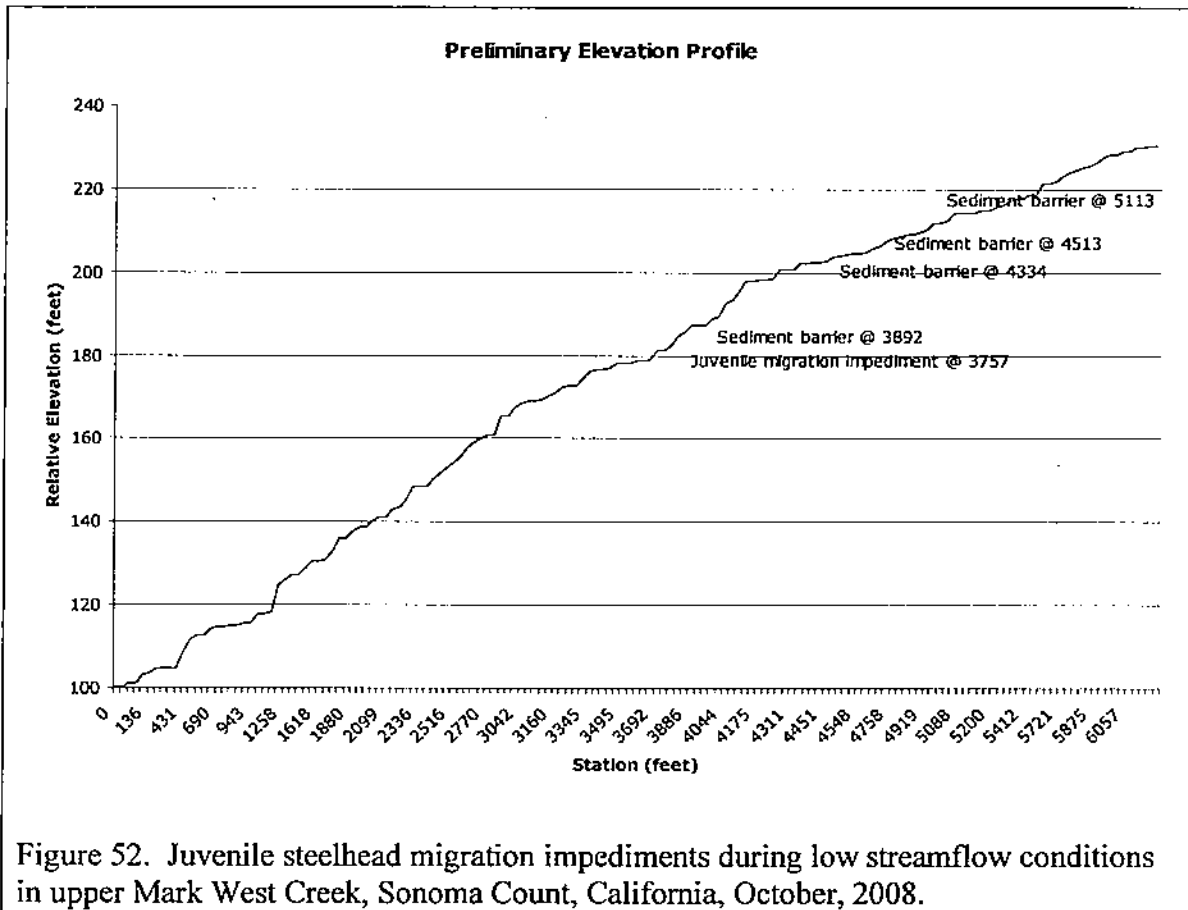
We found five juvenile steelhead migration impediments in upper Mark West Creek during the habitat inventory. One impediment was located at a cascade at station 3757; it consisted of a vertical jump of about two feet with insufficient stream depth for a jumping pool. There are potentially more of these types of impediments at places where boulder-field plugs occur. The other four were the DRY habitat units. These are impassable barriers because neither the length nor depth of water is sufficient and there are dry areas. (Figure 52).

Figure 52. Juvenile steelhead migration impediments during low streamflow conditions in upper Mark West Creek, Sonoma County, California, October, 2008.

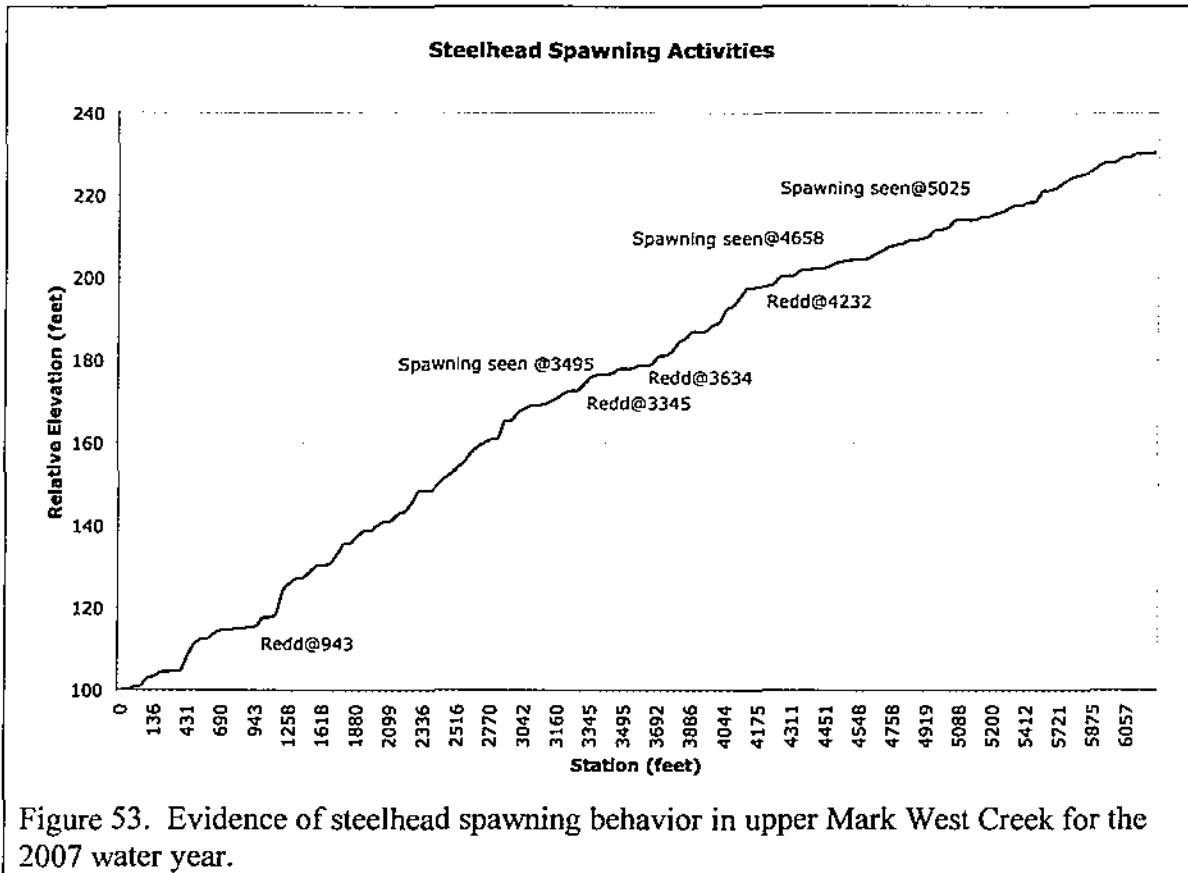
We recorded two types of steelhead spawning activity. First, "Spawning Observed" was noted at locations where spawning behavior was seen, but there was no physical evidence of a redd (spawning nest). "Redd" was noted when evidence of a redd, such as a nest mound, imbricated substrate, nest pit, *etc.*, was identified. Parkinson noted that the redds were not in typical locations, such as the tails of pools, but were in locations of lowest scour or in locations where the gravels were shallow (Figure 53).

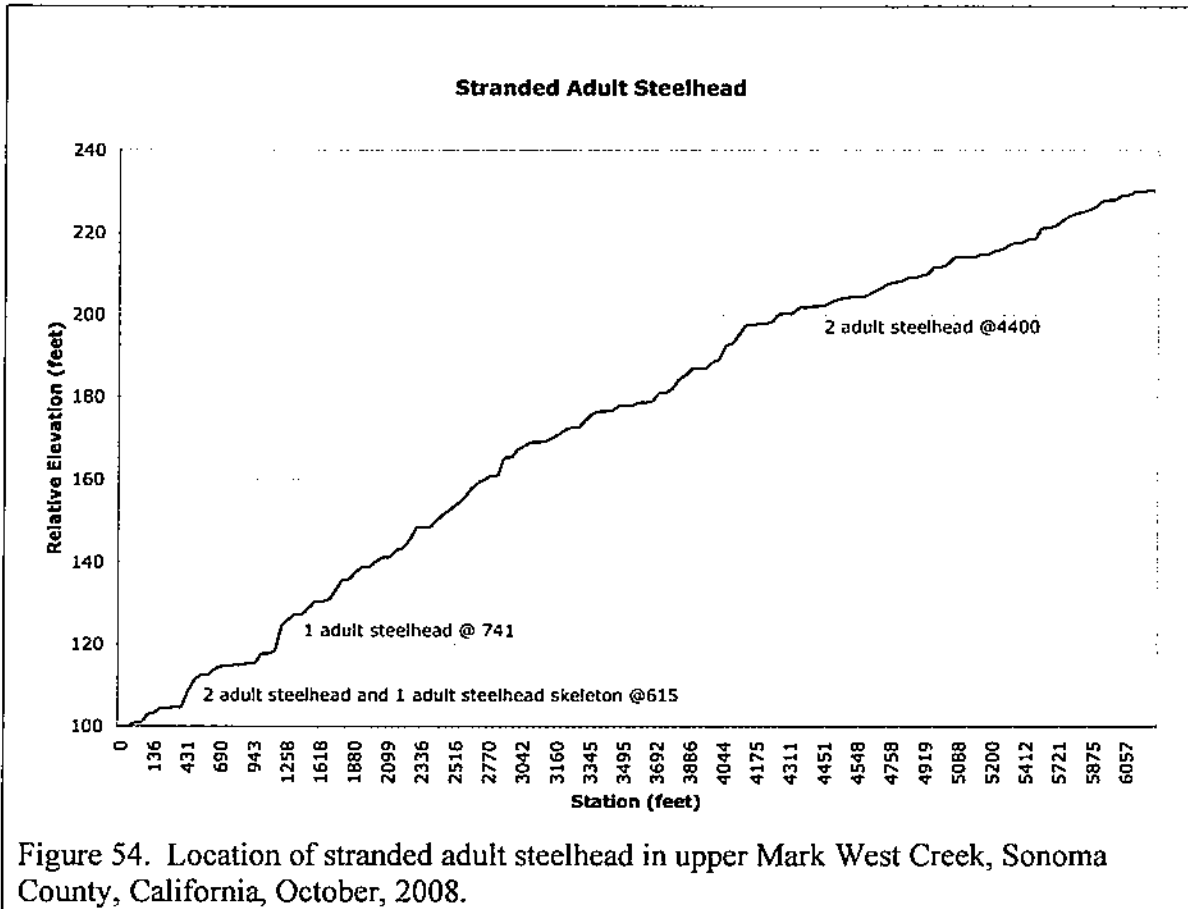
We found five stranded steelhead adults and one steelhead skeleton during the habitat survey (Figure 54). They ranged in size from 24 inches Fork length to 30 inches Fork length.

Figure 54. Location of stranded adult steelhead in upper Mark West Creek, Sonoma County, California, October, 2008.
