**SEDIMENT SOURCES AND FLUVIAL
GEOMORPHIC PROCESSES
OF
LOWER NOVATO CREEK WATERSHED**

**Report to
Marin County Flood Control and Water Conservation District**

**Laurel Collins
2338 Valley St
Berkeley, CA 94702
~~(510) 549-1209~~**

JULY 1998

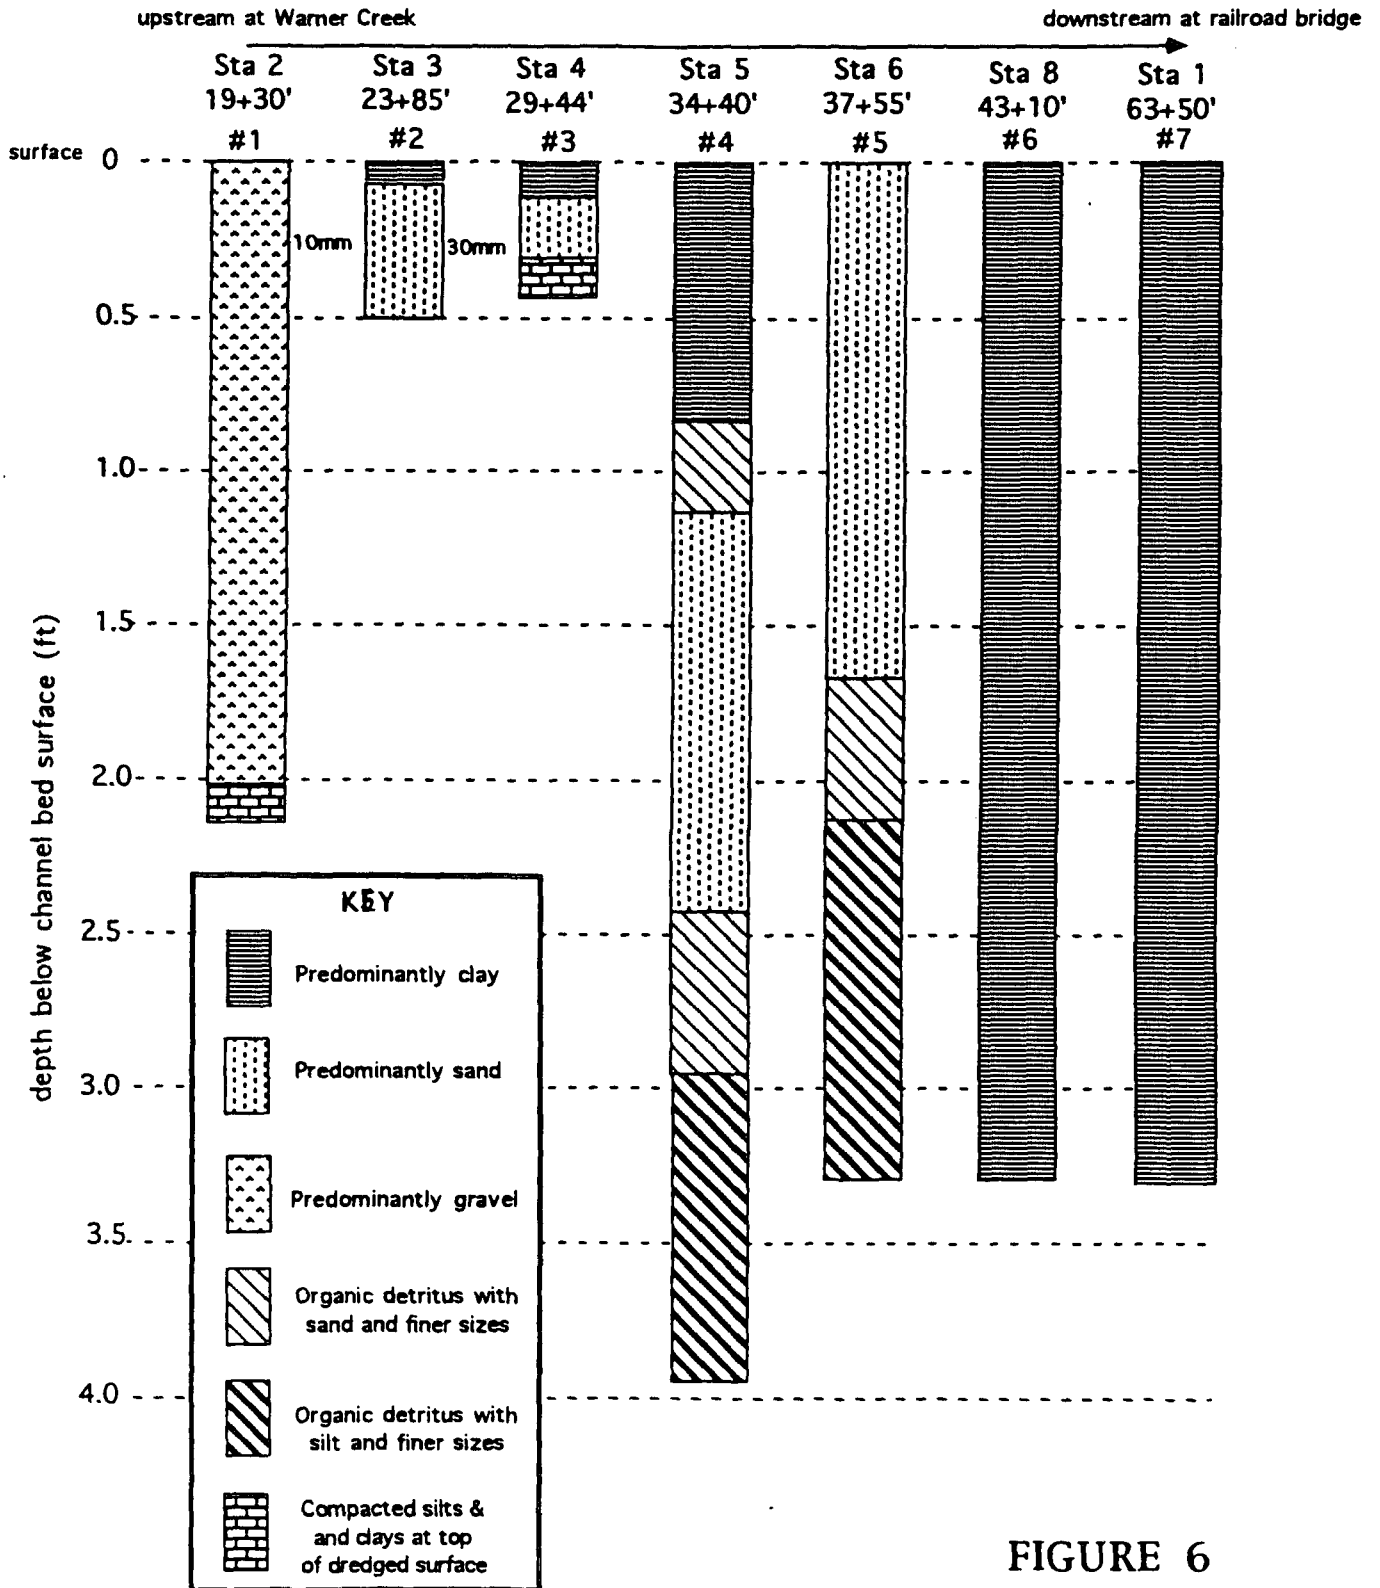
FIGURE 6

The significance of sand and larger gravel-sized sediment is that the source of this material is the upland watershed, not the tides. Tidally derived sediment is not expected to be larger than fine silt to clay-sized. Figure 6 shows another interesting stratum that is associated with organic debris, at core stations 5 (34+40') and 6 (37+55'). At the latter stations, the mixture of organic debris and sand or finer sediment accounts for more than 45% of the volume or bulk of each core. Much of the organic detritus was leaf litter from bay trees and deciduous riparian vegetation, such as willows.

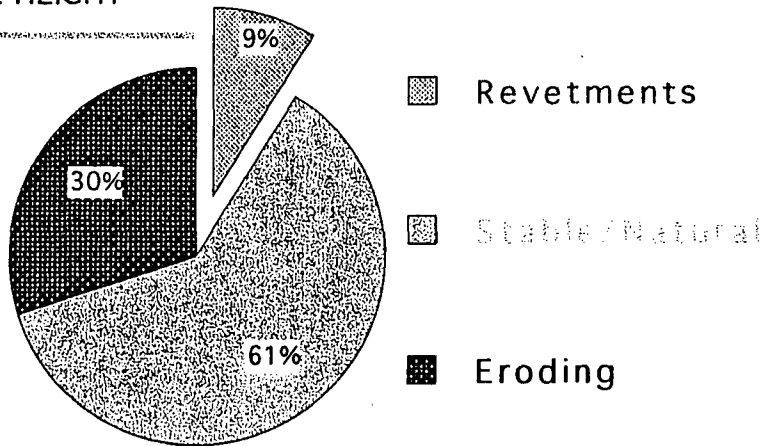
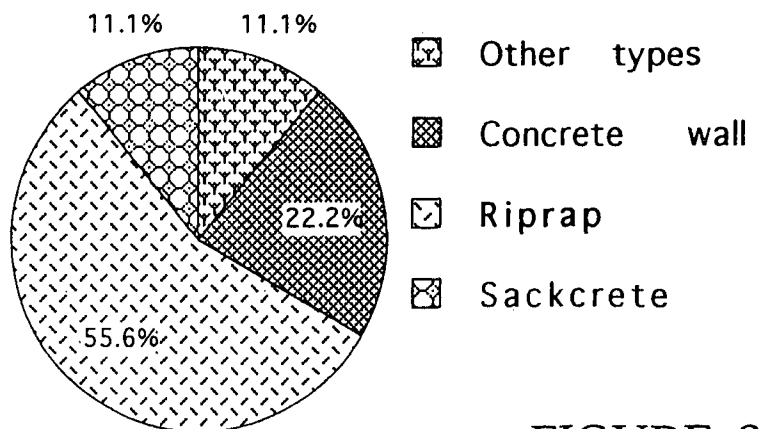
FIGURE 8

The lateral extent of eroding banks and revetment upstream of Diablo Avenue Bridge to Stafford Dam spillway was measured to determine the existing conditions of the channel and terrace banks and to establish whether bank erosion was a significant source of sediment supplied to the NFCP. The raw data are compiled in the Novato Bank Data Table, Appendix A2. Figure 8 shows three pie charts that represent channel bank condition and revetment

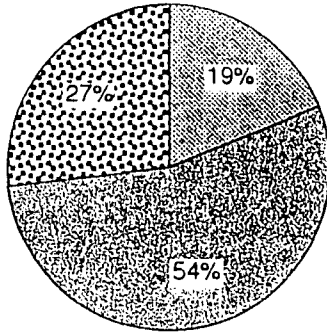
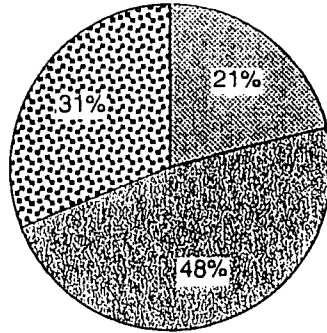
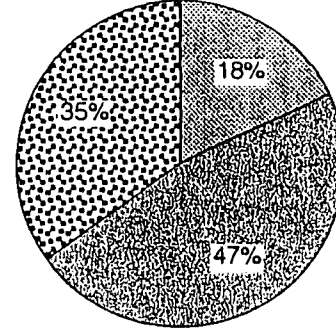
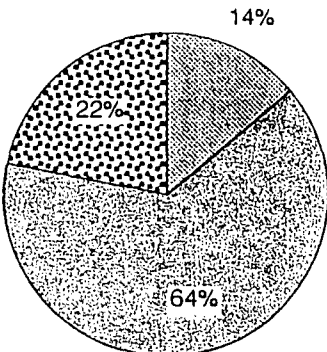
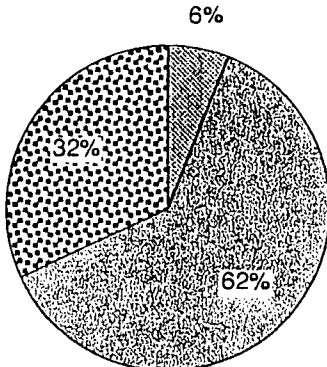
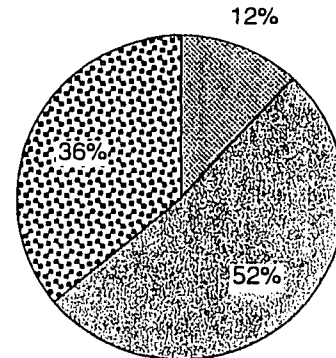
FIGURE 10

Figure 10 shows pie charts representing the percentage of total length of eroding, revetted and stable banks below the bankfull level for each of seven reaches. The charts indicate that eroding banks range from 22% of the total length in the Simmons to Las Dias reach, to 40% in the Bowman reach. If most of the revetted portions of the banks were once supplying sediment, then the banks of 7th and Grant reaches have been the most significant sediment sources, since less than 48% of their bank length is classified as stable. The Simmons reach has the highest percentage of stable banks, 68%.

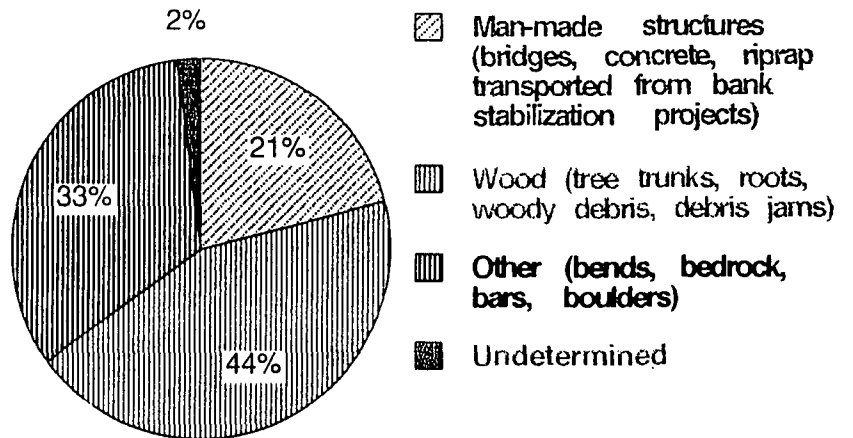
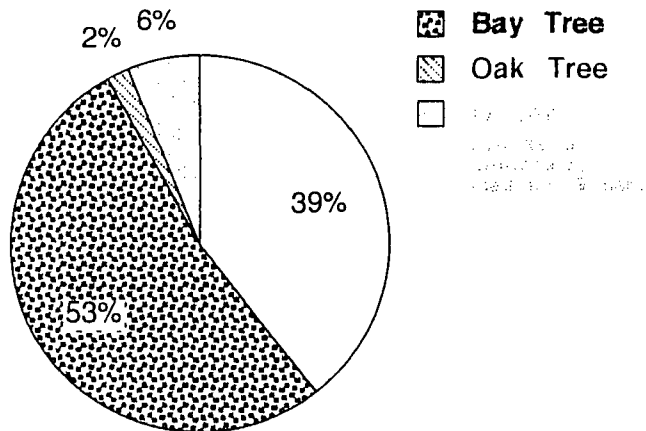
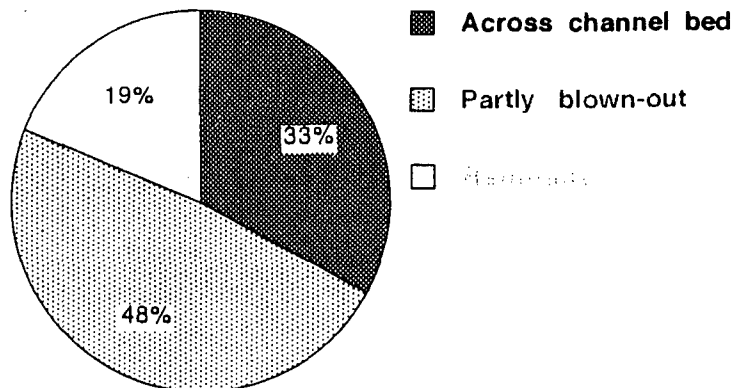
FIGURE 13

Diablo to Stafford RCP
 Of the total 84 pieces of LWD, 44 are bay trees that have fallen from terrace banks.

Diablo to Stafford RCP
 Of the total 21 debris jams, 18 occur upstream of Sutro Ave Bridge

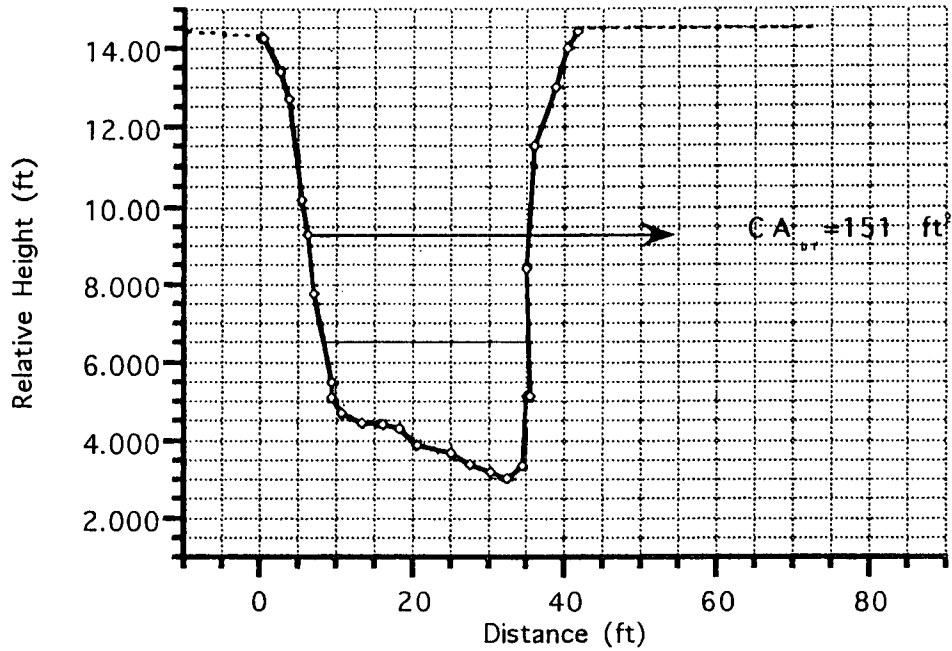
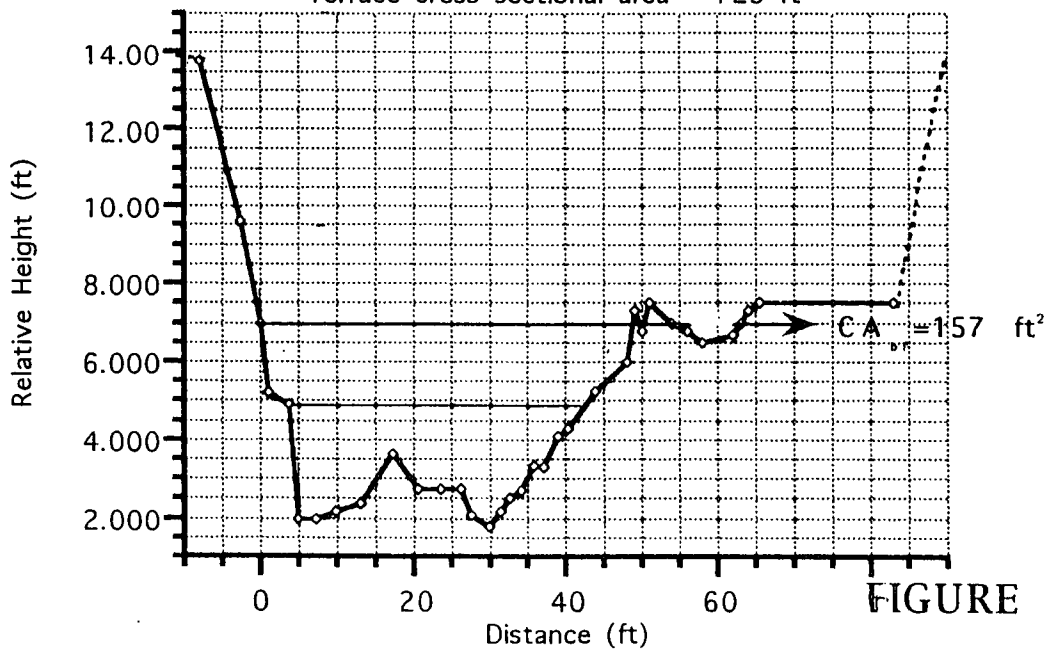
FIGURE 17A

channelization. Stability is needed to produce identifiable bankfull features. Based upon occasional spot measurements of bankfull width in the field and a few cross-sectional surveys, see Figures 17a-c, Novato Creek does not fit the expected bankfull geometry of 46' wide and 3.3' deep. The average bankfull width estimated for the entire reach is about 30'. It ranges from 22' to 57'.

The cross sections in Figure 17 were surveyed to show a range of variation in Novato Creek. The Cross Section Stations are also located on the Watershed Maps in Appendix A. The cross section at Station 16+00' was surveyed to show the typical channel geometry of a straight reach in the lower portion of Novato Creek. Cross Section Station 212-15' was chosen because it was one of the few reaches that actually appeared to have a floodplain. Here the Wbf is about 48', close to the predicted value of 46' from Leopold's regional curve. This site is shown in Photos 256-266, but the floodplain is hidden from view by vegetation. Cross Section Station 214-90' was chosen because it had significant bank and terrace erosion and substantial gravel bars, See Photo 273. Cross Section Station 216-46', Photo 275 was chosen because it was just upstream of the latter station and probably represented the previous geometry. It shows a Wbf of about 28', whereas the lower site has a Wbf of 57'. The Cross Section Station 238-46' was surveyed to see if there was any substantial change in cross sectional area above Bowman Creek. The cross sectional area was 114 sq ft as opposed to 310 sq ft at Cross Section Station 16-00'. The Cross Section Data for the surveys are located in Appendix A2.

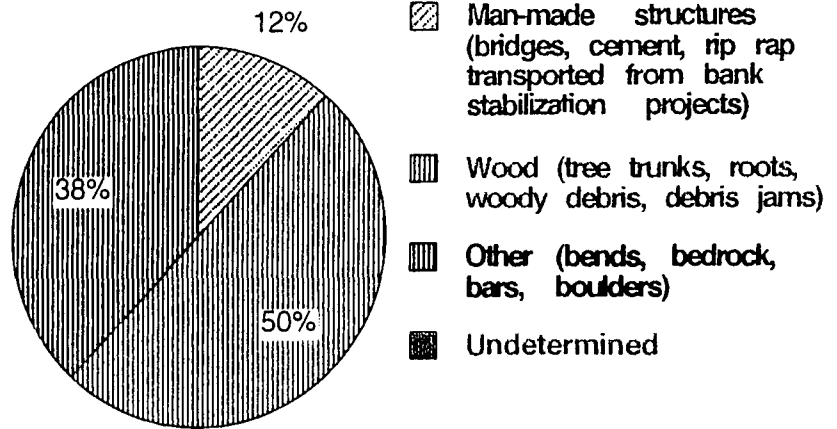
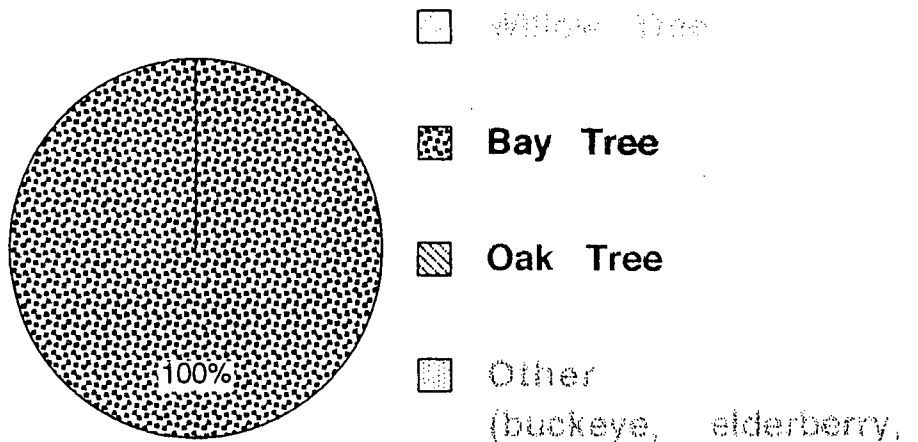
FIGURE 19

Figure 19 shows the results of the pool and woody debris analysis for the 2974' long study reach in Bowman Creek. The upper pie chart shows the total number of pools greater than 1' deep within the study reach was 8. One pool was formed by rip rap, three were from bends, two were from bay tree trunks and the other two were from woody debris. The total number of pools is less than that which would be normally expected for every 5-7 bankfull widths. For example, assuming that the average bankfull width is 21', pool

Bowman Creek
 Total # of pools = 8, average pool spacing = 368', study reach distance = 2974'.

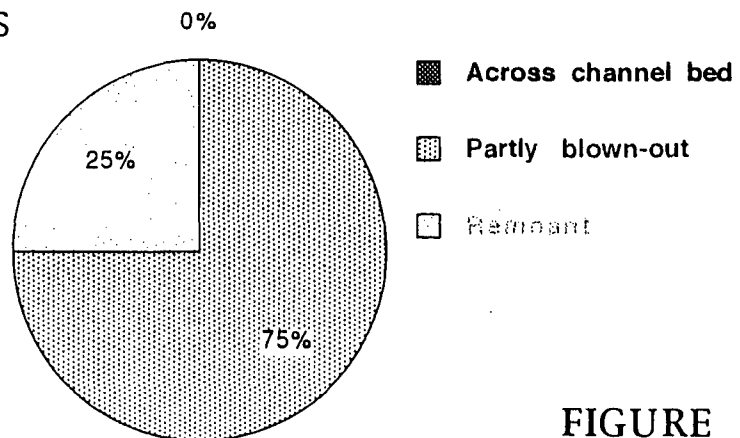
The middle pie chart shows that all the large woody debris in the channel was from bay trees. The lower pie chart shows that of the total of 6 debris jams noted, none of them fully blocked the channel.

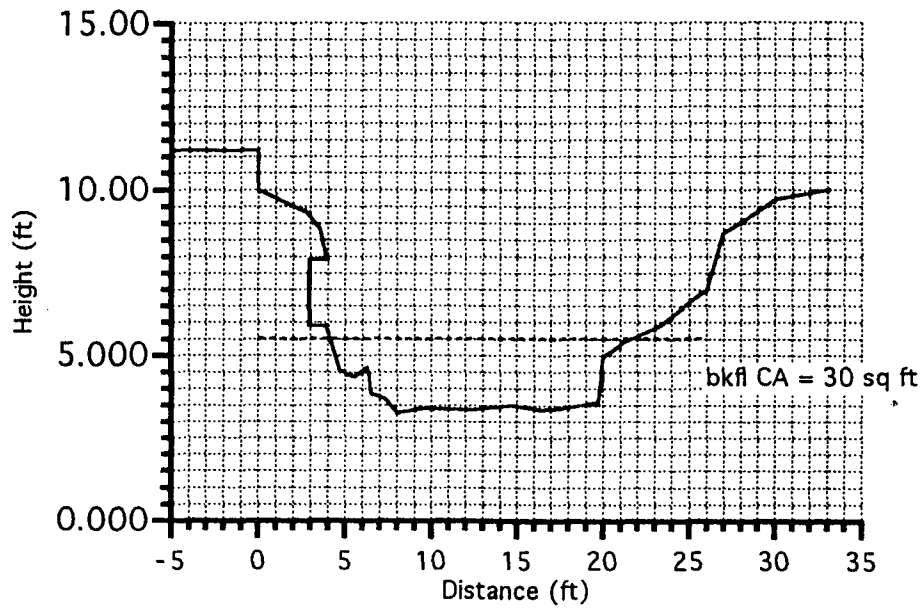
FIGURE 20

Bank retreat measurements average 3.4'. Figure 20 shows a representative cross section that was taken at Station 29-90 that typifies the general look of a G4 Vineyard Creek reach.

Vineyard Creek, Cross Section 29-90

Terrace cross sectional area = 79 sq ft

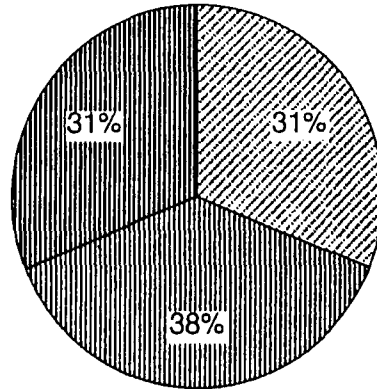
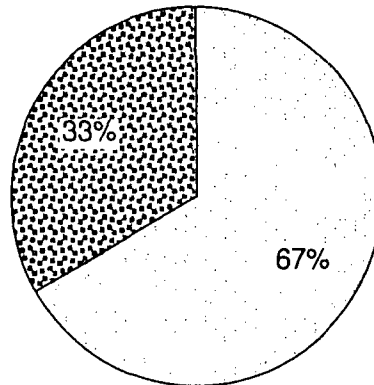
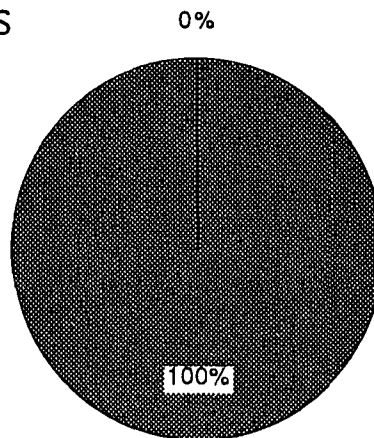
Vineyard Creek Pool and Woody Debris Characteristics for Study Reach between 0+00' AND 50+00'

Vineyard Creek
Total # of pools = 32, average pool spacing = 160', study reach distance = 5110'.

Vineyard Creek
Total # of LWD = 4

Vineyard Creek
Of the total 2 debris jams

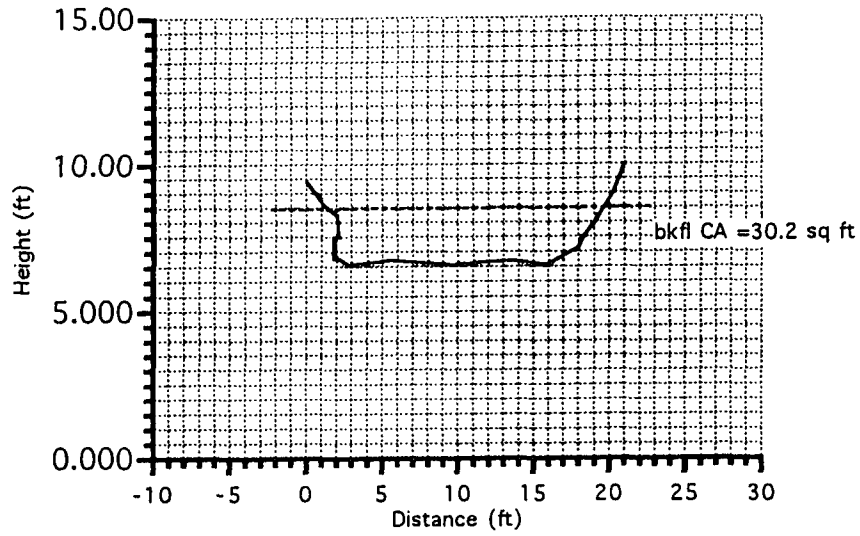
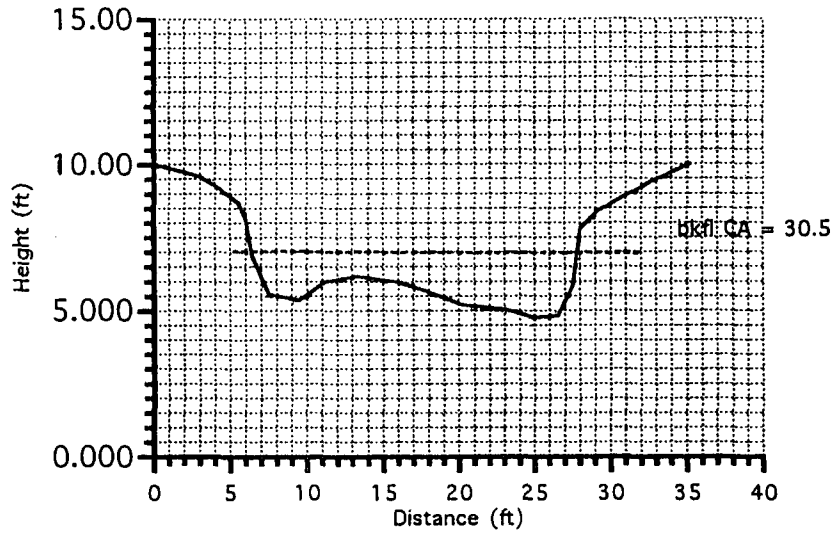
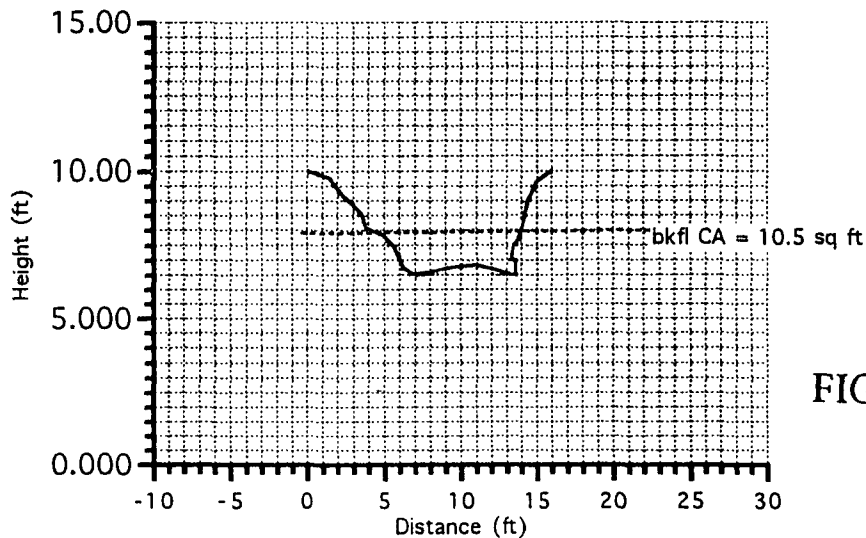
FIGURE 22

Figure 22 shows three representative cross sections for channel conditions of Arroyo Avichi. The bottom graph is a G4 channel and the middle is an F4. As in Vineyard Creek a low geomorphic bank was occasionally measured in the field and noted in the Field notes. It's cross sectional area was not consistent with Leopold's (1994) regional curves for bankfull geometry. The hydraulic flow responsible for this low bank is not known. Leopold predicts that the bankfull cross sectional area should be about 36 sq ft, bankfull width should equal 18.5' and mean depth should equal 1.9'. Our few measurements suggested an average bankfull width of 15.5', ranging up to 20.5'.

Arroyo Avichi, Cross Section at 10+90

Arroyo Avichi, Cross Section at 44-47

Terrace cross sectional area = 97.5

Terrace cross sectional area = 23.7 sq ft

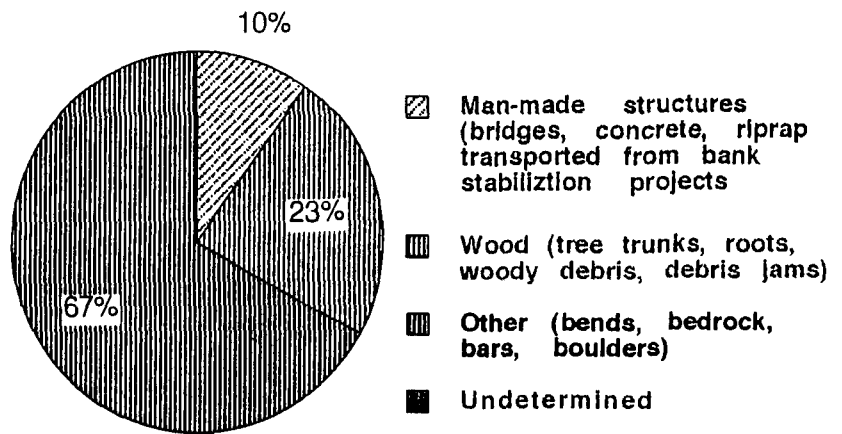
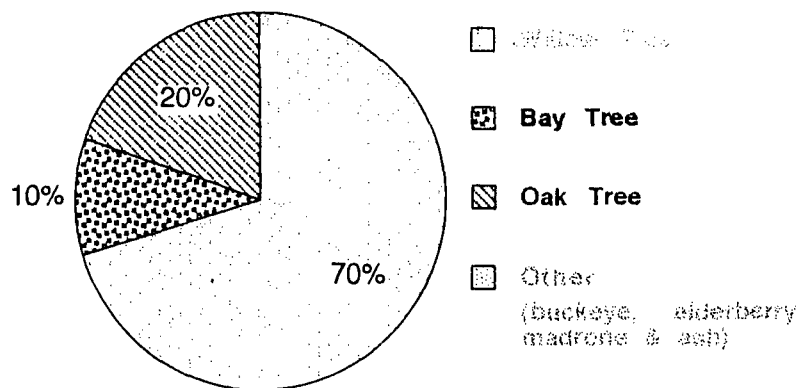
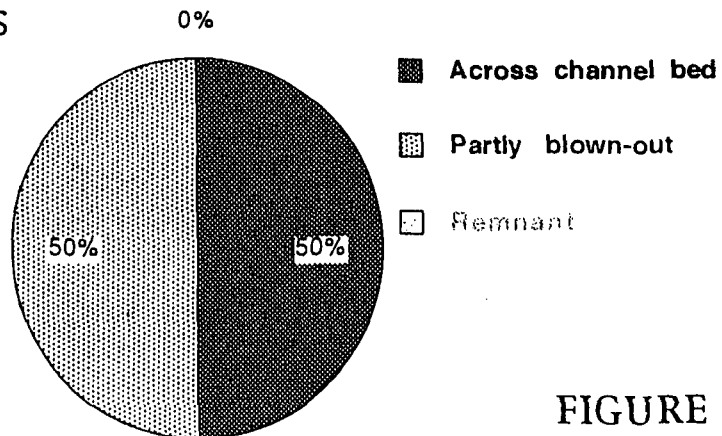
FIGURE 23

Figure 23 shows the pool and woody debris characteristics for Arroyo Avichi. Of the 30 pools greater than 1' deep in the study reach, about 67% of the pools were associated with natural features such as bends, bars and bedrock. This is greater than any of the other channels assessed. On the other hand, the 23% of pools associated with wood was lower than other reaches, as was the 10% associated with man-made structures. Pool spacing is 302', over the total distance measured. The middle pie chart shows that 70% of the LWD in the channel comes from willows, 20% from oak and 10% from bay trees. There were 11 pieces identified. The lower pie chart shows that of the two debris jams, one crossed the channel and the other was partly blown-out.

Arroyo Avichi
Total # of pools = 30, average pool spacing = 302', study reach distance = 9085'.

Arroyo Avichi
Total # of LWD = 11

Arroyo Avichi
Of the total 2 debris jams
