SANTA YNEZ RIVER WATERSHED REPORT

Final Report: May, 2013

Prepared by:
Heidi Block and Aaron Francis
Fisheries Biologists
Pacific States Marine Fisheries Commission, and
California Department of Fish and Wildlife
4665 Lampson Ave, Suite C
Los Alamitos, CA 90720

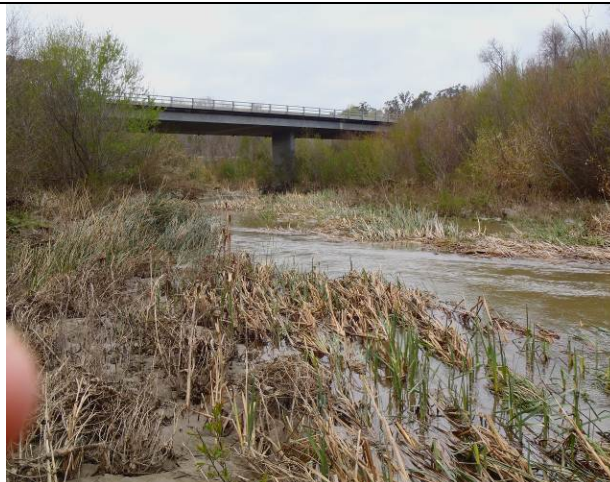
Santa Ynez River, Floridale Bridge Downstream

NAME: Floridale Bridge	
GPS: SYFLORBRG	Stoecker ID: No Stoecker ID
Barrier Type: Natural bottom bridge	Location: 34.67201, -120.49293
Description: This natural bottom bridge measured a width of 43ft and was supported by four concrete pillars.

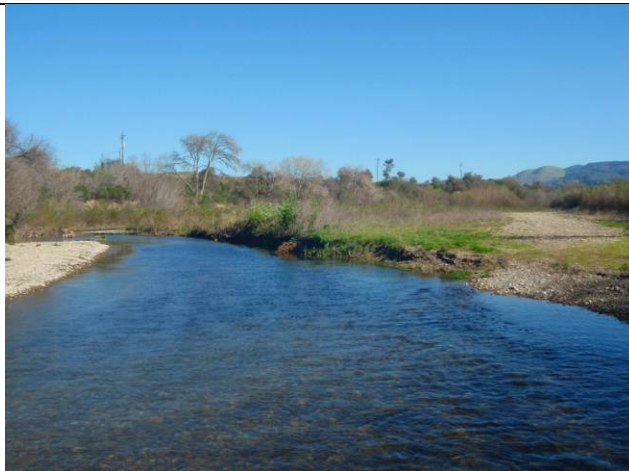
Santa Ynez River, Arizona Crossing 1 Upstream

NAME: SY06 Arizona Crossing 01	
GPS: SY06AZ01	Stoecker ID: No Stoecker Id
Barrier Type: Natural bottom Arizona crossing	Location: 34.61888, -120.37898
Description: Natural bottom Arizona crossing.

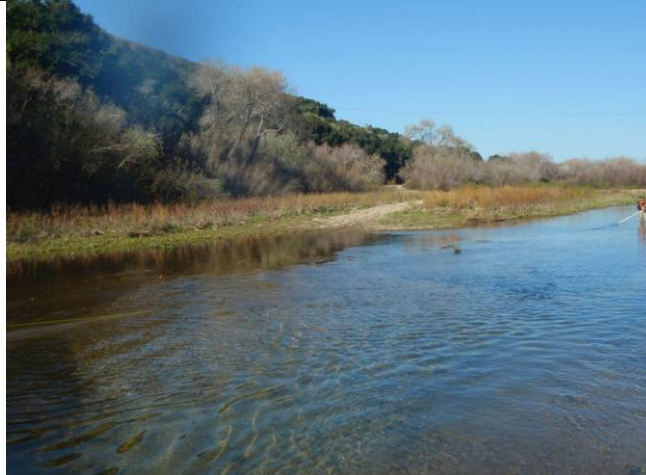
Santa Ynez River, Arizon Crossing 3 Downstream

NAME: SY06 Arizona Crossing 03	
GPS: SY06AZ03	Stoecker ID: No Stoecker ID
Barrier Type: Natural bottom Arizona crossing	Location: 34.61408, -120.37215
Description: This natural bottom Arizona crossing measured a length of 86 ft and crossed from RB to LB.

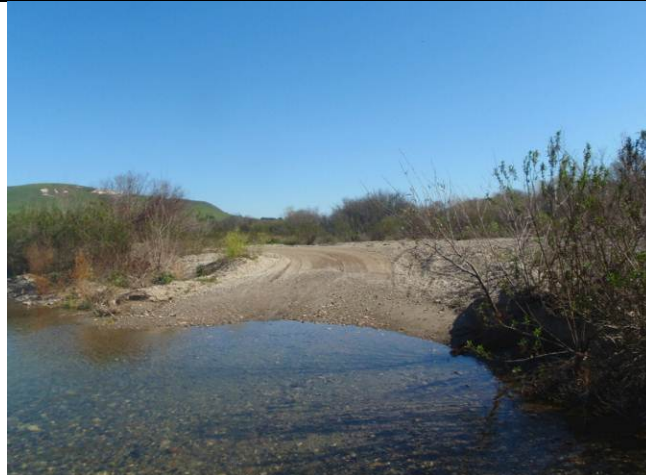
Santa Ynez River, Arizona Crossing 4, Upstream

NAME: SY06 Arizona Crossing 04	
GPS: SY06AZ04	Stoecker ID: No Stoecker ID
Barrier Type: Natural bottom Arizona crossing	Location: 34.6145, -120.36873
Description: This natural bottom Arizona crossing measured 32 ft long by 56ft wide.

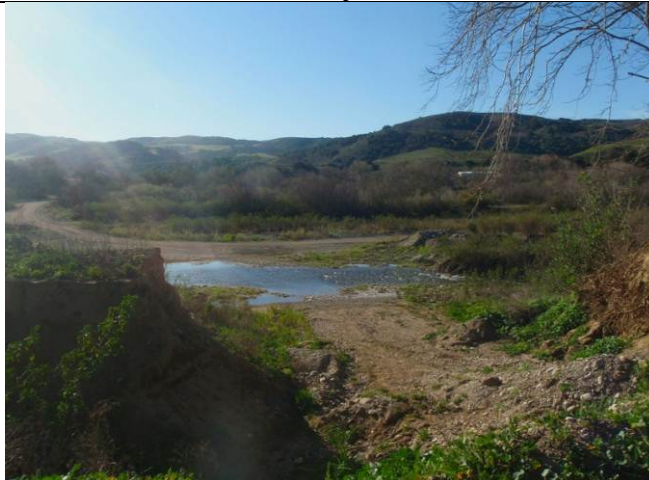
Santa Ynez River, Arizona Crossing 5, View from RB

NAME: SY06 Arizona Crossing 05	
GPS: SY06AZ05	Stoecker ID: No Stoecker ID
Barrier Type: Natural bottom Arizona crossing	Location: 34.6154, -120.36671
Description: This natural bottom Arizona crossing crossed the main stem of the channel and connected to SY06AZ05B, which crossed the adjacent side channel.

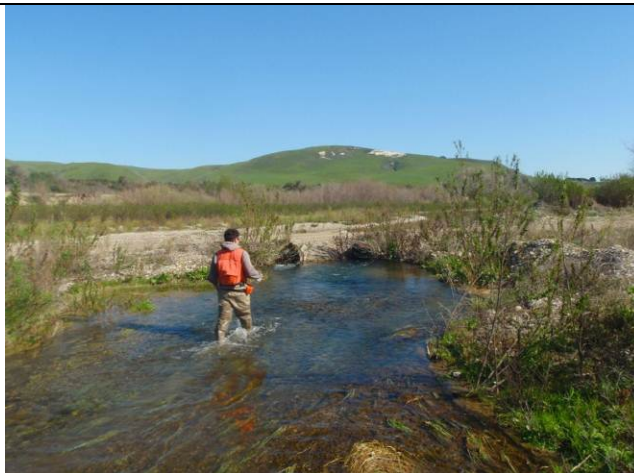
Santa Ynez River, Arizona Crossing 5B Upstream

NAME: SY06 Arizona Crossing 05B	
GPS: SY06AZ05B	Stoecker ID: No Stoecker ID
Barrier Type: Arizona crossing	Location: 34.61505, -120.36631
Description: This corrugated metal culvert Arizona crossing consisted of two metal culvert pipes.

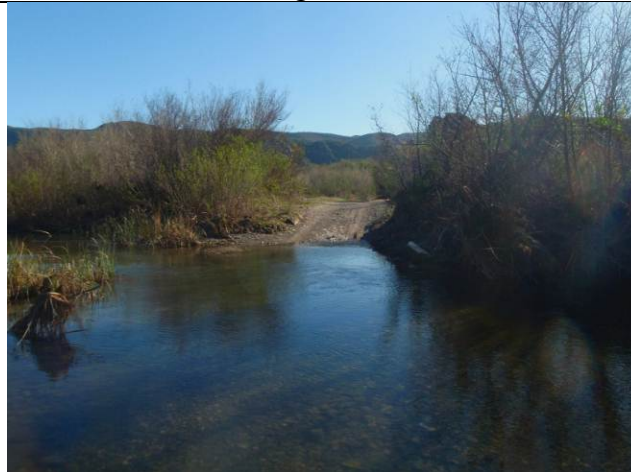
Santa Ynez River, Arizona Crossing structure 6 View of LB

NAME: SY06 Arizona Crossing 06	
GPS: SY06AZ06	Stoecker ID: No Stoecker ID
Barrier Type: Natural bottom Arizona crossing	Location: 34.61449, -120.33165
Description: Natural bottom Arizona crossing.

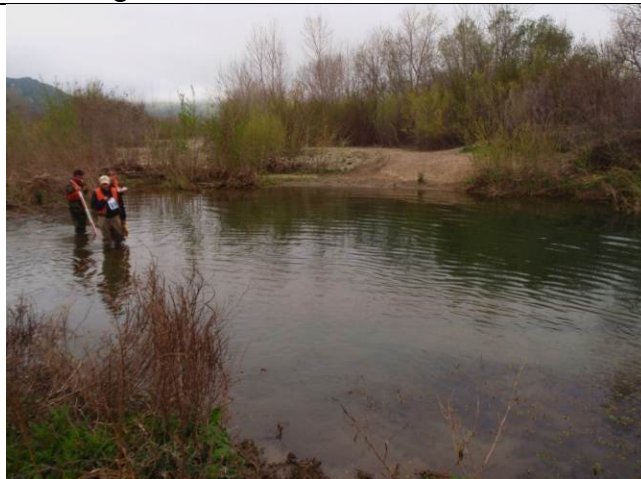
Santa Ynez River, Flag Arizona Crossing, View of RB

NAME: SYFLG Arizona Crossing	
GPS: SYFLGAZ01	Stoecker ID: No Stoecker ID
Barrier Type: Natural bottom Arizona crossing	Location: 34.60641, -120.19858
Description: This natural bottom Arizona crossing had been modified by the addition of gravel and boulders. The Arizona crossing crossed from LB to RB.

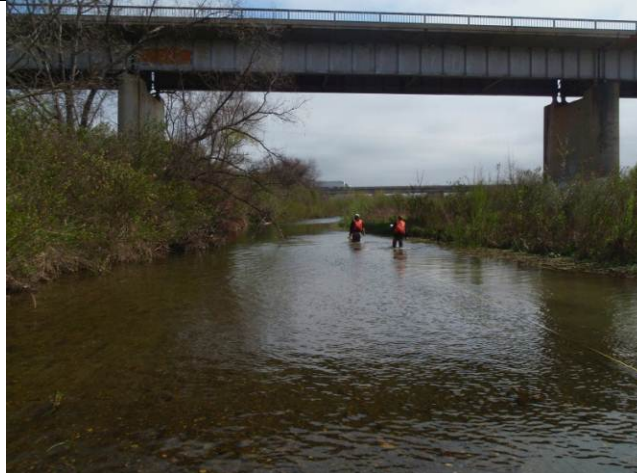
Santa Ynez River, Avenue of the Flags Upstream

NAME: Avenue of Flags Bridge	
GPS: SYFLAG BRG	Stoecker ID: No Stoecker ID
Barrier Type: Natural bottom bridge	Location: 34.60672, -120.19407
Description: This natural bottom bridge measured 43 ft wide. It had two concrete support pillars with 100 ft between the concrete pillars.

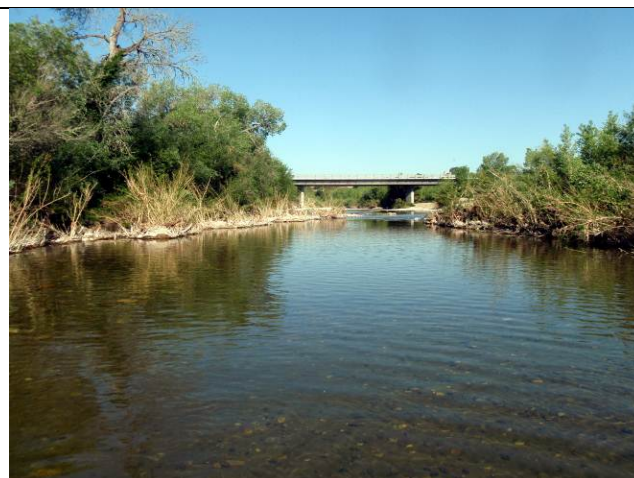
Santa Ynez River, Refugio Bridge Downstream

NAME: Refugio Road Bridge	
GPS: SYRFGBRG	Stoecker ID: No Stoecker ID
Barrier Type: Natural bottom bridge	Location: 34.58506, -120.10046
Description: This natural bottom bridge had two concrete support pillars in wetted channel.

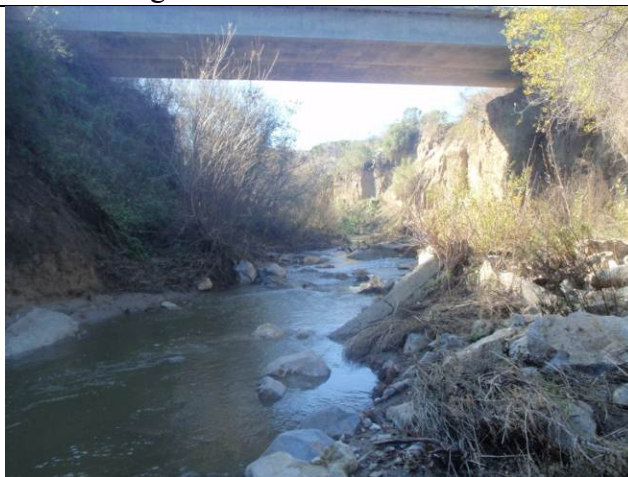
Salsipuedes Creek, Santa Rosa Bridge, Upstream

NAME: Santa Rosa Bridge 01	
GPS: SPCASR01	Stoecker ID: No Stoecker ID
Barrier Type: Natural bottom bridge	Location: 34.62191, -120.42200
Description: Natural bottom bridge.

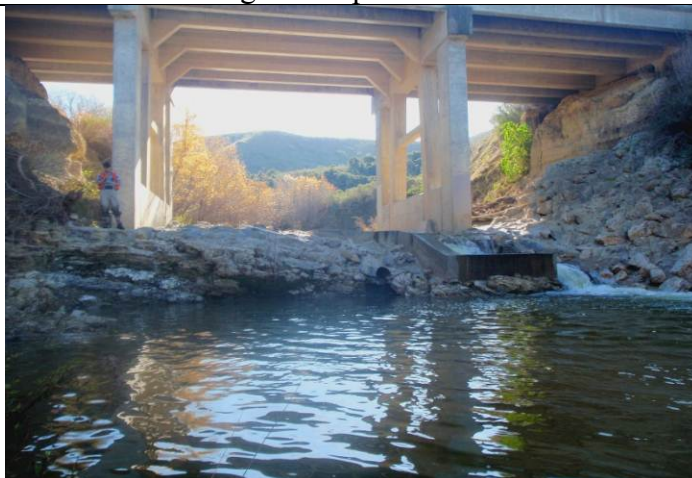
Salsipuedes Creek, Highway 1 Bridge, Upstream

NAME: HWY 1 Bridge	
GPS: SYHWY1SALSI	Stoecker ID: SY_SS_2
Barrier Type: Bridge	Location: 34.59670, -120.41313
Description: This natural bottom bridge was upstream from a concrete fish ladder.

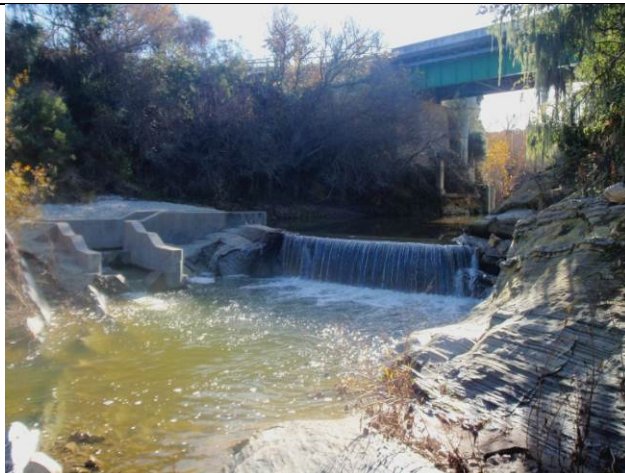
Salsipuedes Creek, Jalama Road Bridge and Fish Ladder, Upstream

NAME: Jalama Rd Bridge	
GPS: SYJALSALI1	Stoecker ID: SY_SS_3
Barrier Type: Bridge	Location: 34.58960, -120.40905
Description: Bridge and fish ladder

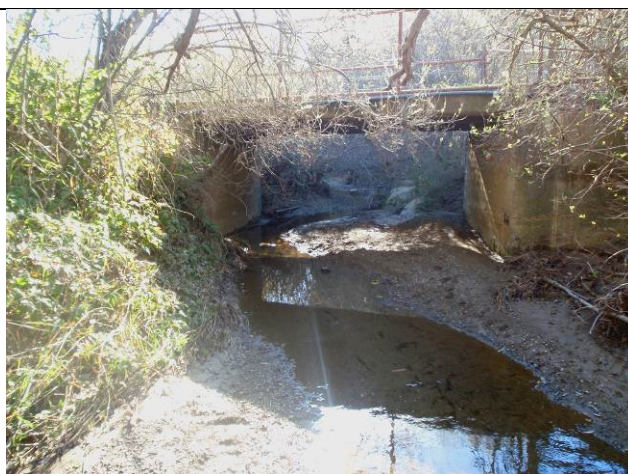
Salsipuedes Creek, SPCB Bridge 1Upstream

NAME: SPCB Bridge 01	
GPS: SPCBBRDG1	Stoecker ID: No Stoecker ID
Barrier Type: Natural bottom bridge	Location: 34.55325, -120.40390
Description: This natural bottom bridge had concrete supports on both banks.

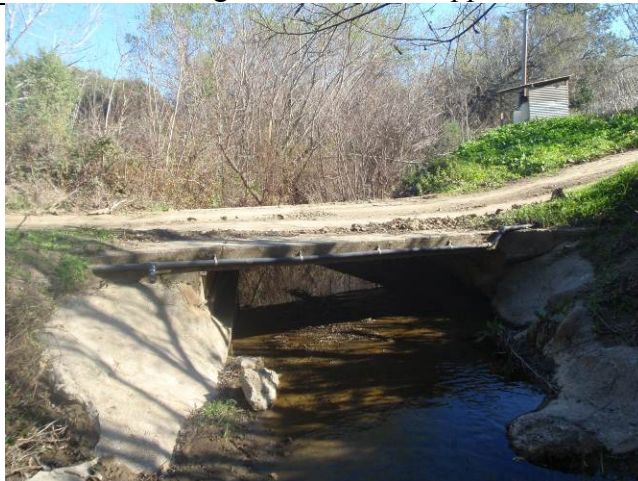
Salsipuedes Creek, SPCB Bridge 2, Upstream

NAME: SPCB Bridge 02	
GPS: SPCBBRDG2	Stoecker ID: No Stoecker ID
Barrier Type: Natural bottom bridge	Location: 34.55187, -120.40292
Description: This natural bottom bridge had concrete supports on both banks.

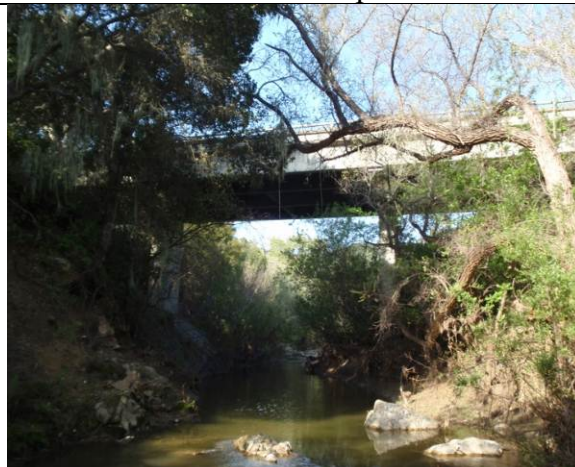
El Jaro Creek, El Jaro Bridge 1, Upstream

NAME: HWY 1 Bridge	
GPS: ELJHGH01	Stoecker ID: No Stoecker ID
Barrier Type: Natural bottom bridge	Location: 34.58347, -120.38512
Description: This natural bottom bridge had two concrete support pillars and small cobble riprap both banks. The riprap extended from the channel up to the base of the concrete pillars.

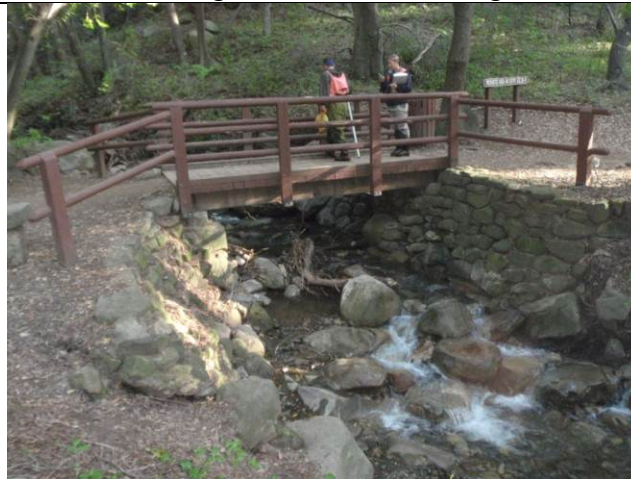
Nojoqui Creek, Nojoqui B 2 Bridge, Upstream

NAME: SYNJB Bridge 02	
GPS: SYNJBBDG02	Stoecker ID: No Stoecker ID
Barrier Type: Natural bottom bridge	Location: 34.52955, -120.17388
Description: This natural bottom bridge measured 14 ft long and 6 ft wide.

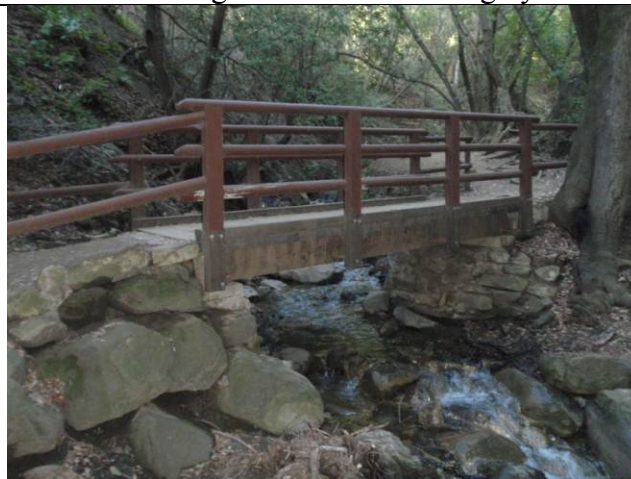
Nojoqui Creek, Nojoqui B 3 Bridge, Upstream

NAME: SYNJB Bridge 03	
GPS: SYNJBBDG03	Stoecker ID: No Stoecker ID
Barrier Type: Natural bottom bridge	Location: 34.52937, -120.17368
Description: This natural bottom bridge measured 15ft long by 6 ft wide.

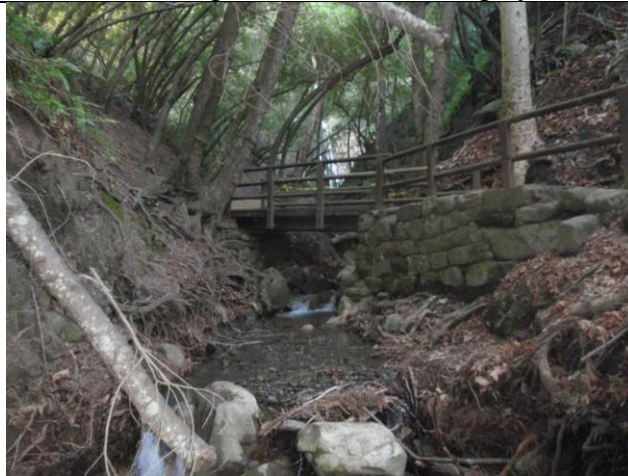
Nojoqui Creek, Nojoqui B 4 Bridge, Upstream

NAME: SYNJB Bridge 04	
GPS: SYNJBBDG04	Stoecker ID: No Stoecker ID
Barrier Type: Natural bottom bridge	Location: 34.52909, -120.17270
Description: This natural bottom bridge measured 15ft long by 6ft wide.

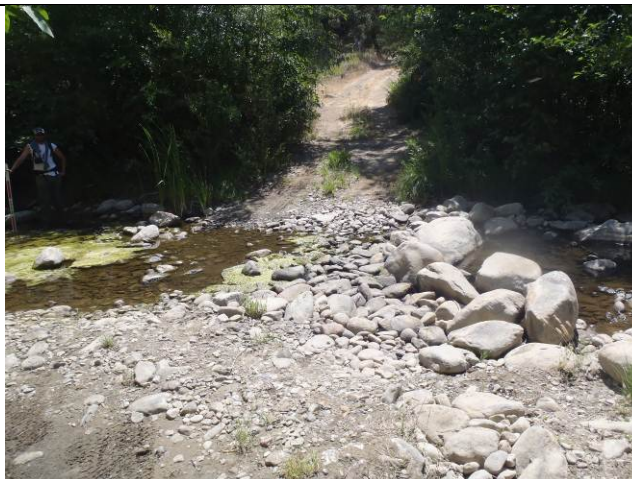
Santa Cruz road crossing from right bank

Name: Santa Cruz Road Crossing	
GPS: SCRDI	Stoecker ID: No ID
Barrier Type: Natural Bottom Arizona Crossing	Location: 34.63265, -119.76098
Description: This is a natural bottom Arizona crossing that does not affect fish movement. This road provides access to the Santa Cruz Ranger station, and is not open to public motorized traffic.

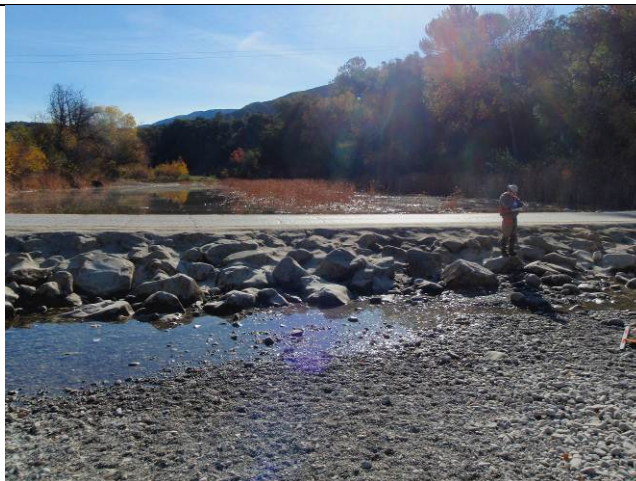
Upper Santa Ynez, Arizona Crossing 1, Upstream

Name: SYA Arizona Crossing 01	
GPS: SYAAZ01	Stoecker ID: SY_7
Barrier Type: Concrete Arizona Crossing	Location: 34.54534, -119.79133
Descriptions: The Arizona crossing at Ranger Station into the campground measured 151 ft across the channel and its bank dammed the stream. The road is 13 ft wide and the downstream crest riprap is approximately 16.5 ft wide with a mild slope.

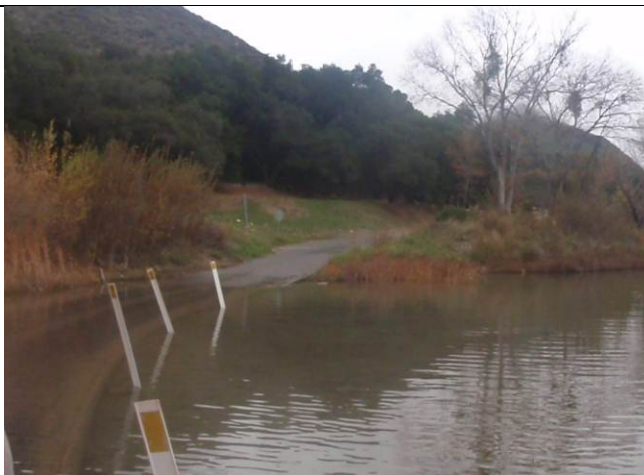
Santa Ynez River, Arizona Crossing 2, Upstream

Name: SYA Arizona Crossing 02	
GPS: SYAAZ02	Stoecker ID: SY_8
Barrier Type: Concrete Arizona Crossing	Location: 34.54611, -119.77715
Descriptions: This concrete Arizona crossing measured 162ft across the channel and is 14ft wide.

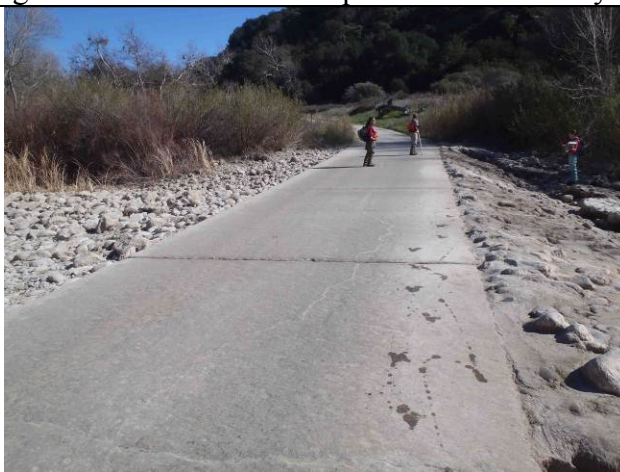
Santa Ynez Arizona crossing 3, picture taken from right bank

Name: SYA Arizona Crossing 03	
GPS: SYAAZ03	Stoecker ID: SY_9
Barrier Type: Concrete Arizona Crossing	Location: 34.53836, -119.74778
Description: This Arizona crossing measured 166ft across the channel and the road was 14 ft wide. There appears to have been a new concrete apron with boulders added to this crossing since the survey for the Stoecker report in Nov. 2003 which showed undercutting on the road and a 6 foot drop. The downstream edge of the road has a steep slope down to the natural stream level. The road has a height of 3.8ft from where a pool would naturally form.

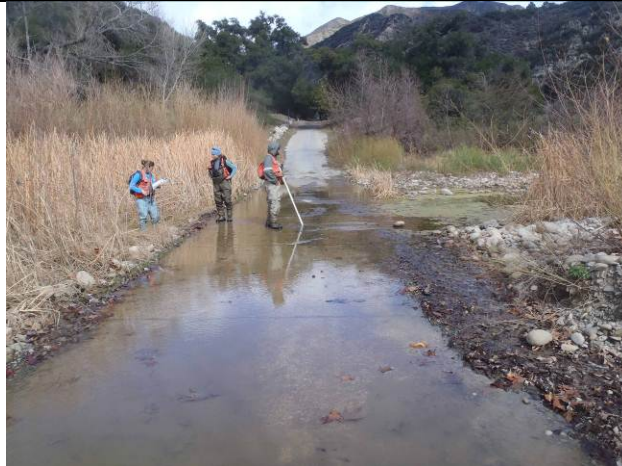
Santa Ynez Arizona crossing 4, picture taken from left bank

Name: SYA Arizona Crossing 04	
GPS: SYAAZ04	Stoecker ID: SY_10
Barrier Type: Concrete Arizona crossing	Location: 34.53493, -119.72448
Description: This concrete Arizona crossing measured 170ft across the channel and influenced the active stream for 90ft. The width of the road was 15ft. The downstream plunge from the road was 1ft, upstream the road was level with the streambed.

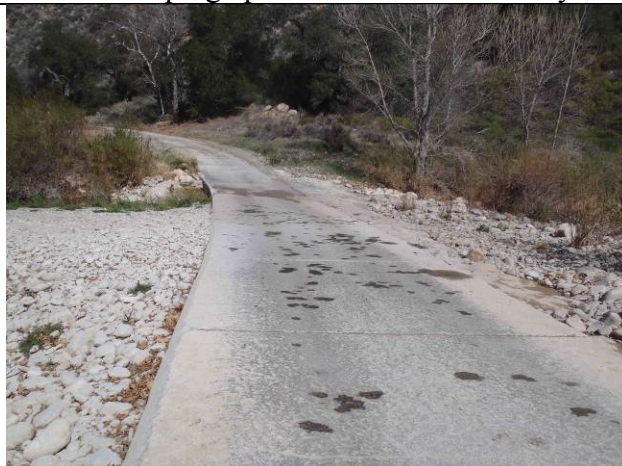
Santa Ynez Arizona crossing 5, picture taken from right bank

Name: SYA Arizona Crossing 05	
GPS: SYAAZ05	Stoecker ID: SY_11
Barrier Type: Concrete Arizona crossing	Location: 34.53692, -119.72337
Description: This road crossing measured 108ft across the channel and the road had a width of 14ft. The downstream side had a sloping apron with a section of dry cobble.

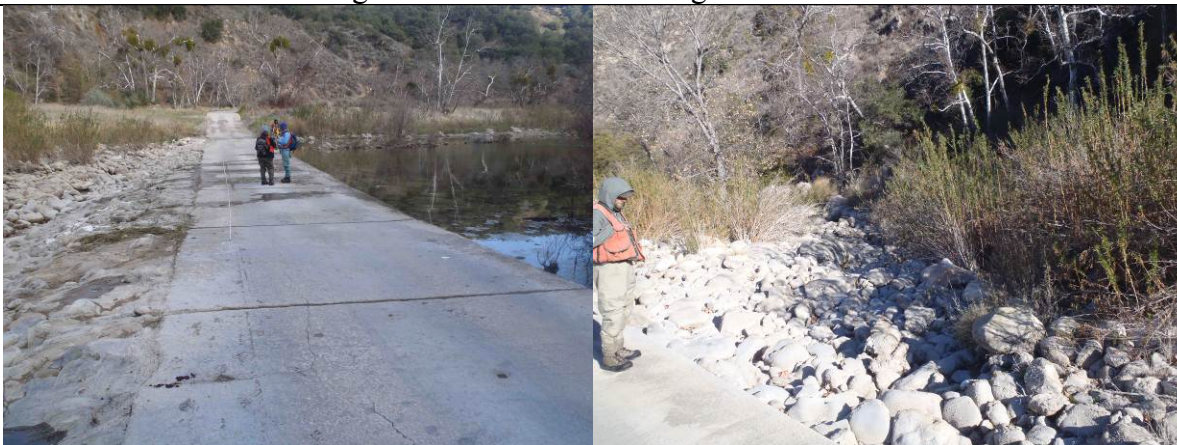
Santa Ynez Arizona crossing 6, left channel crossing Downstream, right channel crossing

Name: SYA Arizona Crossing 06	
GPS: SYAAZ06	Stoecker ID: SY_12
Barrier Type: Concrete Arizona crossing	Location: 34.53983, -119.71662
Description: The road crosses two separate channels at this point with the left bank channel having the majority of the flow and then the flow crosses over to the right bank. The road crossing of the right bank channel had no flow at the time of the survey. The road crossing measured 133ft across the left channel. The road width was 14ft and there was a sloping apron downstream with the road height from downstream being 3.7ft.

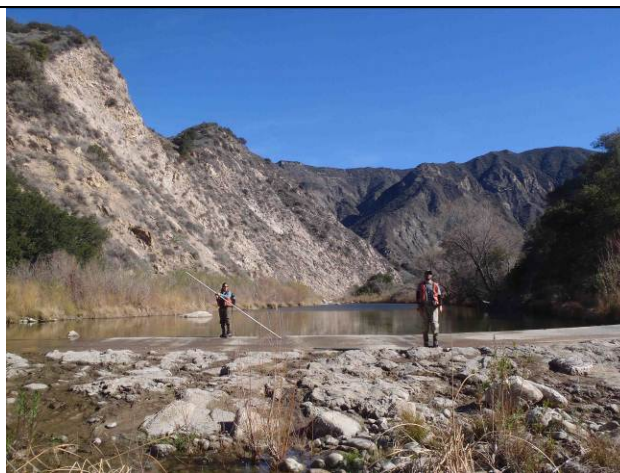
Santa Ynez Arizona crossing 7, upstream

Name: SYA Arizona Crossing 07	
GPS: SYAAZ07	Stoecker ID: SY_13
Barrier Type: Concrete Arizona crossing	Location: 34.53466, -119.71298
Description: This road crossing measured 90ft across the channel and influenced the active channel for 35ft. The downstream side had a gradually sloping apron with a maximum drop from the road of 0.8ft.

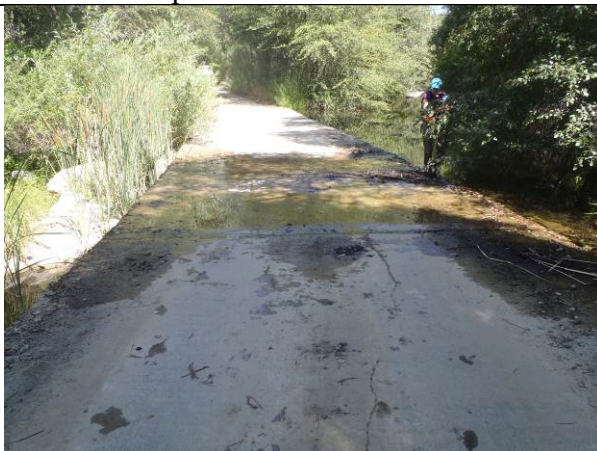
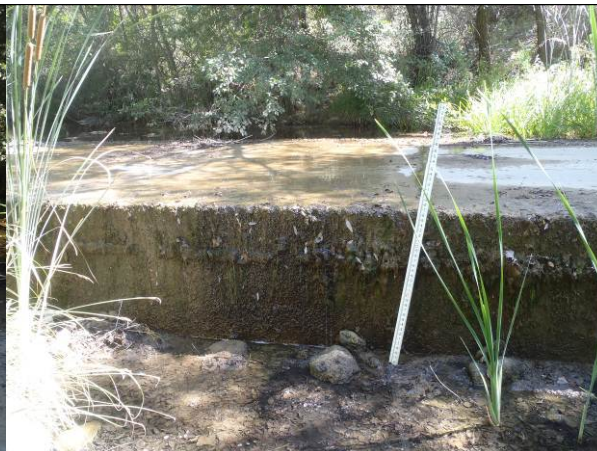
Romero Camuesa Rd Crossing, looking across

Name: SYA Arizona Crossing 08	
GPS: SYAAZ08	Stoecker ID: SY 15
Barrier Type: Concrete Arizona crossing	Location: 34.48647, -119.54159
Description: This is the Romero Camuesa Rd Crossing. The road crossing measured 115 feet across the channel, with 25ft influencing the active channel. A portion of the concrete and boulder apron has separated from the road crossing. The downstream plunge from the road is 3ft with a water depth of 0.1ft.

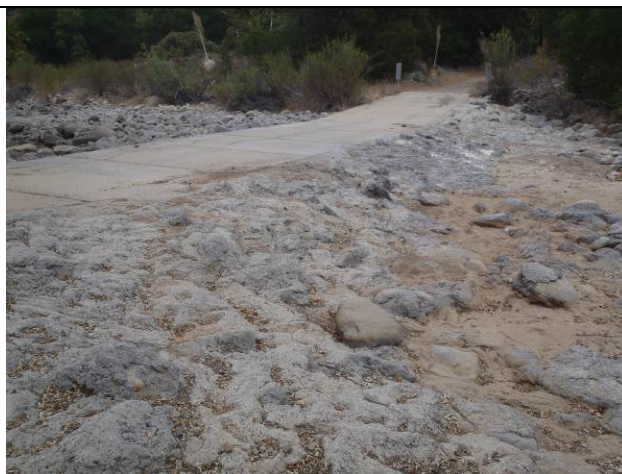
Santa Ynez Arizona crossing 9, upstream

Name: SYA Arizona Crossing 09	
GPS: SYAAZ09	Stoecker ID: SY 16
Barrier Type: Concrete Arizona crossing	Location: 34.48933, -119.51681
Description: This road crossing measured 102ft across the channel; and the stream and crossing were dry at the time of the survey. The downstream side had a rock and concrete sloping apron that extended approximately 26ft downstream. This is the first road crossing downstream of Juncal Dam.

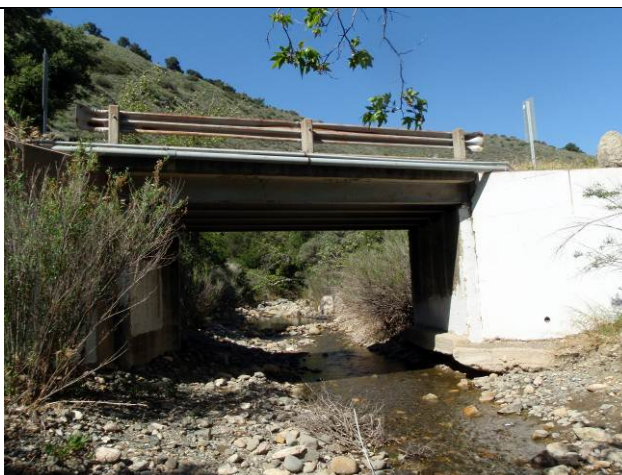
Oso Creek, Oso Bridge 1, Upstream

NAME: Oso Creek Bridge 01	
GPS: SYOSOBDRG01	Stoecker ID: No Stoecker Id
Barrier Type: Natural bottom bridge	Location: 34.54562, -119.77498
Descriptions: This natural bottom bridge measured 22ft long by 15ft wide with concrete supports on both banks.

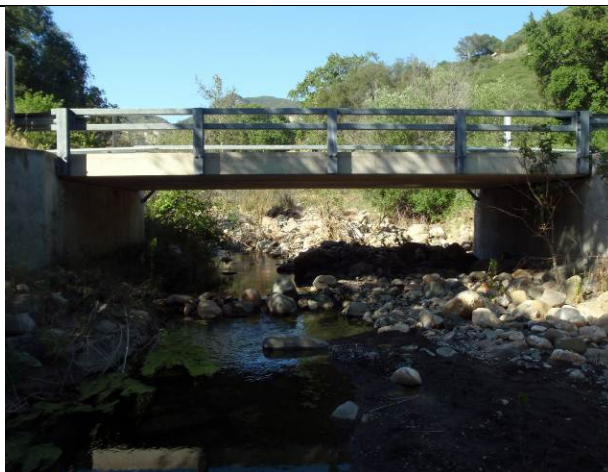
Oso Creek, Oso Bridge 2, Upstream

NAME: Oso Creek Bridge 02	
GPS: SYOSOBDRG02	Stoecker ID: No Stoecker Id
Barrier Type: Natural bottom bridge	Location: 34.54508, -119.77059
Descriptions: This natural bottom bridge measured 35ft long by 16ft with concrete supports on both banks.

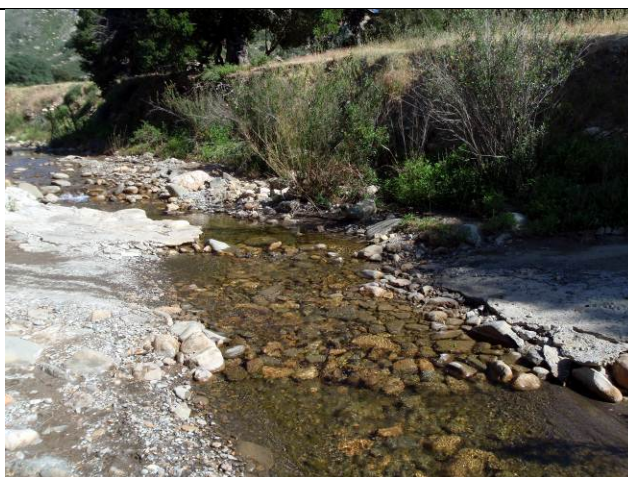
Oso Creek, Oso Arizona Crossing 01, Upstream

NAME: Oso Creek Arizona Crossing 01	
GPS: SYOSOAZ01	Stoecker ID: SY_OO_1
Barrier Type: Arizona Crossing	Location: 34.55488, -119.77009
Descriptions: This natural bottom Arizona crossing measured 21ft long by 15ft wide that consisted of mostly large and small cobble and a few small boulders.

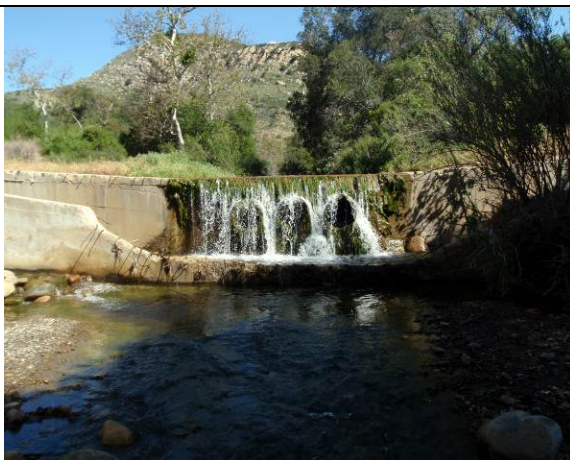
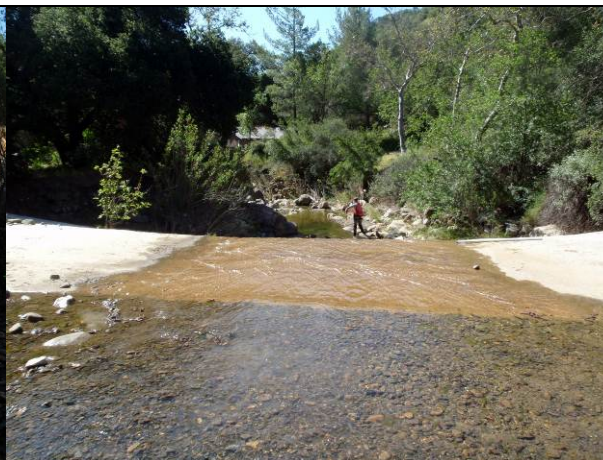
Oso Creek, Oso Bridge 3, Upstream

NAME: Oso Creek Bridge 03	
GPS: SYOSBRDG03	Stoecker ID: No Stoecker ID
Barrier Type: Pipe Culvert	Location: 34.55552, -119.77121
Descriptions: 6.5ft plunge from road above to top of water. A concrete wall with 2ft plunge was 8ft downstream from a concrete bottom bridge with 6.5ft plunge. The concrete bridge measured 60 ft long and 16ft wide. The stream no longer flowed through the three metal pipes due to sediment buildup but, instead, flowed over the road.

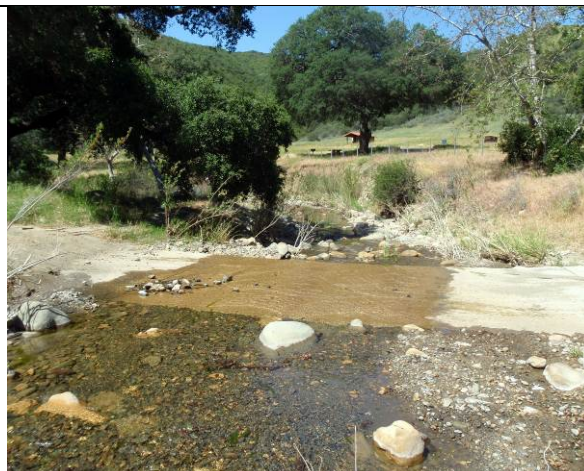
Oso Creek, Oso Arizona Crossing 2, Downstream

NAME: Oso Creek Arizona Crossing 02	
GPS: SYOSOAZ02	Stoecker ID: SY_OO_2
Barrier Type: Concrete Arizona crossing	Location: 34.55745, -119.77168
Descriptions: This concrete bottom Arizona crossing measured 32 ft long and 14 ft wide and was slightly elevated above streambed.

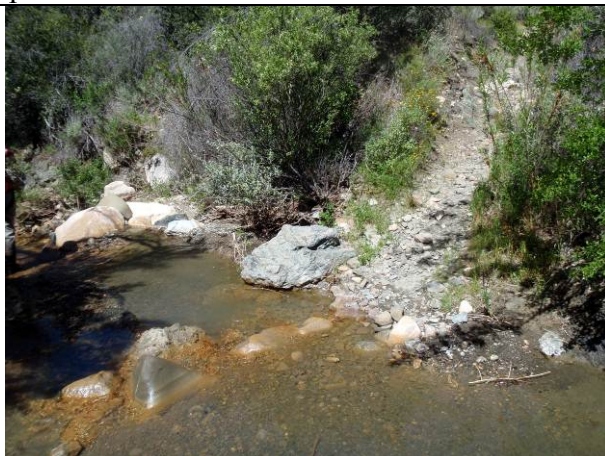
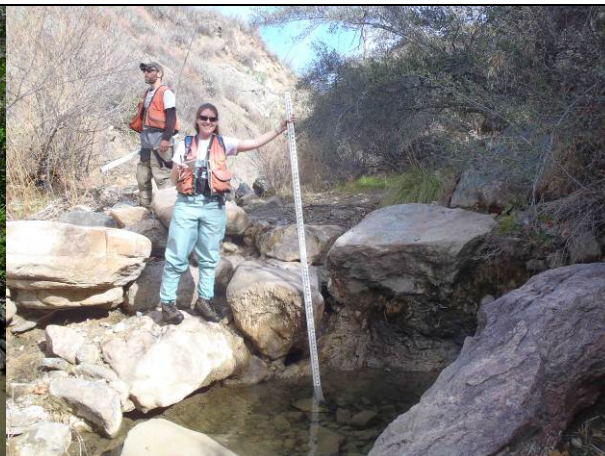
Oso Creek, Oso Trail, Downstream

NAME: Oso Creek Santa Cruz Trail Crossing	
GPS: SYOSOTRAIL	Stoecker ID: No Stoecker ID
Barrier Type: Santa Cruz Trail crossing	Location: 34.57329, -119.75560
Descriptions: This natural bottom trail crossing is part of the Santa Cruz Trail, which follows the stream mostly along the right bank until it crosses the river and veers off and follows a tributary that merges with Oso Creek just downstream from the trail crossing. Just downstream of the trail crossing large boulders create a partial barrier under low flows, plunge height of 4.0ft and a pool depth of 1.3ft.

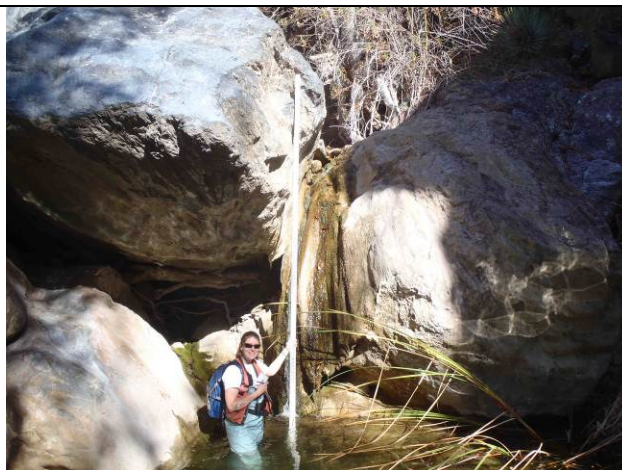
Oso Creek, looking upstream

NAME: Oso Creek partial barrier waterfall	
GPS: SYOSO226	Stoecker ID: No Stoecker ID
Barrier Type: Waterfall	Location: 34.57232, -119.75617
Descriptions: This waterfall has a 10 ft plunge with a jump pool depth of 2.5 ft. This waterfall is a partial barrier under low and moderate flow conditions.

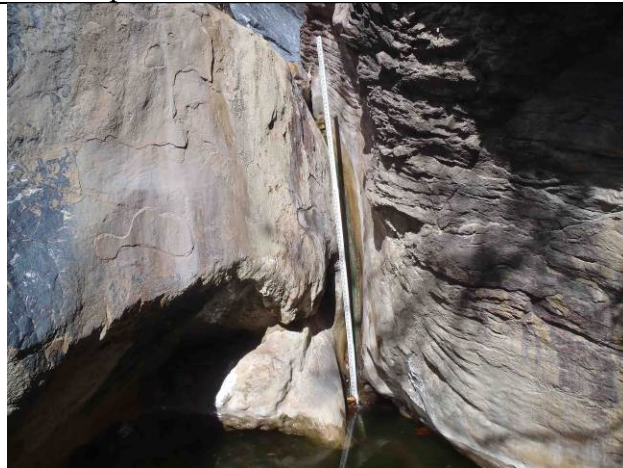
NAME: Oso Creek partial barrier waterfall	
GPS: SYOSO227	Stoecker ID: No Stoecker ID
Barrier Type: Waterfall	Location: 34.57244, -119.75618
Descriptions: This is a 7.6 ft tall waterfall with 2.9 ft deep jump pool. This waterfall presents a partial barrier under low and moderate flow conditions. Fish passage may be possible under higher flows as the downstream pool fills.

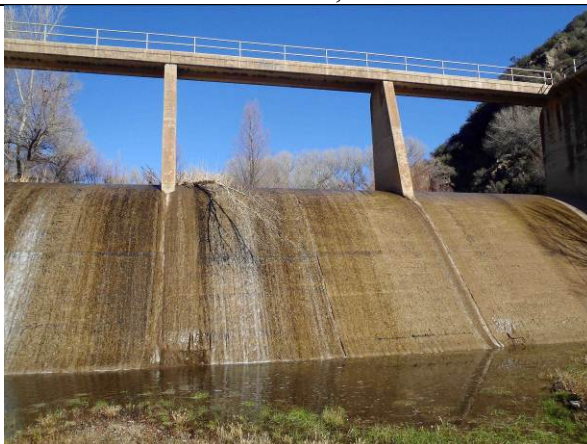
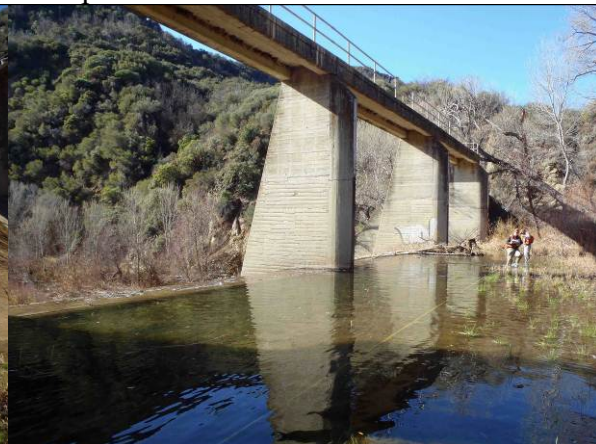
Mono debris dam, upstream

Name: Mono Debris Dam	
GPS: MONODAM	Stoecker ID: SY_MO 1
Barrier Type: Debris Dam	Location: 34.53027, -119.63062
Description: Debris dam constructed in 1935 to limit downstream sediment flow to Gibraltar reservoir. The dam is approximately 20 feet high, 4 feet wide and spans 100 feet across the creek. The dam is filled in with silt, sand and cobble on the upstream side.

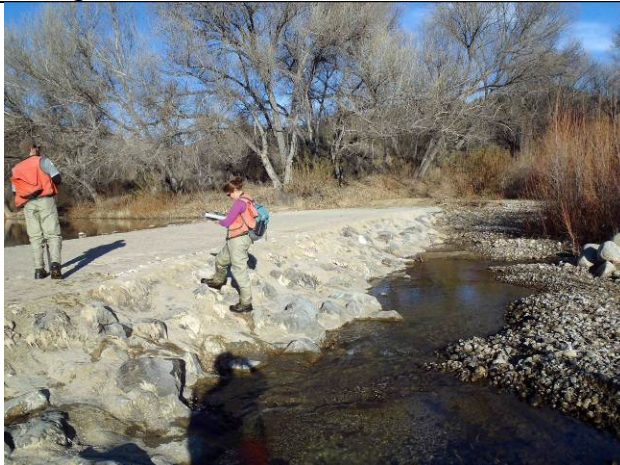
Camuesa rd. crossing, view from RB looking upstream

Name: Camuesa road crossing	
GPS: MONOCAMRD	Stoecker ID: SY MO 2
Barrier Type: Arizona Crossing	Location: 34.53658, -119.63227
Description: Low-flow road crossing, steep gradient on downstream side, height= . This provides a barrier to fish passage during low flows.

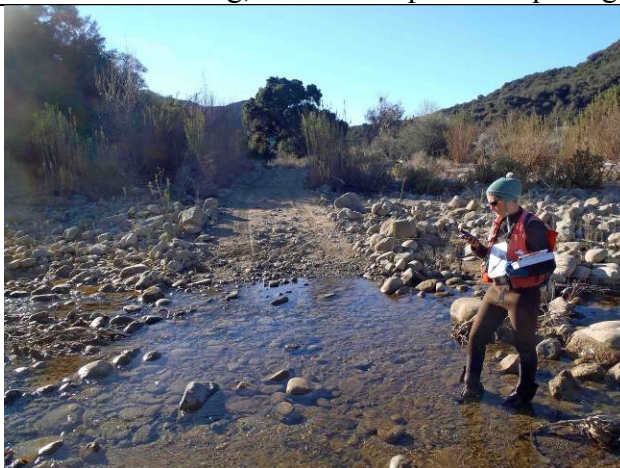
Ogilvy Ranch Road, view from RB

Name: Ogilvy Ranch Rd., 6N30A	
GPS: MONORANCHRD1	Stoecker ID: No ID
Barrier Type: Natural bottom arizona crossing	Location: 34.56892, -119.61544
Description: Natural bottom road crossing, does not impede fish passage.

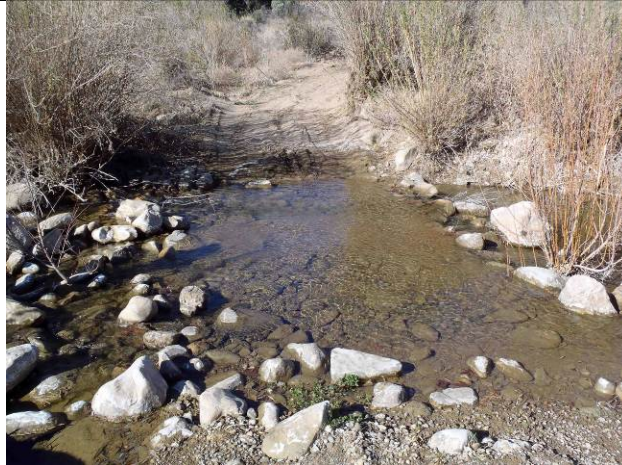
Ogilvy Ranch Rd. arizona crossing, view from RB

Name: Ogilvy Ranch Rd., 6N30A	
GPS: MONORANCHRD2	Stoecker ID: No ID
Barrier Type: Natural bottom arizona crossing	Location: 34.58444. -119.61149
Description: Natural bottom road crossing; does not impede fish passage.

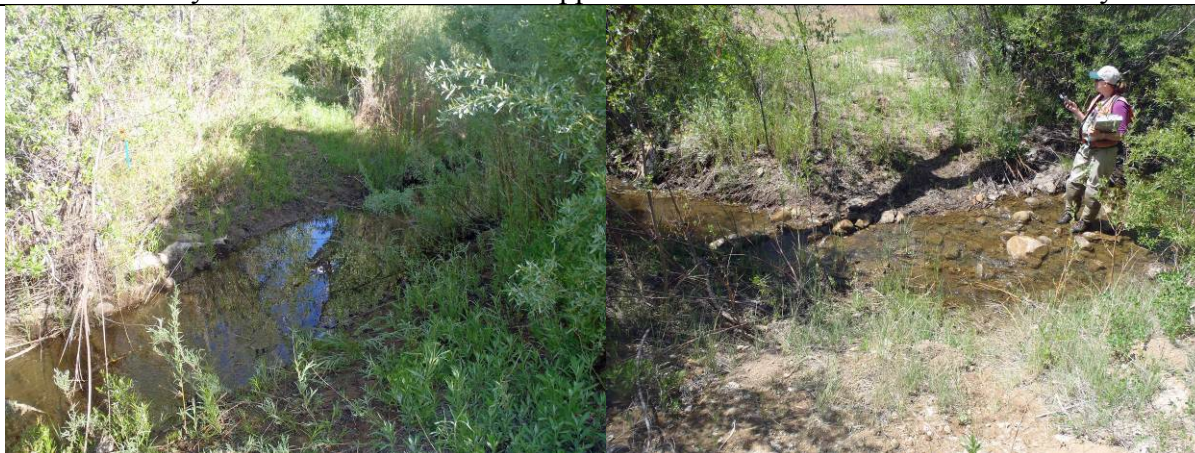
Don Victor Valley Fire Trail crossings

Name: Mono Reference Reach Road Crossings	
GPS: MONOR2RD1-6	Stoecker ID: No ID
Barrier Type: Natural bottom road crossings	Location: 34.65806, -119.50586 to 34.66548, -119.51063
Description: There are 6 natural bottom road crossings in the upper reference reach on Mono Creek. These road crossings are from the Don Victor Fire Trail and pose no barrier to fish movement. They have natural bottoms and appear not to have been traveled in several years.

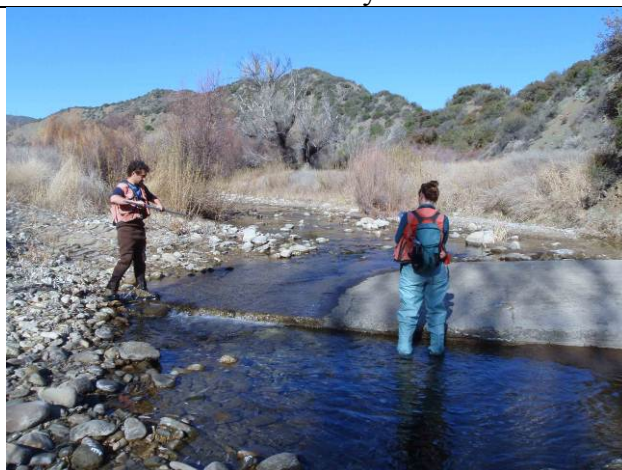
Camuesa rd. crossing 1, upstream

Name: Indian Creek Camuesa Rd. crossing 1	
GPS: INDCAMRD1	Stoecker ID: SY_MO_IN_1
Barrier Type: Arizona crossing	Location: 34.53651, -119.63346
Description: This is a low flow concrete road crossing. The road impacts the creek for 51ft, with a 12ft wetted channel crossing the road, the road was 14ft wide. There was a slight drop on the downstream edge of 1ft. This would be a low flow barrier, with the shallow water depth crossing the road surface causing a barrier to migration. Under moderate to high flow salmonids should be able to cross the road surface without much difficulty.

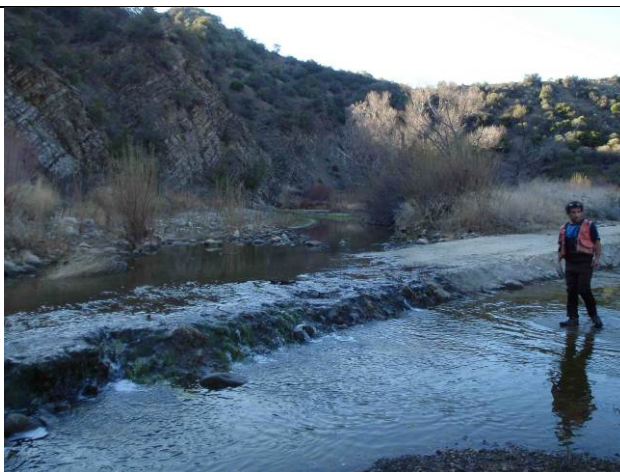
Camuesa rd. crossing 2, upstream

Name: Indian Creek Camuesa Rd. crossing 2	
GPS: INDCAMRD2	Stoecker ID: SY MO IN 2
Barrier Type: Arizona crossing	Location: 34.53993, -119.63620
Description: This is a low flow concrete road crossing. The total concrete crossing measured 73ft from bank to bank, and spanned the active channel for 40 ft, the width of the crossing measured 16ft. The downstream side of the crossing was 0.3ft above the downstream pool surface. The downstream pool had a maximum depth of 1.7ft. Fish passage would be prevented only under low flow conditions.

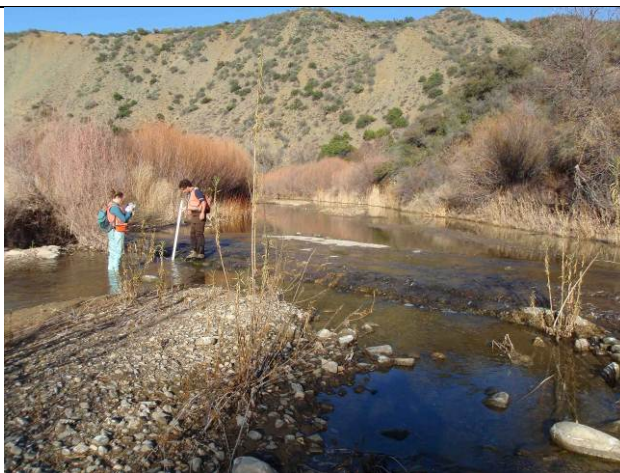
Camuesa rd. crossing 3, upstream

Name: Indian Creek Camuesa Rd. crossing 3	
GPS: INDCAMRD3	Stoecker ID: SY MO IN 3
Barrier Type: Arizona crossing	Location: 34.54039, -119.63645
Description: This is a low flow concrete road crossing. The total concrete crossing is 69ft from bank to bank, the crossing influenced the active channel for a distance of 48ft, and the width of the crossing measured 14ft. The downstream edge of the crossing had a height of 0.5ft from the surface of the downstream pool, which had a depth of 0.7ft. This would only be a barrier to fish passage under low flow conditions.

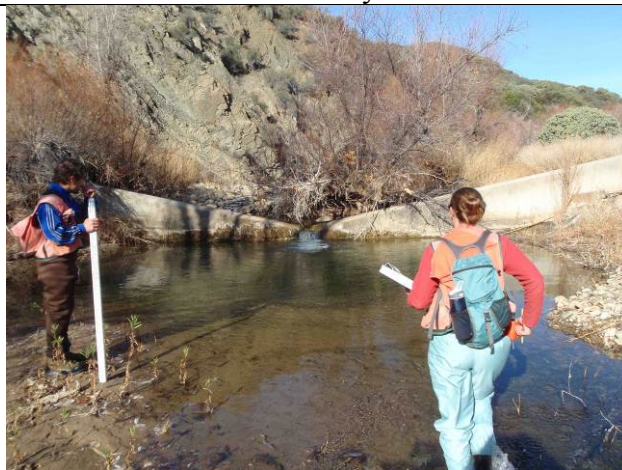
Indian creek weir, upstream

Name: Indian Creek Weir	
GPS: INDWEIR	Stoecker ID: SY MO IN 4
Barrier Type: Weir	Location: 34.54330, -119.64220
Description: This is a concrete weir, which measured 110ft long, extending up both banks, the weir thickness was 1.5ft. The weir forms a V and water spills over at the low point. The downstream pool had a maximum depth of 7ft, and the jump height was 1.5ft, from the surface of the water to the top of the weir. This is a barrier only under low flow conditions.

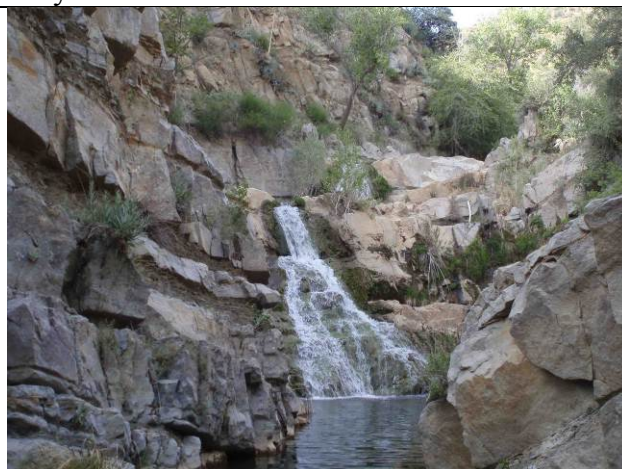
Name: Indian Creek Waterfall	
GPS: INDIANBARRIER	Stoecker ID: SY MO IN 5
Barrier Type: Waterfall	Location: 34.62381, -119.66611
Description: This is a two stage bedrock waterfall, and is a complete barrier to salmonid migration. The upper waterfall is approximately 16 feet high and drops into a pool that connects the two falls. The second waterfall is approximately 27 feet high and drops into a deep narrow bedrock pool. Height measurements were taken from Stoecker 2004, as the water levels were too high at the time of the survey to take measurements of the waterfalls.

Indian Creek Waterfall, complete barrier

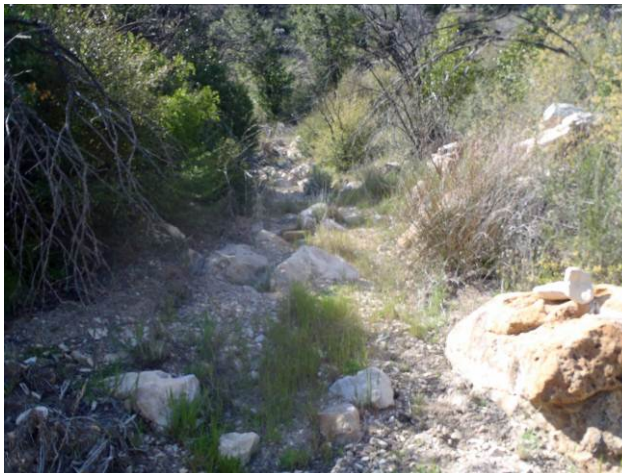
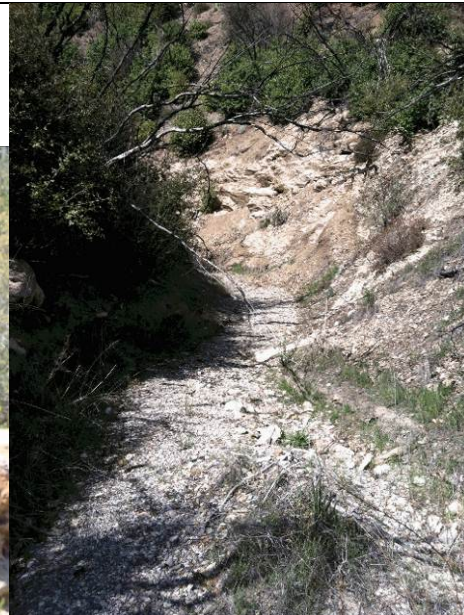
Name: Buckhorn Creek Low Flow	
GPS: BUCKBARRIER	Stoecker ID: MO_IN_BU_1
Barrier Type: Dry	Location: 34.59056, -119.70461
Description: No evidence of recent flow, stream bed is completely dry and has grasses and other terrestrial plants growing in stream bed. Buckhorn Creek appears to be largely fed by two left bank tributaries. The last left bank tributary provides all of the water in upper Buckhorn, Buckhorn is dry after this tributary (34.58947, -119.70015). Creek is dry from this point to the listed Stoecker barrier.

Start of dry section at second trib., Upstream

Buckhorn Creek, Dry Barrier, Upstream

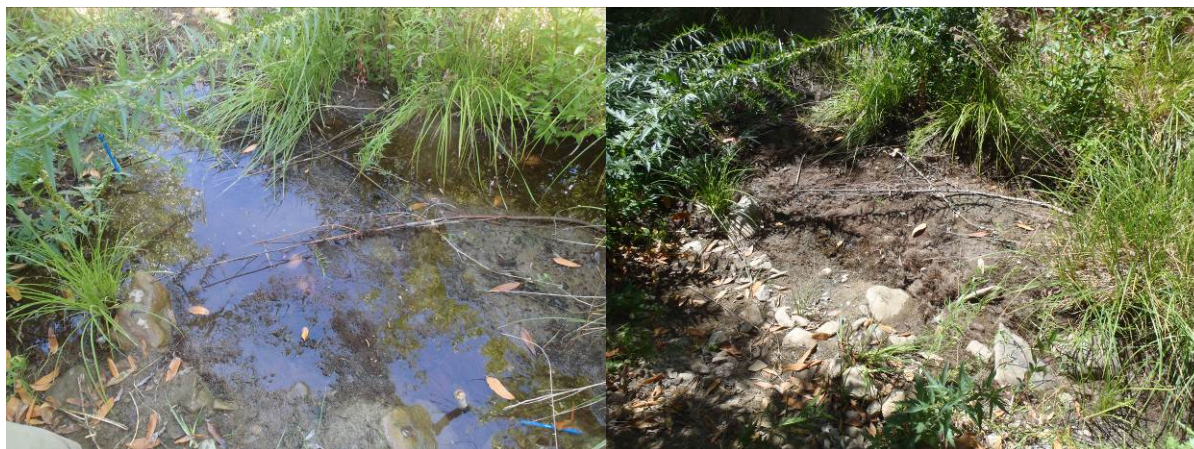
The wetted width of the stream channel was on average approximately 3 feet and the depth was between 2 and 4 inches. In addition when hiking back along the trail it was noted that some of the crossings that had flowing water 1-2 hours previously were now dry (see pictures below).

The picture on the left was taken around 12pm. The picture on the right was taken 2 hours later.
