CALIFORNIA REGIONAL WATER QUALITY CONTROL BOARD  
NORTH COAST REGION

CLEANUP AND ABATEMENT ORDER NO. R1-2015-0048  
FOR  
JENNIFER NIELSEN, ASSESSOR PARCEL NUMBER 210-141-011  
WDID 1B14099CNHU

HUMBOLDT COUNTY

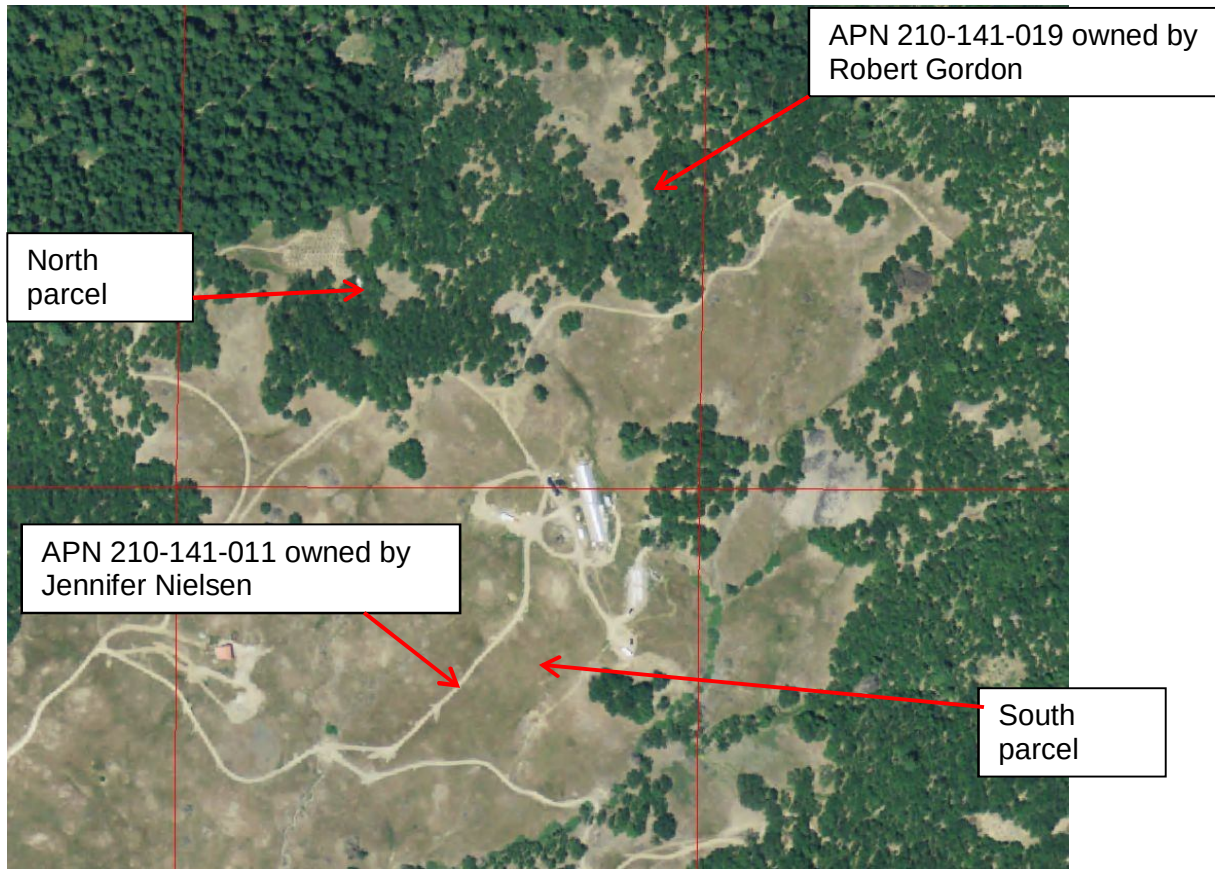
As shown in Image 1, below, both parcels are rectangular, sharing a property line between the North parcel and South parcel. Both parcels have been developed and each had active marijuana cultivation areas at the time of the inspection. Access roads on each parcel meet at a large greenhouse located on or near the shared property line, indicating that the activities on both parcels may be part of a single or coordinated operation.

Image 1: Overview of both parcels showing the shared property line and a number of the features discussed in the observations section below. The image is on a north-south orientation. (Note that this image shows that the parcel boundary line transects the large greenhouse in the center of the image; this may or may not correctly depict the location of the property line, as there is sometimes variation in the parcel layer.) (Image Source NAIP 2012)

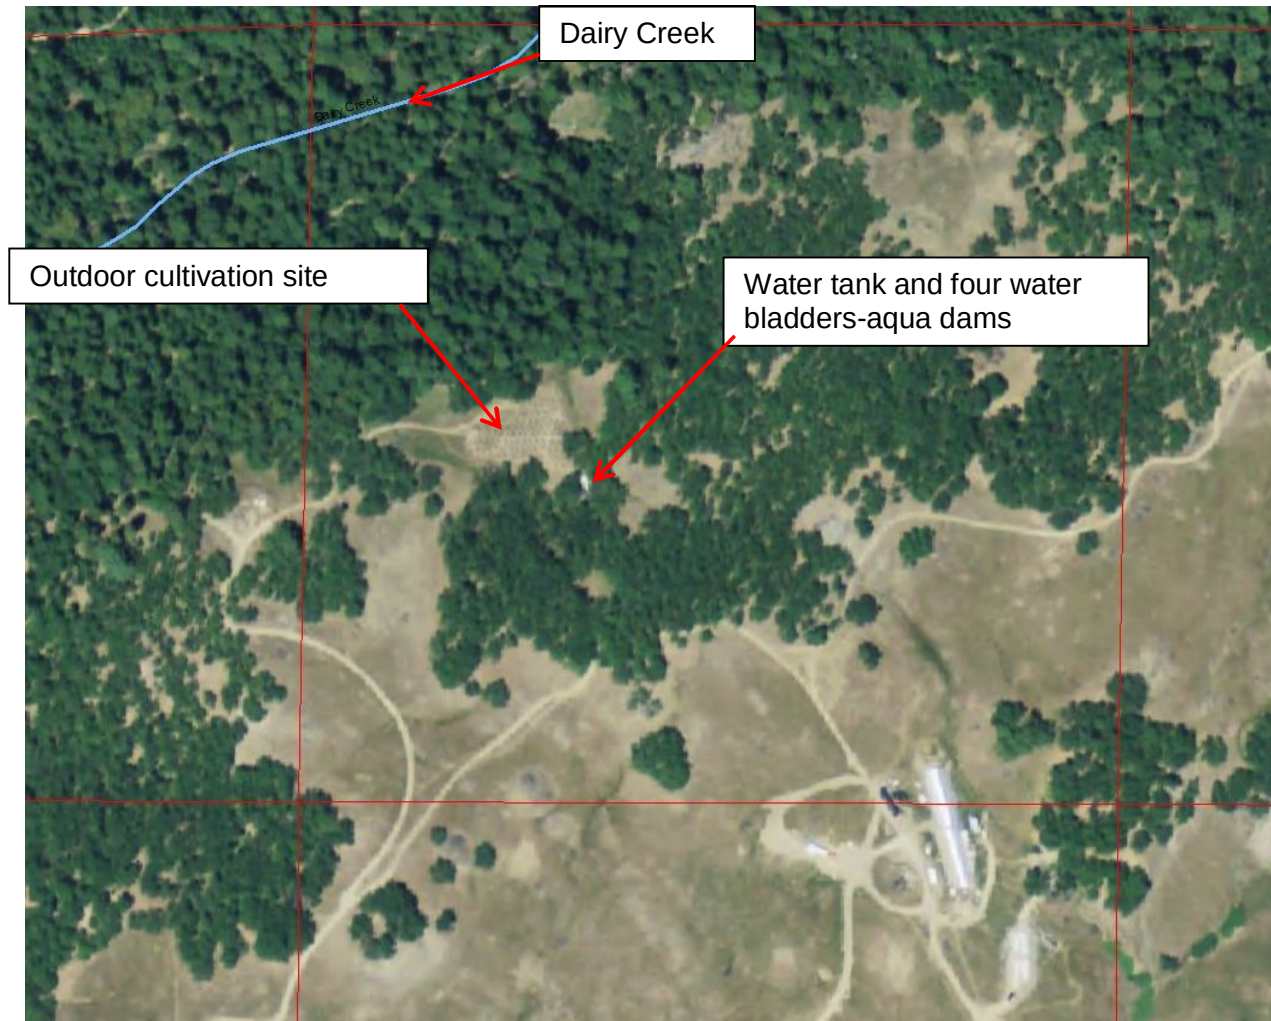
Dairy Creek crosses the parcel approximately 500 feet away from this cultivation area, closer than it appears on the aerial images, and appears to be a water source for irrigation at this location. One of the law enforcement officers participating in the inspection showed me the location adjacent to Dairy Creek where law enforcement officers had removed a gasoline-powered pump just prior to my visit to the site. (Refer to Image 5, below). I observed a gas can at this location, a pipe that had reportedly been connected to the pump, and wet and discolored soils on the ground below the end of the pipe, where the pump had reportedly been sitting. The officer advised me that the pipe led to the water bladders and tank. I did not observe any fuel spill containment or cleanup materials or features at the site where the pump had been placed. Dairy Creek was dry at the time of my inspection.

My inspection of this parcel was not exhaustive. Upon returning to the office I reviewed Google Earth imagery, and noted what appears to be an additional cannabis cultivation area and additional roads on portions of the parcel that I did not visit while in the field. However, those roads that I did travel and observe in the vicinity of Dairy Creek while on the inspection generally appeared to be poorly sited and constructed, with wet ford stream crossings and several locations where it was apparent runoff from roads had entered streams and where it appeared likely that runoff from roads will enter and deliver sediment to Dairy Creek during rainfall events.

Image 3- North parcel, APN 210-141-019, Robert Gordon Property. The blue line stream denotes the approximate location of Dairy Creek, according to the GIS stream layer. (Image source NAIP 2012)

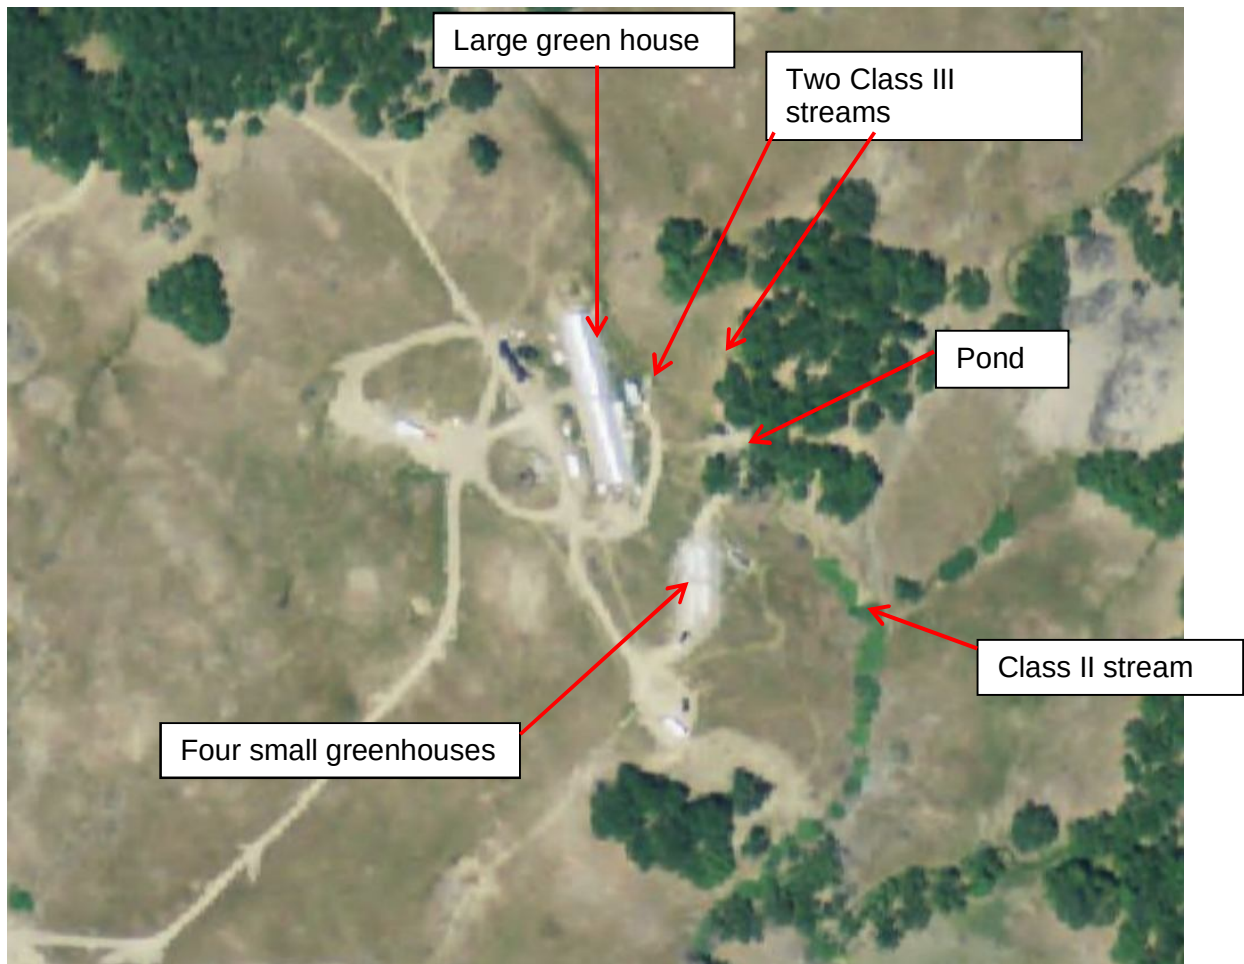
The South parcel is the more extensively developed of the two parcels. As noted above, I observed evidence of extensive grading and instream excavation associated with an instream dam, roads, and a terrace. In addition to the large

In my opinion, the earthen dam is unstable and likely to fail. Failure of the dam would result in a substantial sediment discharge and the release of a nonnative species into the Van Duzen River watershed. As discussed below, I gathered measurements while in the field, and following the inspection, calculated an estimated volume of fill material comprising the dam and available to be transported downstream in the event of a catastrophic failure.

Image 4- South Parcel, APN 210-141-011, Jennifer Nielsen Property where one large, and four smaller greenhouses, and an instream pond are located. (Image Source NAIP 2012)
