Attachment A

Field Inspection Report

Name and Location of Facility Inspected	Rhys Vineyard, Clarke Ranch, 6501 Branscomb Road, Laytonville, CA		
Inspection Date & Time:	September 29, 2015 0830-1700 Travel time included	Mendocino County Assessor Parcel Numbers (APN)	015-050-061 015-050-057 015-050-056 015-050-055 015-050-050 015, 050-051 014-300-019

Report Prepared By:
Stormer Feiler, Environmental Scientist (ES), North Coast Regional Water Board (RWB)

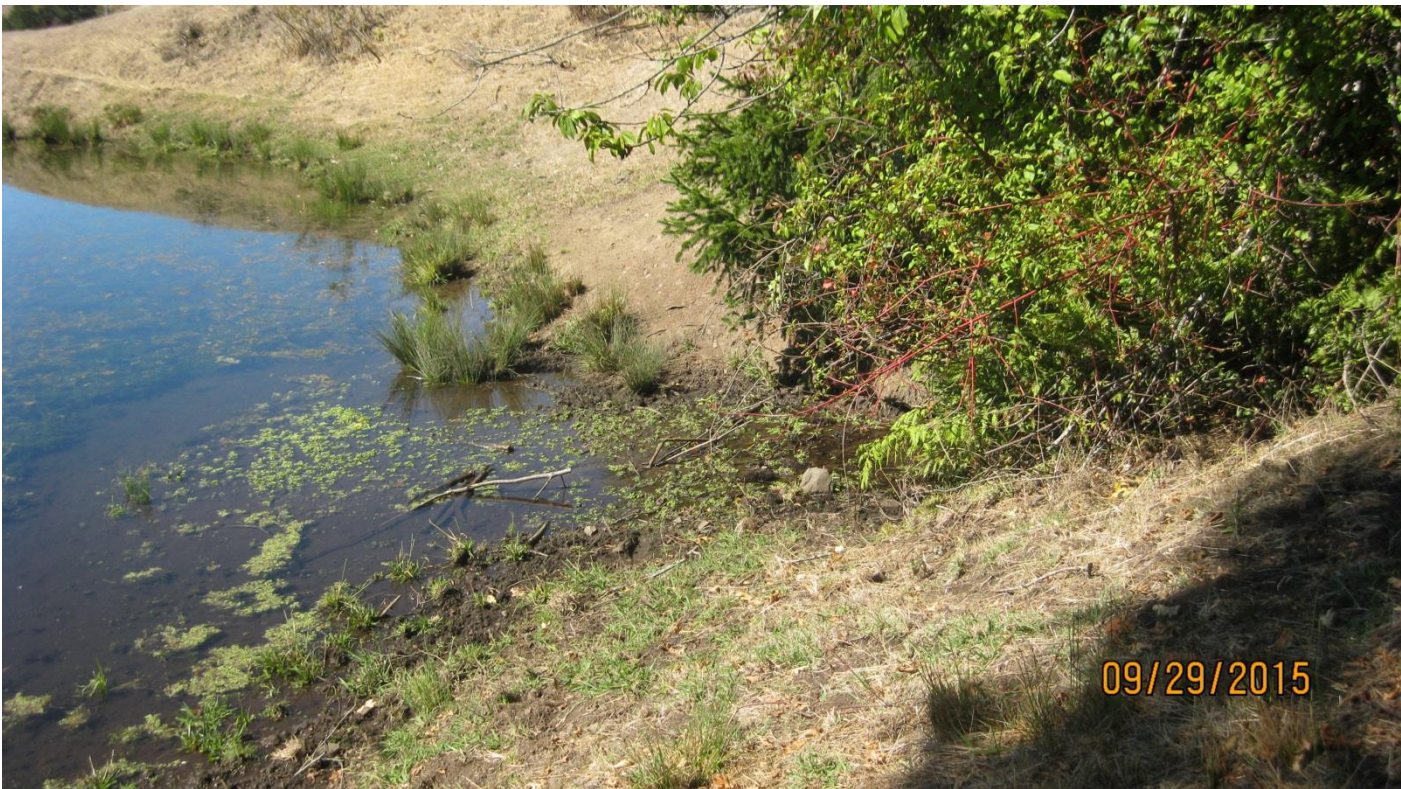
Outflows from the larger of the two ponds (GPS 8) pass through a culvert into a Class II perennial stream channel below the pond. The culvert outlet is exposed and shotgunned. Staff observed signs of significant erosion around and downstream of the culvert outlet, likely on the order of hundreds of cubic yards of soil have eroded while this culvert has served as the pond outlet. The erosion of the dam's fill face is potentially compromising the integrity of the downstream berm/dam.

Image 25 provides another view of the shot-gunned spillway culvert outlet for GPS 8. (IMG 0282).

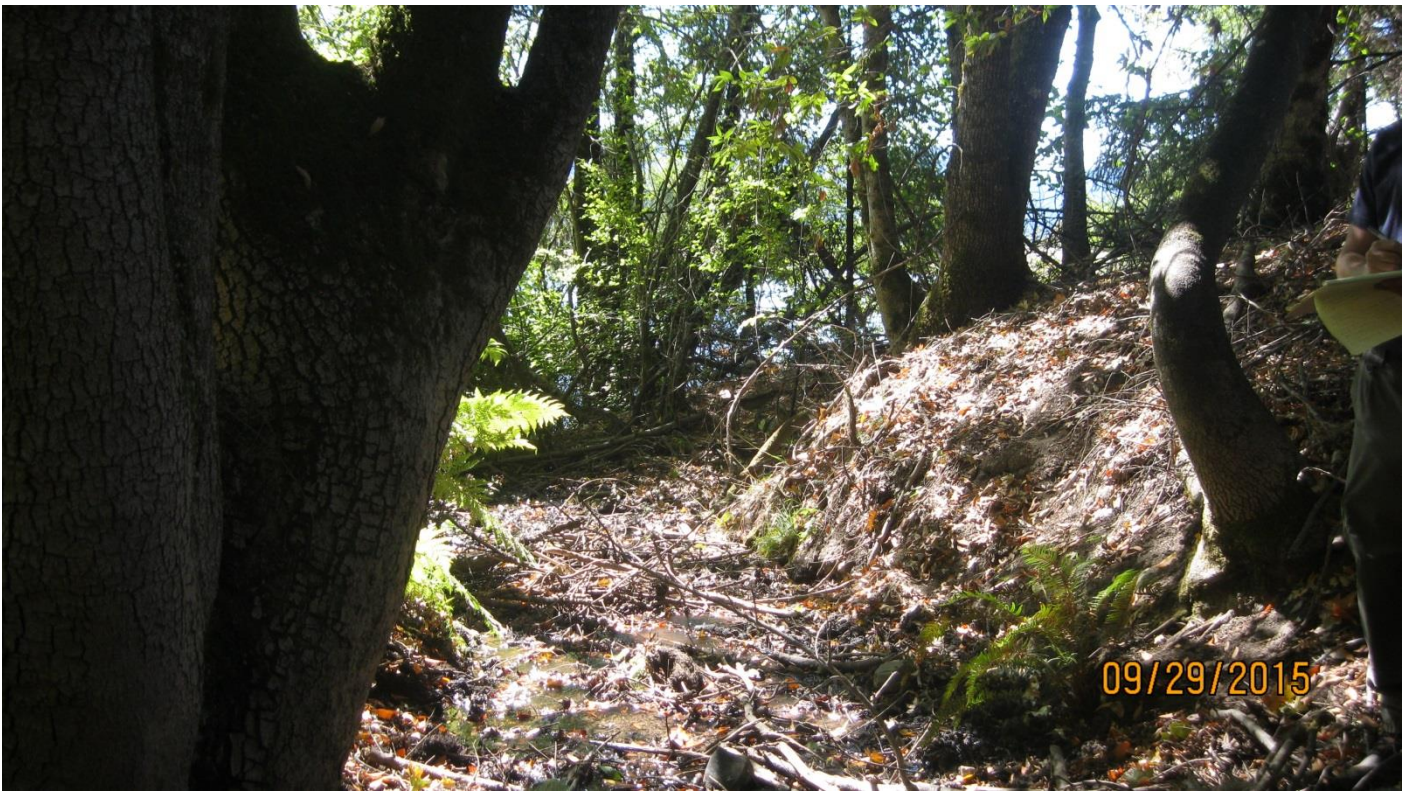
Image 26 shows the perennial Class II stream flowing into GPS 8. (Division of Water Rights staff took photo IMG_0614)

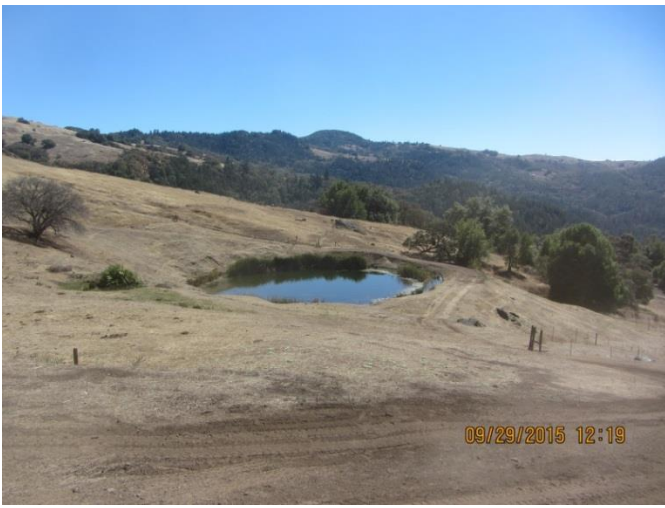
The smaller of the two ponds, GPS 9, also intercepts a Class II perennial stream. The pond outlet flows into a Class II stream. I observed minor evidence of erosion in the stream below the pond; this erosion may be a result of increased winter flows from the pond or may be associated with wild hogs and/or use by grazing animals.

Image 28 shows the outfall from the smaller pond (GPS 9). Note the culvert and half pipe do not appear to be structurally sound; however, the half pipe was carrying flows during the inspection. (IMG_0284)

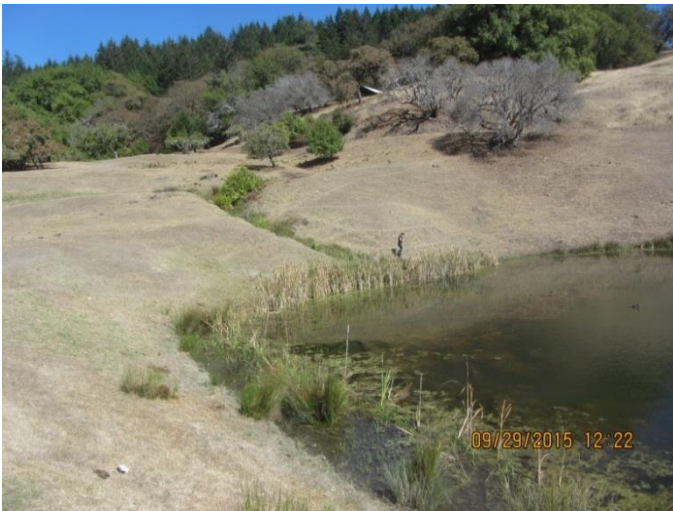
Image 29 shows an overview of GPS 9. (IMG 0281)
