North Coast Regional Water Quality Control Board

Shadow Light Ranch LLC Property
CIWQS Place ID No. 825542
Inspection Date May 10, 2018
WDID No. 1B16868CHUM

Attachment A:
Photographic Record of May 10, 2018, Inspection of
Shadow Light Ranch LLC (formerly Joshua Sweet) Property including Humboldt County
Assessor's Parcel Numbers 223-073-004-000, 223-073-005-000, 223-061-003-000, 223-
061-038-000, 223-061-039-000, 223-061-043-000, 223-061-046-000 (All photos taken by
Shannon Utley during the May 2018 inspection, unless otherwise noted)

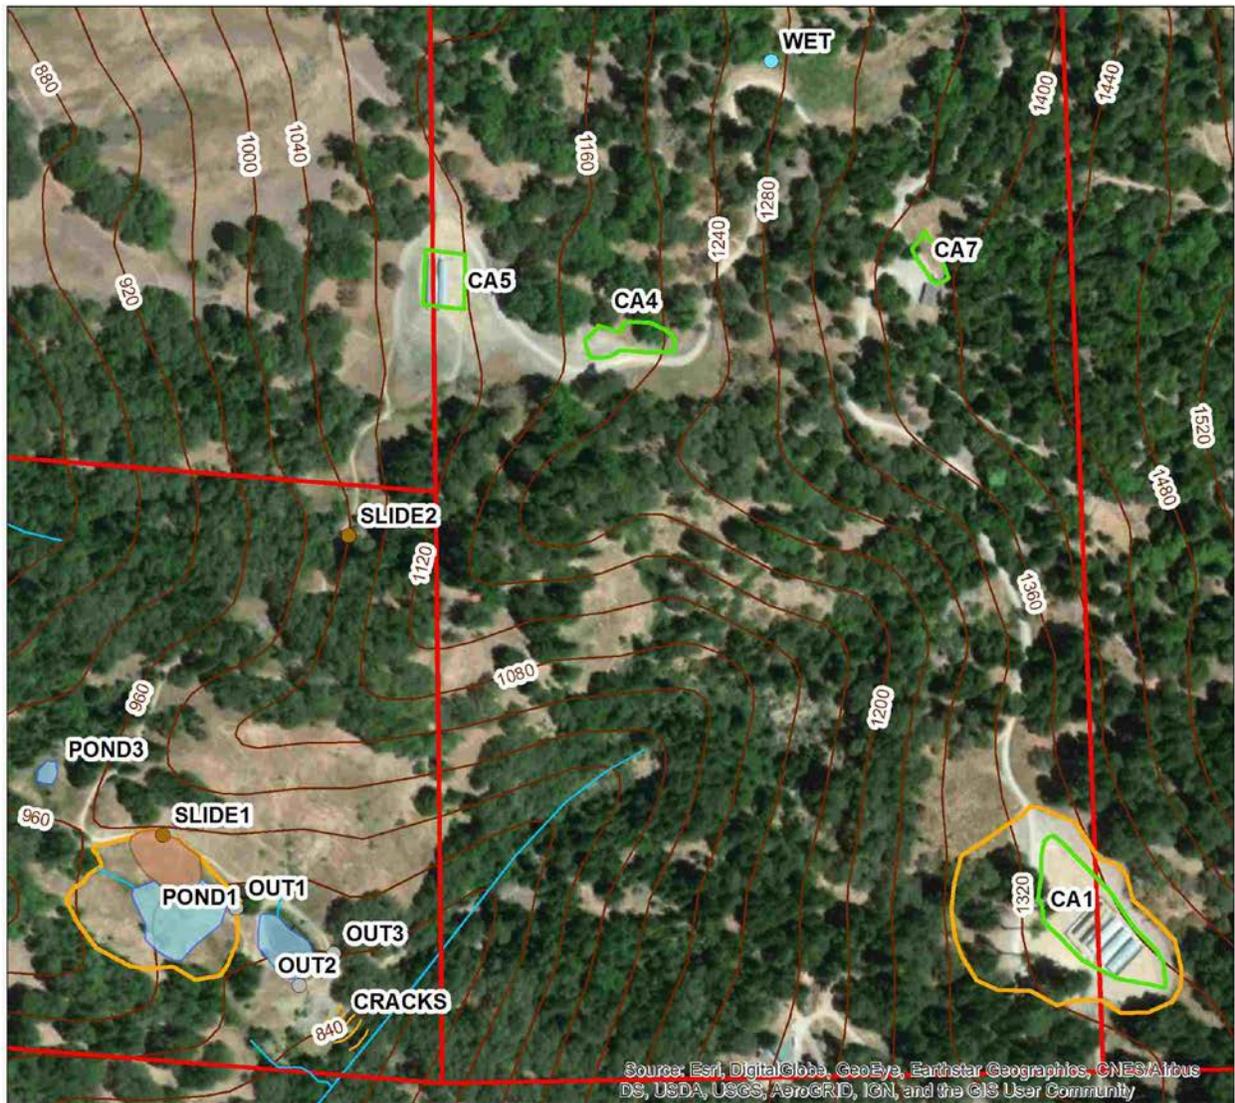
Site Map of Shadow Light Ranch LLC Property
 5/22/2018

Regional Water Board staff inspected the Shadow Light Ranch, LLC property (then owned by Mr. Sweet) on January 29, 2016, and observed an on-stream wetland area (identified as WET on the Site Map, below), which Mr. Sweet reportedly wanted to turn into a recreational pond.

Pond construction reactivated a portion of a historic landslide amphitheater complex of approximately 15,000 square feet (SLIDE1 on Site Map), which delivered sediment into POND1, and damaged the access road to the lower pond to make it impassable by any motorized vehicle (Photo 10). The landslide material in the pond has reduced the pond capacity and likely resulted in increased discharges from POND1 into the lower pond (POND2). Since the November 2017 inspection the landslide scarp and disturbed area associated with the slope failure has continued to revegetate with grasses.

The lower older pond (POND2 on Site Map) is first visible in the available aerial imagery in October 2006. As noted, above, Mr. Sweet purchased the Property in November 2006. The DIV estimated POND2 to be approximately 11,480 square feet (0.25 acres) and up to 14 feet deep (Photo 11).
