**North Coast Regional Water Quality Control Board**

Inspection Report  
Stanshaw Creek Diversion  
Marble Mountain Ranch  
Douglas and Heidi Cole, Landowners  
92520 Hwy 96, Somes Bar  
Siskiyou County  
WDID No. 1A15024NSI

Date: March 9, 2015

Inspection Date: February 12, 2015

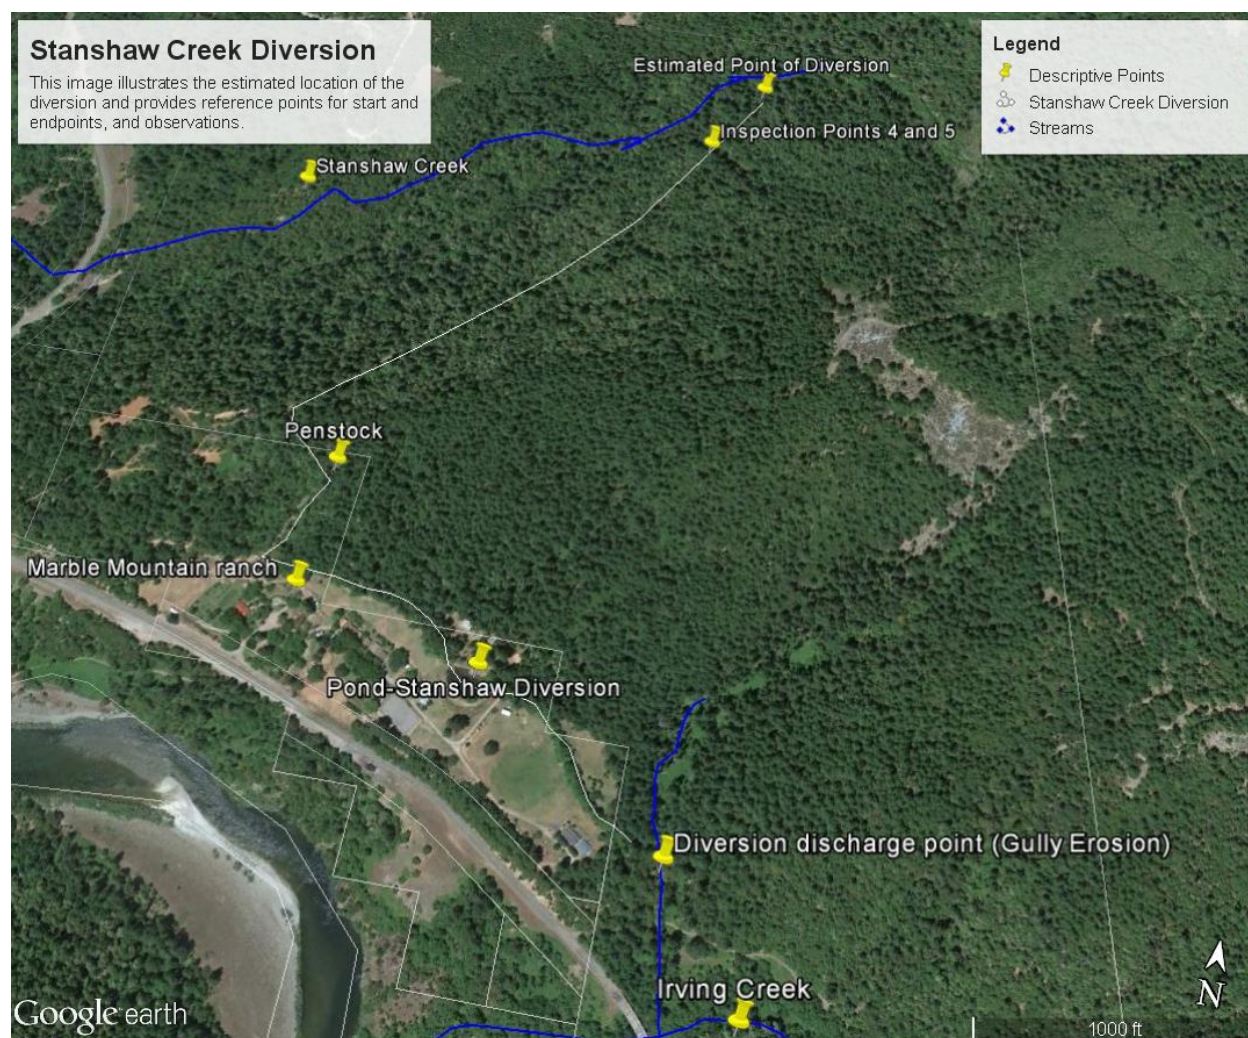
Image 1- shows an overview of the Stanshaw Diversion route and Marble Mountain Ranch. The locations identified are estimated based upon visual observation of the area during the inspection and through subsequent comparison with existing 6/6/2013 Google Earth Pro imagery, Arcview GIS topographic maps, and historic maps of the diversion.
