Field Inspection Report

Name and Location of Facility Inspected	Rhys Vineyard, Clarke Ranch, 6501 Branscomb Road, Laytonville, CA		
Inspection Date & Time:	January 13, 2017 , 0800-1900 Travel time included	Mendocino County Assessor Parcel Numbers (APN)	015-050-061, 015-050-057, 015-050-056, 015-050-055, 015-050-050, 015 050-051, 014-300-019
Names & Titles of On-Site Representatives and Consenting Parties	Consent¹or Warrant		Notified of Inspection?
Javier Tapia Meza, Ken Seckora	Consent Inspection		<input checked="" type="checkbox"/> YES
Property Owner(s):	Rhys Vineyards LLC		
Physical Address:	6501 Branscomb Road, Laytonville, CA.		
Mailing Address:	11715 Skyline Blvd., Los Gatos, CA 95033		
Property Representatives Present:	Randy Jacobszoon, Registered Professional Forester		
Report Prepared By:			
Stormer Feiler, Senior Environmental Scientist Specialist (SES), North Coast Regional Water Board (RWB)			
Report Reviewed By:

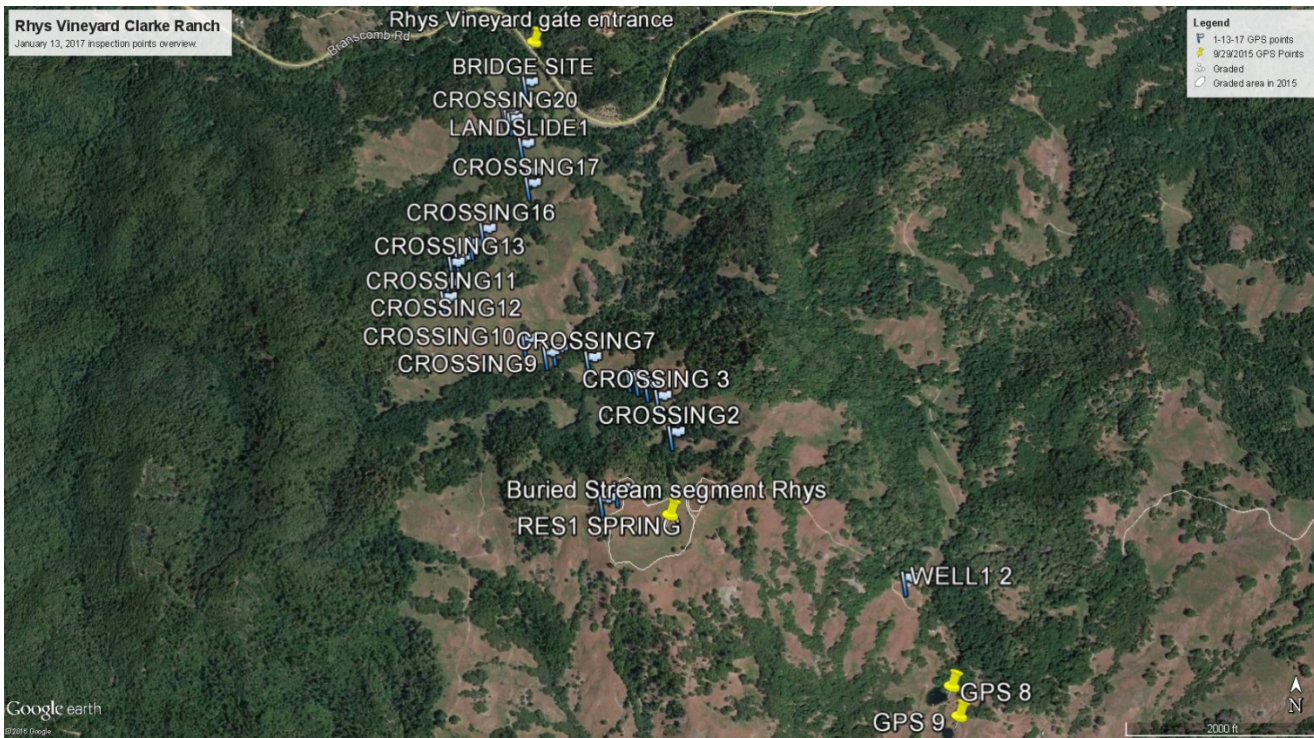
Image 3 - area inspected on January 13, 2017, 2015.

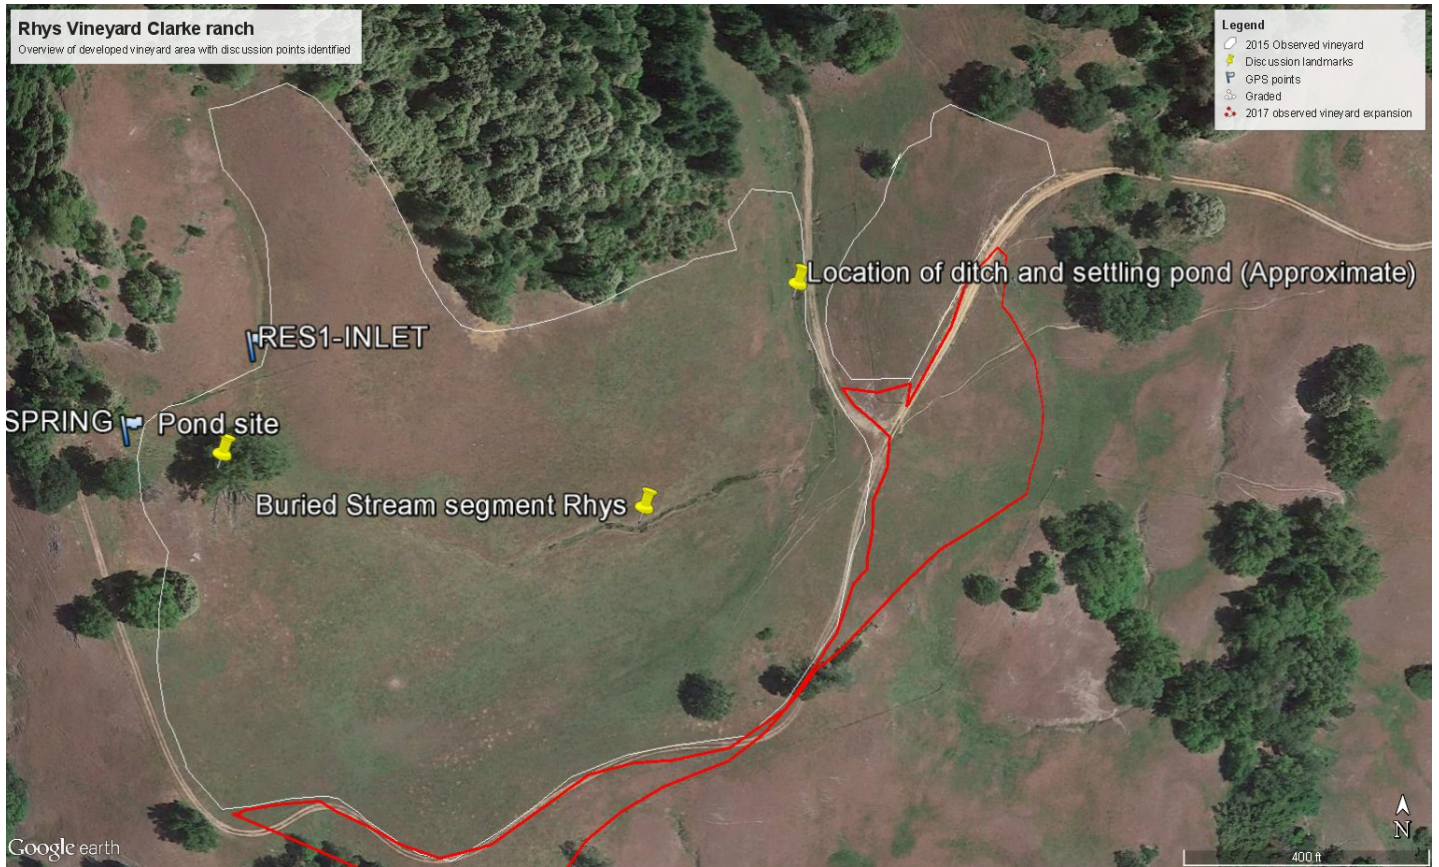
Image 5 shows an overview of the developed vineyard (5-28-2014 Google Earth Imagery).

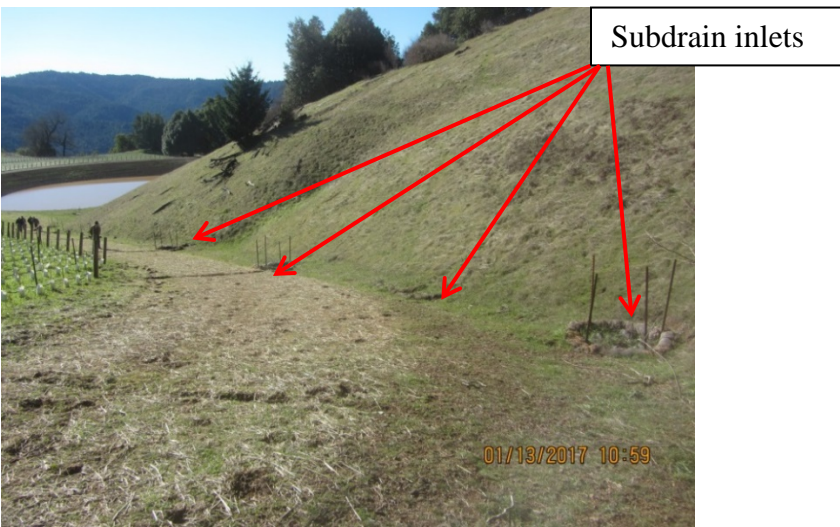
Image 10 shows a series of subdrain inlets leading to the pond along the course of the stream that once flowed here. (IMG 2942)

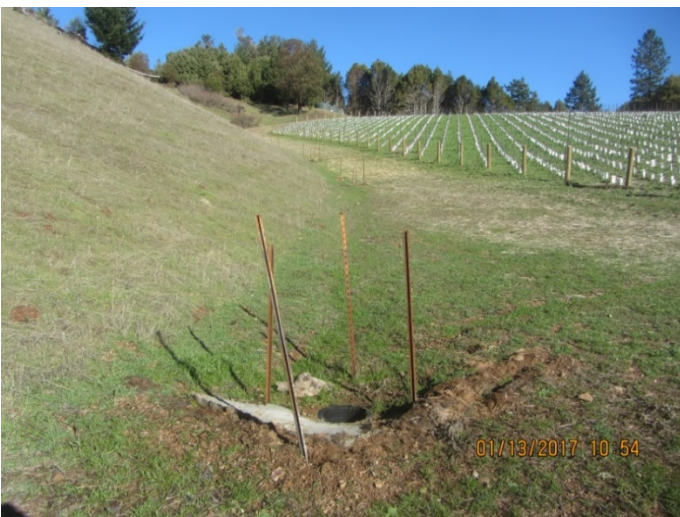
Image 11 shows a subdrain inlet in the location the original stream once flowed. (Image 2928)

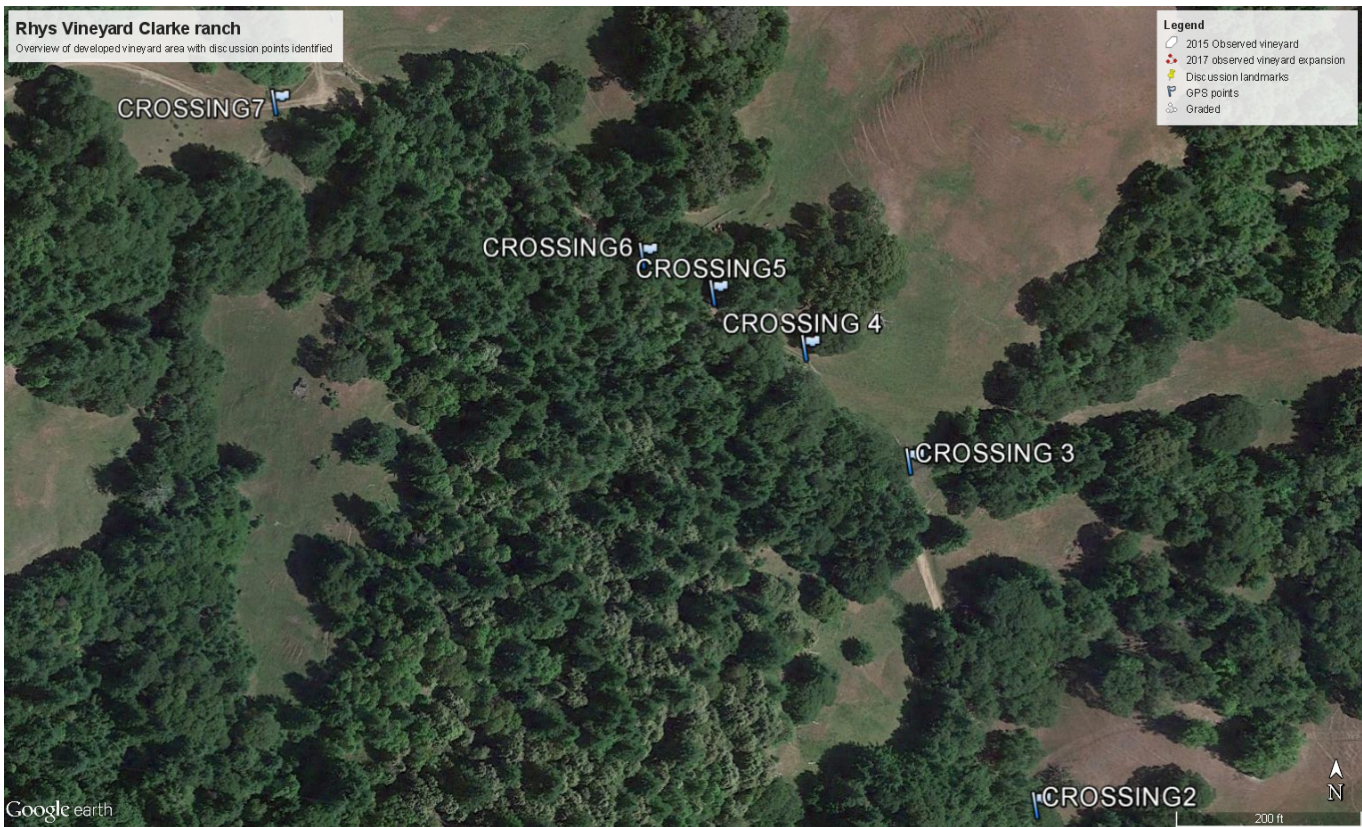
The following observations of GPS points 2-7 identify issues observed which, in summary, consist of unstable cut banks linked to inside ditch drainage; long lengths of inside ditch connected to the road surface and streams, and the proximity of the road to the stream through this reach

Image 16 shows an overview of inspection points 2-7. (Google Earth Imagery 2014)

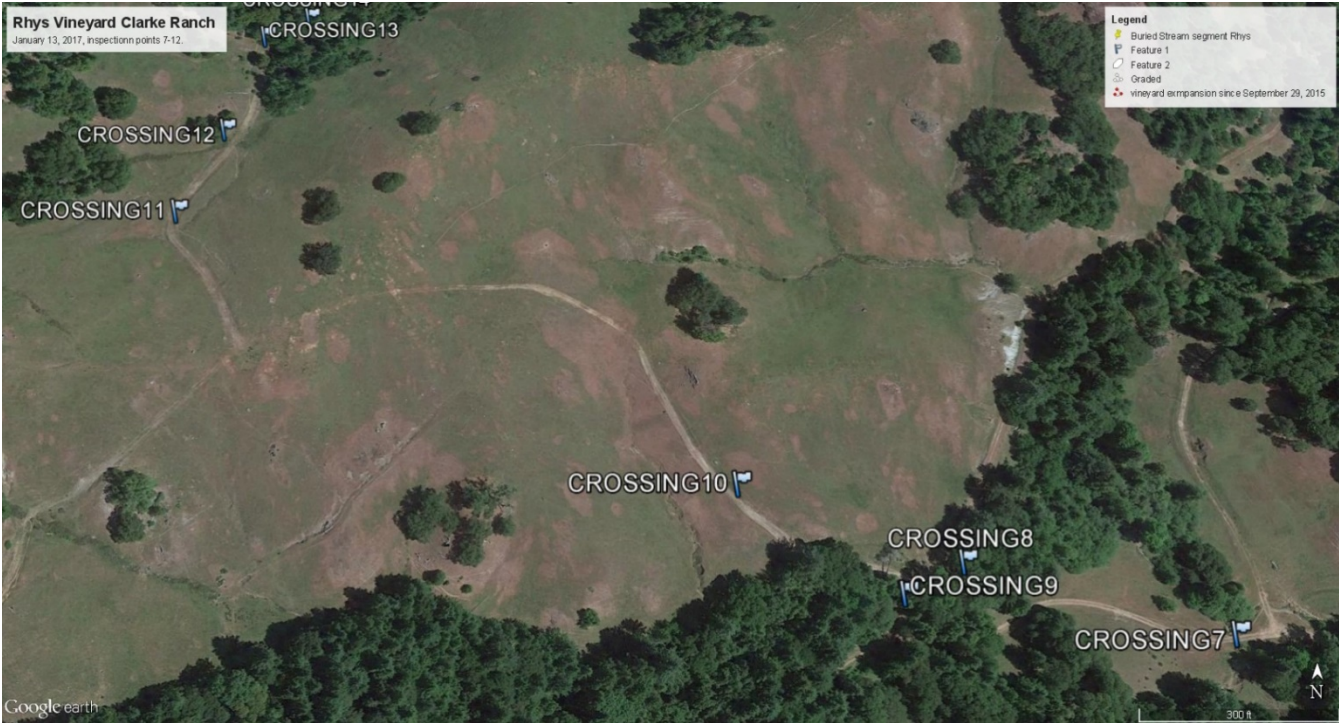
Image 34 shows 2014 Google Earth aerial overview of stream crossings 7-12.

GPS points 8-12 identify areas where stream diversions and surface drainage from roads and landings are exacerbating sediment loads in the watershed. In addition, drainage practices are noted that are unlikely to function over the long term effectively and in the short term in some instances appear to be contributing to sediment delivery. This road segment emphasizes the importance of avoiding diversion of stream flows onto roads.

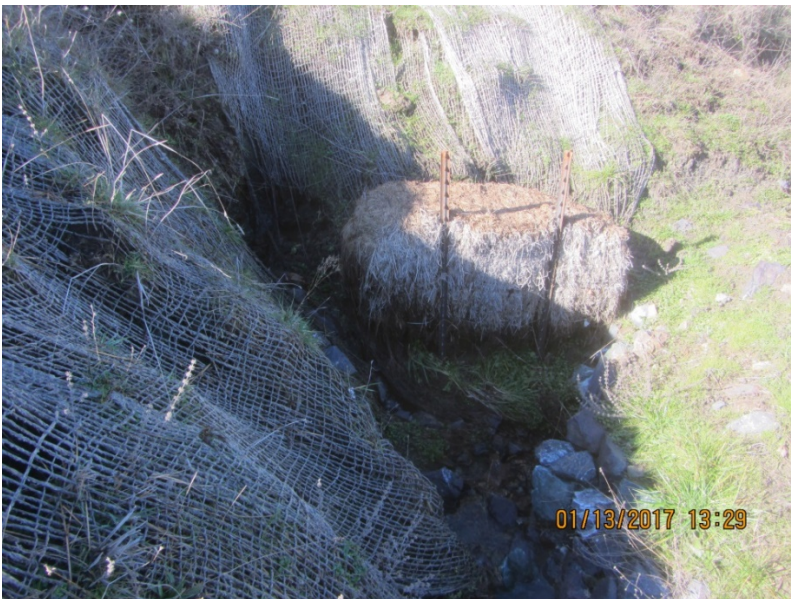
Image 43 shows the Stream Crossing 11 inlet. Note again hay bales and jute netting are applied to try to limit sediment discharges from the excavated inlet to the culvert. (IMG 3071)

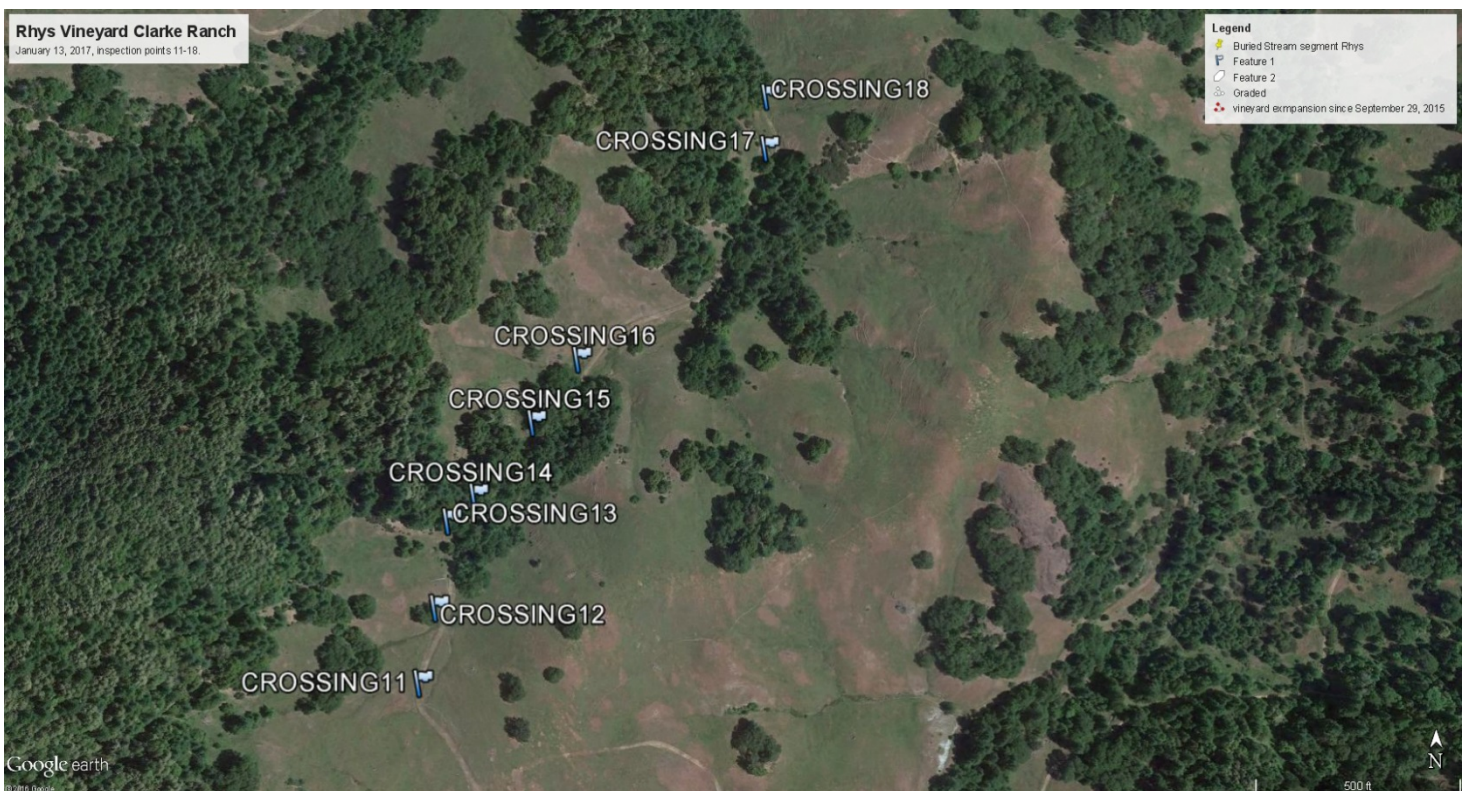
Image 45 shows the access road segment from Crossing 11 to Crossing 18. (2014 Google Earth Imagery)

GPS Points 13-15 identify three ditch relief culverts relieving the inside ditch along a road segment that parallels a Class II stream. The cut bank of the road upslope of ditch relief crossing 14 is unstable and failing. Each outlet was delivering sediments to the stream during the inspection. Above Crossing 14, the unstable cut bank slope was treated with jute netting, and the slope was visibly failing; the slope failure is likely to pose a potential plugging problem for the inside ditch and to increase the delivery rate of sediment to the stream through the inside ditch connection to the failing slope and the stream.

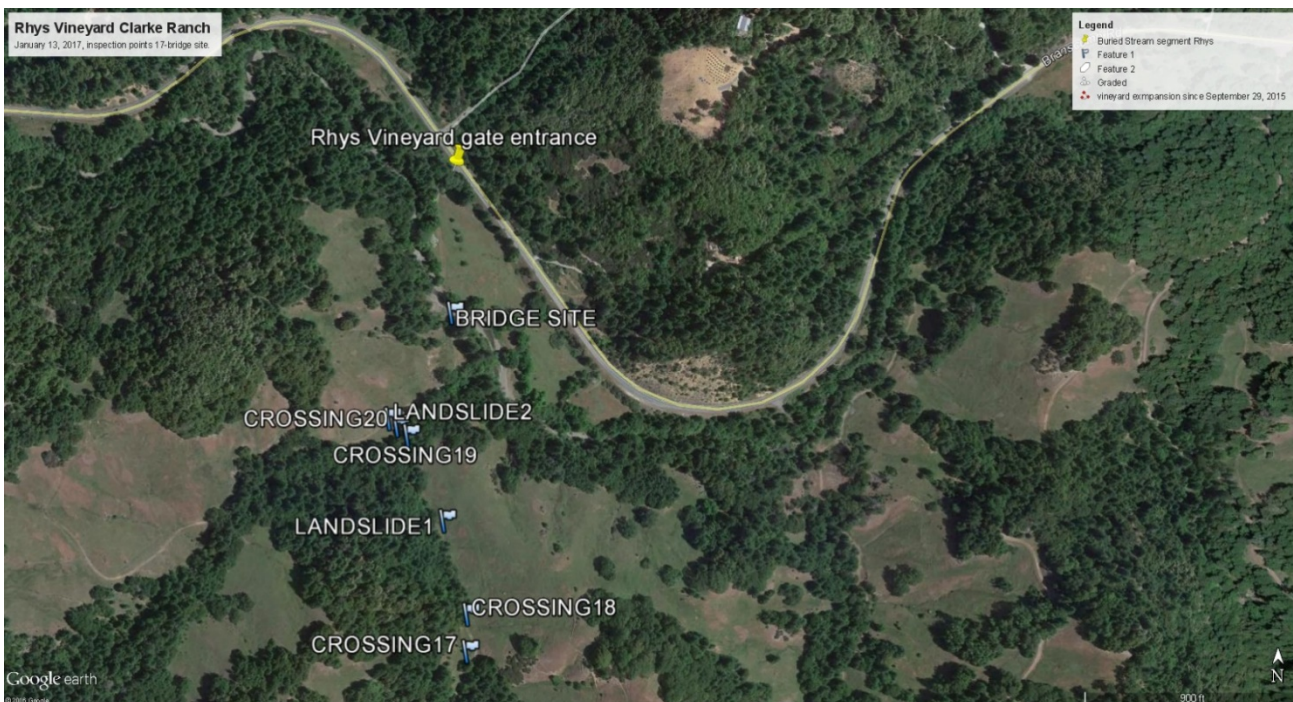
Image 59 shows Google Earth 2014 imagery of inspection points 17 through the bridge site.

GPS points 19 through the bridge site continue to show the connection of the inside ditch to the road surface, unstable cut banks, and streams.

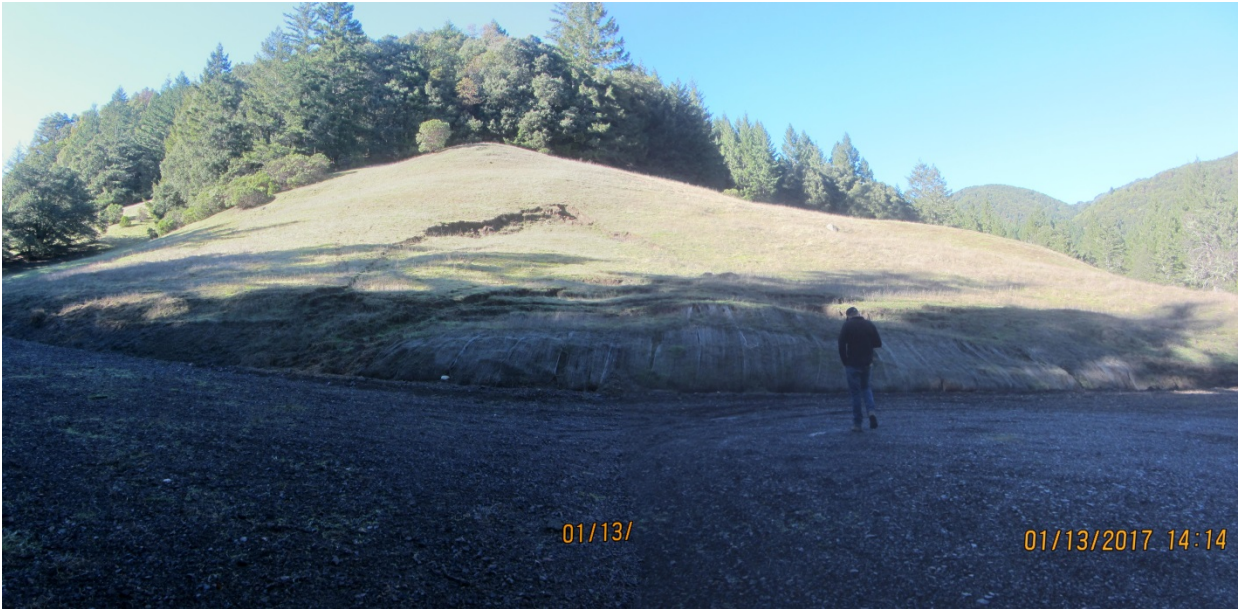
Image 66 shows inspection point Landslide 2 . (IMG 3150-3151 stitch)

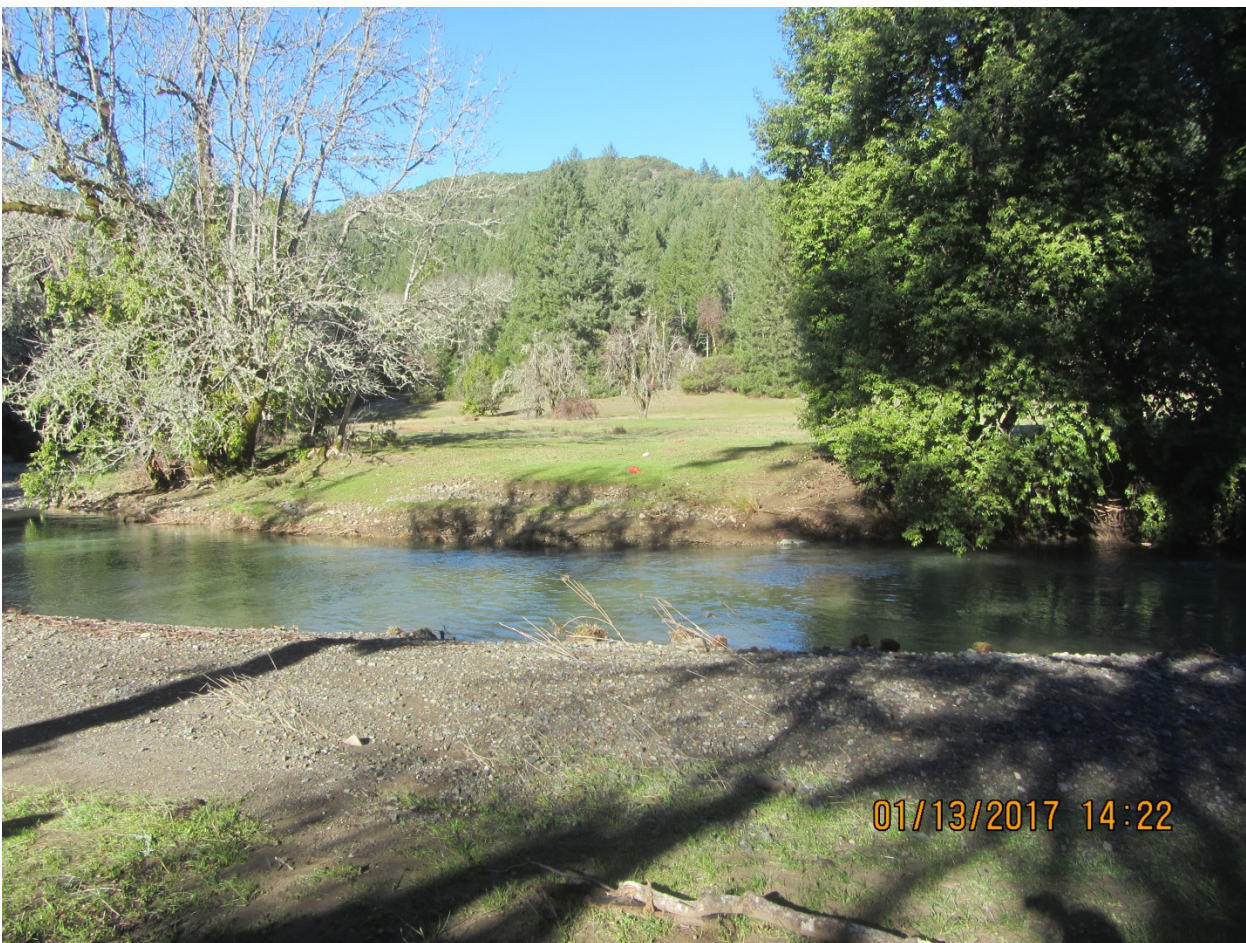
Image 67 shows the bridge location proposed for the South Fork Eel River. (IMG 3160)

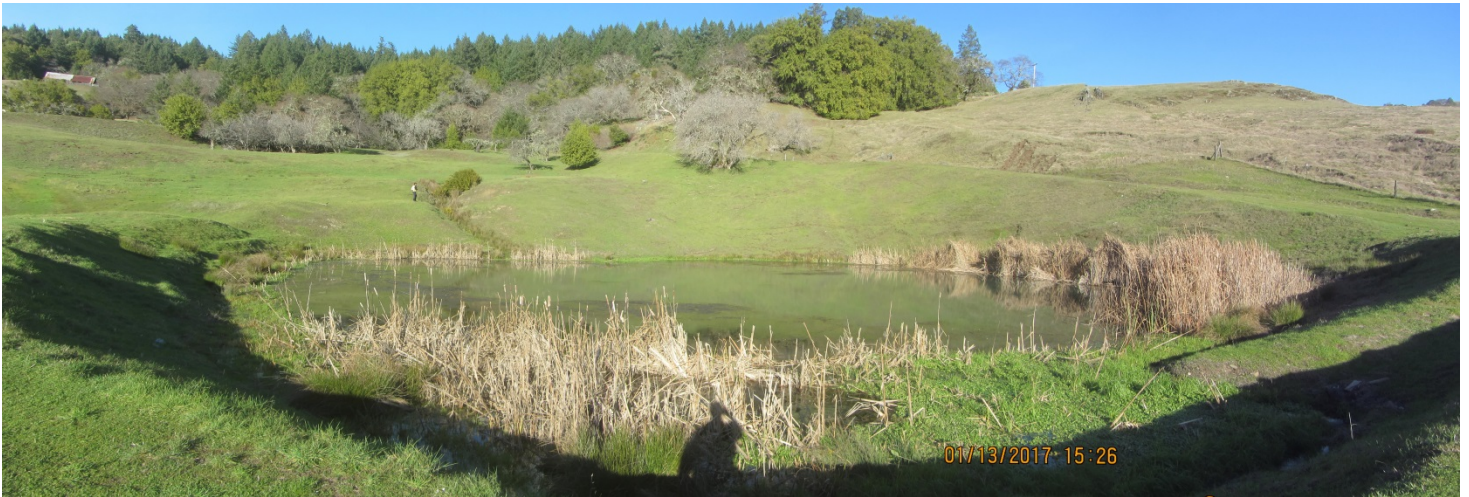
Image 71 shows the pond located at GPS9. (IMG 3182-3184)
