# Attachment C

## Field Inspection Report

<b>Name and Location of Facility Inspected</b> Telles Property Trinity County APN 015-170-07 Douglas City, CA	<b>Inspection Date</b> April 9-10, 2015	<b>Inspection Time</b> 13:30
--	--	---------------------------------

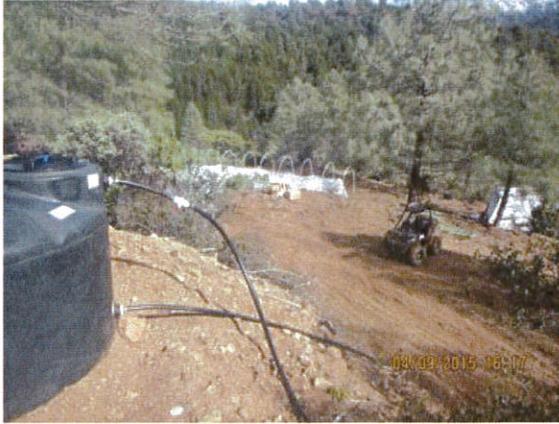
Photo 17

On the part of the property, which I now understand is part of APN 015-170-40, where Jace Richter has his residence, his greenhouse (GH2) and his outdoor cultivation area (OG2), it is more heavily vegetated. The clearings are much smaller. However, there is still a lot of loose, bare soil (Photos 17 and 18). The roads are poor with unstabilized, steep side slopes and there were spoils placed on the edge of the road (Photos 19 through 21). I did not observe any crossings or watercourses cutting through the road. However, my colleague Scott Bauer of the CDFW took measurements and geographical locations of several crossings onsite and these are included in Figure 2.

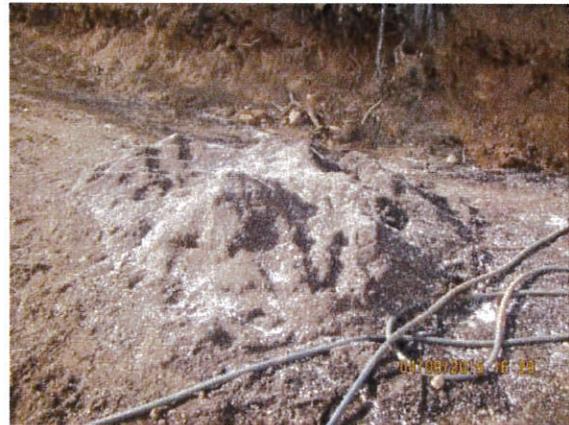
Photo 24

On the property there is an existing latrine (L2) near OG2 (Photo 22) and there was a hole for what Mr. Richter said would be a latrine (L3) near the greenhouse (GH2) (Photo 23). There was also a small pile of soil amendment near the greenhouse (Photo 24). I observed bags of fertilizer on the ground near the outdoor cultivation area (Photo 25). However, they didn't appear to be open. I also observed erosion on the northern slope where the ground was cut to create the clearing for the outdoor cultivation area (Photo 26). The erosion is indicative of an unstable slope configuration. The side slopes of the clearing were cut so steep that large pieces of soil are starting to break off.

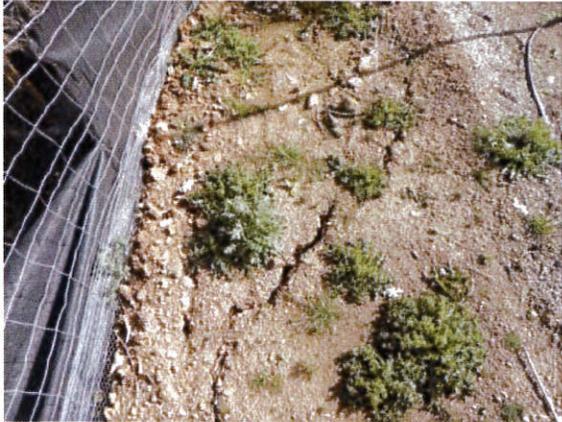
Photo 37 (Magnuson)

Along the road on the way to a clearing on Mr. Zarcufsky's portion of the property, staff noted another channel without a proper crossing (C2) (Photos 34). They measured the dimensions of the fill over the watercourse and estimated its volume to be between 6 and 7 cubic yards. Staff noted rills forming in the road continuing east from the crossing (Photo 35). Northeast of crossing C2 is another cleared area with an upper and lower pad; with what once was an outdoor cultivation area on the lower pad and a residence (trailer) on the upper pad. They observed evidence of slumping at E4 (Photo 36) and tension cracks along the edges of the upper and lower fill slopes at E5 (Photo 37). On the upper pad, there was some chemical spilled on the bare soil (Photo 38).

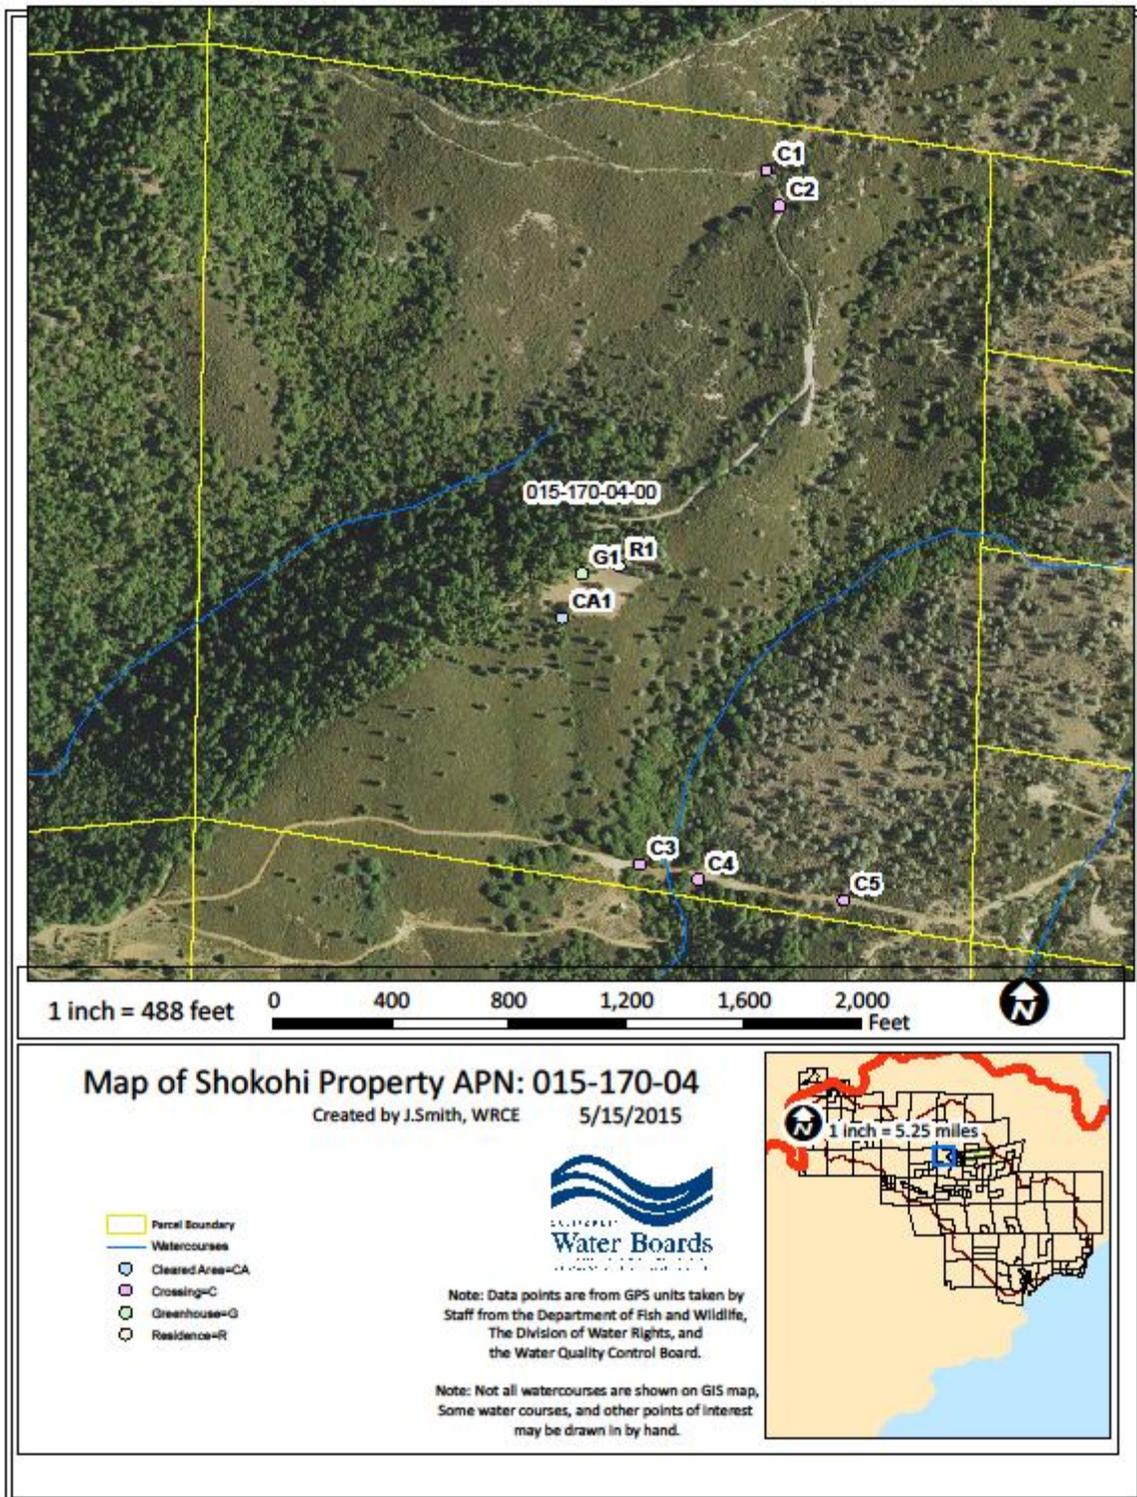
**Figure 2** – Google Earth 2012 aerial including inspection points and parcel boundaries. This map and the points identified are used as a basis for discussion in this report. The points are identified using the Division of Water Rights GIS data collected in the field.

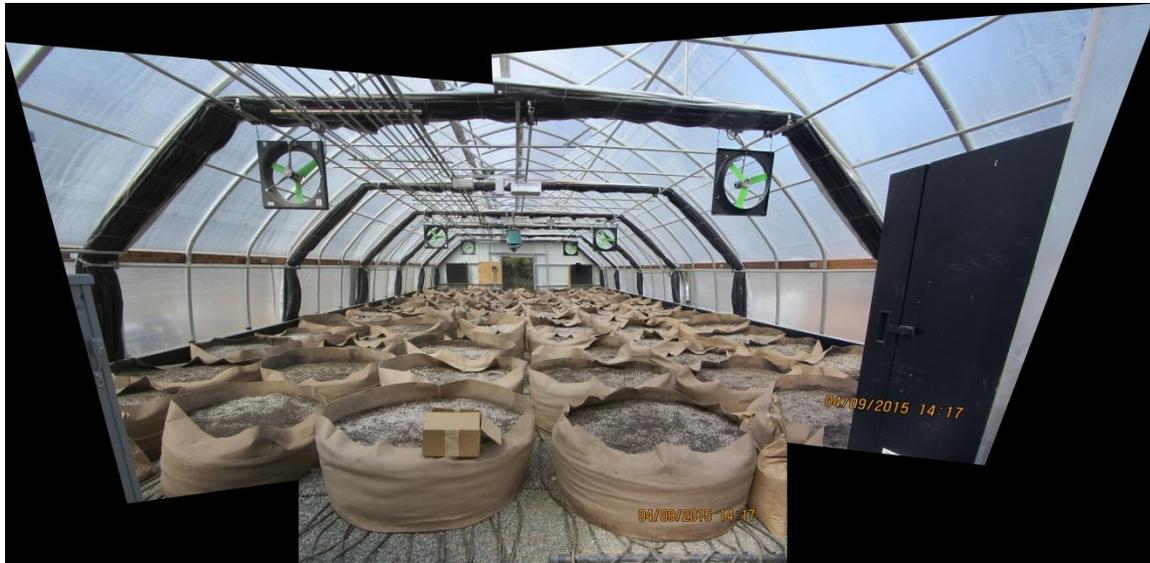
Image 4 shows the interior of the greenhouse; note the tarps above the pots that are designed to open and close electronically. (Stitch of Photos 8948-8950)

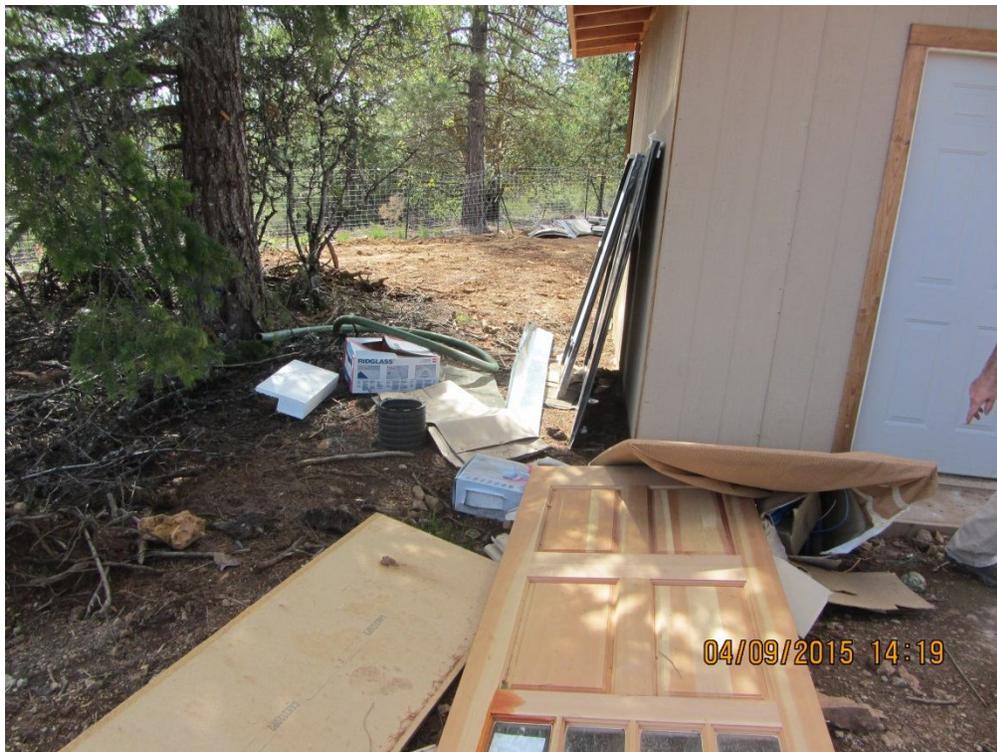
Image 7 shows the area around the shed. (Photo 8958)
