Attachment D

Field Inspection Report		
Name and Location of Facility Inspected Indian Creek Watershed Trinity County APN 015-170-24 Douglas City, CA	Inspection Date April 10, 2015	Inspection Time ~10:30 a.m.
Names & Titles of On-Site Representatives	Contact Information	Notified of Inspection?
Andrew Carey	3025 Osceola Street Denver, CO 80212 Phone: (530) 784-3551	<input checked="" type="checkbox"/> NO
Howard Randol Jr.	7450 W 52nd Ave M208 Arvada, CO 80002	<input checked="" type="checkbox"/> NO
Names & Titles of Property Owner¹ at Time of Inspection	Address	Consent Provided?
RNC Holdings, LLC	PO Box 2954 Weaverville, California 374 Clarkson St. Denver, CO 80218	Administrative Warrent
Names & Titles of Current Property Owner	Address	Consent Provided?
Eduardo Guerrero	4708 Millbrook Way Bakersfield, CA 93313-4004	N/A
WQ Inspector Name(s) & Title(s)² Erin Mustain, Senior Water Resource Control Engineer, State Water Resources Control Board (SWRCB) Office of Enforcement (OE) Derek Magnuson, Engineering Geologist (EG), North Coast Regional Water Quality Control Board (NCRWQCB) Kason Grady, Water Resource Control Engineer (WRCE), NCRWQCB

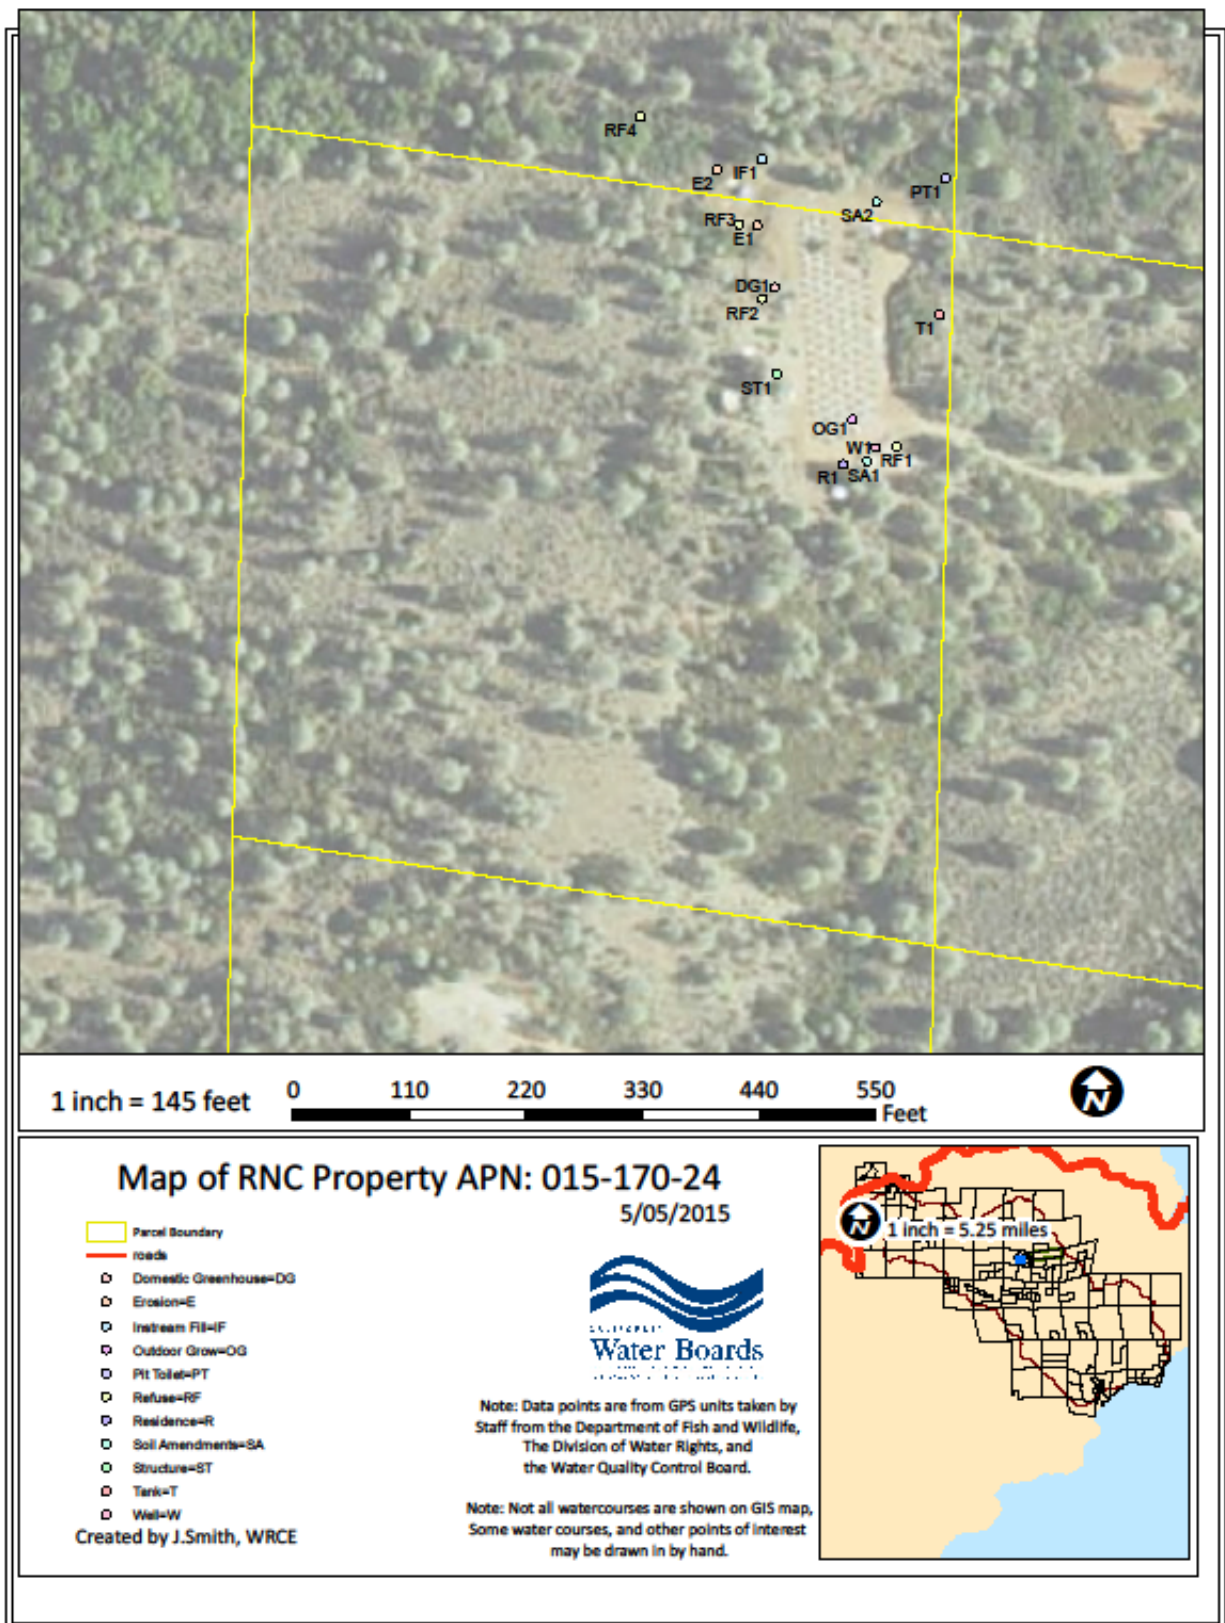
Figure 2 – Parcel aerial image, showing inspection points
(Image source: NAIP 2014 County Mosaics)

Inspection observations and photos are referenced to points shown in Figure 2, above. Figure 2 includes features of concern and reference points collected by Water Rights and CDFW staff during the inspection. The team periodically split up to look at different features throughout the parcel, and I did not visit all points shown on the map. I report on those features that the Water Quality inspection team (Regional Water Board and OE staff) visited and where we observed conditions that represent an impact or threatened impact to water quality; reports prepared by the Water Rights and/or by the CDFW staff, if any, may report on additional features and areas of concern observed on the parcel.

As illustrated in Figure 2, the developed portion of the parcel is comprised of several features generally located atop a larger graded pad, including a trailer (Map Point R1), a water supply well (Map Point W1), an outdoor cultivation area (Map point OG1), a wooden shed (ST1), and a greenhouse containing various vegetable and fruit plants (Map Point DG1). A pit toilet lies to the northeast of the graded pad (Map Point PT1). A water storage tank is located to the east of the pad (Map Point T1). The northwestern corner of the pad features significant fill slopes. The following features observed are of concern for water quality:
