Attachment E

Field Inspection Report

Name and Location of Facility Inspected Trinity County APNs 015-180-06-00, 015-180-38-00, 015-170-39-00 and 015-170-31-00 Frietas Gulch and Mule Gulch, Douglas City, CA		Inspection Date(s) April 9-10, 2015 October 7, 2015	Receiving Waters: Frietas Gulch, Indian Creek, and their tributaries
Names & Titles of Property Owner¹ at Time of Inspection	Address	Notified of Inspection?	
John R. Kimball and Edna L. Kimball	843 Mallard Loop Logan, UT 84321	Consent Provided? Administrative Warrant	
Michael Linarte	12537 Mitchell Ave. Los Angeles, CA 90066-4805		
Vada Trott Horacio Cufre-Urrutia	4088 D ST Eureka, CA 95503-6025	Notified of Inspection? No	
Inspector Name & Title² Erin Mustain, Senior Water Resource Control Engineer, State Water Resources Control Board (State Water Board) Office of Enforcement (OE)			
Attending Agency Representatives Derek Magnuson, Engineering Geologist, North Coast Regional Water Quality Control Board (RWQCB) Adona White, Water Resource Control Engineer, RWQCB Tobi Freeny, Staff ES, California Department of Fish and Wildlife (CDFW) Scott Bauer, Staff ES, CDFW Kason Grady, WRCE, RWQCB CDFW Wardens

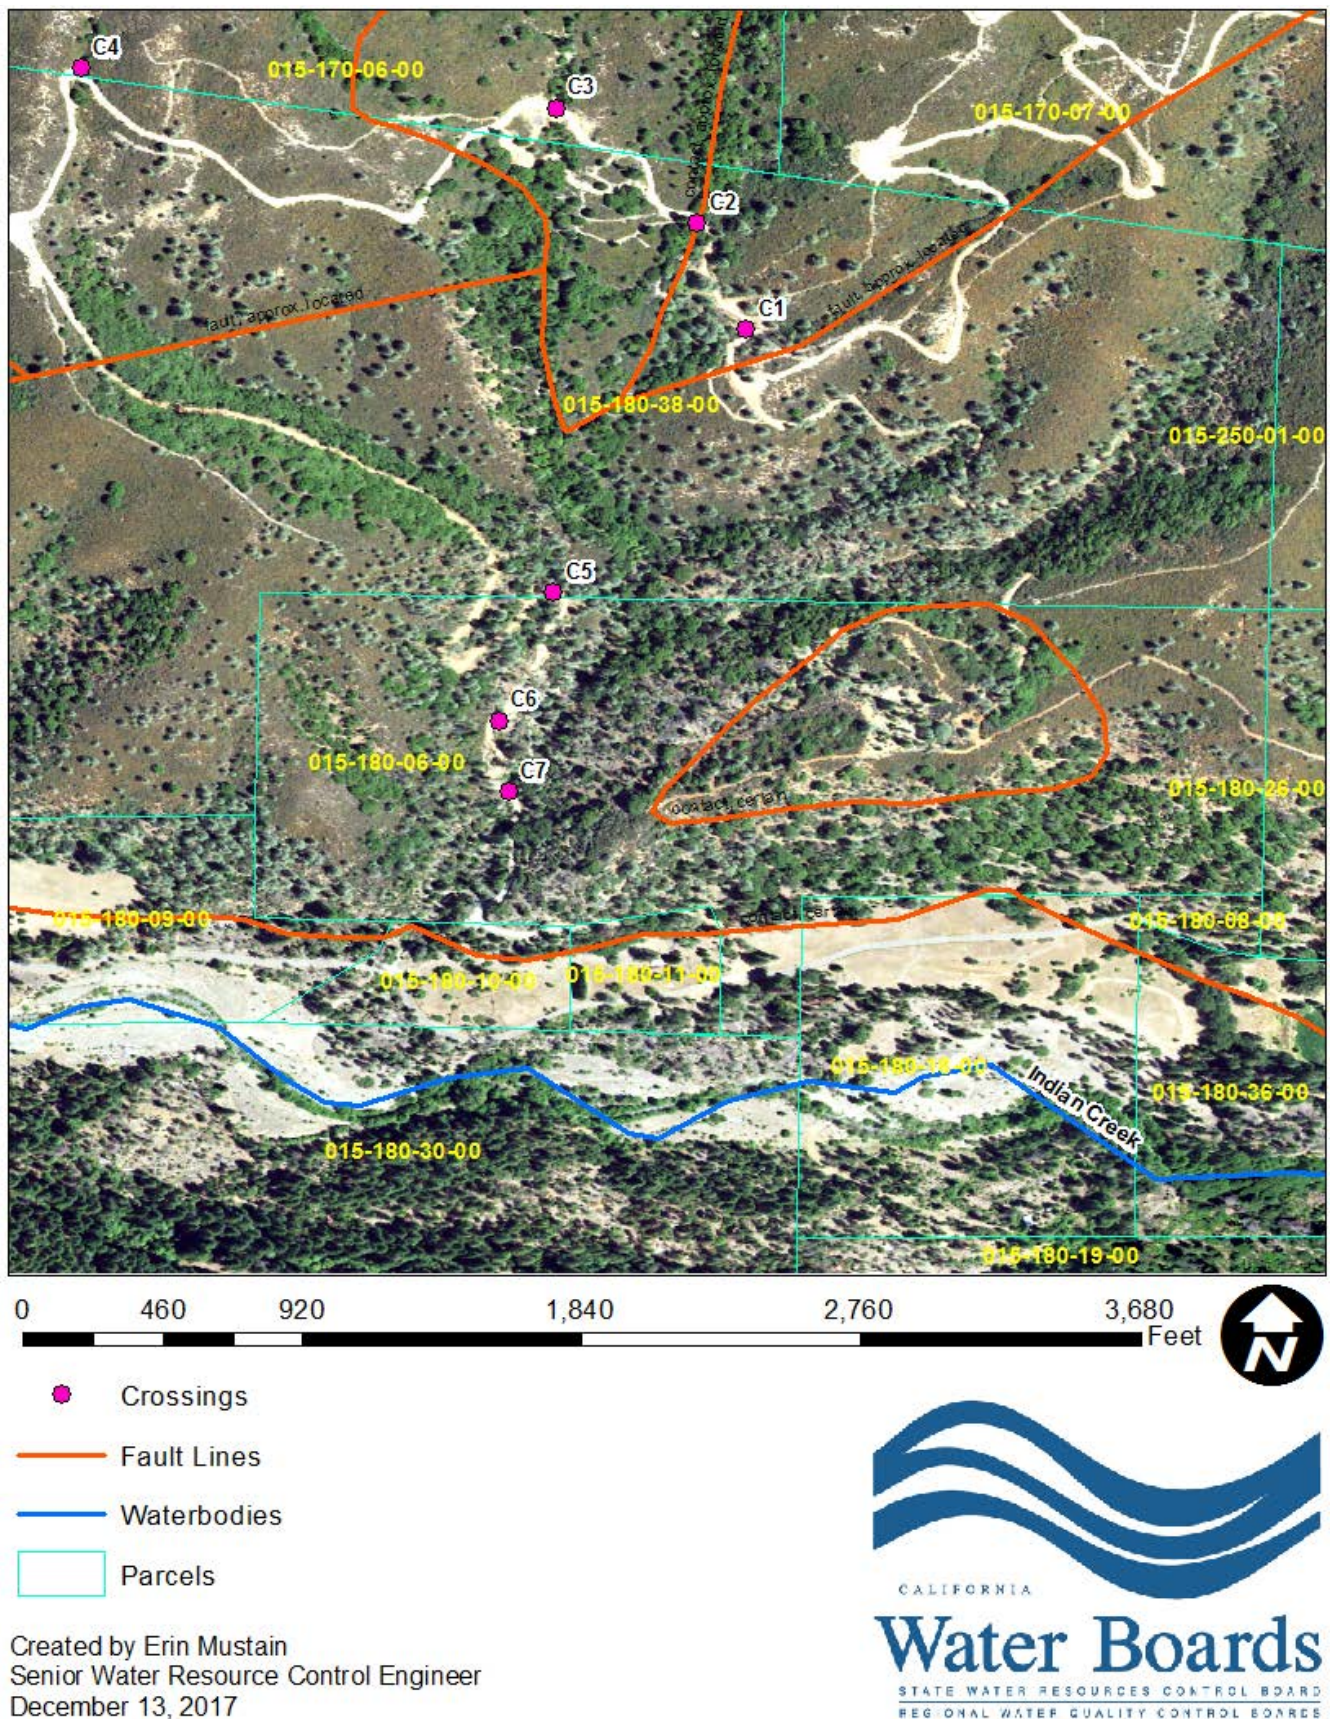
Figure 1 – Kimball Parcels (015-180-06-00 and 015-180-38-00)

Figure 1 (below) shows a portion of the watershed just north of Indian Creek, specifically APNs 015-180-06 and 015-180-38. Figure 2 shows a portion of the watershed including the upper reach of Frietas Gulch, specifically, APNs 015-170-39 and 015-170-31. Parcel lines are provided by the County Assessor's Office and are approximate.
