# Attachment F

| Field Inspection Report | | | |
| <b>Name and Location of Facility Inspected</b><br>Trinity County APNs 015-170-29<br>015-170-32, and 015-170-34<br>1400 Frietas Gulch, Douglas City, CA | | <b>Inspection Date</b><br>October 7, 2015 | <b>Inspection Time</b><br>9:30 a.m. |

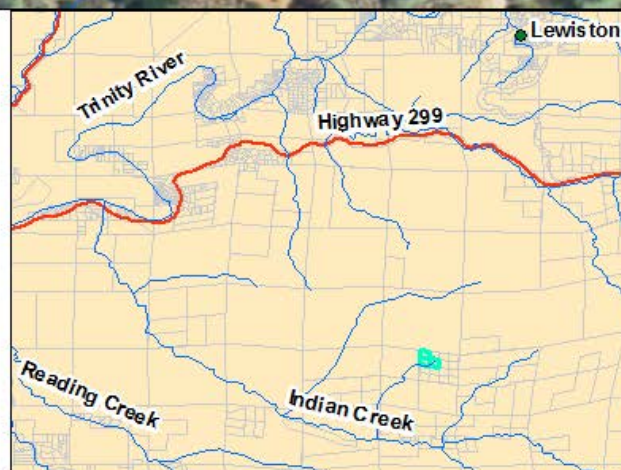
**Figure 1 – Site Diagram**

In the uppermost corner of the Property, I observed an outdoor cultivation area, denoted as OC1 on Figure 1 (Photo 1). In the background of Photo 1, the outdoor cultivation area, the greenhouse, and a recreational vehicle are visible. In the foreground lies water storage tanks, the well, and a storage shed. The well is denoted as W on Figure 1 and shown in Photo 2. Mr. Memari stated that the well was 280 feet deep, which is consistent with the application for the water well that the county provided State Water Board staff. There were two water tanks; one had a 5,000-gallon capacity and the other 550-gallon. Staff knocked on the tank walls and estimated that the larger was only holding approximately 1000 gallons at the time of inspection.

The shed near OC1 is denoted as S on Figure 1. There were chemicals inside the shed and in trash cans near the shed (Photo 5). With the exception of the Extreme Gardening Mykos, which was in a sealed bag, the chemicals were in capped, plastic containers. The following fertilizers/amendments were on a shelf in the shed: Dark Energy Plant Nutrient, Extreme Gardening Mykos, Botanicare Fulvex, and Cal-Mag. The following pesticides were on the shelf: OxiDate 2.0 (hydrogen peroxide), Monterey Garden Insect Spray (spinosad), Safer Caterpillar Killer, Bionide Sulfur, and Botanicare Hydroguard. There was also a container of pH 7.0 calibration solution on the shelf.

On the side of the road southwest of OC1, there was a large pile of soil that was uncovered and exposed to the elements (Photo 6). There was an earthen pad that was approximately three to four feet in height and was covered in straw, with a large tent, denoted as R on Figure 1. Derek Magnuson probed the fill pad to a depth of two feet.

On the southeast end of another outdoor cultivation area, denoted OC2 on Figure 1, I observed a padlocked shed that we did not investigate. Walking the perimeter of the disturbed area, we observed tension cracks on the side slopes (Photo 7). There was a 60-gallon mixing tank that was lying empty on a wooden pallet and not connected to any pipes. Approximately 10 feet from the mixing tank, staff saw the black irrigation pipes (seen throughout cultivation pad) were connected to white polyvinyl chloride (PVC) pipes, water valves, and a water timer. Near the connection, two small garden sprayers were lying on the ground. These were hooked up to the irrigation apparatus with smaller black, plastic pipes. Two pallets had debris consisting of zip ties, angle connectors, bamboo rods, and metal cans of what was likely joint compound. The cannabis plants were planted in potting soil with straw spread on the ground throughout the area.

On the road leading to the cultivation area, denoted as OC3 on Figure 1, there was another pile of dark soil; the pile lay between the northwest ends of OC2 and OC3. White PVC pipe connecting these two cultivation pads was buried where it crossed the road, but was otherwise exposed.

We continued southwest along the road to another outdoor cultivation area, denoted as OC4 in Figure 1. OC4 consisted of three terraces that were vegetated in between the terraces; OC4 had less disturbed soil than the other cultivation areas. OC4 had a similar irrigation system and similar conditions at this location, with straw spread among the cannabis plants. On the east side of OC4, just outside of its fence, I observed another pile of soil. I also observed a sealed, plastic container of Earth Juice fertilizer on the ground near the cannabis plants.

Approximately 250 feet south of OC4, on the central north end of APN 015-170-29, we observed a Class 3 stream crossing, denoted as C1 on Figure 1 (Photo 10). The channel/ditch did not have a ford or culvert and was approximately 24 feet long.

We continued traveling east along the main road to APN 015-170-34, and followed what appeared to be a skid road that crossed Frietas Gulch (Photo 11). The crossing is denoted as C2 on Figure 1 and consisted of cobbles. Photo 12 shows the upstream channel.

Staff followed the main road as it snaked around to see if it also crossed the tributary and observed another crossing, denoted C3 on Figure 1 (Photos 13 and 14). C3 was located at the headwaters of Freitas Gulch and had a black, corrugated plastic 12-inch culvert. Derek Magnuson determined the soil content at this crossing to be brown, clayey sand.
