North Coast Regional Water Quality Control Board

Name and Location of Facility Inspected Saggio Hills, 16840 Healdsburg Avenue Healdsburg, CA, 95448 Construction General Permit WDID #: 1 49C375878 App ID: 470857 CWA Section 401 Water Quality Certification WDID #: 1B06169WNSO		Inspection Date November 29, 2018	Inspection Time 1:00 pm-6:00 pm
Names & Titles of On-Site Representatives and Consultants Chris Theiss – The Robert Green Company Bob Keys – The Robert Green Company Clay Thistle – City of Healdsburg Curt Bates – City of Healdsburg Linda Ruffing – City of Healdsburg Steve Stenson – Advanced Stormwater Protection Kevin Kruizenga – Advanced Stormwater Protection Jim Fane – Carlile/Macy		Consent¹ Provided? Yes <input checked="" type="checkbox"/> No <input type="checkbox"/>	Notified of Inspection? Yes <input checked="" type="checkbox"/> No <input type="checkbox"/>
Regional Water Board Inspector Name & Title Heidi M. Bauer - Engineering Geologist, P.G. Paul Nelson - Engineering Geologist, P.G., C.Hg. Josh Luders - Water Resources Control Engineer Jeremiah Puget - Senior. Environmental Scientist (Specialist) *Referred to as inspection team / staff

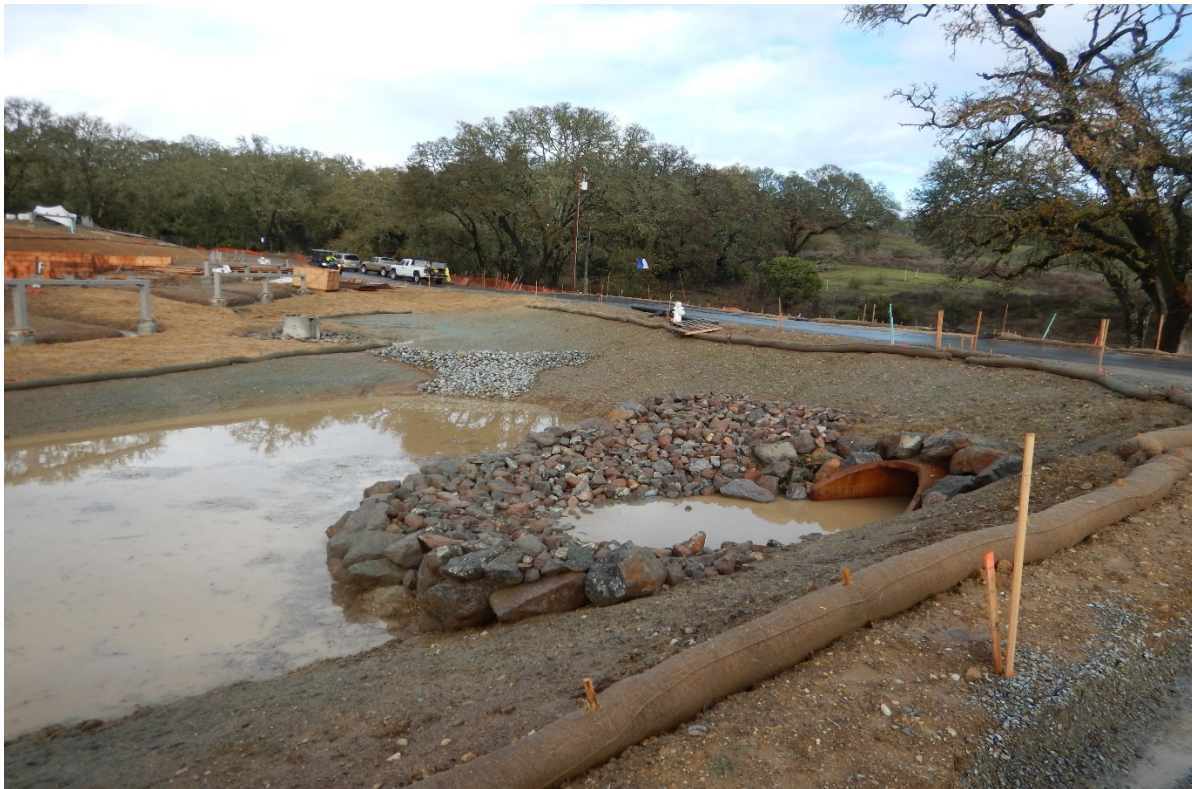
Picture 13 above. Resort Area. Instream sediment basin.

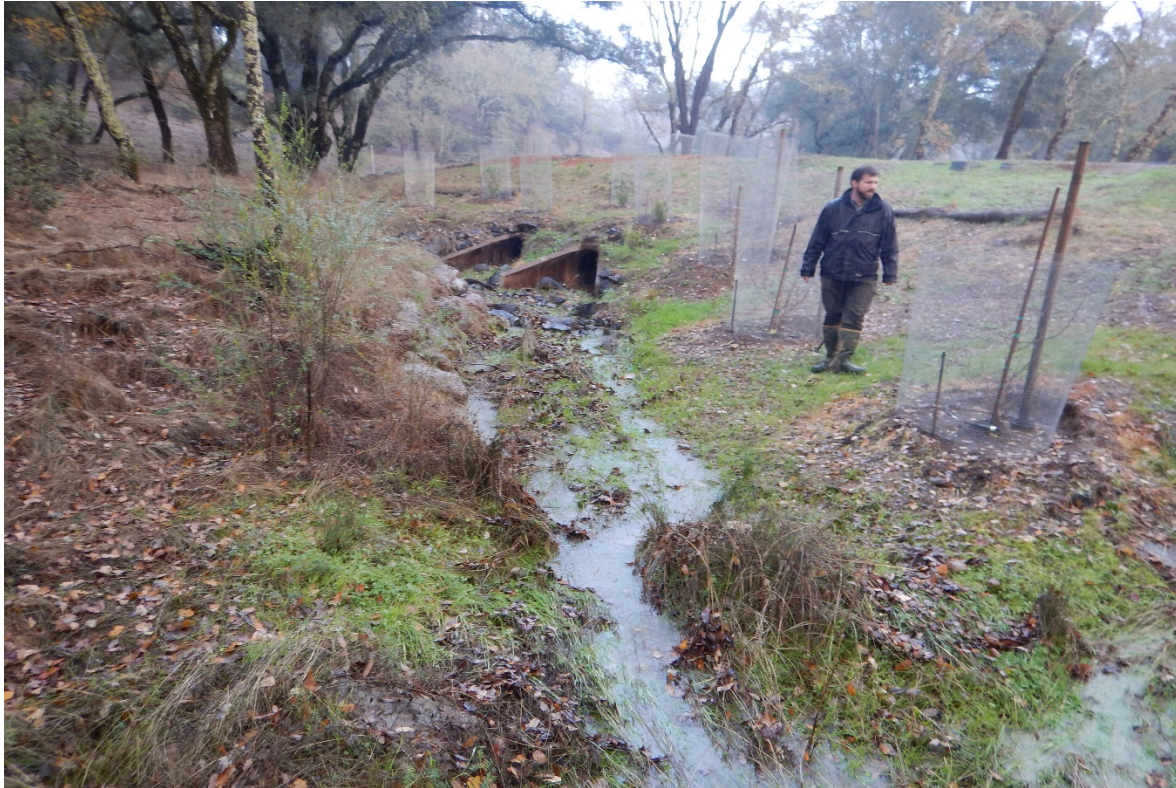
Picture 47 above. Shannon Road upstream of lower entrance to Road 8.

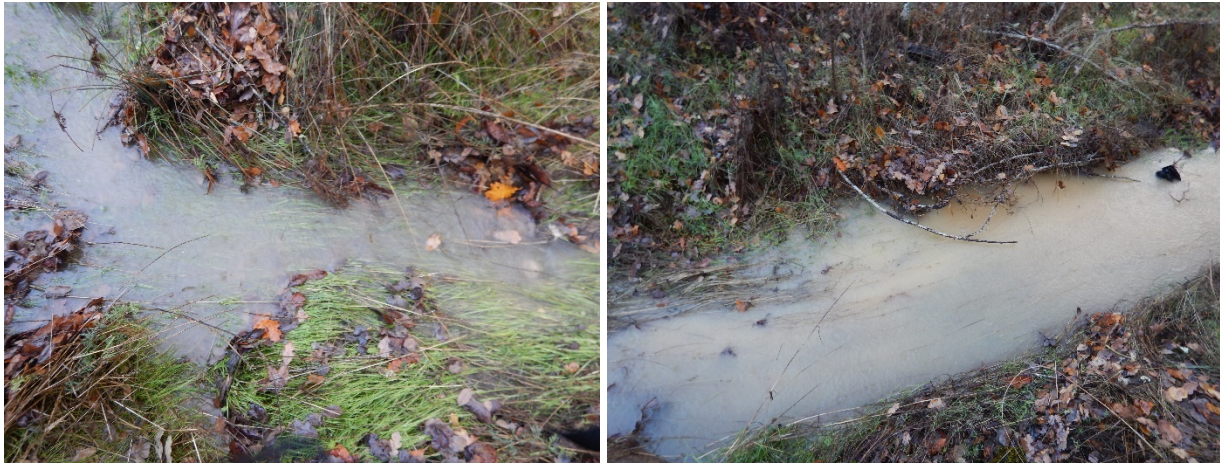
Picture 49 above. Upstream and downstream of confluence of Road 5 tributary and Shannon Road tributary.

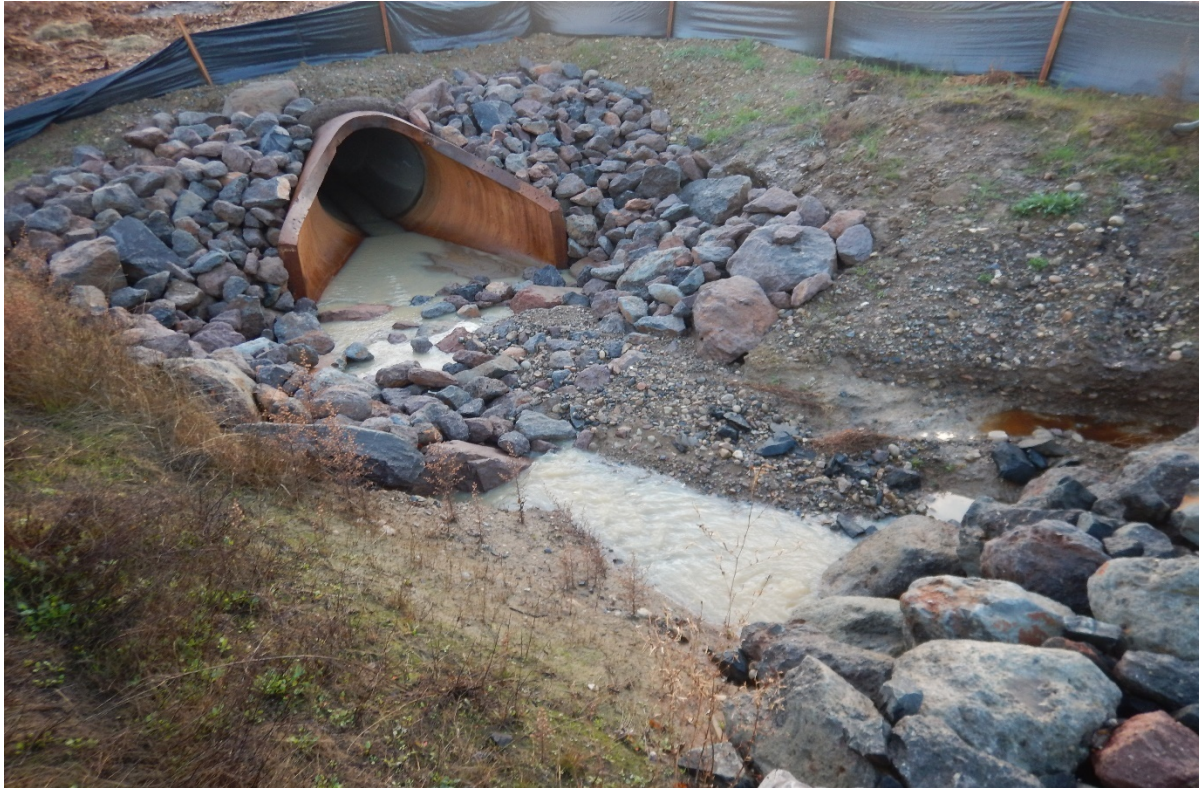
Picture 61 above. Shannon Road. Culvert inlet along Shannon Road that carries flows beneath Passalacqua Rd. Culvert outlets into Foss Creek.

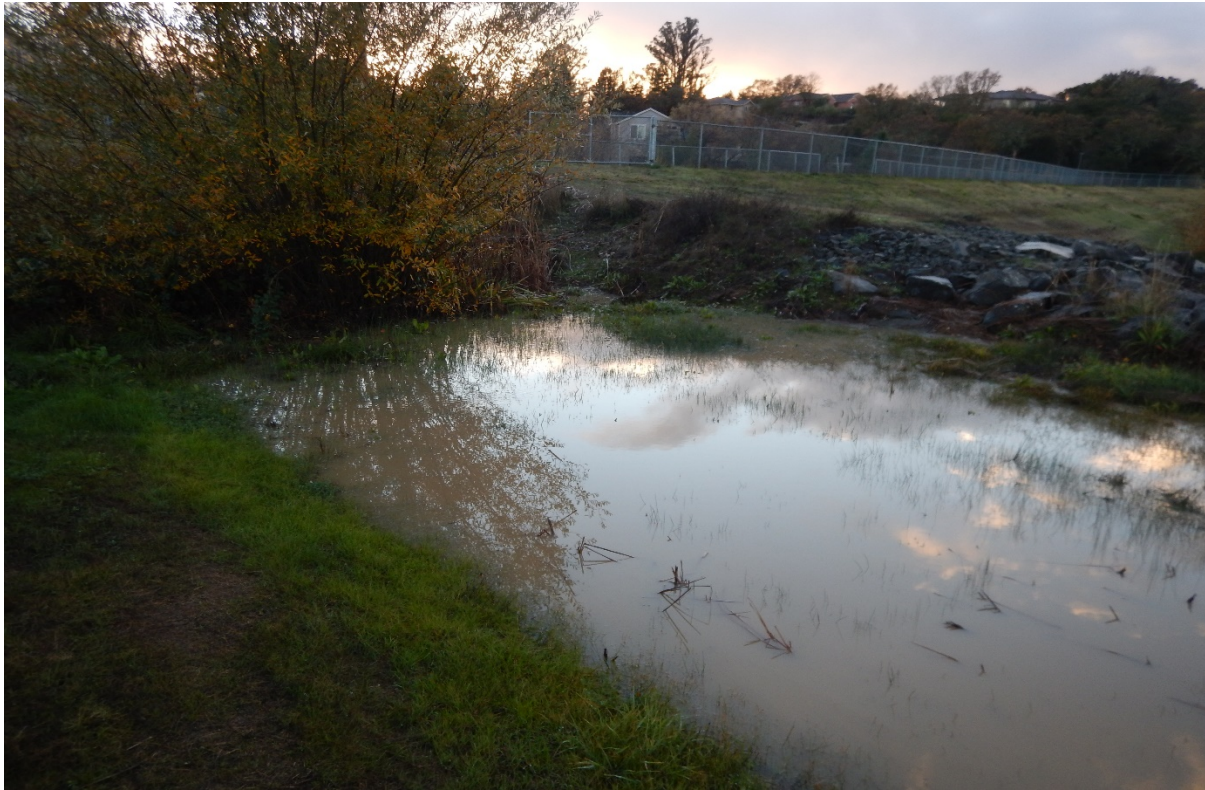
Picture 65 above. Confluence of Foss Creek and unnamed tributary from Parkland farms. City detention pond bypass to the right.

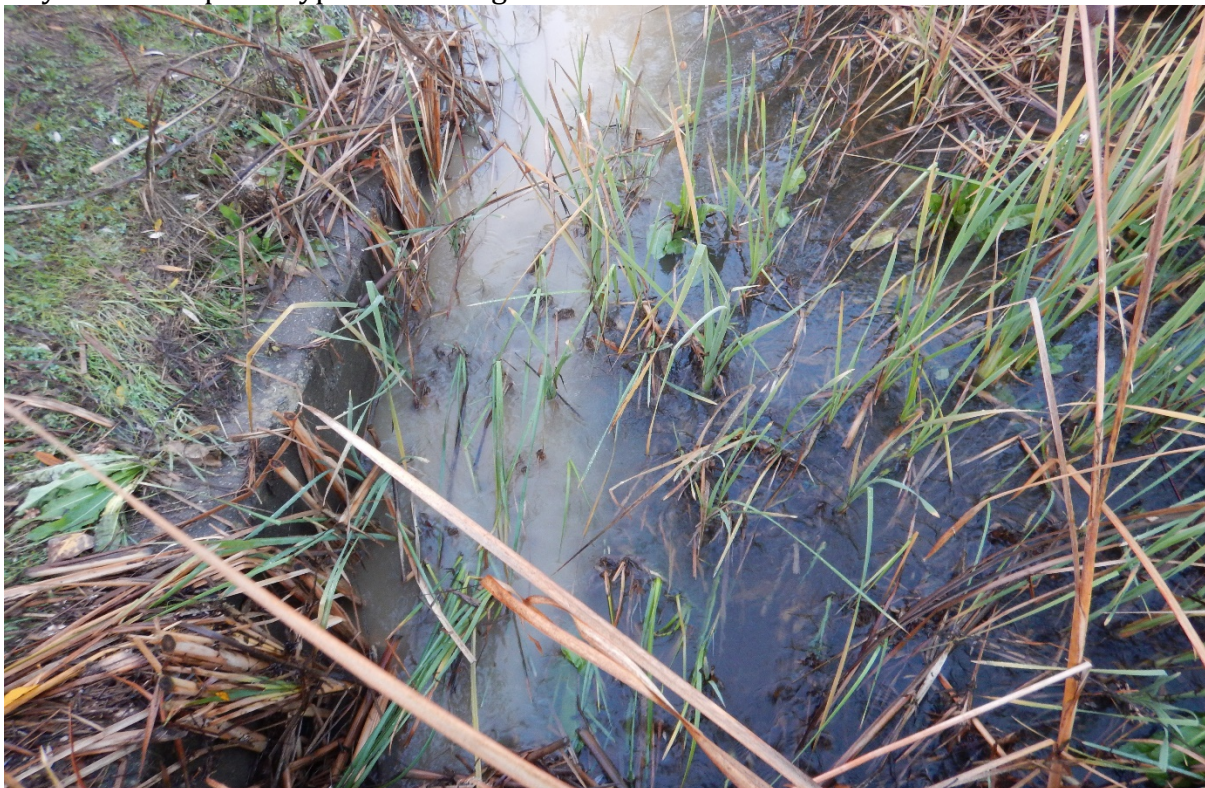
Picture 66 above. Confluence of Foss Creek and unnamed tributary from Parkland farms.
