North Coast Regional Water Quality Control Board

**Edwin Barahona Property
Inspection Date December 6, 2017
CIWQS Place ID: 843667**

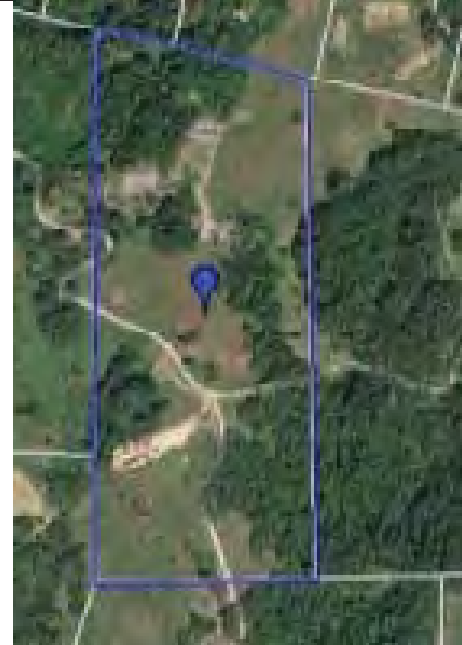
Figure 2. 2016 Aerial photograph and parcel boundaries. Note the greenhouse complex in northern portion of parcel; this is the primary area of cultivation in the upper area near the house. In the southern portion of the property I observed a 50,000 gallon water bladder (see graded area), and outdoor cultivation with some greenhouses and associated pads.

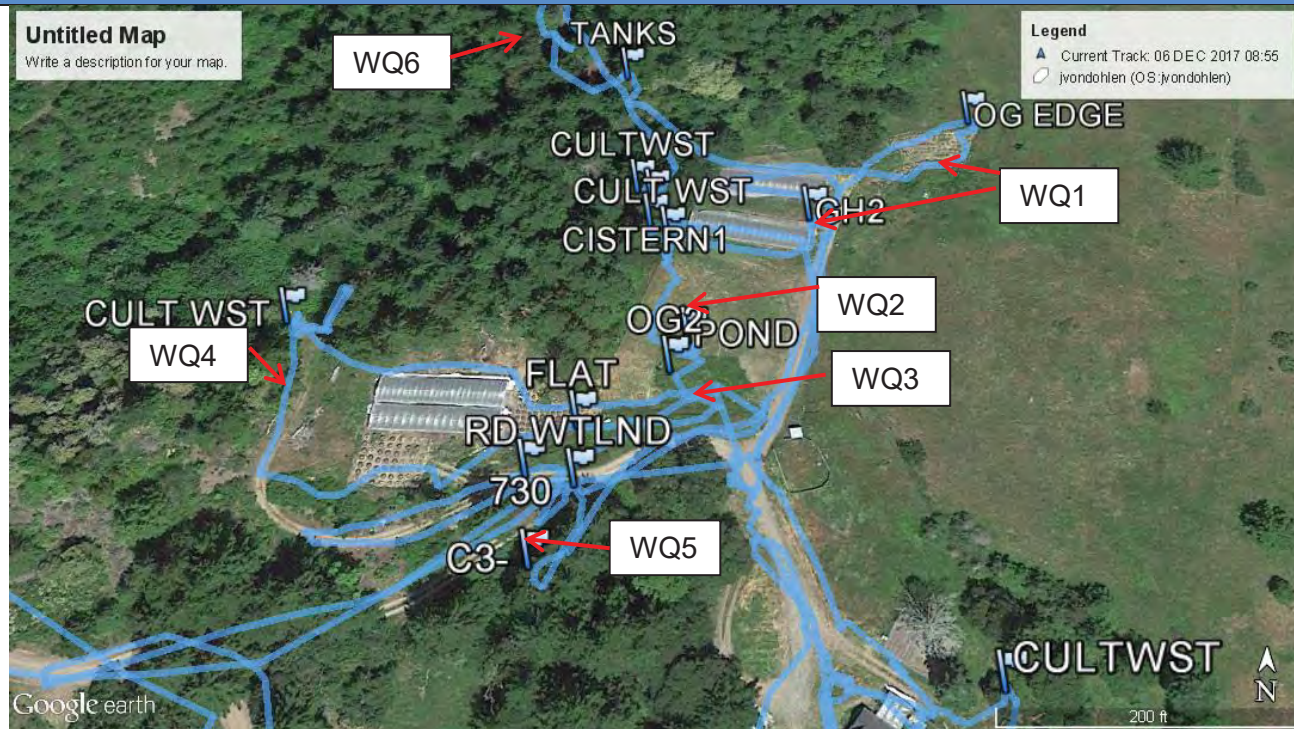
Figure 3. Inspection Map – Upper Property. Blue track identifies inspection route as recorded on Garmin GPS. Way points indicate features of interest with respect to water quality. WQ numbers (WQ-X) indicate a water quality violation or recommendation.

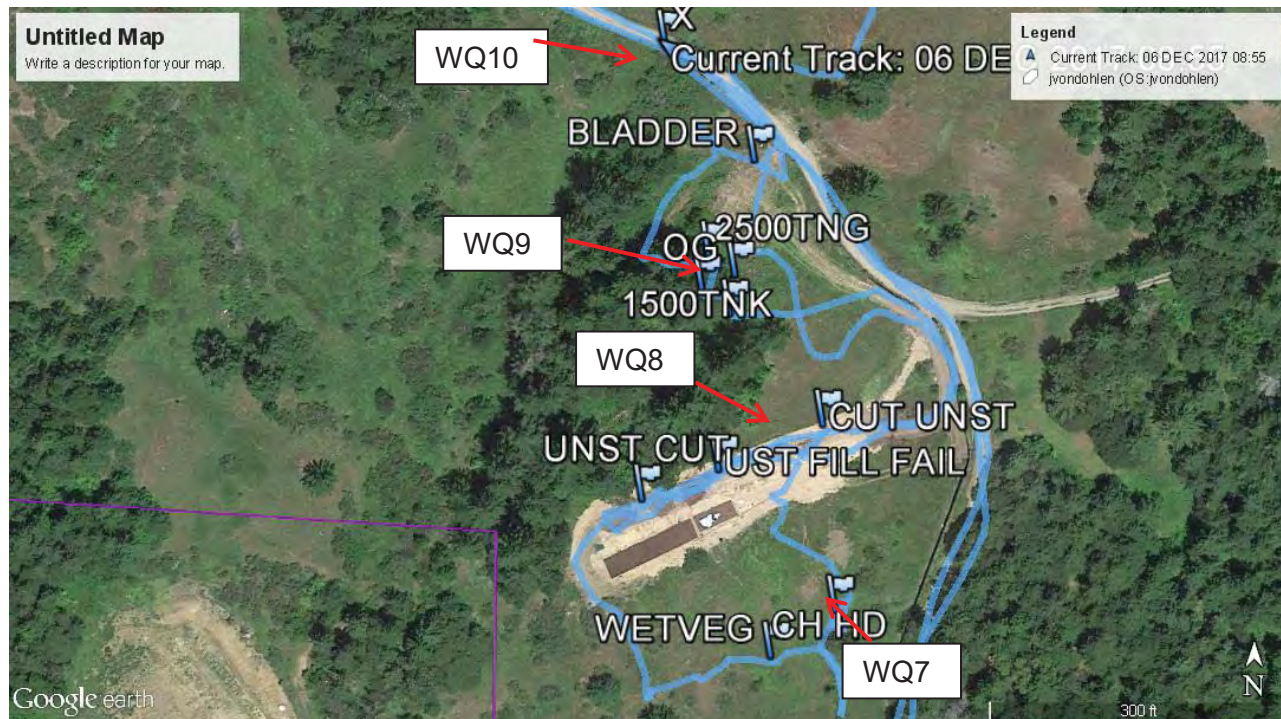
Figure 4. Inspection Map – Lower Property. Blue track identifies inspection route as recorded on Garmin GPS XXX. Way points indicate features of interest with respect to water quality. WQ numbers (WQ-X) indicate a water quality violation or recommendation.

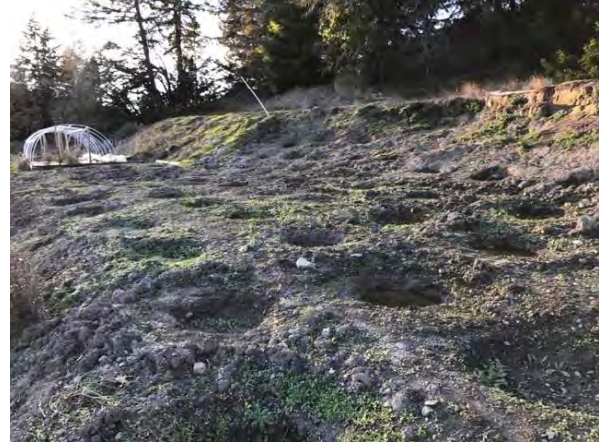
Figure 26. Greenhouse terraces.

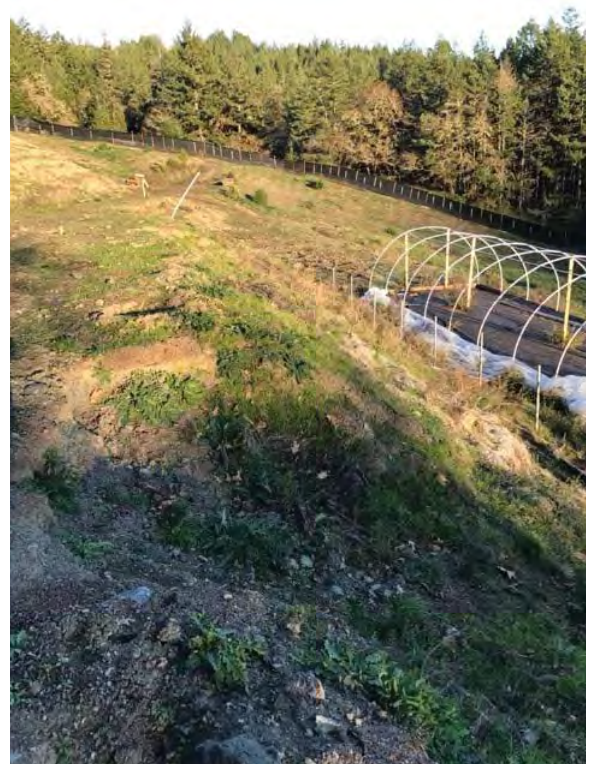
Figure 27. Greenhouse terraces.

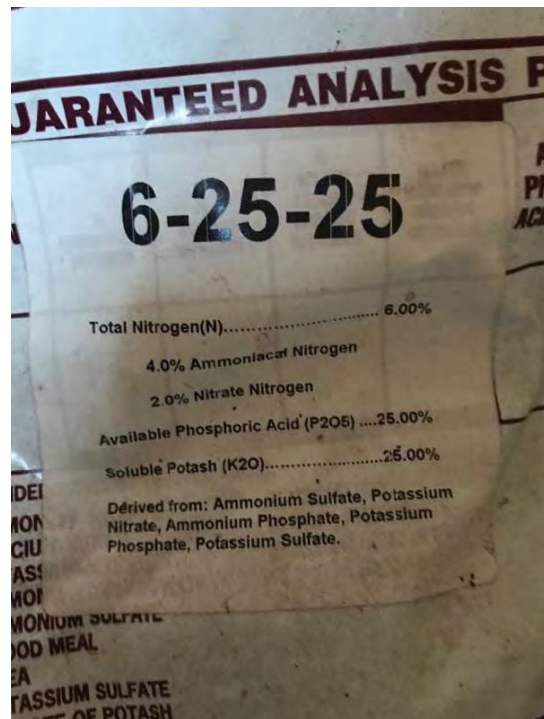
Figure 31. Detail of label on fertilizer bag.

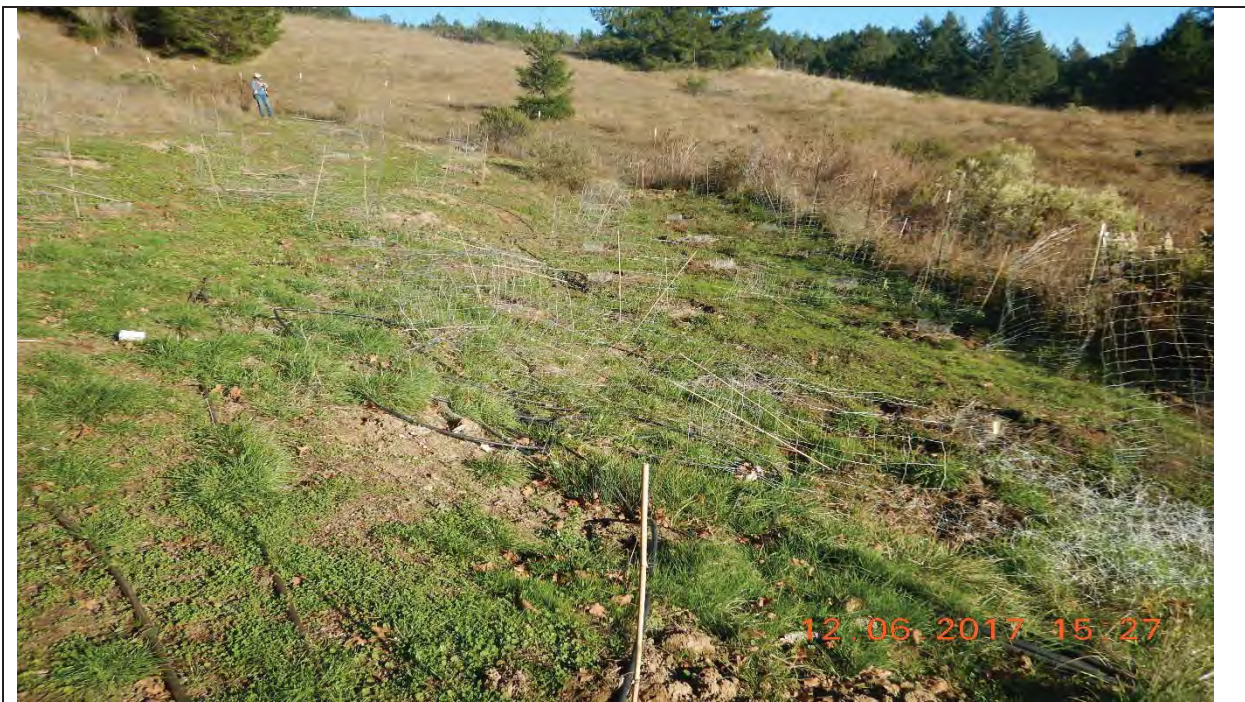
The northern cultivation site (Photo 1) appeared to be saturated with water, with the presence of a small pond 25 feet long, 15 feet wide and 4 feet deep (Photo 2). Adona and I checked the grounds for sources of pipes feeding this pond, but only found a pipeline going across it, as well as another attached hose leading to the greenhouses above (Photo 3), telling us this pipe was attached to a pump to draw water from the pond. The presence of the pond, with no surface water connectivity, leads us to conclude that groundwater is shallow across this hill slope. Ponding water was also observed on the roads throughout the site (Photo 4).

Photo 1. Northern Cultivation Site facing east.

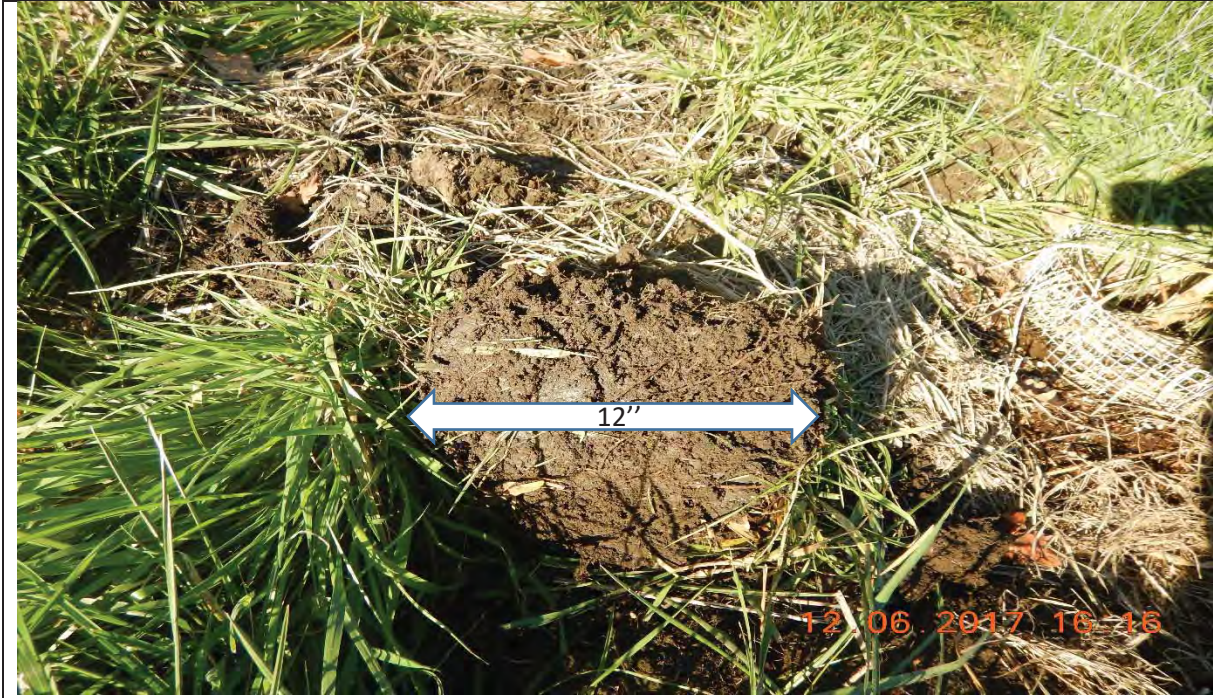
Photo 6. Soil sample #2 dug into the road cut (Nikon CoolPix camera captured contrast and color brighter in the photograph, than originally observed in the field).

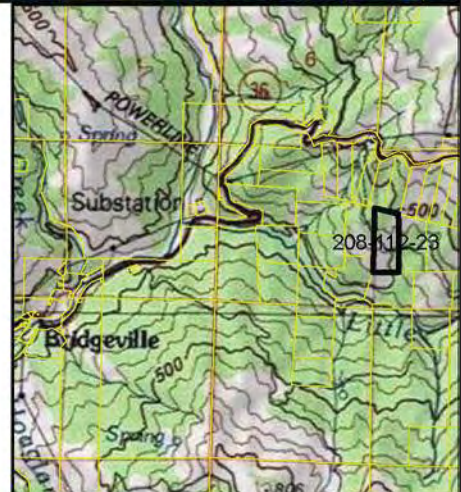
Figure 1: Wetland Impacts
APN: 208-112-023-000

Using the parameters measured above, I used the location of wetland vegetation and wetted soil to draw a boundary around areas I suspected to possess the three characteristics of a wetland (Figure 1).

It is my opinion that this area supports wetland resources, which were not set back within the mentioned cultivation sites. This includes the greenhouse overlaid within the orange polygon (Figure 1) in the northern cultivation site. In the course of the inspection, we may have not recognized the entire wetland boundary across the entire parcel. It will be up to the land owner to hire a professional to identify the boundary of wetland and stream boundaries, in order to find areas for cultivation site setbacks, or seek the proper permits for such activities within the wetland.
