North Coast Regional Water Quality Control Board

ORDER TO SUBMIT INFORMATION

Subject: **Order Requiring Submittal of Technical Information** Pursuant to California Water Code section 13267 (Order)

File: Kuehl Property, 380, 441, & 553 Henrietta Road, Lewiston, Trinity County APNs 025-350-53-00, 025-350-52-00, and 025-350-22-00 (the Property); CIWQS Place ID No. 827450, WDID Nos. 1A161078CTRI and 153C378658

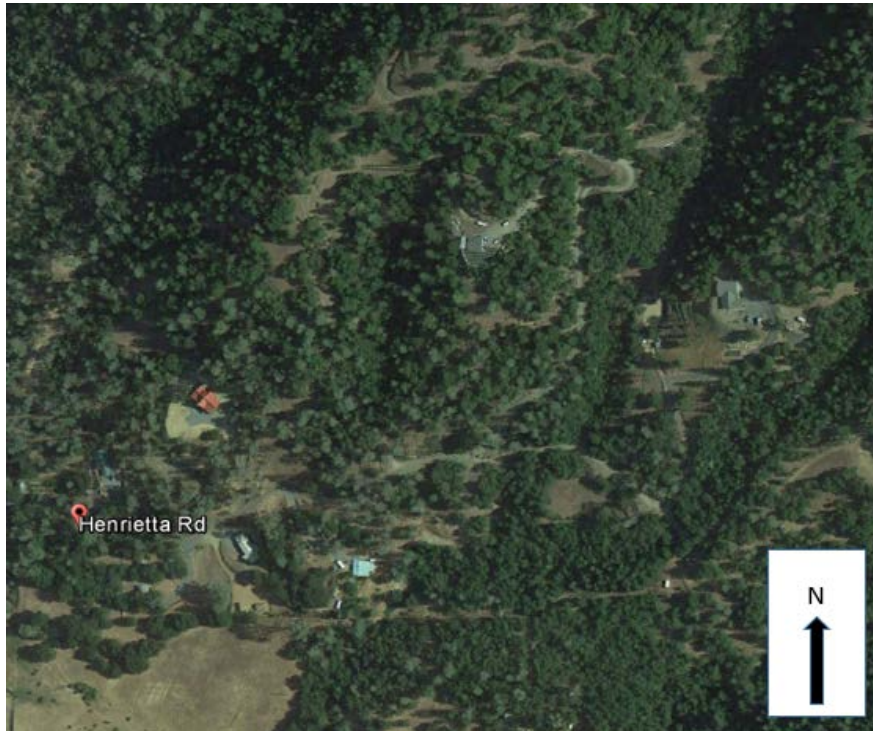
Figure 3: Aerial view of the three parcels and surroundings on July 10, 2012 (Google Earth Pro, 2017). No visible signs of significant land disturbance (Edited by Luders, J.).

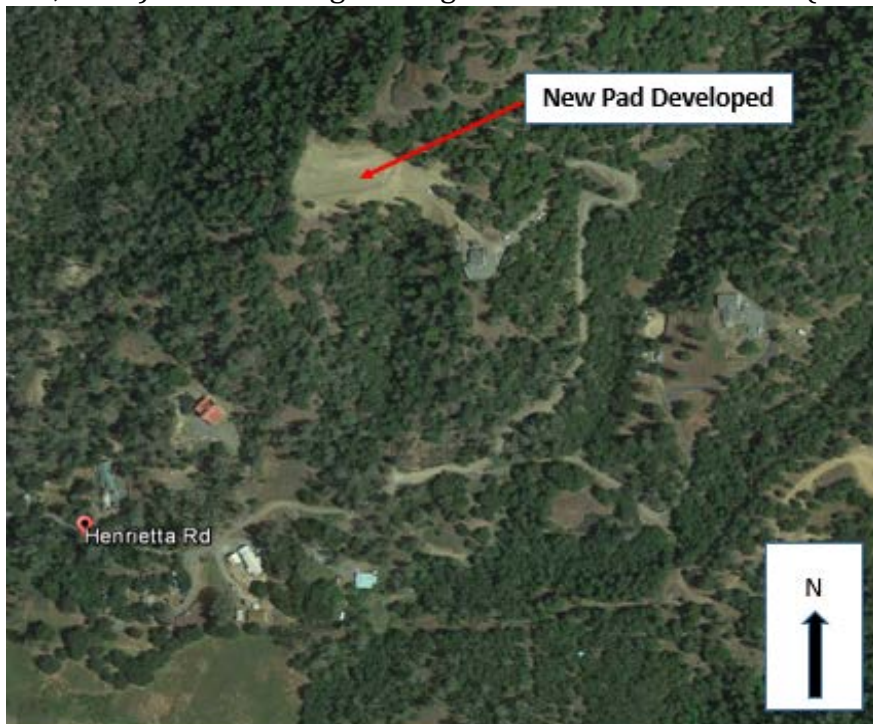
Reviewing Google Earth historical imagery, I attempted to identify the approximate time line of property development. Based on available imagery, it appears that sometime between July 10, 2012, and May 28, 2016, the Property was progressively graded and developed.

Based upon the apparent level of compaction or lack thereof, and the rough unwashed surface of many near vertical, recently worked earthen hillslopes, staff expect that most of the construction occurred sometime before May 28, 2016, and continued on into 2017. Mr. Kuehl told staff he was not yet finished with the work and he intended to perform additional work.

Figure 4: Aerial view of the three parcels and surroundings on May 28, 2016 (Google Earth Pro, 2017). A large clearing is now visible (Edited by Luders, J.).

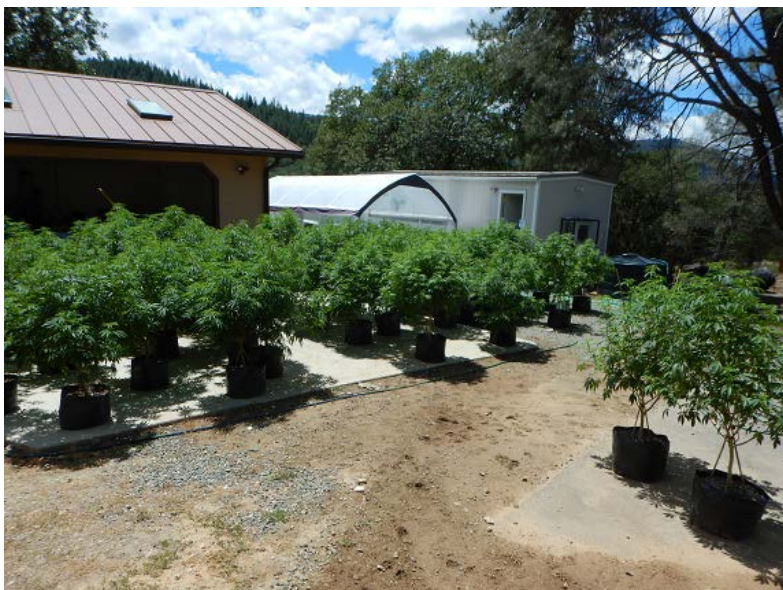
Staff observed an approximately 2,000 square foot cannabis cultivation area on APN 025-350-22-00. Staff did not observe any significant water quality concerns on this parcel.

Figure 31: ~2000 ft.² cannabis cultivation on APN 025-350-22-00 (DSCN1322 Luders, J.).
