**North Coast Regional Water Quality Control Board**

Subject: **Notice of Violation** of State Water Resources Control Board Order No. 2014-0057-DWQ *General Permit for Storm Water Discharges Associated with Industrial Activities* (Industrial General Permit) and Denial of Proposed Extension to Submit Level 2 ERA Technical Report

File: Mark West Quarry, 4611 Porter Creek Road, Sonoma County  
WDID No. 1 49I009813

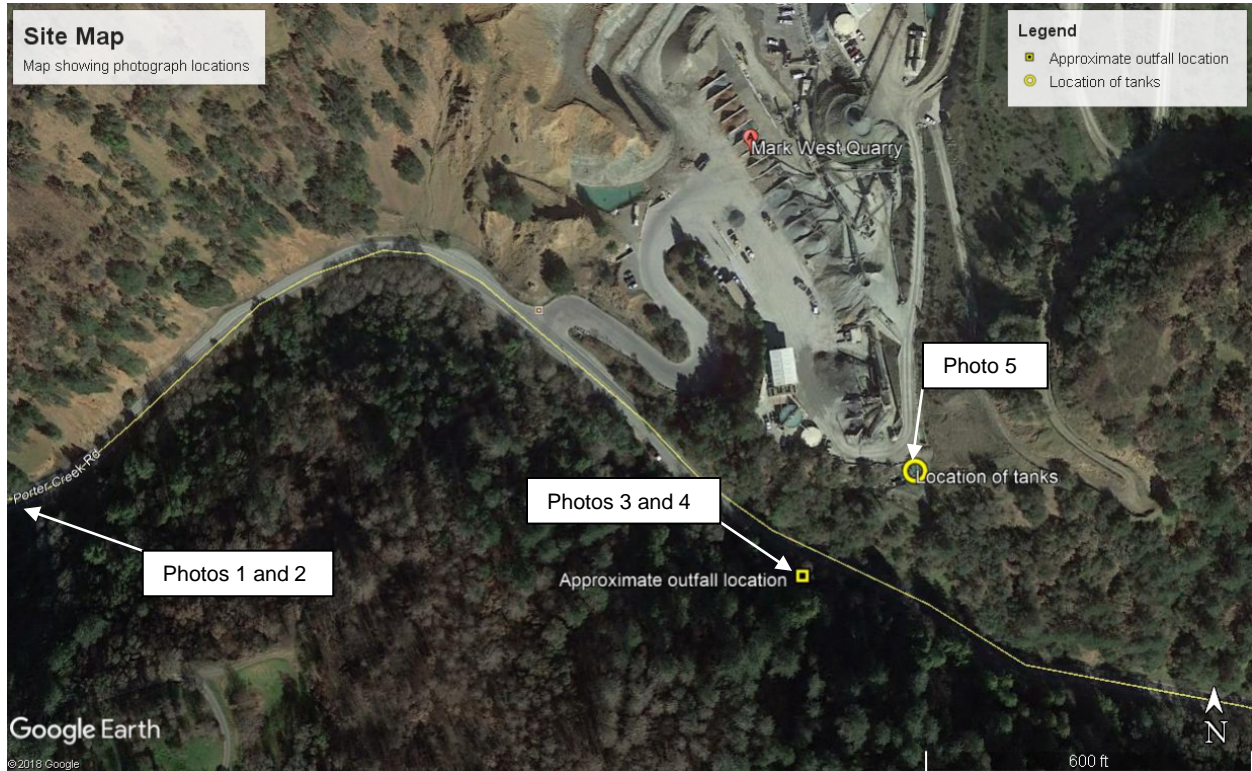
On December 16, 2018, Kason Grady, a Regional Water Board Supervisor, notified the Stormwater Unit of a discharge of sediment to Porter Creek. Kason Grady sent photographs to Regional Water Board staff indicating highly turbid water in Porter Creek near the facility.

Site map with photo locations.

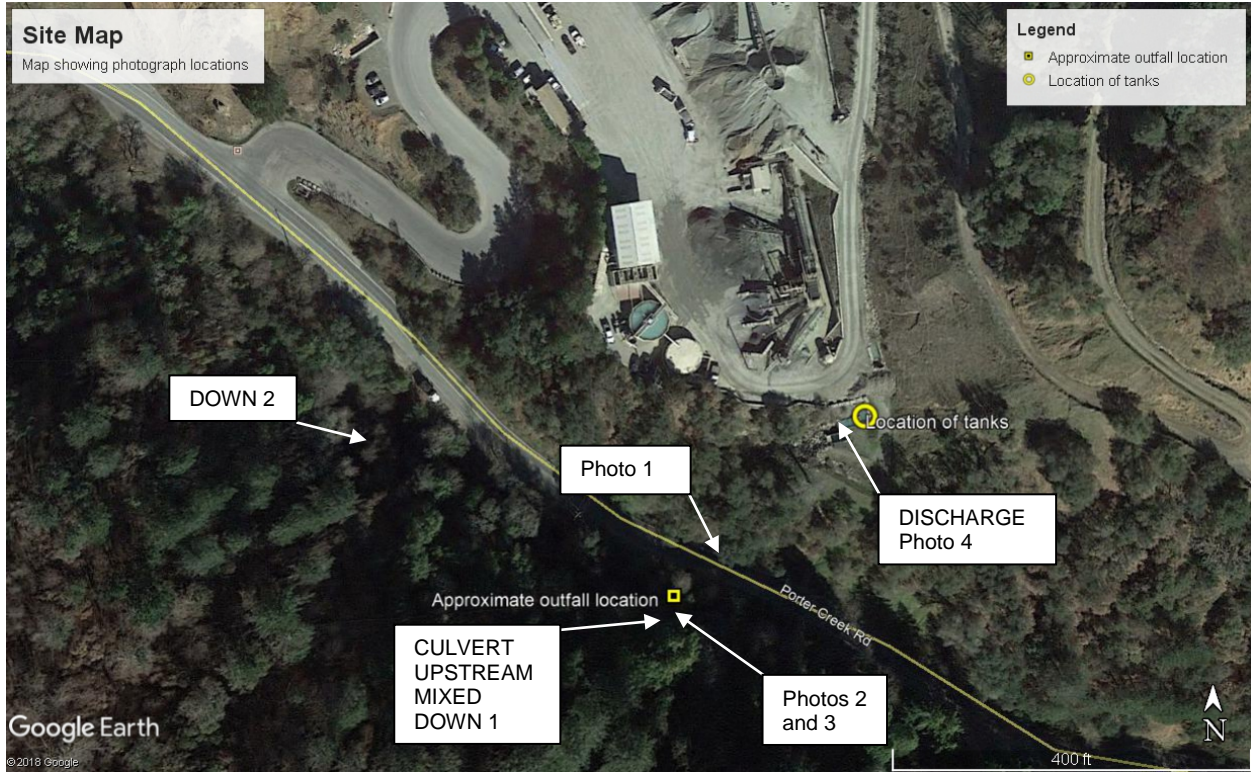
The inspection team signed in at the facility office and met with site representatives Bryan Goodrich and Anthony Boyle. We then proceeded to the eastern settling tank location and observed the discharge of stormwater from the settling tanks to the drainage on the eastern side of the site (see map and photograph below). Staff were accompanied by site representatives Anthony Boyle and Bryan Goodrich during the site inspection.

Site Map showing sample and photograph locations.

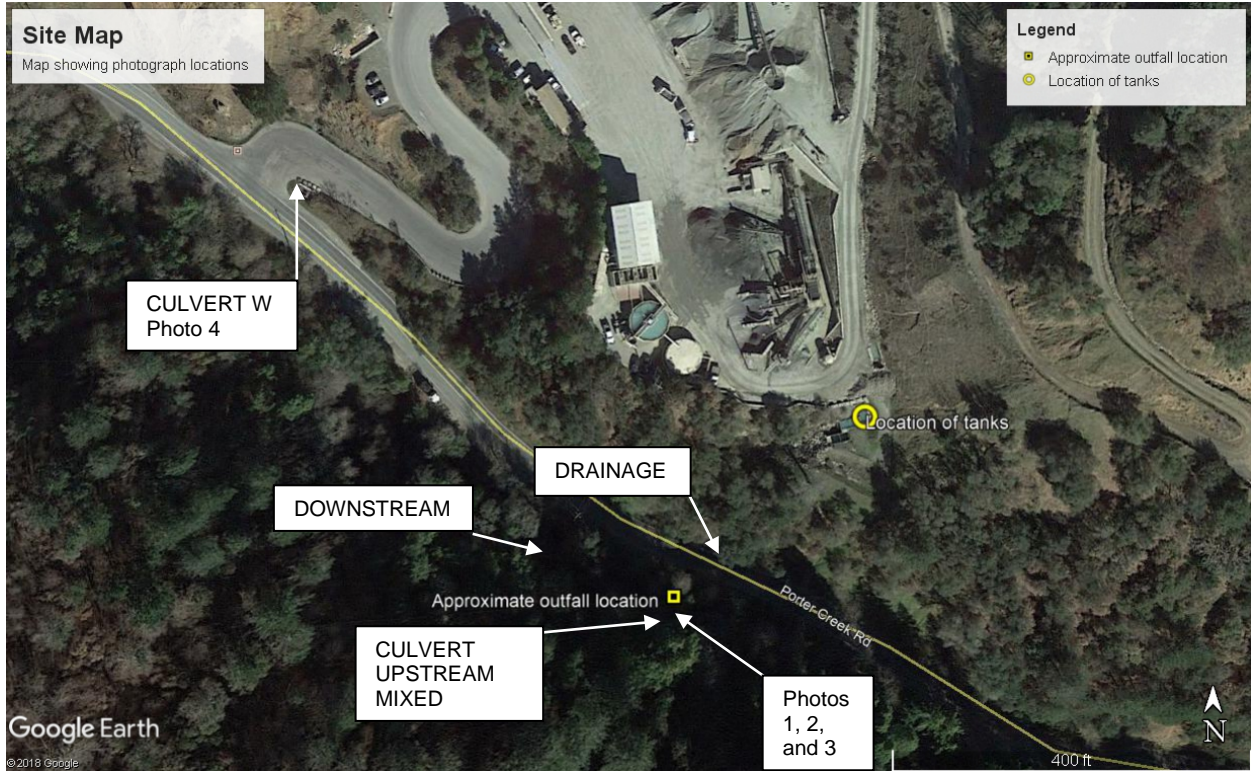
The inspection team proceeded to collect water samples from the area of discharge (see site map below) and the western discharge location (CULVERT W). The water samples were collected directly from the culvert discharges and Porter Creek using a sample dipper and laboratory-supplied sample containers. The samples were logged on a chain of custody form and placed under secured refrigerated conditions pending analysis at the Regional Water Board laboratory for turbidity.

Site Map showing sample and photograph locations.

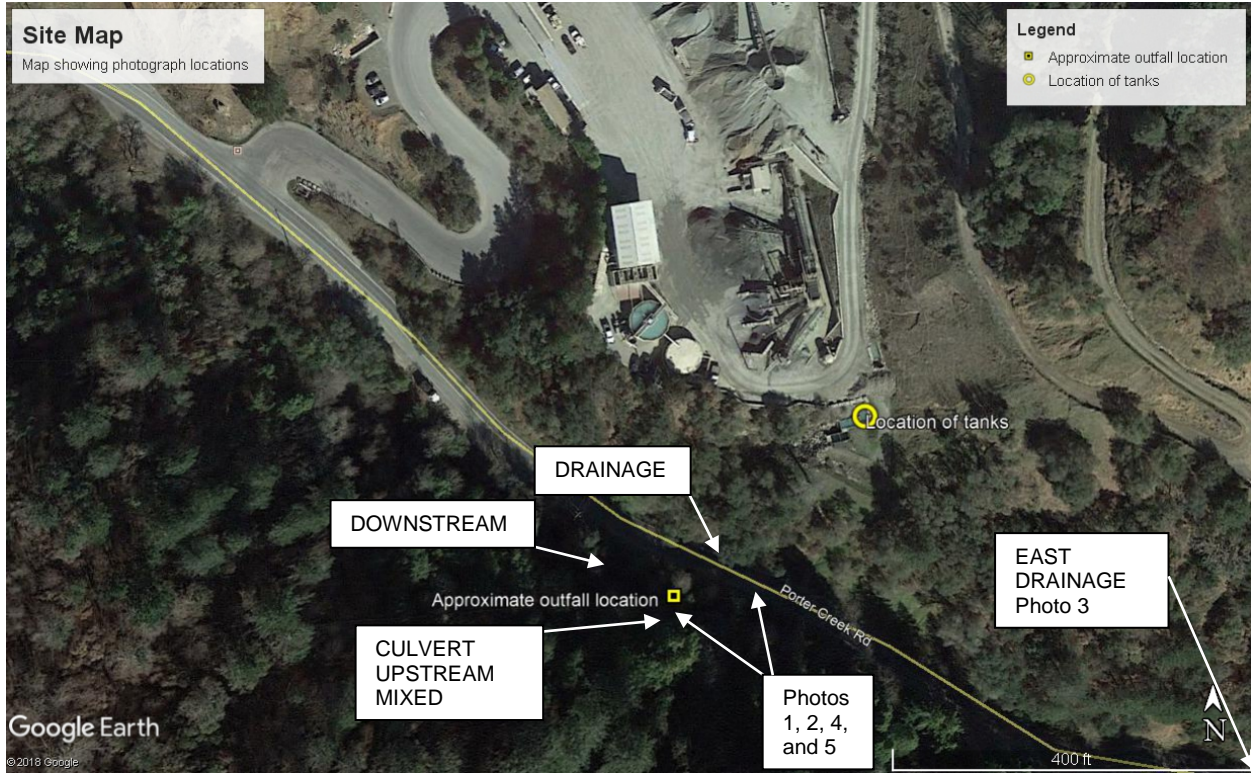
The inspection team proceeded to collect water samples from the areas of discharge (see site map below). The water samples were collected directly from the culvert discharges and Porter Creek using a sample dipper and laboratory-supplied sample containers. The samples were logged on a chain of custody form and placed under secured refrigerated conditions pending analysis at the Regional Water Board laboratory for turbidity.

Site Map showing sample and photograph locations.
