North Coast Regional Water Quality Control Board

Name and Location of Facility Inspected Krasilsa Pacific Farms LLC Sonoma County Assessor's Parcel Numbers: 116-240-006-000, 115-210-002-000, 117-260-002-000, 117-260-001-000, 117-270-002-000, 117-270-003-000, and 117-270-006-000		Inspection Date January 14, 2019	Inspection Time 8:30 am-12:30 pm
Property Ownership Hugh Reimers, Manager Krasilsa Pacific Farms LLC 7030 Faught Road Santa Rosa Ca, 95403		Consent Provided? Yes X No <input type="checkbox"/>	Notified of Inspection? Yes X No <input type="checkbox"/>
Inspection Attendance Hugh Reimers, landowner/developer Cort Munselle, P.E., Munselle Civil Engineering and Land Surveying North Coast Regional Water Quality Control Board Staff (Staff): Ryan Bey - Environmental Scientist (ES) Brian Fuller - Engineering Geologist (EG) Paul Nelson - EG, P.G., C.Hg. Josh Luders - Water Resource Control Engineer (WRCE) Scott Gergus - EG Jeremiah Puget – Senior ES (Specialist) Sonoma County Department of Agriculture (SCACO) Staff Andy Casarez John Bishop

Weather Conditions at the Time of the Inspection: Overcast		Facility Receiving Water Names: Unnamed Tributaries to Little Sulphur Creek, Big Sulfu

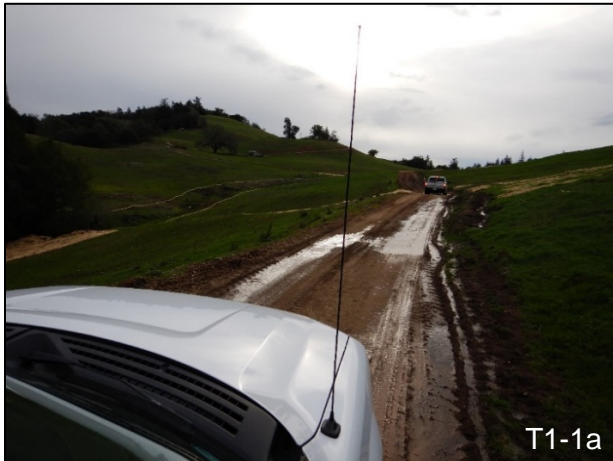
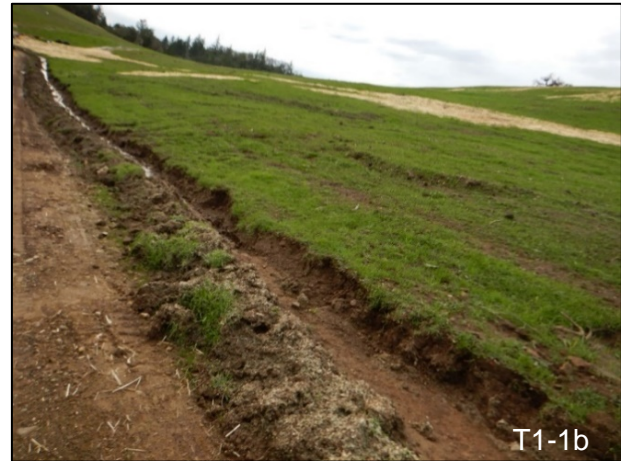
Rills, ruts, and depressions in the road, likely formed by surface flow eroding the road-surface, were filled with water (Photo 1). Without improvement to road drainage features, the roads will likely continue to erode. Furthermore, portions of the road are hydrologically connected to adjacent watercourses, enabling the fine sediment eroded from the road surface to be transported to receiving waters.

Photo T1-1a: Poorly drained road between WQ 1.4 and 1.6, along the road segment between RP2 and RP3, Photo T1-1b: Berm preventing road surface flow from draining into inboard ditch along the road segment between WQ 1.4 and 1.6.

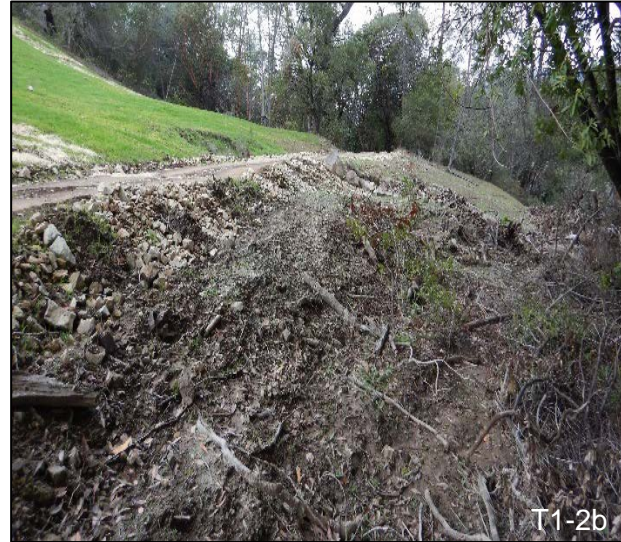
Staff observed earthen spoils apparently associated with road construction/reconstruction and/or maintenance activities along and below the road's outboard edge (Photos T1-2a and T1-2b).

Photos T1-2a and T1-2b: Northeast side of the road between WQ 1.2 and 1.3, showing perched fill associated with road construction/reconstruction and/or maintenance pushed over the road's outboard edge.

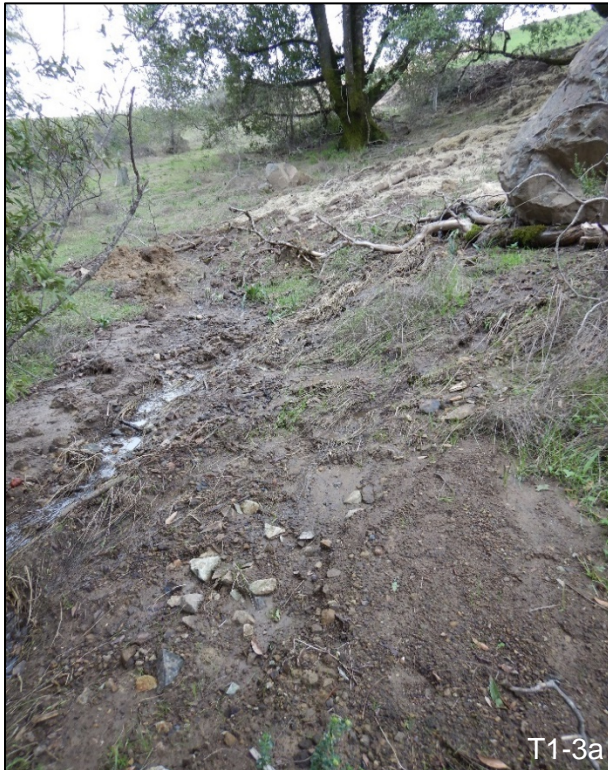
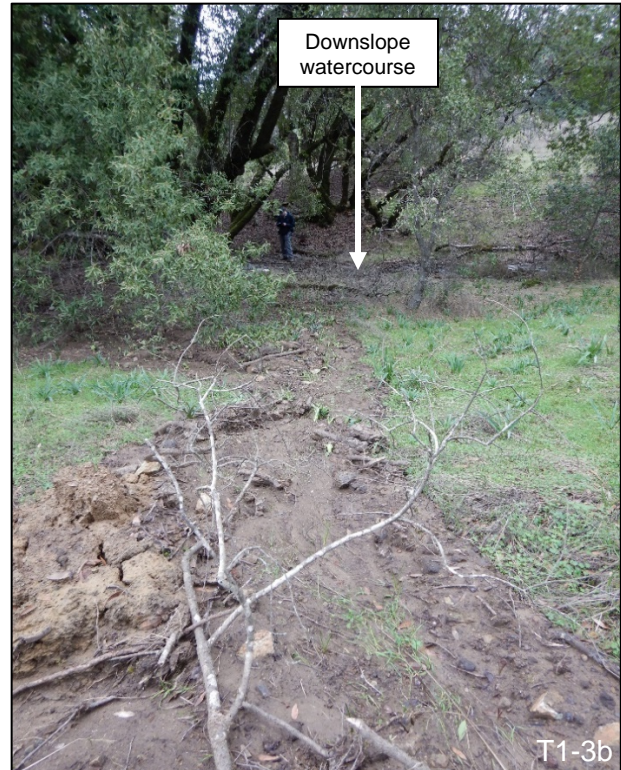
Surface flow has begun eroding this perched fill and depositing fine sediment into downslope watercourses (Photos T1-3a and T1-3b).

Photos T1-3a and T1-3b: east side of road near WQ 1.3 showing eroded perched fill draining downslope into an adjacent watercourse.

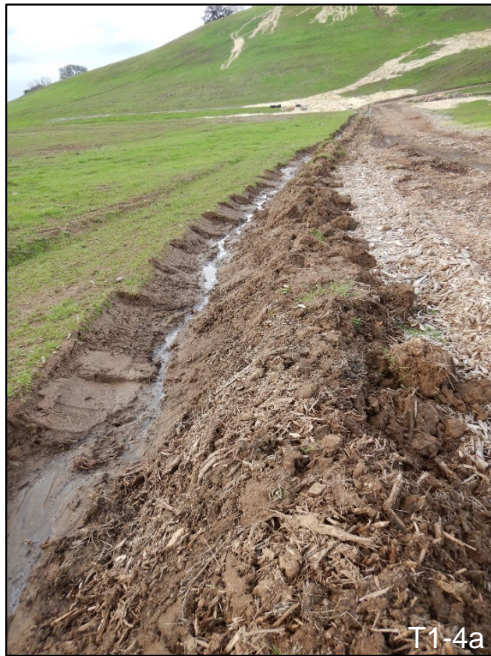
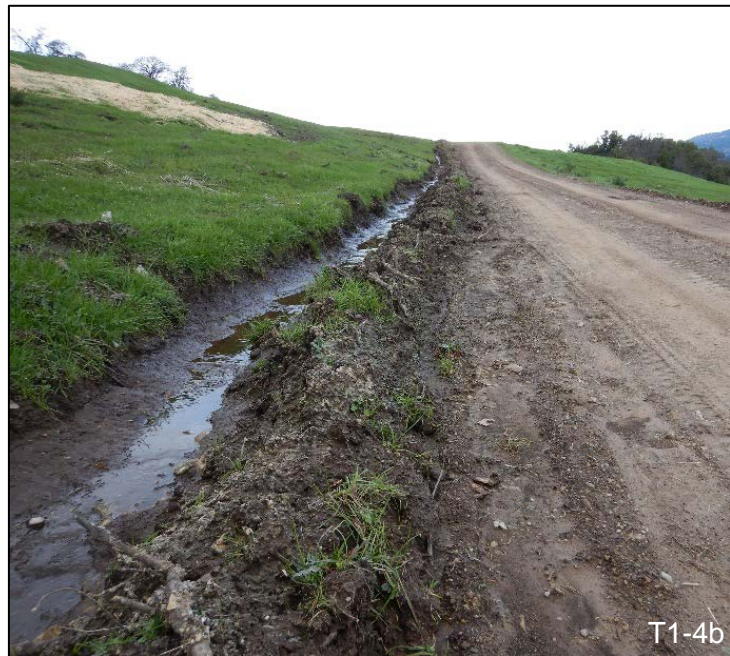
The inboard ditch along the road appeared to have been recently constructed or reconstructed (Photo T1-4a). Earthen spoils associated with roadwork had been placed on the road, forming a berm between the road and the inboard ditch (Photo T1-4b). Surface flow from the hillslopes above the road drained into the inboard ditch. There appeared to be an insufficient number of ditch relief culverts to effectively drain inboard ditch flow captured from both the hillslopes and road. Long portions of the inboard ditch drain into adjacent watercourses.

Photo T1-4a: Looking southwest towards WQ 1.6 at recently a constructed inboard ditch (note bucket scar marks) and photo T1-4b: Looking northwest from WQ 1.6 at the berm between the road and ditch.

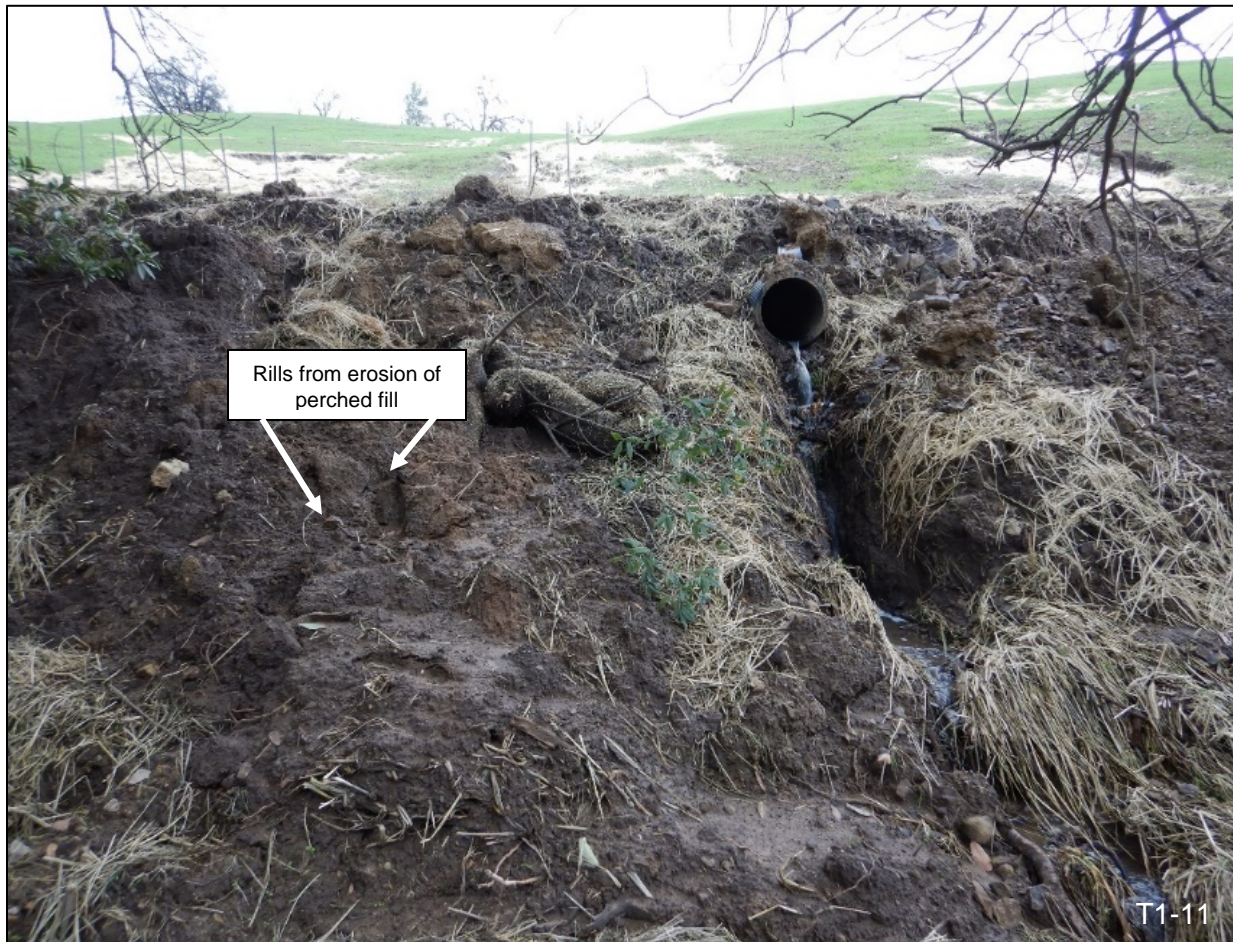
Photo T1-11: Plastic culvert installed in perched fill and not to grade at WQ 1.3. Note lack of rock armoring and erosion of material downslope of the culvert outlet. Also note rills forming from erosion on unconsolidated fill adjacent to the culvert outlet.

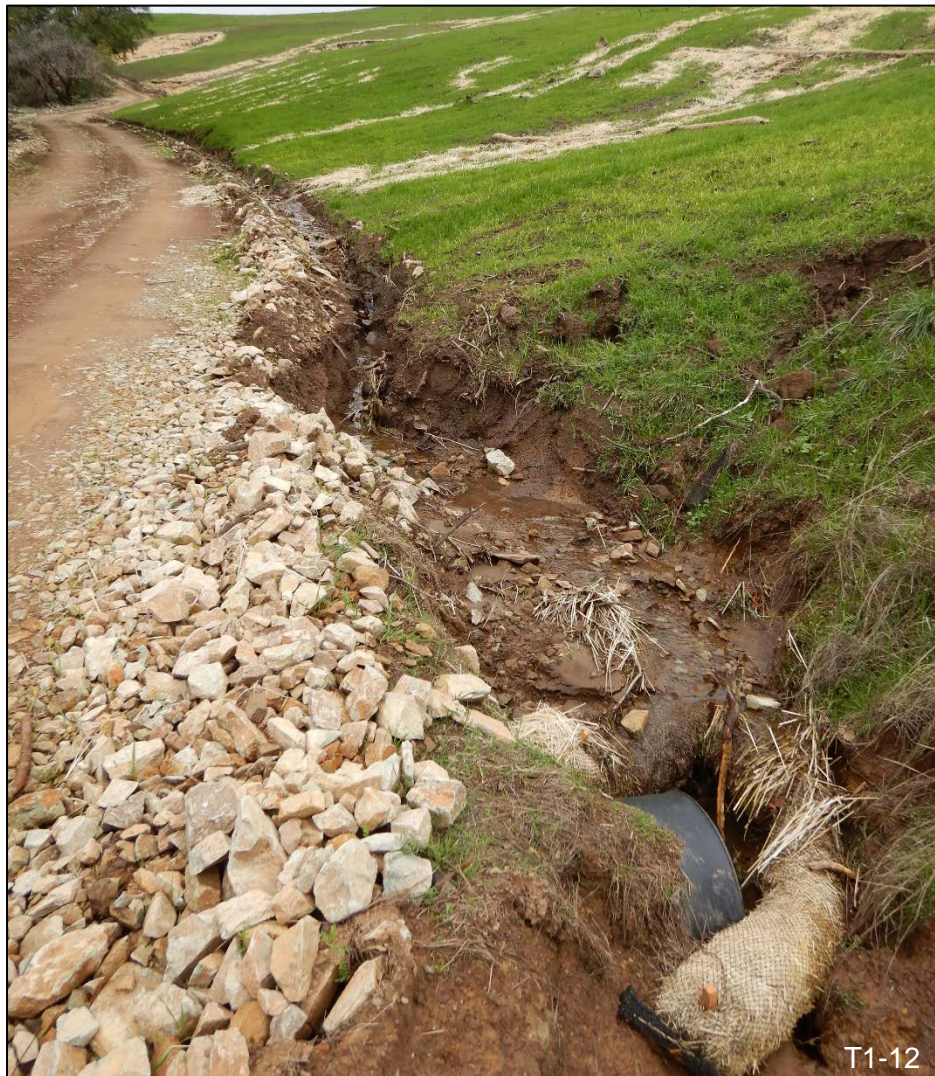
Culverted crossing inlets were partially blocked with erosion control material (straw wattles) and debris and sediment, leaving them vulnerable to plugging during periods of high flow (Photo T1-12). If the inlet plugged, flow would be redirected onto the road and would likely erode the road's surface and perched fill below the road's outboard edge

Photo T1-12: Watercourse crossing culvert, at WQ 1.2. The inlet is mostly blocked by straw wattle and debris and sediment accumulated in the inboard ditch

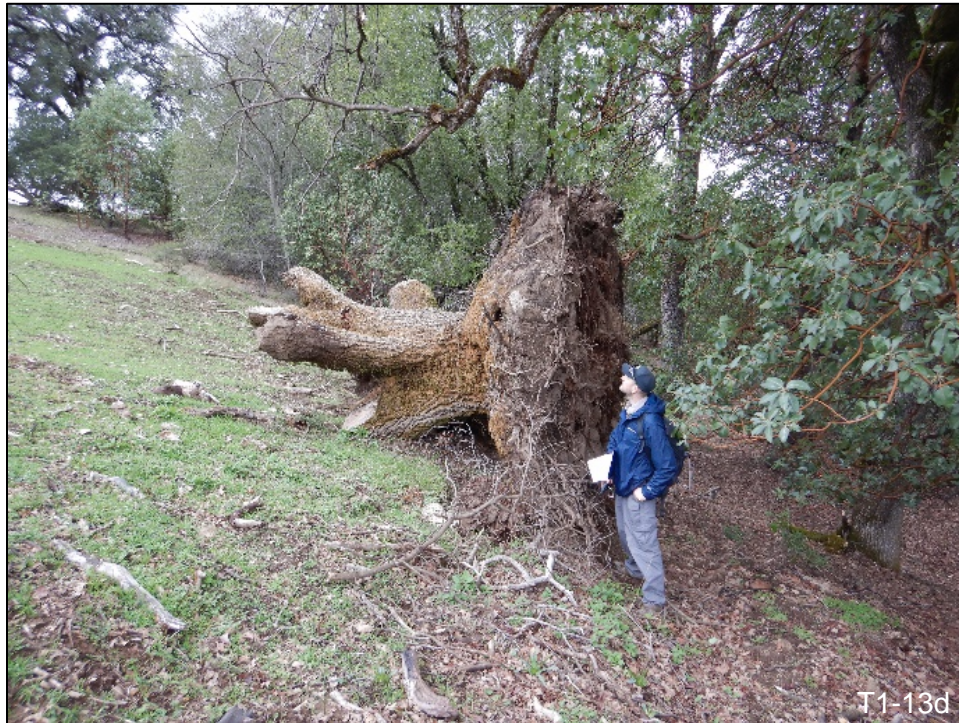
Photos T1-13d: Trees and earthen material removed during activities south of WQ 1.1.

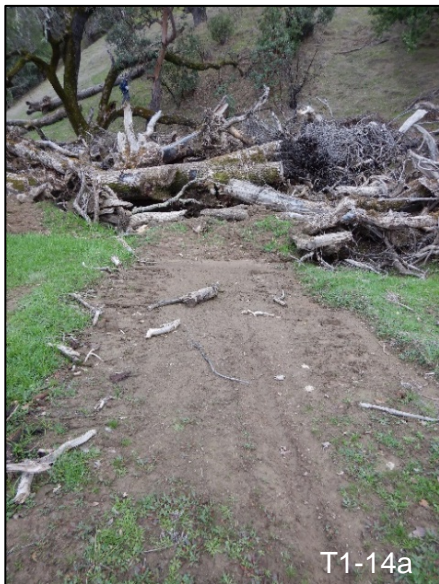
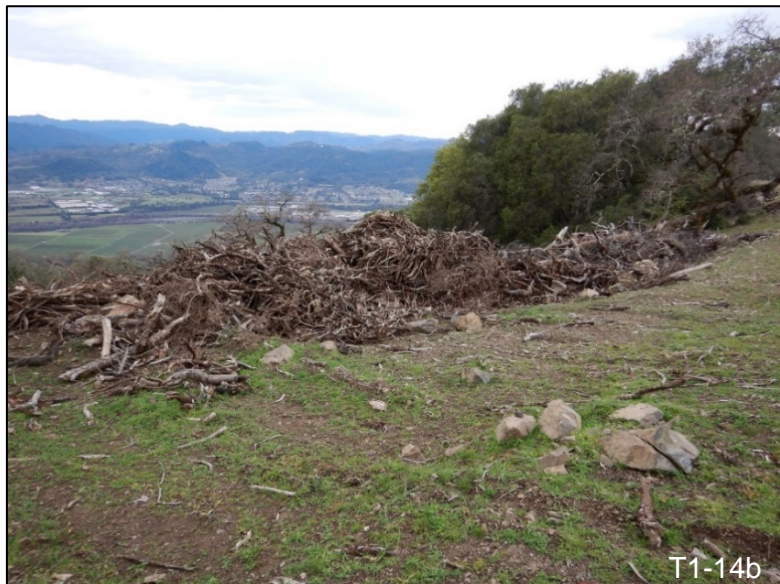
Photo T1-14a: Bulldozer tracks at the top of the slash pile in the watercourse at WQ 1.8, Photo T1-14b: shows evidence of ripping and grading activities at WQ 1.9, overlooking Cloverdale (South West).

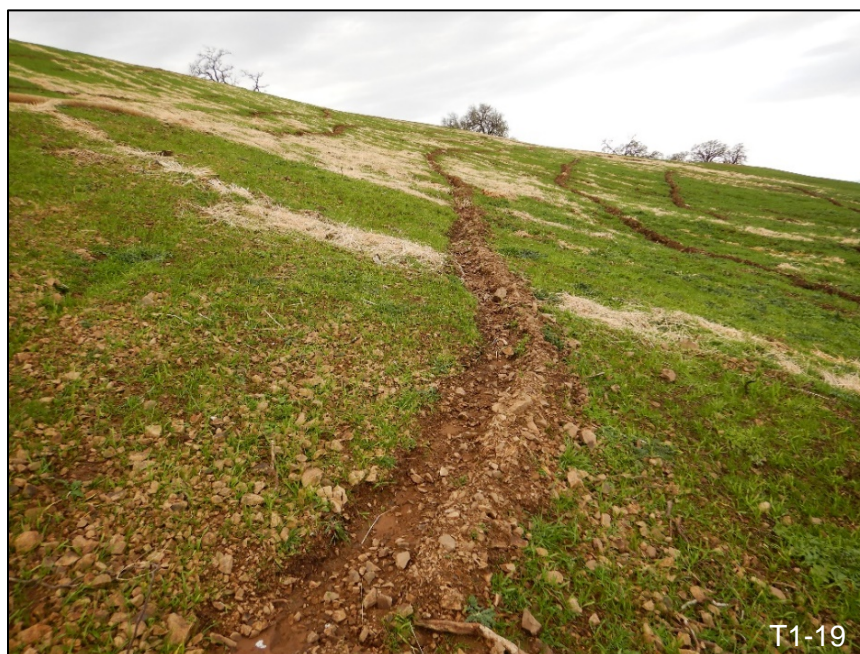
Photo T1-19: Looking northwest from WQ 1.7 at wattles in trenches on the hillslope above the road.

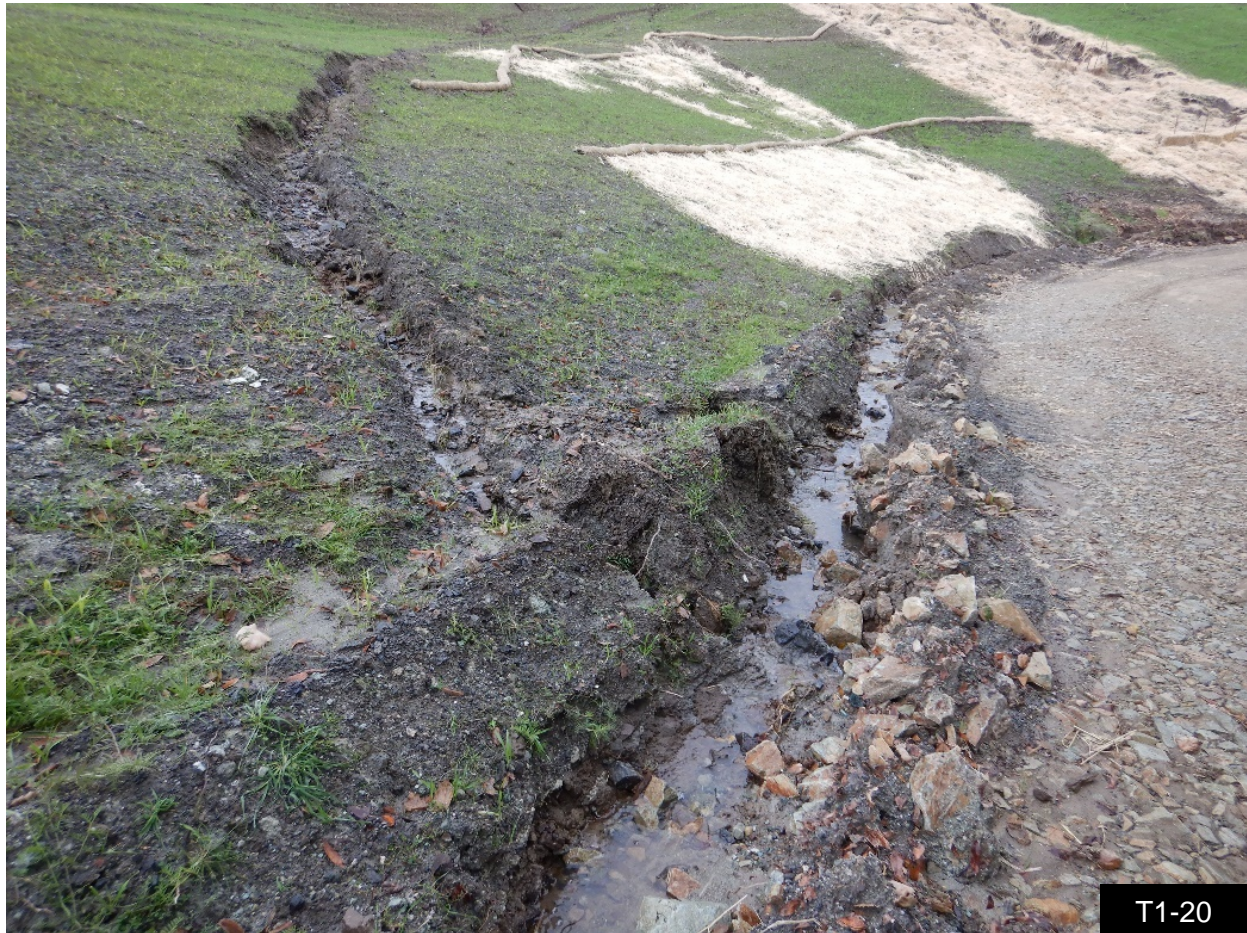
Several trenches did not contain wattles, and functioned as ditches, intercepting hillside surface flow. The off-contour trenches that drained steeply downslope were wider and deeper than on-contour trenches because of ongoing erosion (Photo T1-20). Trenches were connected and drained into the road's inboard ditch. The inboard ditch drained into ditch relief culverts or drained directly into watercourse crossings.

Photo T1-20: Shows a gully on the hillslope above the road between WQ 1.3 and 1.4, presumably formed when runoff concentrated in an off-contour wattle trench. The trench width and depth were increasing downslope along the off-contour wattle trench.

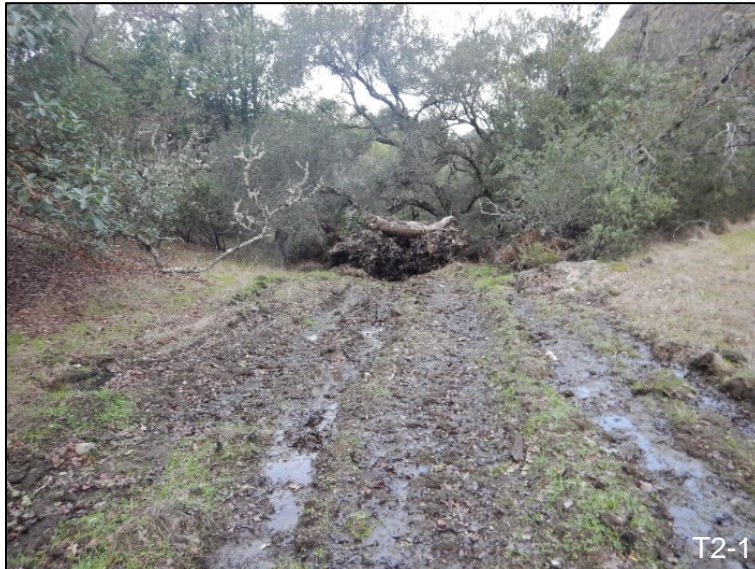
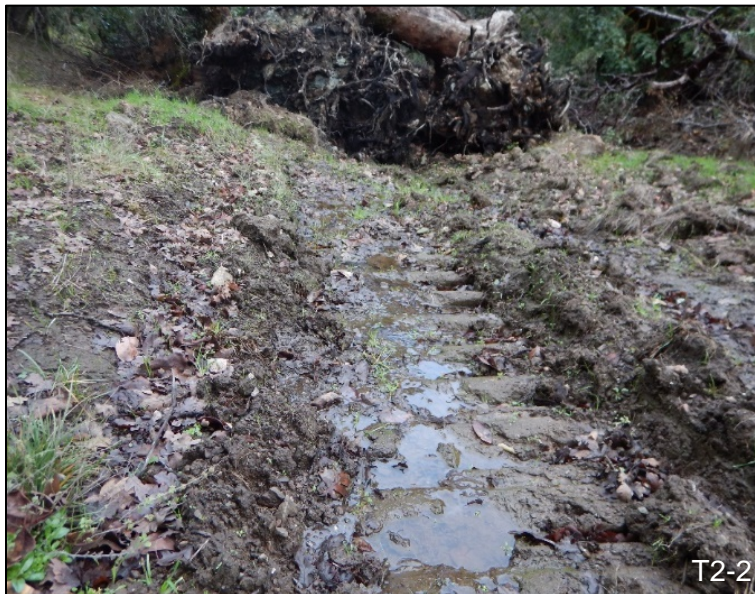
Photos T2-1 and T2-2: Show slash/debris pushed by heavy equipment into the headwaters of an ephemeral stream, looking north from Location WQ 2.1- 2.2. Free water is present in heavy equipment tracks and flowing beneath the slash pile. Soil and debris pushed into the watercourse poses a threat to water quality.

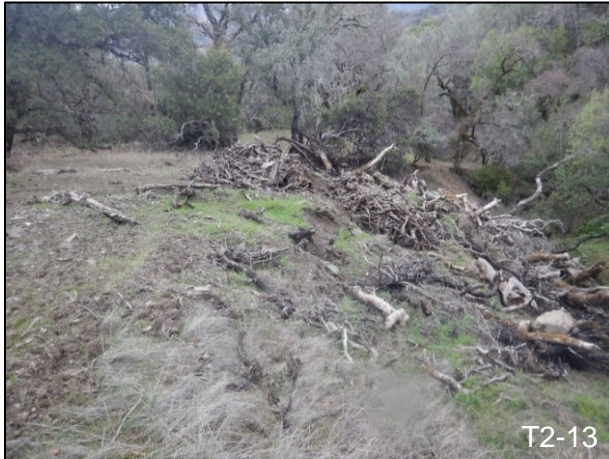
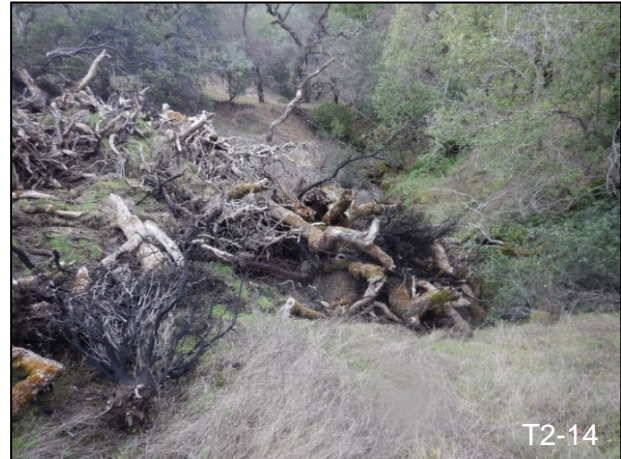
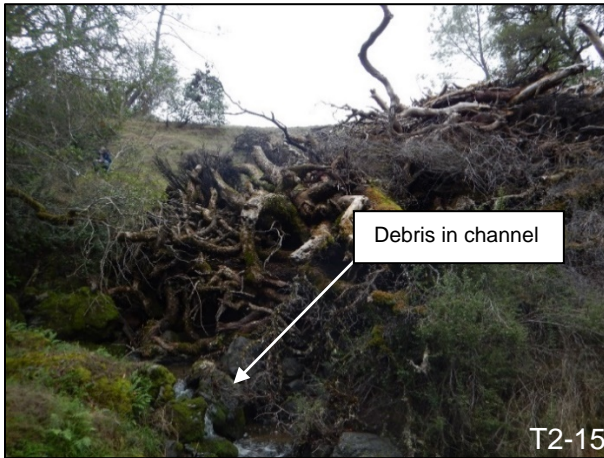
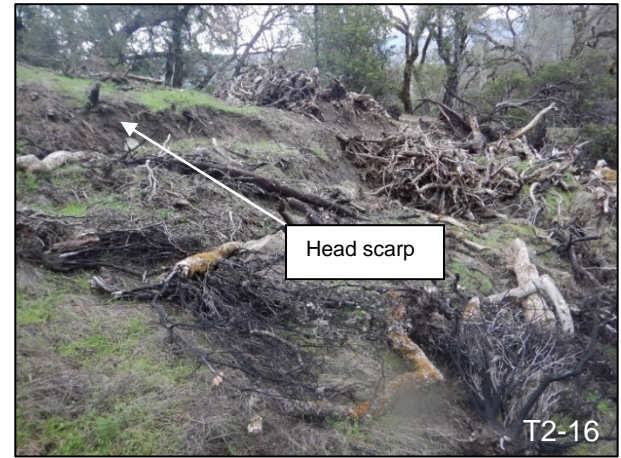
Photos T2-13 through T2-16: View of slash, soil, and rock that has been pushed into the stream channel at Location WQ 2.8. This debris caused/exacerbated slope failure into the stream. The area of slope failure is approximately 75 feet wide and 50 feet from the head scarp to the streambed (about 3,700 sf). This feature poses an ongoing threat to water quality and instream habitat as it continues to erode and fail, impeding stream flows, and contributing additional earthen and organic material and fine sediment in the downstream watercourses.

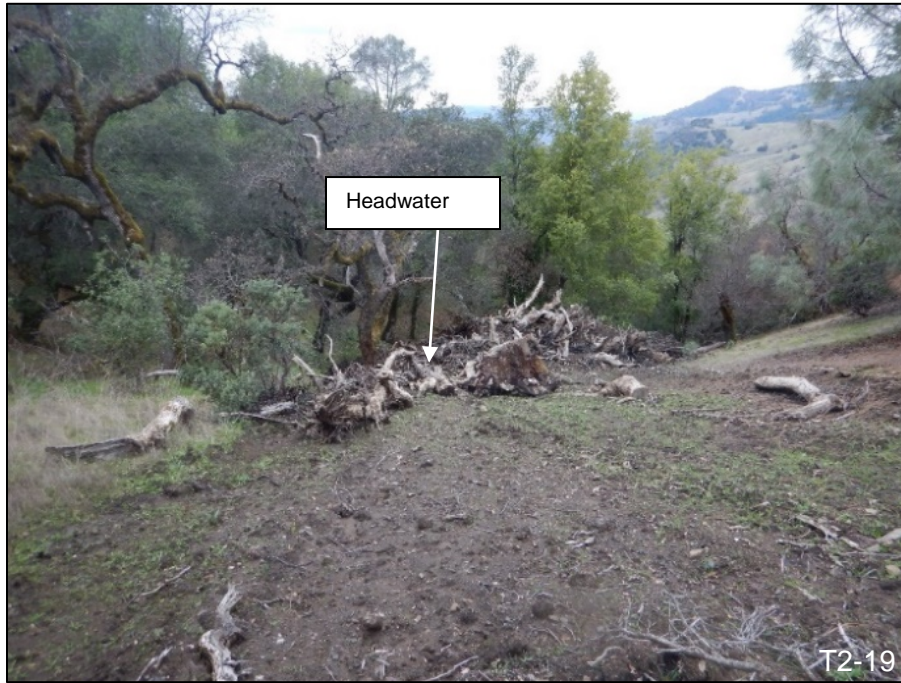
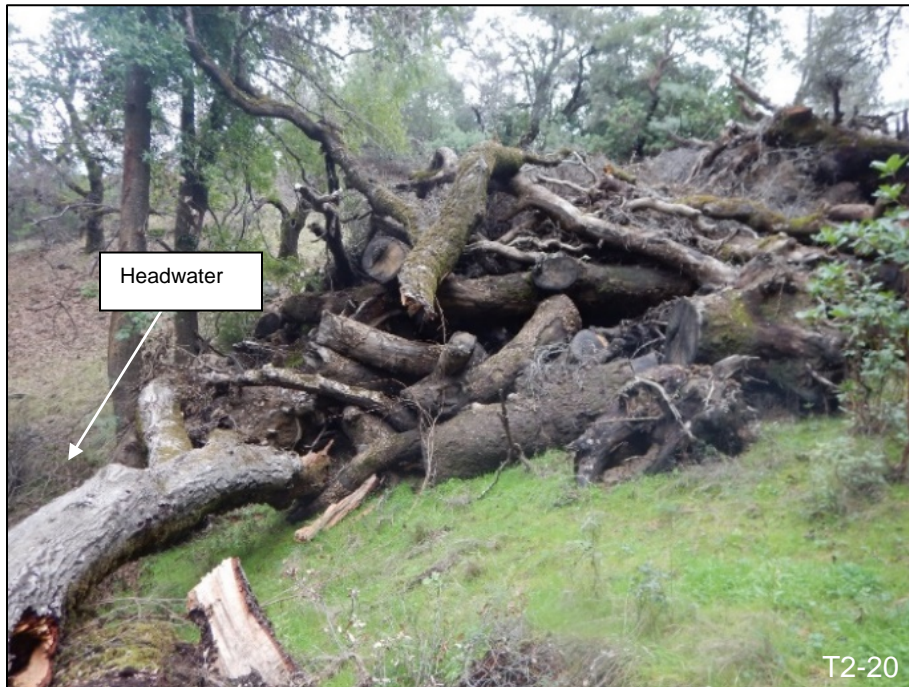
Photos T2-19 and T2-20: Slash and soil/debris pushed into the headwaters of an ephemeral stream (Location WQ 2.10). This slash pile is approximately 100 feet long, by 50 feet wide, by 20 feet high. This feature impacts and threatens to impact water quality and instream habitat as material continues to erode and migrate downstream.

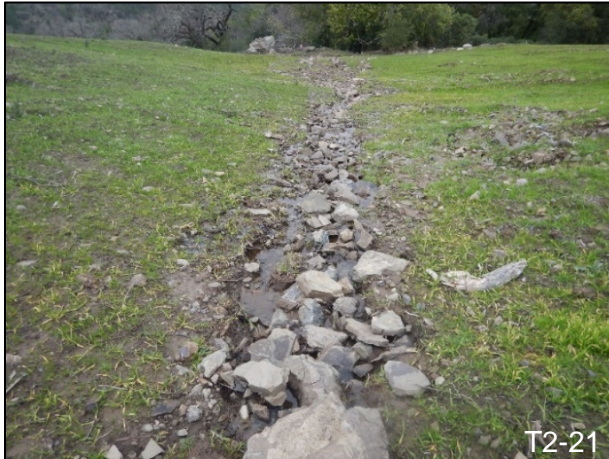
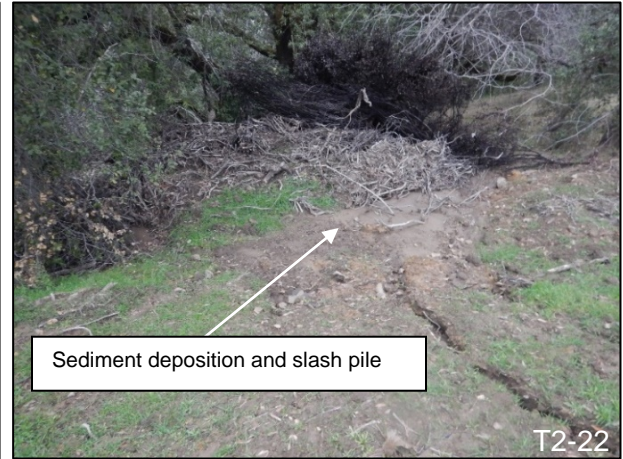
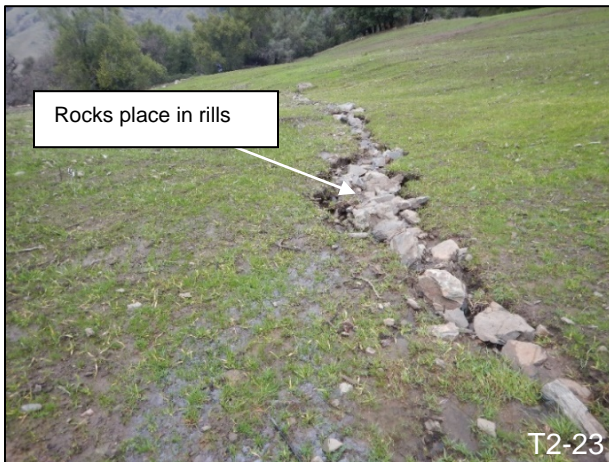
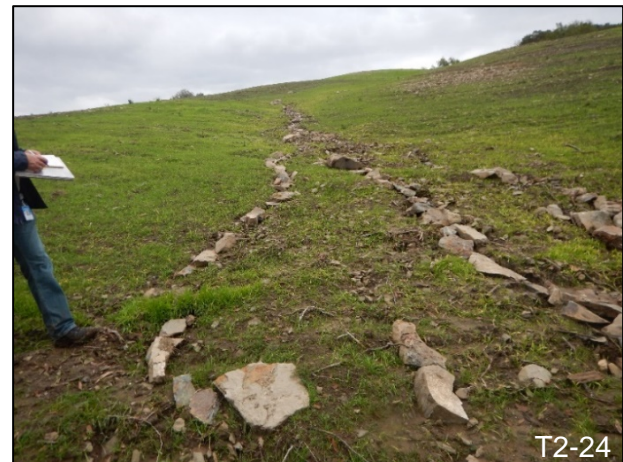
Photos T2-21 through T2-24: View of two ephemeral streams at Location WQ 2.11, below the hunting camp. Photos show rocks that have been placed in the rills, and sediment deposits and a slash pile at the base of the slope. These features impact and threaten to impact water quality and instream habitat as they continue to erode, and eroded material continues to migrate or be transported downstream.

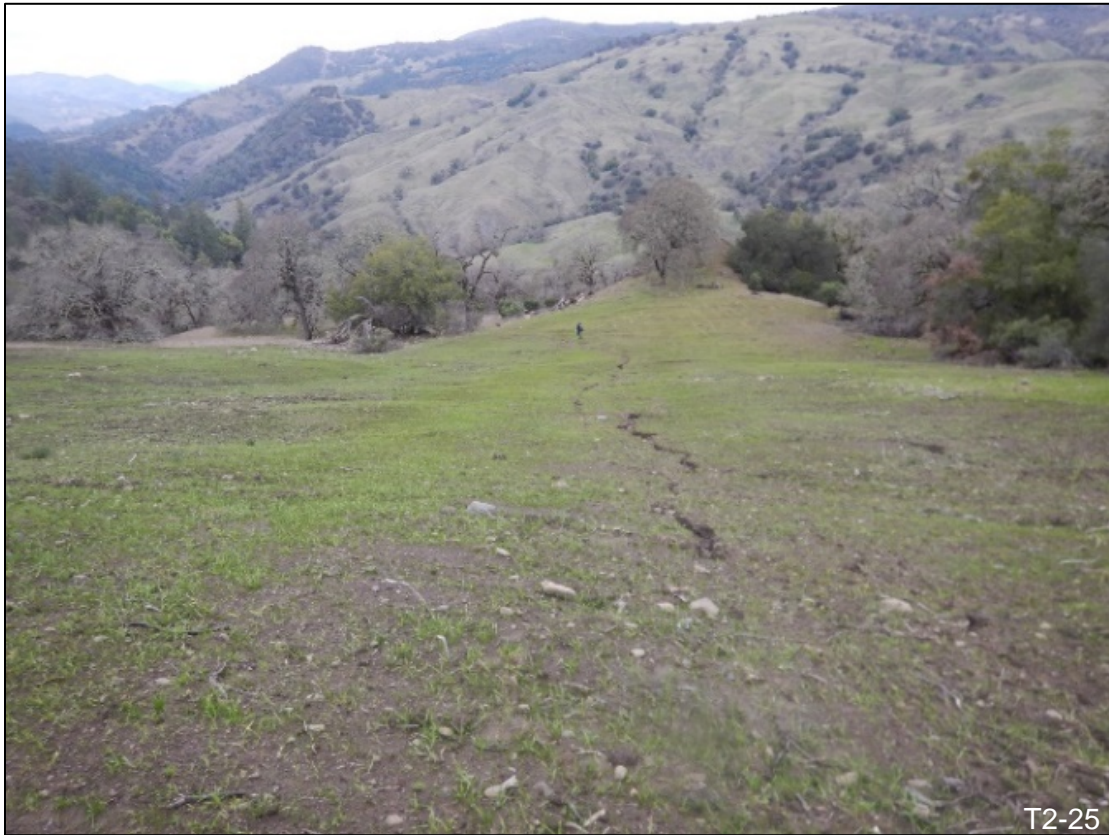
Photo T2-25: Rill in the northwest meadow at Location WQ 2.12. Staff estimated rill dimensions to be approximately 200 feet long by six inches wide by six inches deep. This feature impact and threatens to impact water quality and instream habitat as it continues to erode, and eroded material continues to migrate or be transported downstream

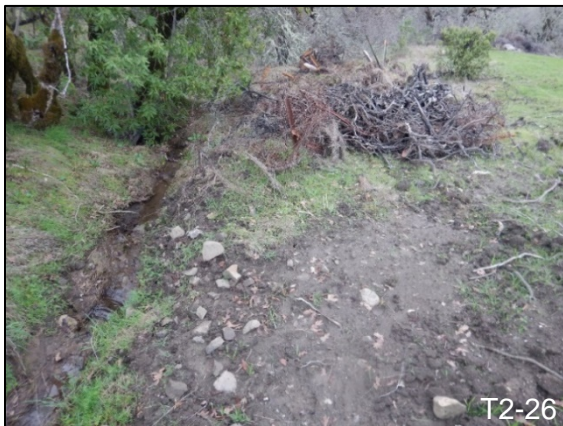
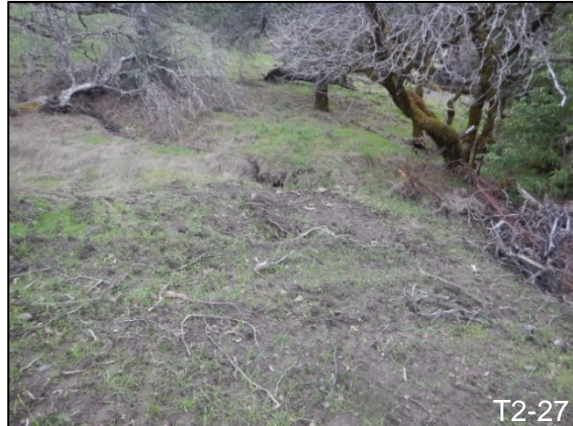
Photos T2-26 and T2-27: Disturbed soil and spoils adjacent to an ephemeral stream at Location WQ 2.13.

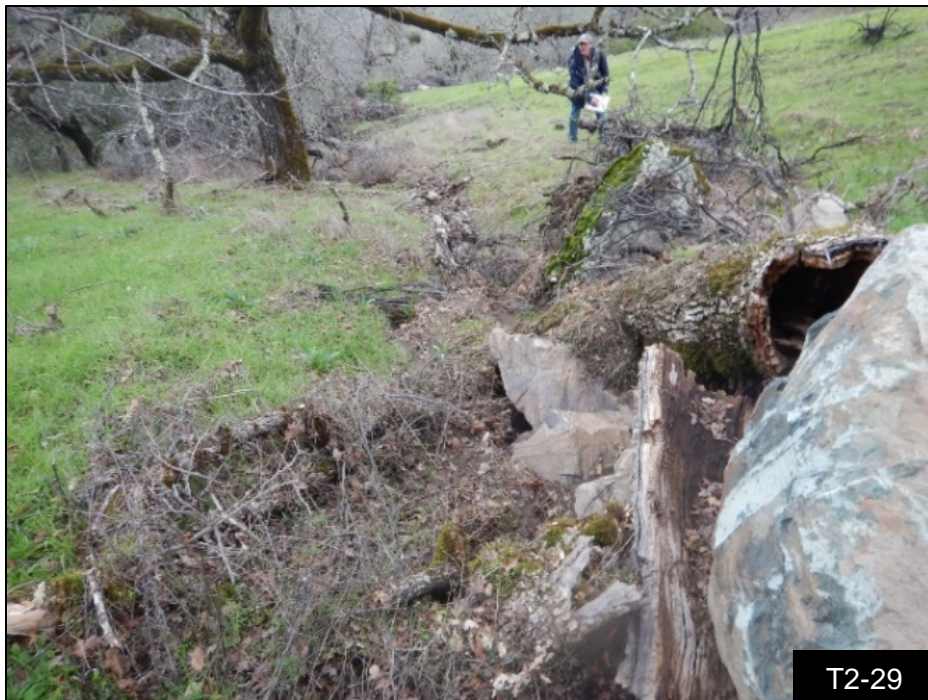
T2-29

Photos T2-28 and T2-29: Boulders and soil pushed into an ephemeral stream at the western edge of the meadow below the hunting camp (Location WQ 2.14).

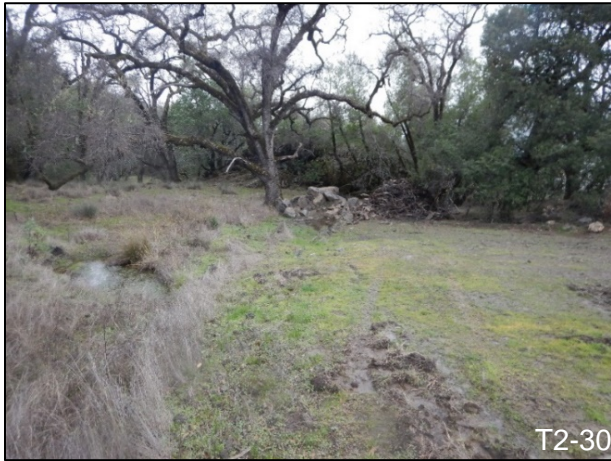
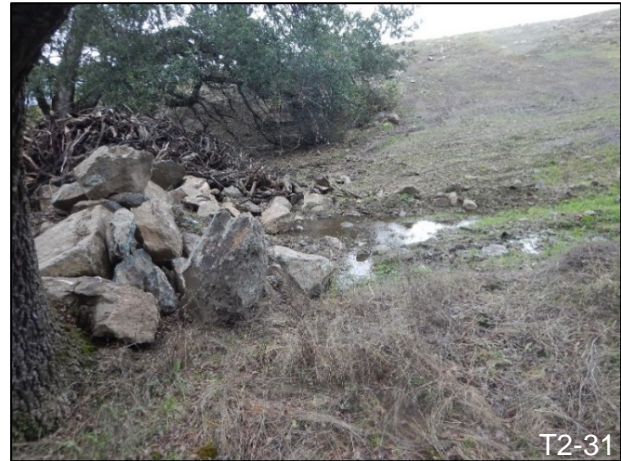
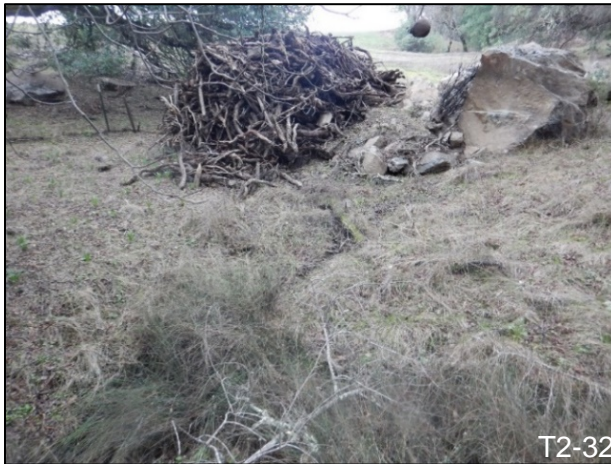
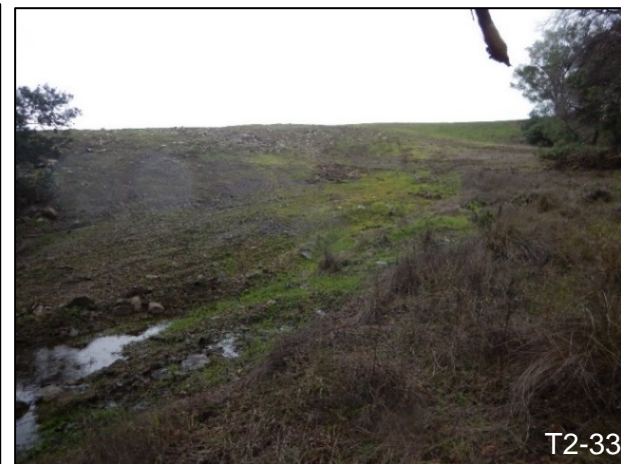
Photos T2-30 through T2-33: Boulders, soil, and slash that have been pushed into an ephemeral stream at Location WQ 2.15. Staff observed pooled water uphill from the graded area and *Juncus sp.* growing at the edges of the disturbed area, suggesting this is the site of a wetland/spring.

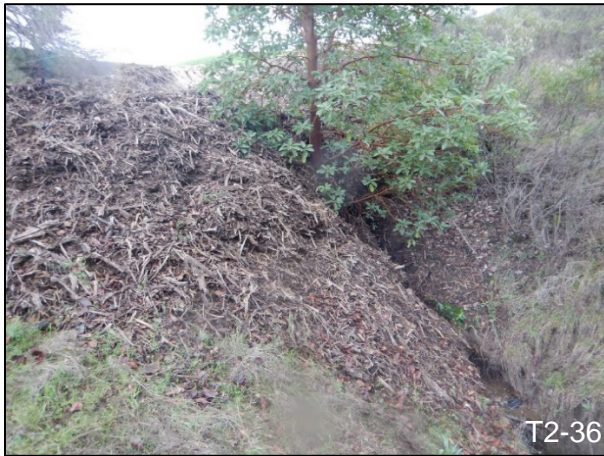
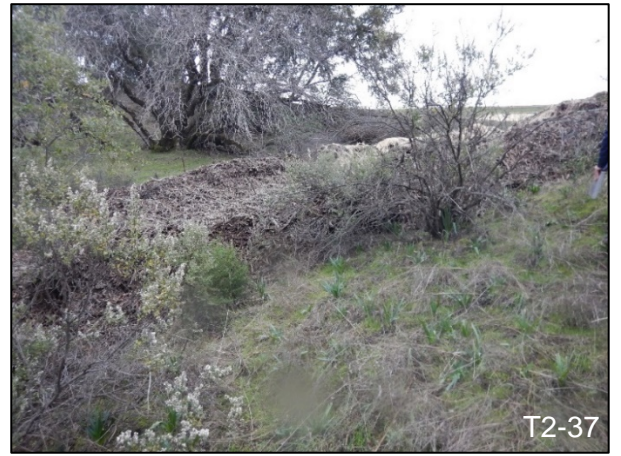
Photos T2-34 through T2-37: Wood chips and soil pushed into an ephemeral stream at Location WQ 2.16.

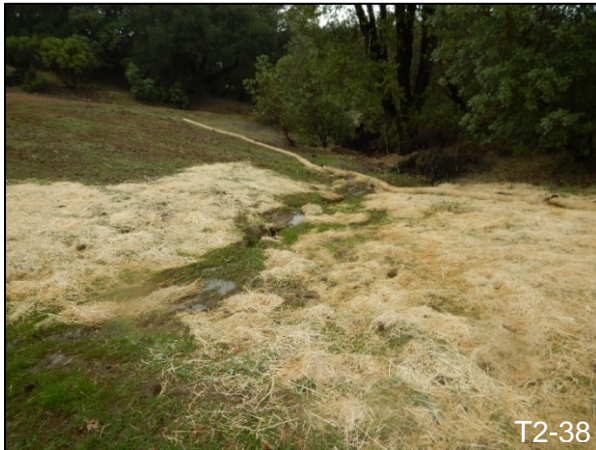
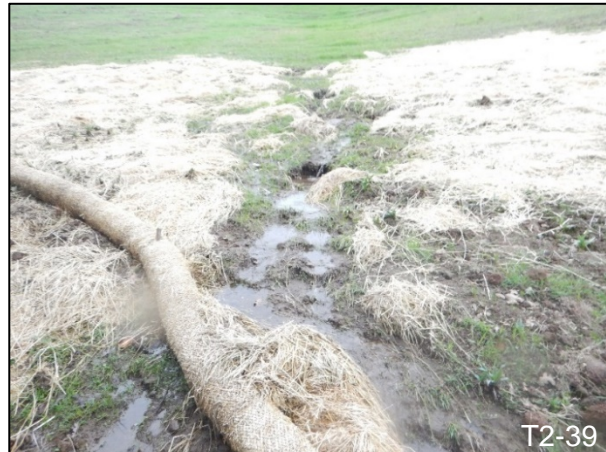
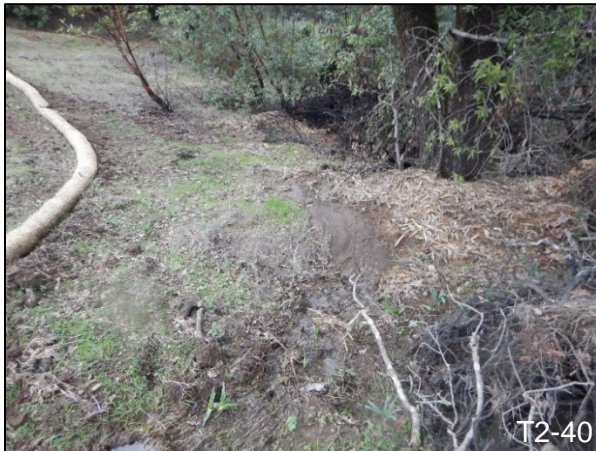
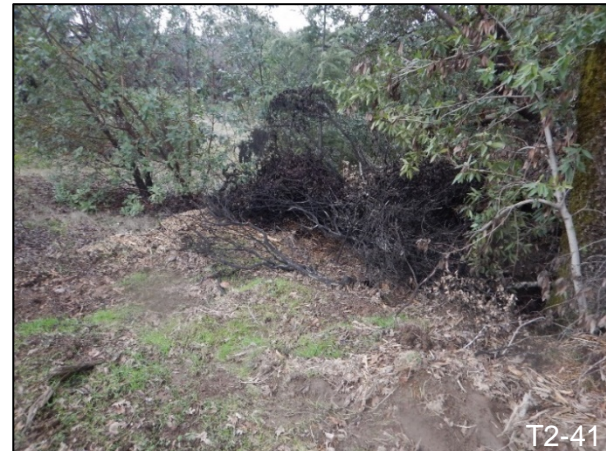
Photos T2-38 through T2-41: Ephemeral stream east of the main road at Location WQ 2.17. Wood chips and debris in the watercourse. Sediment accumulations at the base of the slope.

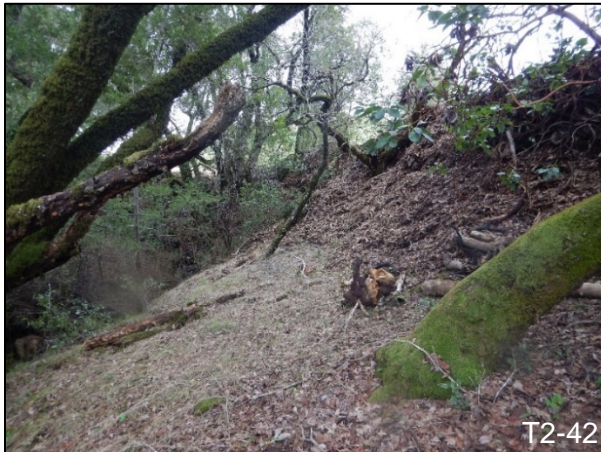
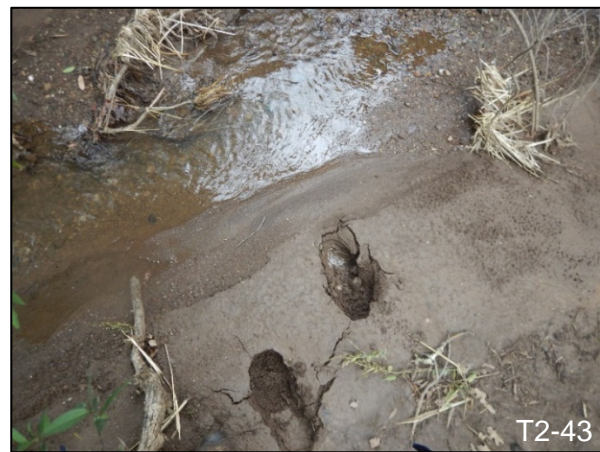
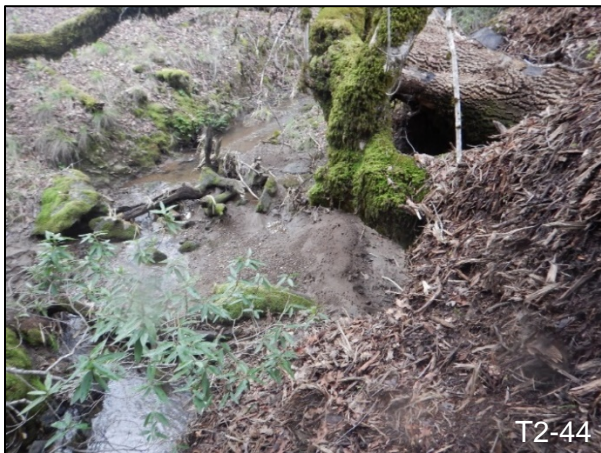
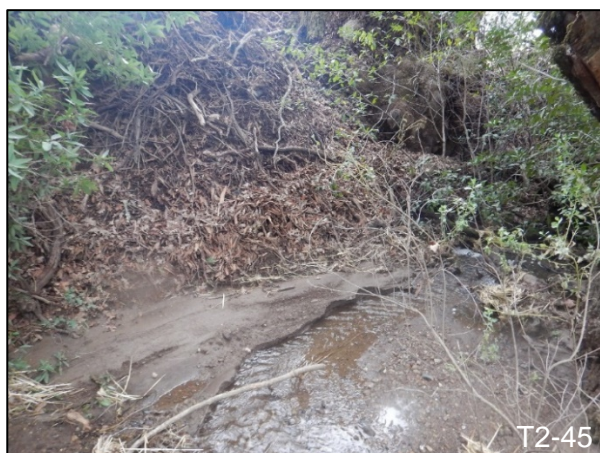
Photos T2-42 through T2-45: Wood chips piled in and adjacent to a watercourse at location WQ 2.18. Evidence of sediment transport and delivery from the adjacent hillslopes and fine sediment deposits in the channel.

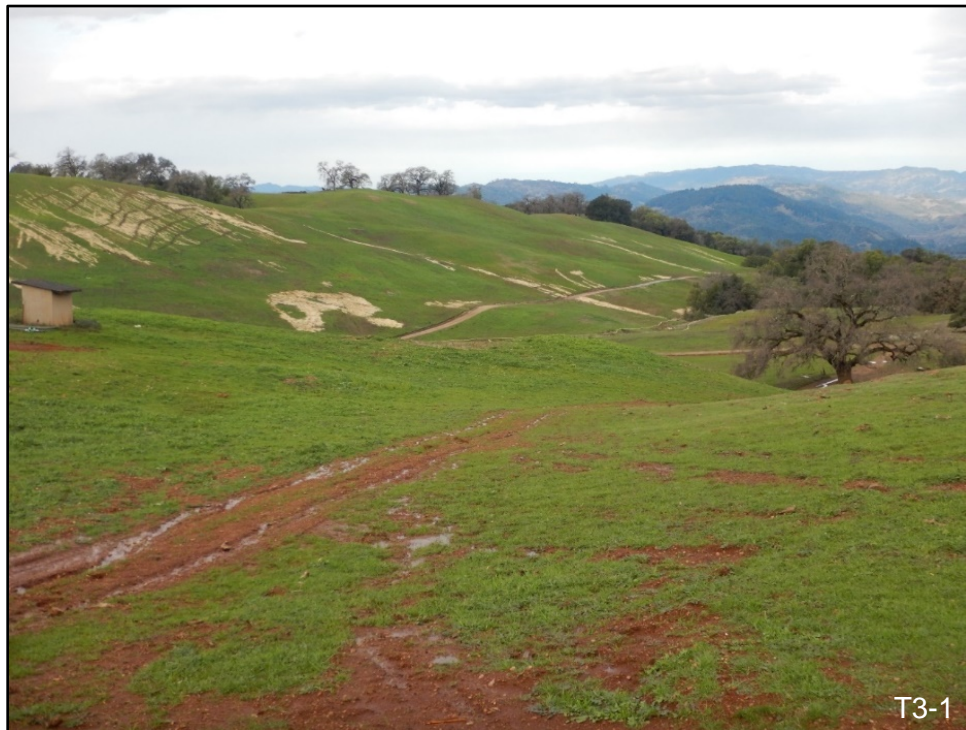
Team 3 inspected approximately 80 acres of cleared, ripped, and graded oak woodlands and pastures area (*Figure 5*), south of the ranch manager's house. All disturbed areas appeared to have been seeded with a cover crop (see Photo T3-1), however, the cover crop was sparse, undeveloped, and ineffective at controlling soil erosion and preventing sediment transport.

Photo T3-1. Looking northwest towards the cleared, ripped, and graded hillside west of the main access road to the Property (Shellenger Road). Cover crop, straw mulch, and "V" ditches can be seen on the distant hillside. All grassy hillsides visible in the foreground are part of the area that was cleared, ripped, graded, and seeded with cover crop.

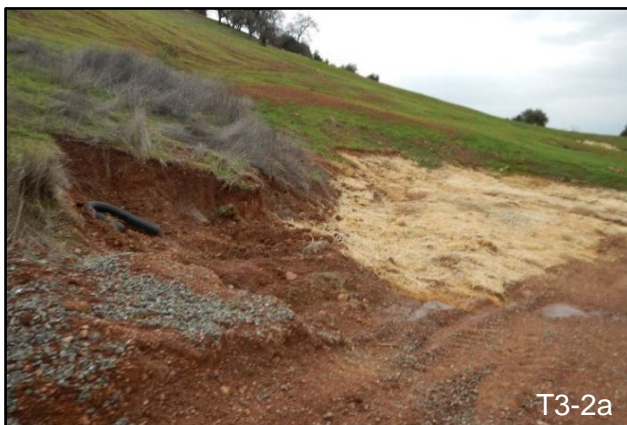
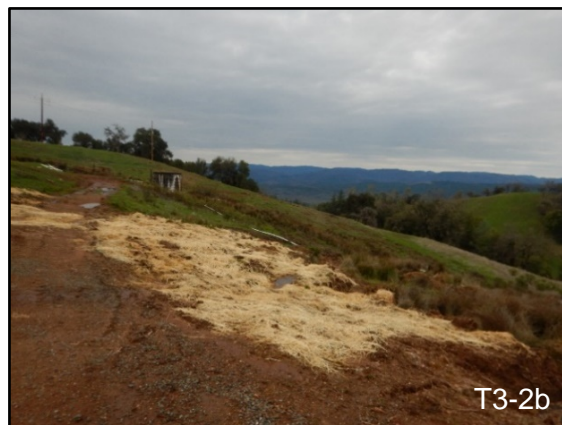
Staff observed signs of active erosion and rilling on the disturbed slopes and soils above the headwater seep complex, and evidence of sediment transport and delivery into the headwater seep complex and the ephemeral streams. Staff did not observe any additional erosion and sediment control such as straw, "V" ditches, straw wattles, or sediment basins. Staff observed *Juncus sp.*, a wetland obligate plant, resprouting throughout the headwater seep complex and along the ephemeral streams. Based on the presence of obligate wetland vegetation and standing and flowing waters, staff identified the seep and the two ephemeral streams draining as waters of the state, and potentially jurisdictional waters of the United States as well. There is no record that Mr. Reimers and/or his agents applied for, nor obtained, permits for dredge/fill activities in state/federal waters.

Photos T3-2a and T3-2b, inspection point WQ 3.1, showing a widened road and excavated wet area (suspected wetlands). In the foreground of each picture, recently applied straw mulch is visible, but observably ineffective at controlling erosion and sedimentation. An abandoned water tank and wetland features, including *Juncus sp.*, are visible in the background of photo T3-2b.

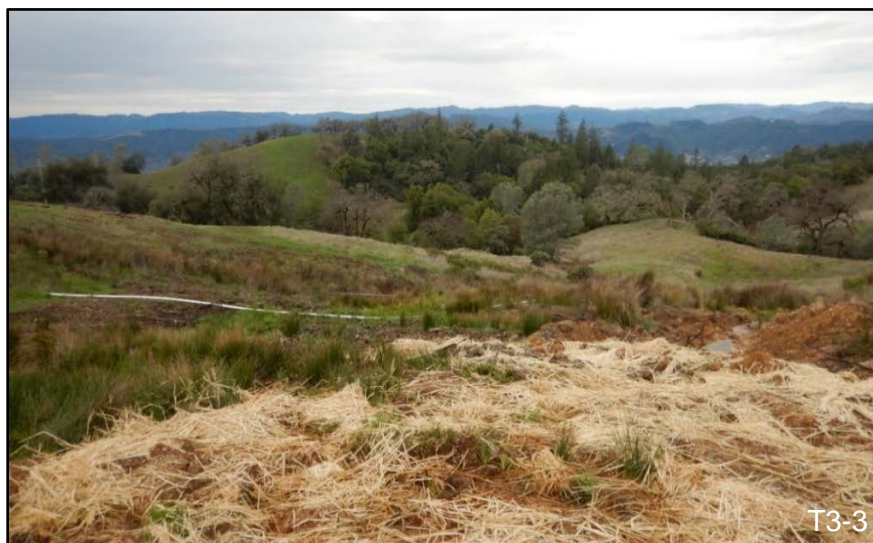
Photo T3-3. Inspection point WQ 3.1, looking west at disturbed soils in a headwater seep complex with recently applied straw mulch. *Juncus sp.* can be seen resprouting throughout the disturbed soils in the headwater seep complex.
