North Coast Regional Water Quality Control Board

Name and Location of Facility Inspected Krasilsa Pacific Farms LLC Sonoma County Assessor's Parcel Numbers: 116-240-006-000, 115-210-002-000, 117-260-002-000, 117-260-001-000, 117-270-002-000, 117-270-003-000, and 117-270-006-000		Inspection Date January 14, 2019	Inspection Time 8:30 am-12:30 pm
Property Ownership Hugh Reimers, Manager Krasilsa Pacific Farms LLC 7030 Faught Road Santa Rosa Ca, 95403		Consent Provided? Yes X No <input type="checkbox"/>	Notified of Inspection? Yes X No <input type="checkbox"/>
Inspection Attendance Hugh Reimers, landowner/developer Cort Munselle, P.E., Munselle Civil Engineering and Land Surveying North Coast Regional Water Quality Control Board Staff (Staff): Ryan Bey - Environmental Scientist (ES) Brian Fuller - Engineering Geologist (EG) Paul Nelson - EG, P.G., C.Hg. Josh Luders - Water Resource Control Engineer (WRCE) Scott Gergus - EG Jeremiah Puget – Senior ES (Specialist) Sonoma County Department of Agriculture (SCACO) Staff Andy Casarez John Bishop

Weather Conditions at the Time of the Inspection: Overcast		Facility Receiving Water Names: Unnamed Tributaries to Little Sulphur Creek, Big Sulfu

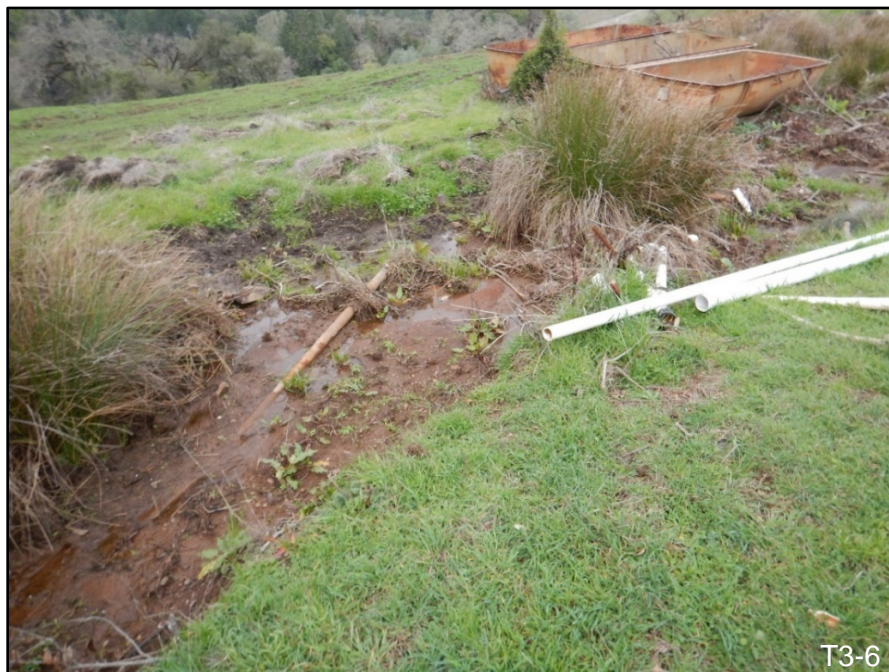
Photo T3-6. Inspection point WQ 3.1, looking at fine sediment deposits in the suspected wetland area and ephemeral stream. Insufficient erosion and sediment controls on the adjacent disturbed hillsides has resulted in sediment transport and deposition into these surface waters.

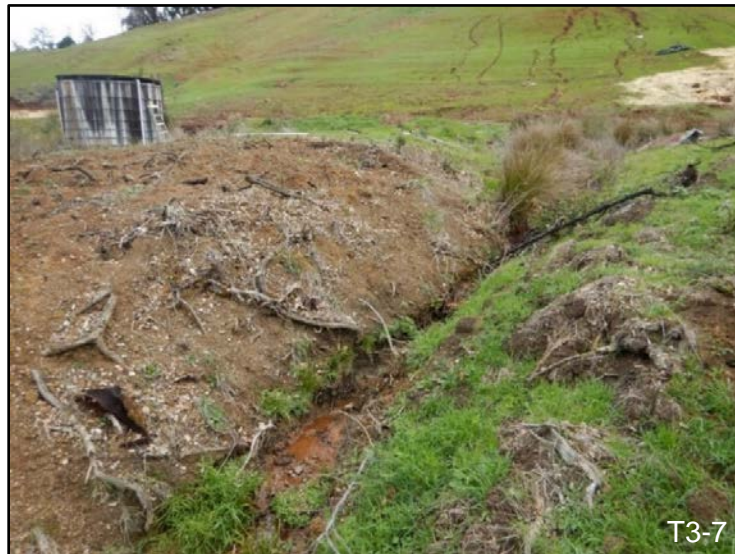
Photo T3-7. Inspection point WQ 3.1, looking east at loose, disturbed, unstable soils at the headwater seep complex and ephemeral stream, and fine sediment deposits in the stream channel. This unstabilized material will continue to enter and/or be transported into surface waters. Resprouting *Juncus sp.* is visible in the disturbed soil. Erosional rills are visible in the steep hillside slope above this area, and staff observed evidence of sediment transport via these rills into the ephemeral stream. Mr. Reimers reported the water tank visible in the upper left of the photo leaks and is no longer in use.

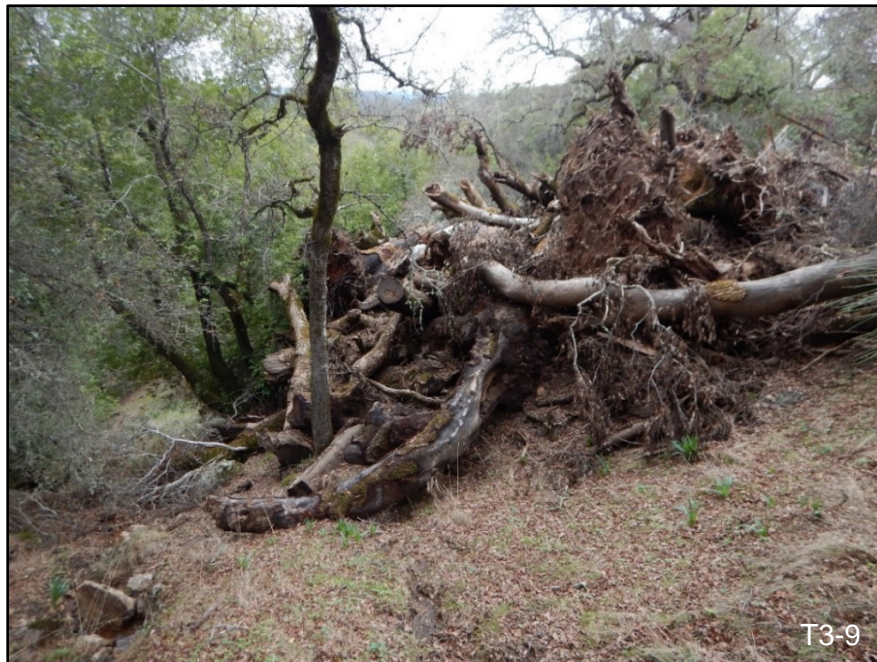
At this location, staff observed a large pile of logs, slash, roots, and soil (Photos T3-9 – T3-11) that had been bulldozed into two ephemeral streams, approximately 500 feet downstream of the headwater seep complex at WQ 3.1. This was just one of several areas throughout the Team 3 area where staff observed organic and earthen material, including oaks and California bay laurels, as well as tree roots and rocks, that had been bulldozed into swales and ephemeral watercourses. Staff observed erosional rills on the disturbed slopes and soils above the debris piles, and sediment deposits in and below the debris piles. These soil erosion features are impacting and threatening to impact water quality and instream habitat as they continue to erode, and eroded material continues to enter and transported into downstream watercourses.

Photo T3-9. Inspection point WQ 3.2, looking west down an ephemeral drainage filled with trees, slash, and soil.

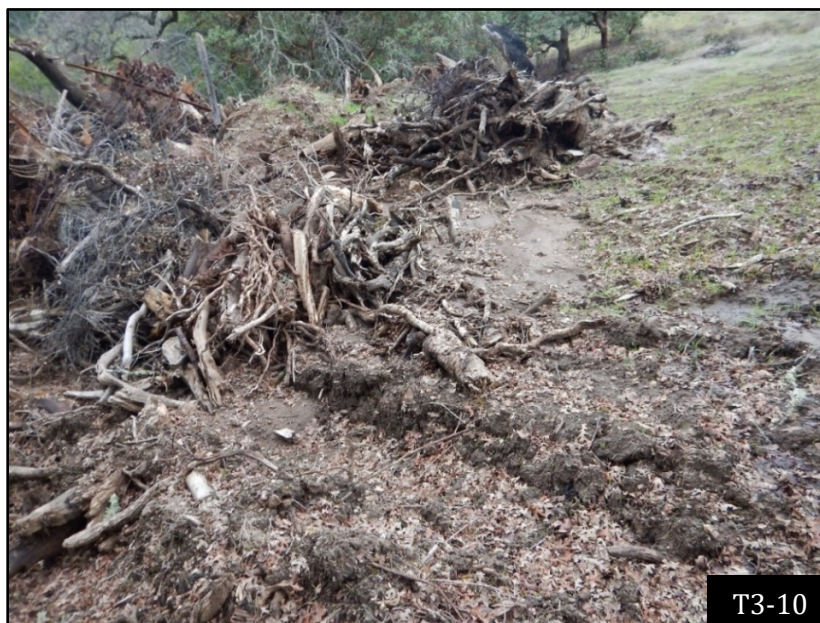
Photo T3-10. Inspection point WQ 3.2, looking north. Cleared trees and slash has been pushed into two ephemeral drainages. Fine sediment from this pile of debris has discharged into and deposited in the two ephemeral watercourses downhill from the debris piles. Sediment in this pile is likely to continue to enter or be discharged into the watercourse.

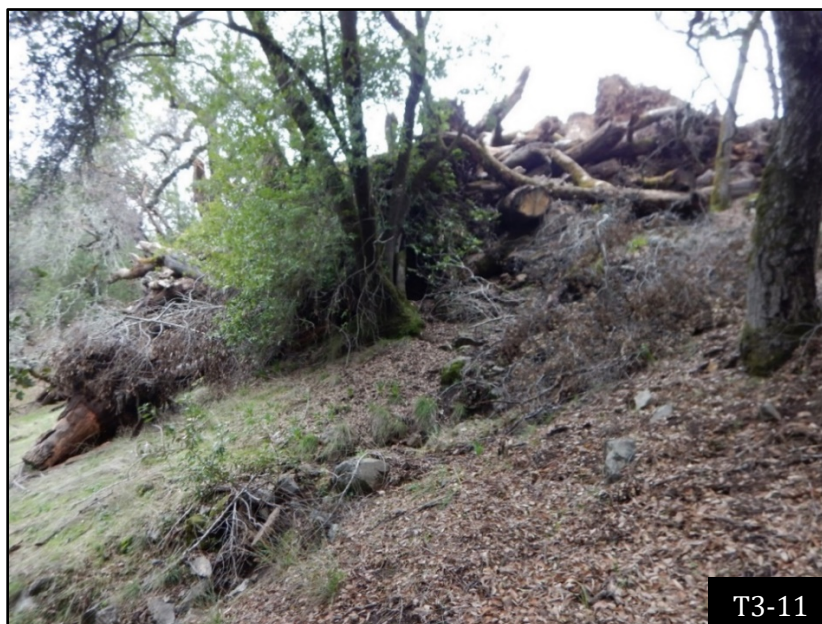
Photo T3-11. Inspection point WQ 3.2, below the pile of trees and slash, looking north. One of the ephemeral drainages that originates at inspection point WQ 3.1, upslope of the debris pile can be seen in the foreground. Soil mixed into the trees and slash and pushed into the ephemeral drainage will continue to be a source of discharging sediment.

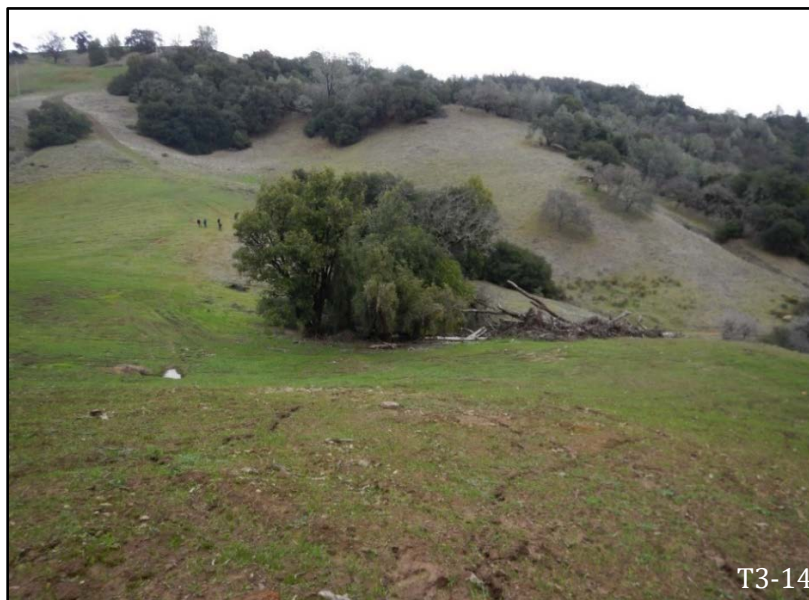
Photo T3-14. Inspection point WQ 3.3, looking east. The bright green cover crop shows the extent of the area that was subject to clearing, ripping, and grading. Organic and earthen spoils and slash, bulldozed into an ephemeral drainage at the base of the slope, are visible just to the right of the trees at the center of the photo. Rilling is visible on the sparsely cover cropped steep slope. Members of inspection Team 3 are visible to the left of the California bay laurel.

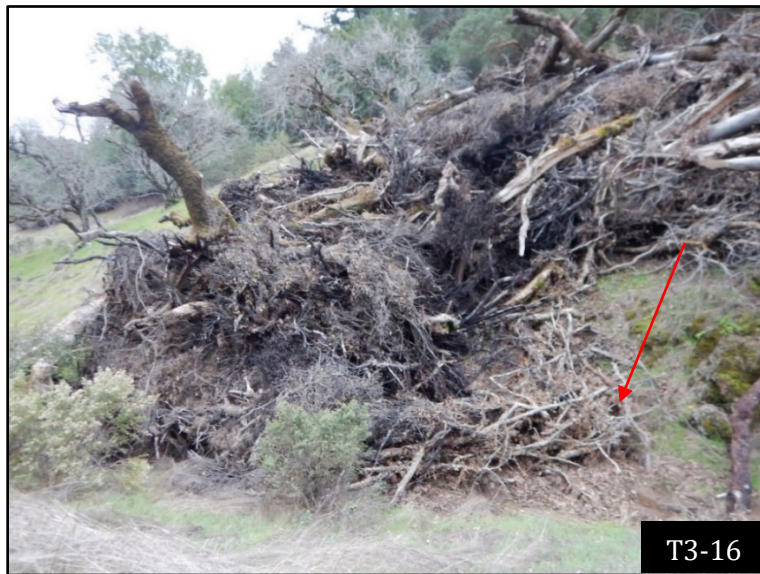
Photo T3-16. Taken at WQ 3.3, looking west across an ephemeral watercourse filled with trees, slash, and soil bulldozed from the cleared slope seen in Photo T3-14. Soil from this pile of debris has entered or been transported into the watercourse, and additional sediment within the pile is likely to enter or be transported into the watercourse over time, and with continued exposure to the elements. The pile of debris is approximately 225 linear feet long with 90 linear feet of debris in the watercourse. Sediment deposited in the stream can be seen to the right of the debris pile at the red arrow.

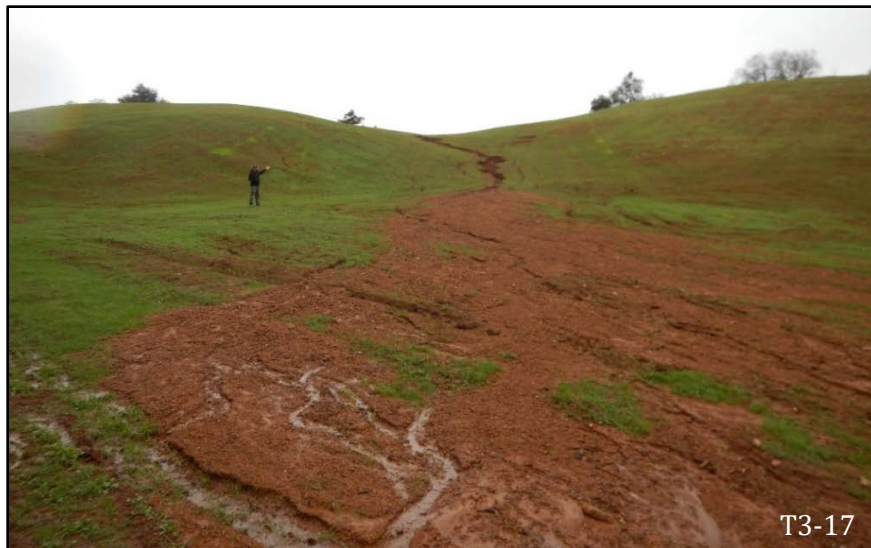
At inspection point WQ 3.4, shown in photos T3-17 through T3-21, staff observed hillslopes where soils had been deeply ripped, graded smooth, and seeded with cover crop, and where subsequent runoff was now beginning to form erosional rills and gullies following pre-project drainage patterns. This area typifies conditions observed on vast portions of the project area. Pre-project LIDAR (see Figure 1) shows an erosional feature resembling a stabilized gully that should have been recognized and avoided when the area was undergoing development. The gully is now re-establishing itself as stormwater runoff drains over the graded soil which, absent a functional cover crop and other erosion and sediment controls, is easily susceptible to erosion. Eroded soils are transported from the filled stabilized gully and being deposited into a potential wet meadow (wetland feature) lower on the slope. From this wetland feature, soils will continue to be transported downslope into a grassy ephemeral stream, where they will eventually be transported to Big Sulfur Creek.

Photo T3-17. Taken at WQ 3.4, looking northwest. This area had been cleared, ripped and graded. The LIDAR map in Figure 1 shows an erosion feature resembling a stabilized gully that had been ripped and graded over. A gully is forming between the two hills resulting from concentrated rainfall runoff eroding the graded fill soils. Sediment from the gully has been deposited in a potential wet meadow (wetland feature) (see photo T3-19) that drains to an ephemeral drainage (see photo T3-20). A member of the inspection team can be seen to left for scale.

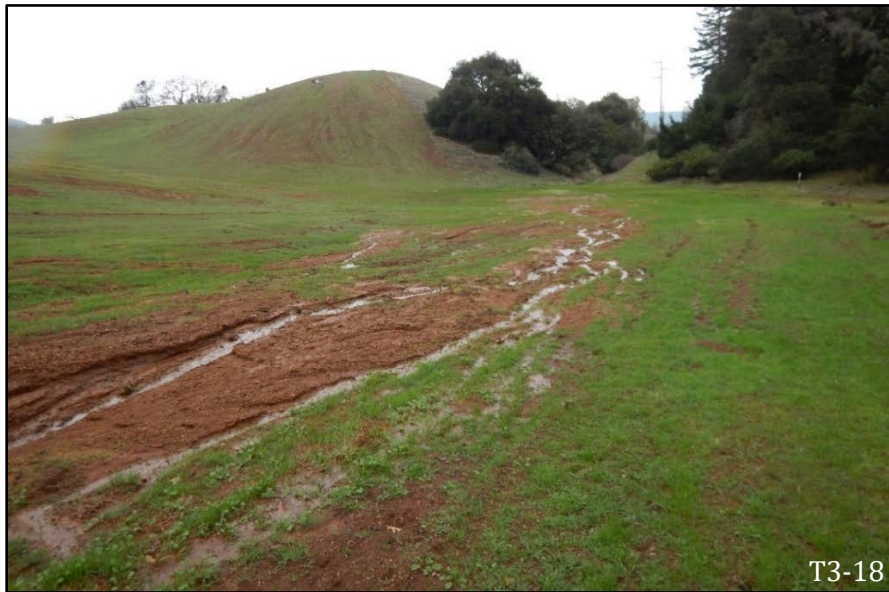
Photo T3-18. Taken at WQ 3.4 looking east. This area has also been cleared, ripped, and graded. Sediment has discharged to a potential wet meadow (suspected wetland feature) that drains to an ephemeral drainage in the distance. Runoff is now eroding the sediment deposited in the potential wet meadow and transporting it farther downslope to an ephemeral drainage.

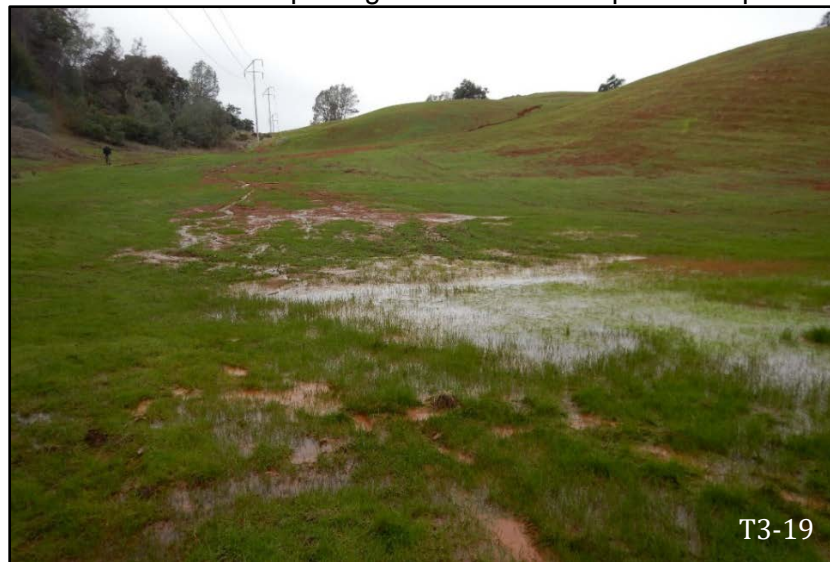
Photo T3-19. Taken at WQ 3.4, looking west towards the gully shown in Photo T3-17. Sediment has been deposited in the potential wet meadow (suspected wetland feature) shown in the center of the photo. Note footprints filled with muddy water in the foreground show fine sediments that have been transported from the gully shown in Photo T3-17 and deposited into this area.

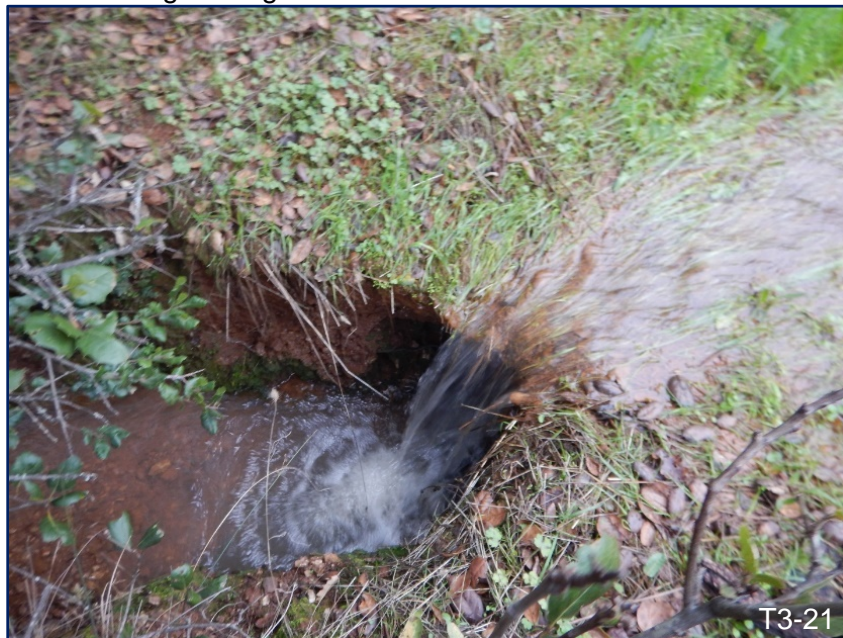
Photo T3-21 Inspection point WQ 3.4; runoff draining from the grassy swale shown in Photo T3-20.

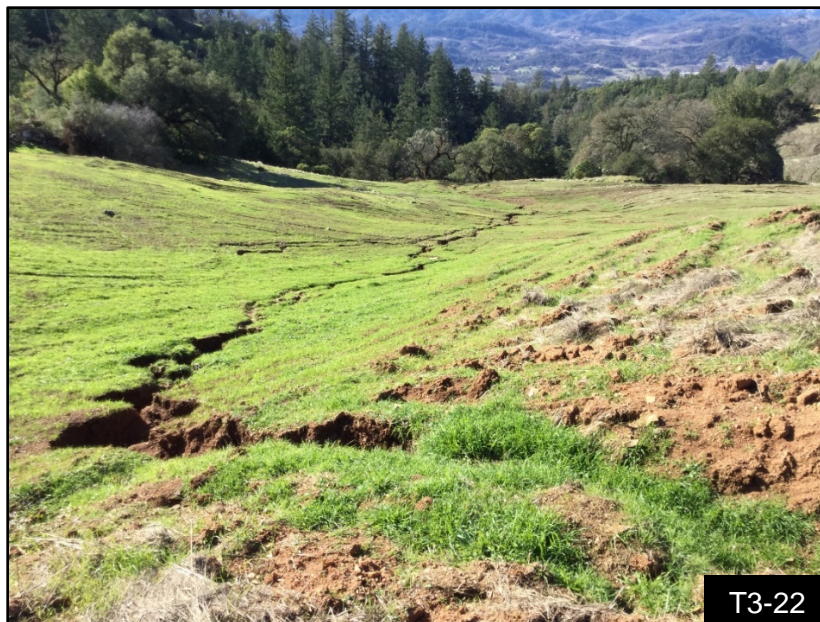
Inspection point WQ 3.5, shown in photos T3-22 through T3-24, is a gully resulting from poorly constructed and/or maintained road drainage features associated with drainage from the main access road (Shellenger Road). This gully is approximately 375 feet long and resulted from concentrated flow from the inside ditch along Shellenger Road, flowing through a cross culvert and draining onto a hillslope that had been cleared, ripped, graded, and seeded with cover crop. As shown in photo T3-22, taken on December 28, 2018, by James Bishop of SCACO, runoff from the road has caused rilling and gullying on the slope. During the January 14, 2019, inspection, Team 3 staff observed straw mulch and straw wattles on this erosional feature. As mentioned below, staff noted that these erosion control measures were not effectively controlling continued erosion on the hillslope.

Photo T3-22. Inspection point WQ 3.5, looking west towards Cloverdale. John Bishop, Sonoma County Agricultural Commissioner's Office, took this photo during the December 28, 2018, site visit with Mr. Gergus and Mr. Reimers. Note several rills and a developing gully, approximately 375 feet long, resulting from concentrated flow from a ditch relief culvert under Shellenger Road.
