North Coast Regional Water Quality Control Board

Subject: Notice of Violation, Directive to Obtain Regulatory Coverage for Cannabis Cultivation, and Transmittal of Inspection Report for July 18, 2019, warrant inspection of Mendocino County Assessor's Parcel No. 032-225-22

File: Cannabis Inspections, Mendocino County, 2019, 190718 Pedro Martinez Garcia 032-225-22, CIWQS Place ID No. 859922

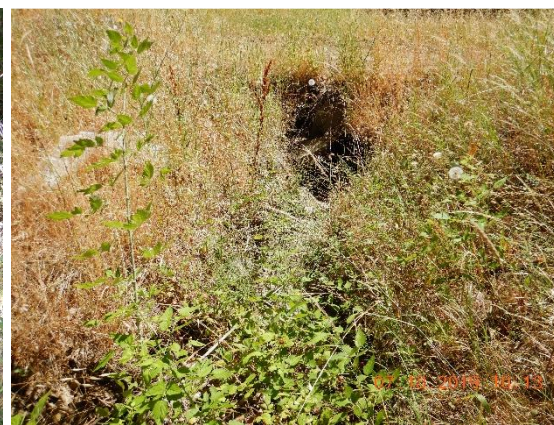
Photo 2 – Crossing 1 Downstream

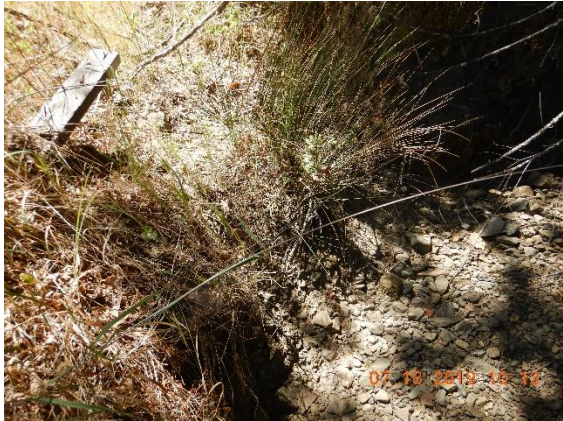
Photo 3 – Crossing 1 Upstream (undersized culvert)

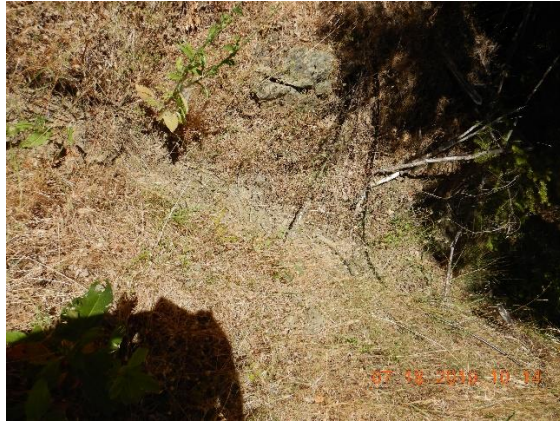
Crossing 1 (shown on Figure 2, Figure 3, and photos 4-7), consisted of an undersized culvert. I observed evidence of sediment discharge from the road into the watercourse at this location and I observed trash in the watercourse as well (Photo 7).

Photo 4 –Sediment in Crossing 1

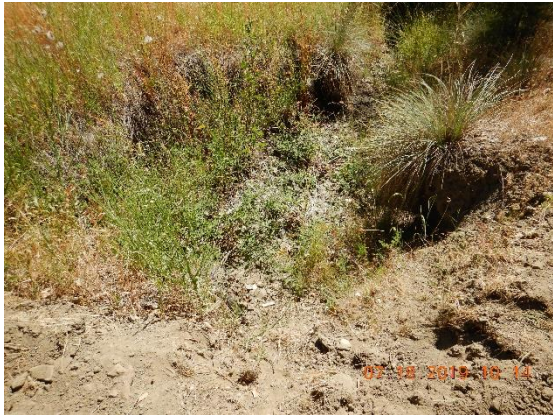
Photo 5 –Sediment in Crossing 1

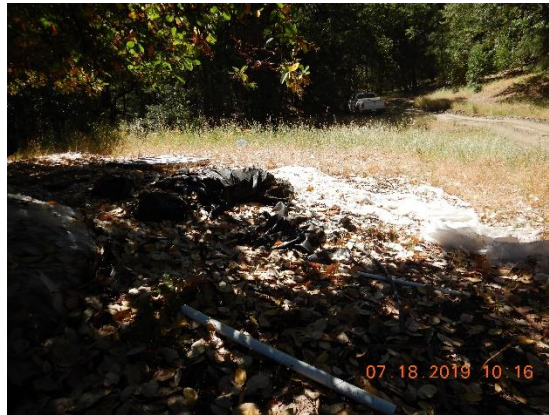
Photo 6 – Sediment in Crossing 1

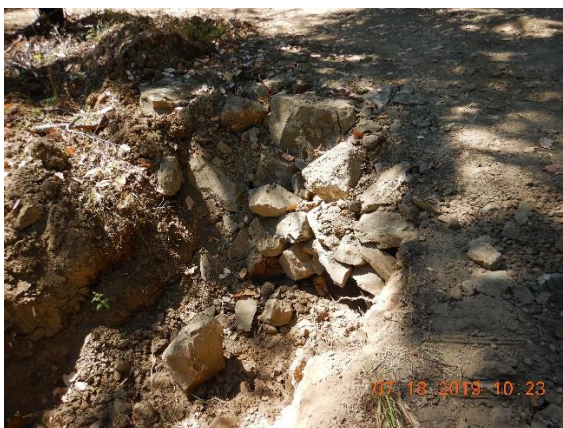
Photo 7 – Trash in Crossing 1

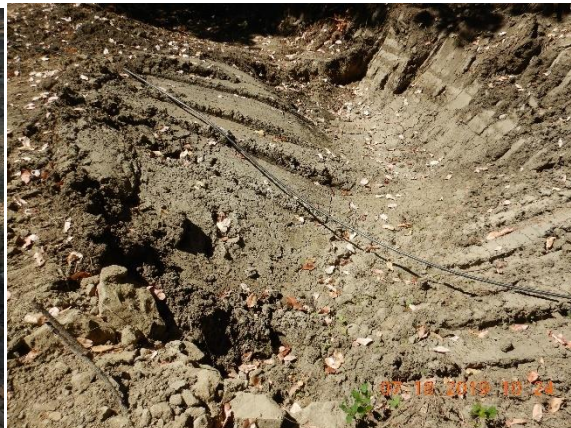
At Crossing 2 (Figure 3, photos 8-11 and 13-21), the access road is built through a Class III watercourse, with no constructed feature to allow for stable conveyance of stream flows. At this crossing, I saw evidence (photos 9-11) of recent heavy equipment work in the watercourse (bucket tracks). Fill material extended several feet into the stream channel beyond the roadway (photos 13-21). The volume of fill placed in the watercourse was approximately 2500 ft³, based on field measurements.

Photo 8 – road fill in crossing (Crossing 2)

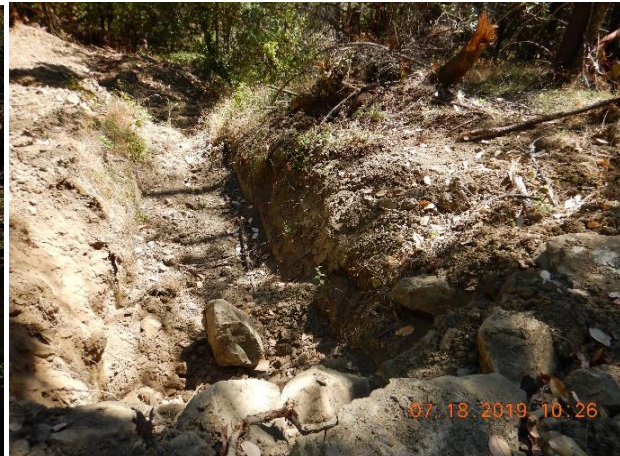
Along the access road south of the three cultivation areas, I observed 5 watercourse crossings (Crossings 1-5, Figure 3), and steep cut banks with loose and eroding sediment (photo 12 and 30). Based on recent heavy equipment marks on the surface and no vegetation growth it appears that this road was built and/or widened fairly recently.

Photo 12 – Sediment from road work in ditch

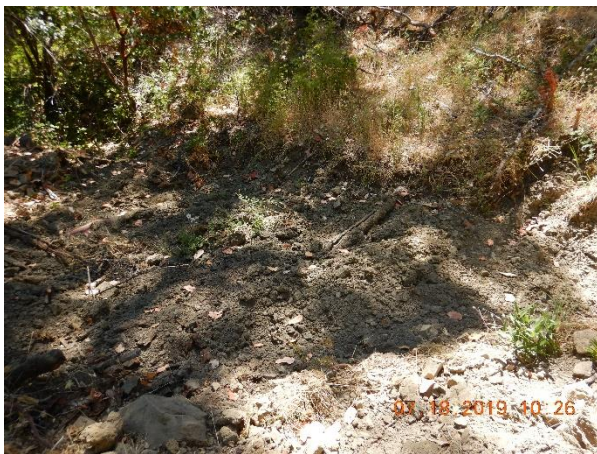
Photo 13 – Fill in crossing (Crossing 2)

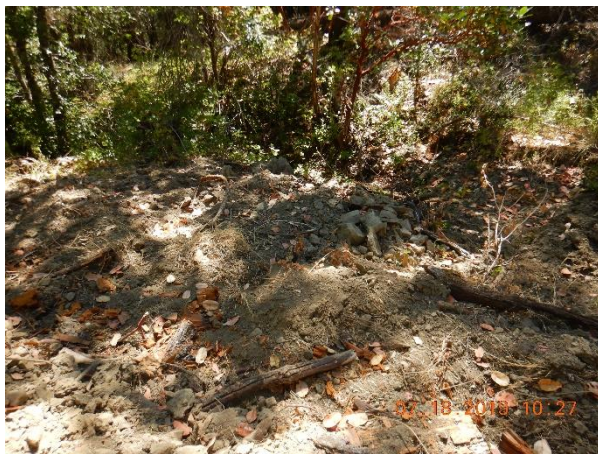
Photo 14 – Sediment in Class 3 (Crossing 2)

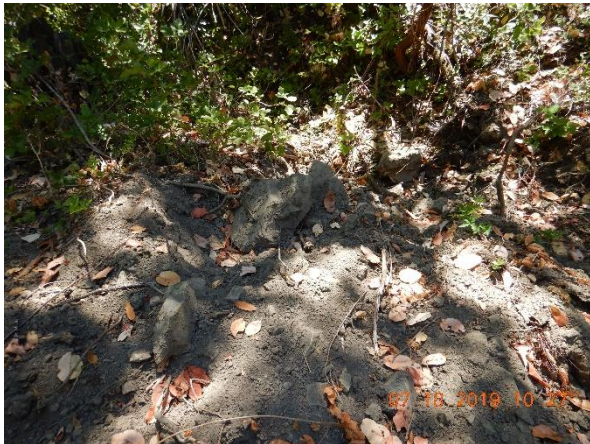
Photo 15 – Sediment in Class 3 (Crossing 2)

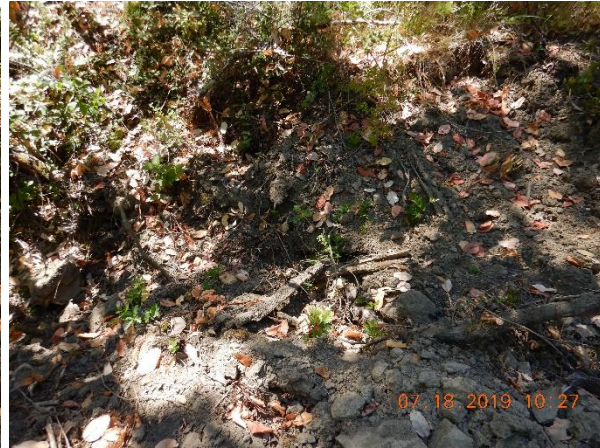
Photo 16 – Sediment in Class 3 (Crossing 2)

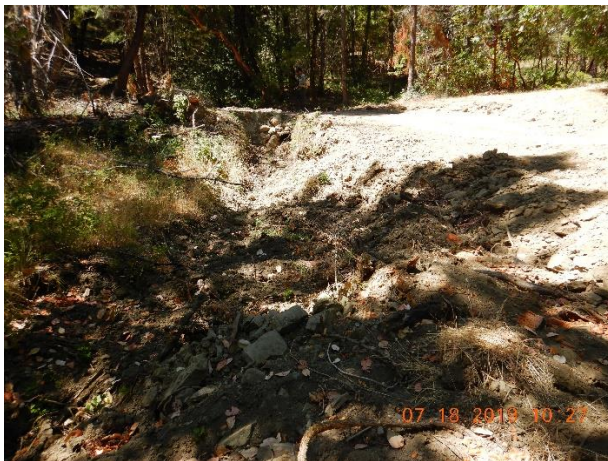
Photo 17 – Sediment in Class 3 (Crossing 2)

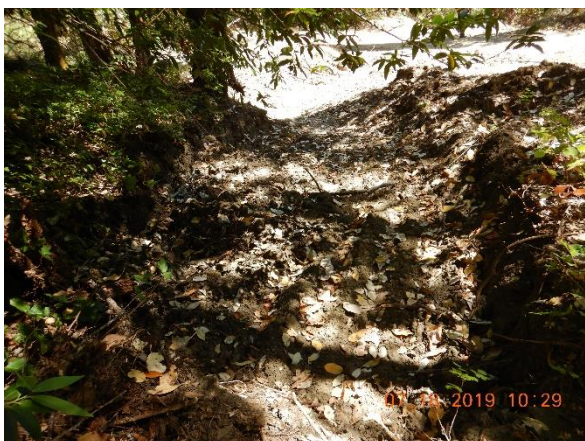
Photo 19 – Sediment in Class 3 (Cross 2)

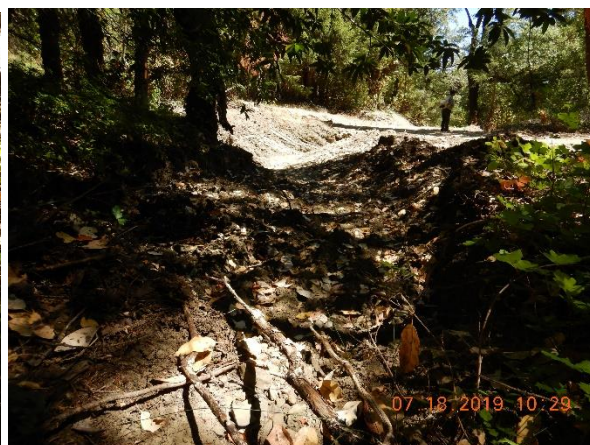
Photo 20 – Sediment in Class 3 (Crossing 2)

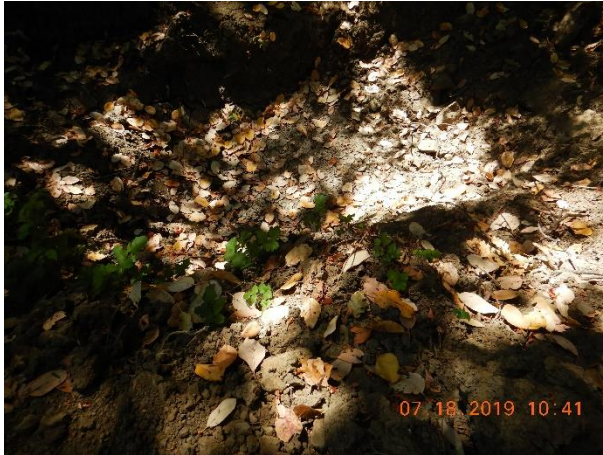
Photo 32 – Class 3 watercourse (Crossing 5) Photo 33 – Class 3 watercourse (Crossing 5)

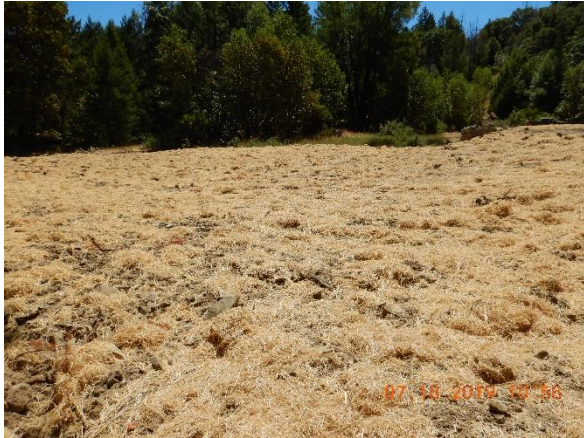
Based on the presence of the pond, features visible in previous aerial images, and wetland indicators observed in the field (plants and soil moisture (photo 39)), it appears likely that the disturbed area is all or mostly in wetland. Image 1 shows the suspected wetland boundary.

Photo 39 – Pond and disturbed area

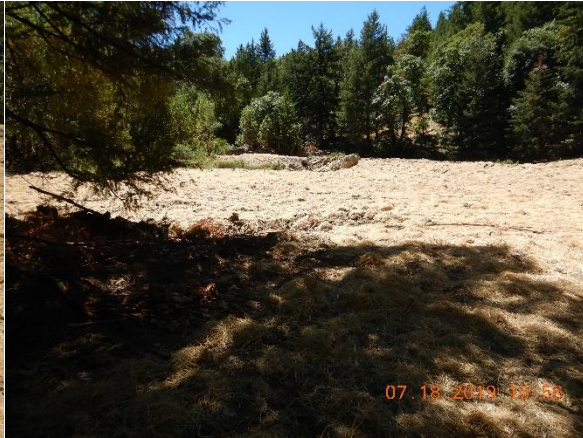
Photo 40 –Disturbed area with straw BMP

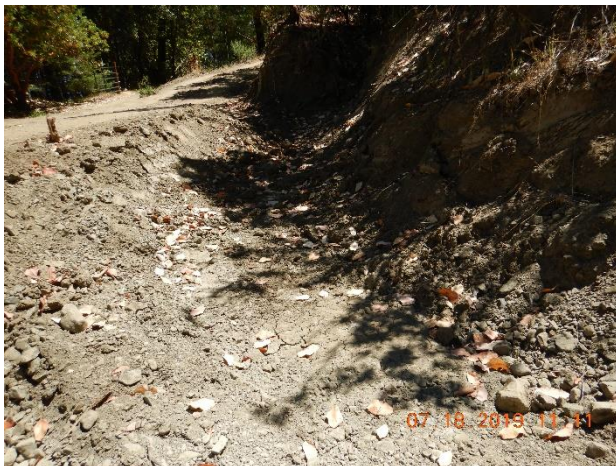
To the west of the pond I observed Crossing 6, with a 32" cement culvert that appeared undersized when compared to the channel (photos 46, 47). I also noticed sediment deposited into the watercourse here (photo 48), likely associated both with the recent earthwork and with drainage from the hydrologically connected roadside ditch (photos 46, 47, 49).

Photo 48 – Downstream Crossing 6

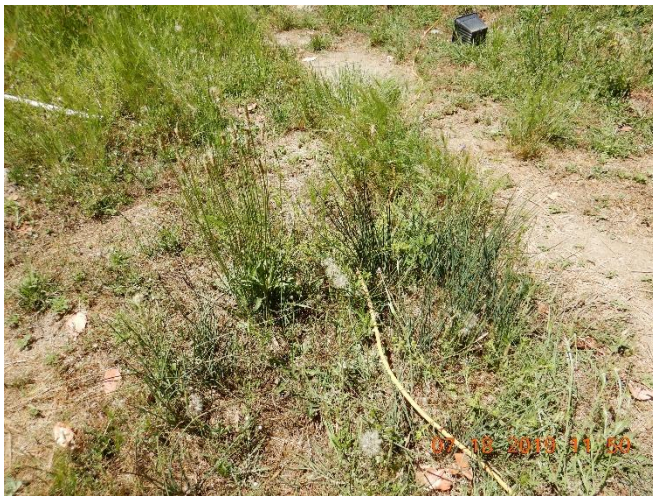
Photo 58 –Outdoor cultivation area in potential wetland (“Outdoor Grow 1” on Figure 5).
Photo showing possible hydrophytic vegetation (Juncus)

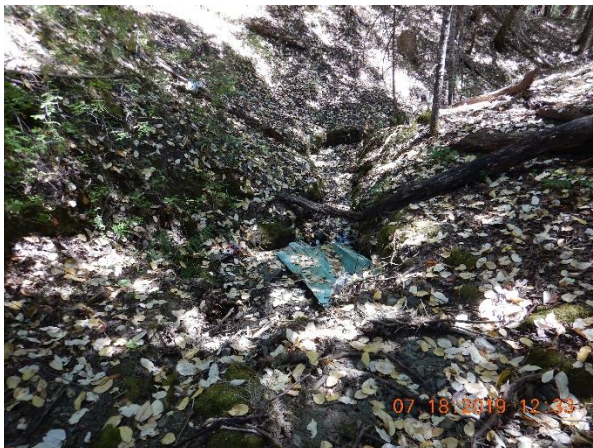
Within the stream channel, I observed trash and chemical containers. One nutrient container was hanging up, indicating it may have been used to mix nutrients within the watercourse. (“Tsh n channel” and “Chems n channel,” photos 55, 56 and 63).

Photo 63 – Trash in Class 2 watercourse (Figure 5)

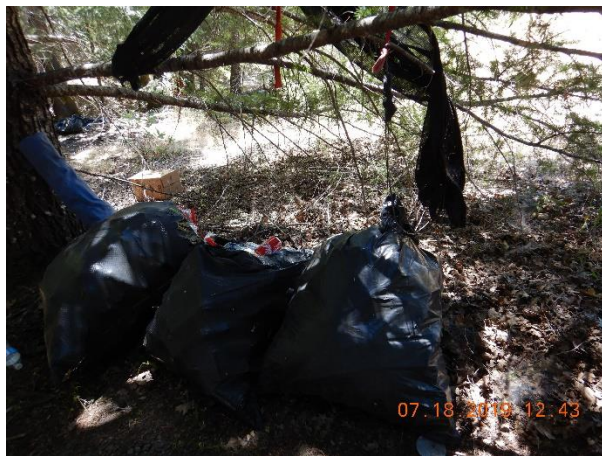
Photo 70 –Refuse not properly disposed of adjacent to Class 2 (Figure 5)

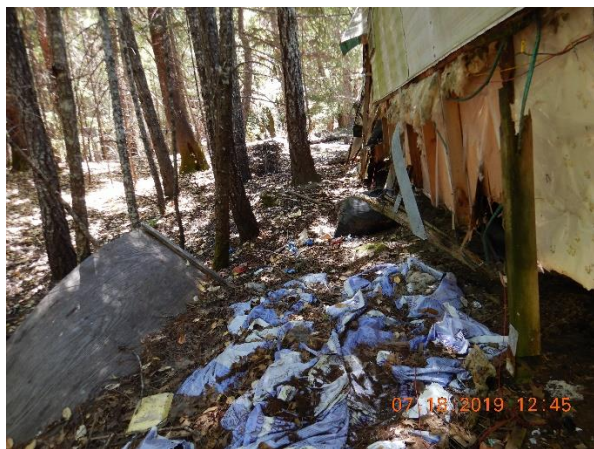
Photo 71 –Refuse and trailer falling apart adjacent to Class 2 watercourse (Figure 5)

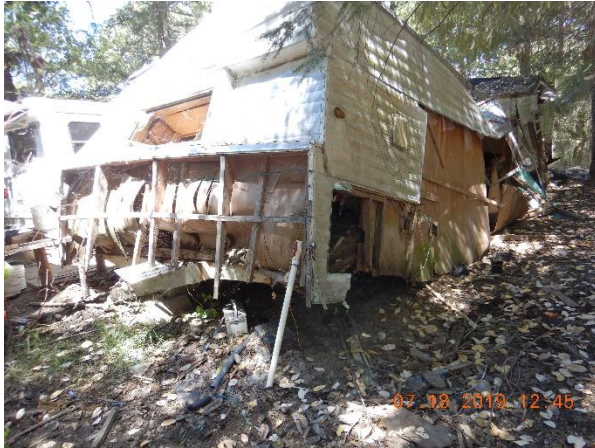
Photo 72 –Refuse and trailer falling apart adjacent to Class 2 watercourse (Figure 5)
