CANNABIS WATER QUALITY INSPECTION MEMO

August 23, 2019

SITE/FACILITY: 11 North Meadow Lane, Hayfork, CA 96041
Trinity County APN: 015-420-27

PURPOSE: Assess cannabis cultivation site for potential Water Quality violations

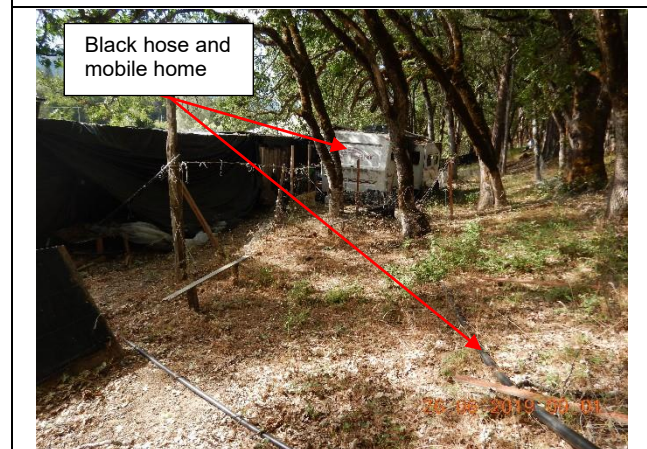
<i>Feature</i>	<i>Brief Description</i>	<i>Water Quality Violation</i>	<i>Applicable Water Code</i>	<i>Associated Photo(s)</i>
	into the southern end of the structure, which discharges into a pit. Measurement of the concrete structure was 6 feet long on top, 3 feet long on the bottom, and with a height of 2.5 feet. The outlet pipe had a 6-inch diameter.			
Construction of a Pit for Water Diversion from a Class III Watercourse	A pit was used divert water from a Class III watercourse via a concrete diversion structure in the Class III connected to the pit with a pipe. The southern end of the pit around the pipe was eroded with signs of rilling from liquid flowing out of the pipe. Measurements taken of the pit were 60 feet long by 25 feet wide, with a depth of 5 feet.	Under Assessment	Under Assessment	14 to 17
Discharge of Domestic Greywater	Greywater was observed on the ground under a wooden structure functioning as a sink. The wooden structure constructed behind a mobile home had a water hose with a water faucet tied to a pole in the front. Dirty dishes, a bottle of dish washing liquid, and a dish drying rack were on the wooden structure.	Under Assessment	Under Assessment	3 to 8,10, 11

Photo Taken by: Pansy Yuen, 26 June 2019
 Photo 11 – Southeast view of hoses connected to a water tank in Photo 11 running toward the left side of the photo and toward a mobile home.

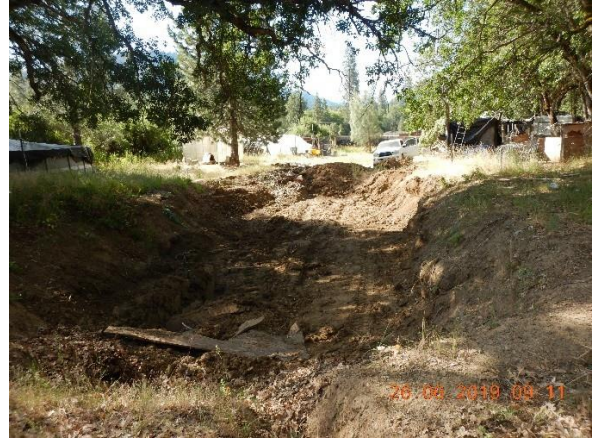
Photo Taken by: Pansy Yuen, 26 June 2019

Photo 14 – South view of a pit under excavation with loose soil on the south side of the pit.

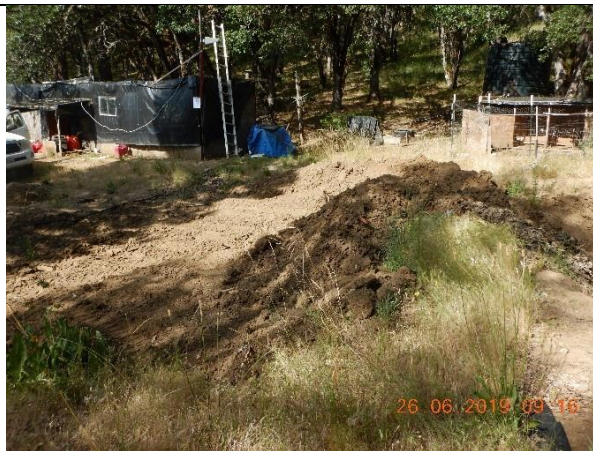
Photo Taken by: Pansy Yuen, 26 June 2019

Photo 17 – Southwest view of a pile of loose native soil stored at the southern end of the pit shown in Photos 14 and 15.

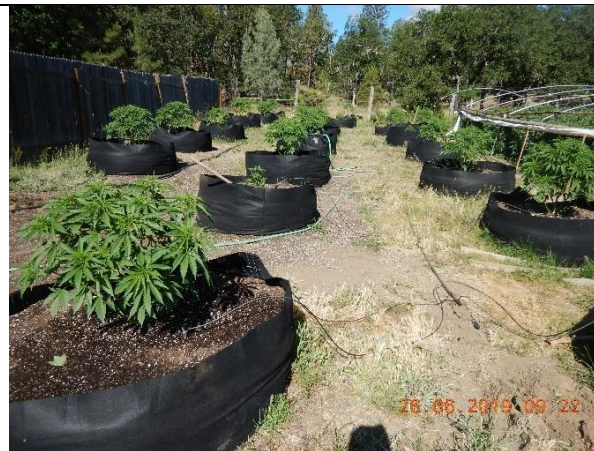
Photo Taken by: Pansy Yuen, 26 June 2019

Photo 18 – Cannabis Cultivation Site No. 1 on the north end of the parcel. Cannabis plants were grown inside black fabric bags and watered using drip irrigation system.

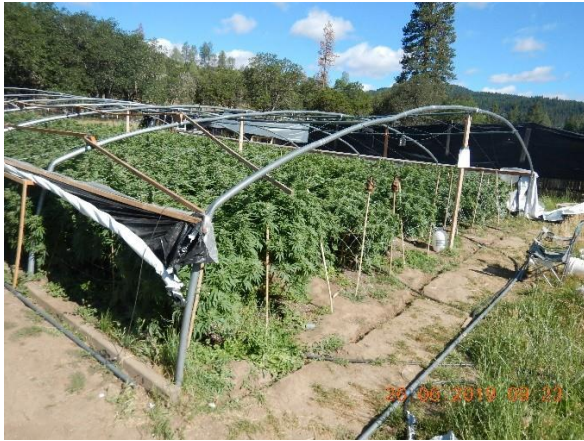
Photo Taken by: Pansy Yuen, 26 June 2019

Photo 19 – Northeast view of an uncovered greenhouse at Cultivation Site No. 1. The plants were grown in ground and watered using drip irrigation system.

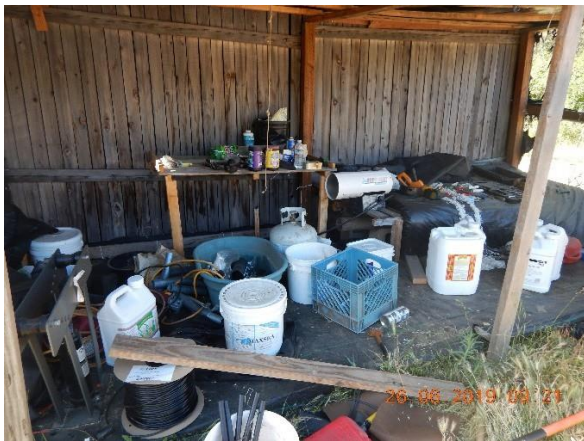
Photo Taken by: Pansy Yuen, 26 June 2019

Burning of Solid Waste	There was evidence of burning waste on the west and east side of the building structures located on the west side of the parcel and south of a pit. An example of evidence of waste included ashes and burnt aluminum containers.	Under Assessment	Under Assessment	9,44,47
Fertilizer Storage and Storage within Riparian Setback of a Class III Watercourse	Storage of fertilizers were found outdoors at the cultivation area with no secondary containment or spill control for fertilizer storage and no protection of fertilizer containers from weather and wildlife. In addition, a trash container filled with bright green liquid was 25 feet from a Class III watercourse. Fertilizer containers	Under Assessment	Under Assessment	21, 22, 27-28, 33, 34

Photo 21 – Southwest view of an unenclosed wooden structure at Cultivation Site No. 1. for storing materials including fertilizer, a propane tank, and portable heater.

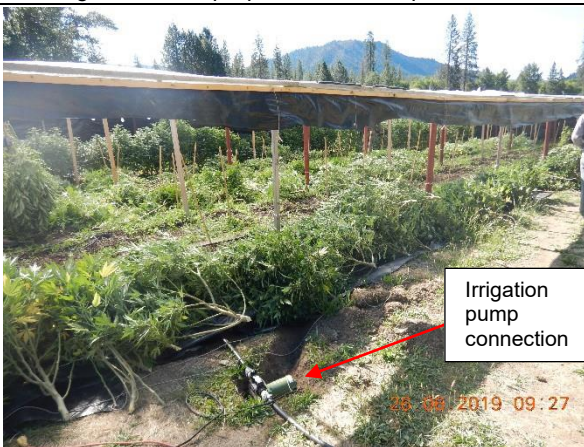
Photo Taken by: Pansy Yuen, 26 June 2019

Photo 23 – Cultivation Site No. 2 with plants grown in ground watered using an irrigation pump connected to a PVC pipe running east into the cultivation. A black hose was connected to the other end of the pump.

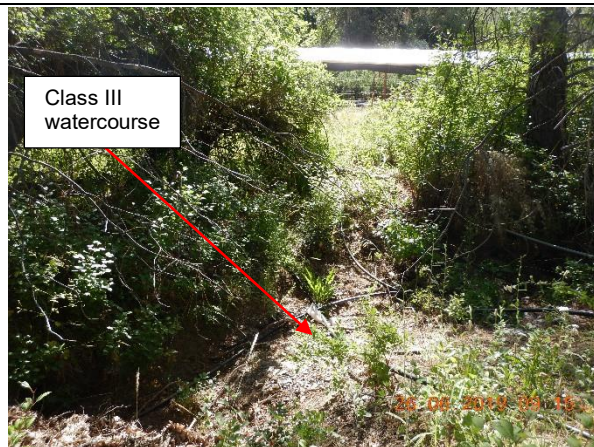
Photo Taken by: Pansy Yuen, 26 June 2019

Photo 24 – Class III watercourse with Cultivation Site No. 2 shown in the back of the photo.

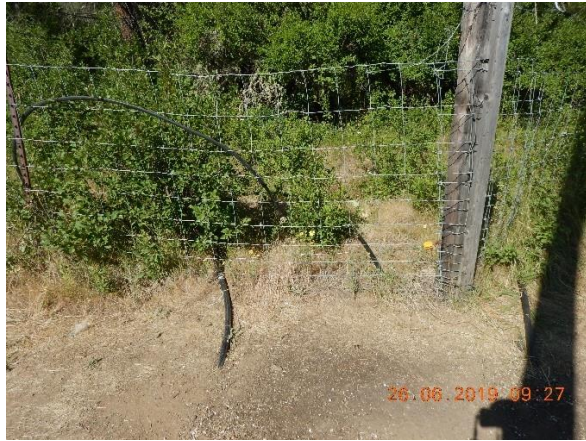
Photo Taken by: Pansy Yuen, 26 June 2019

Photo 25 – West view of a black hose crossing a wired fence aboveground and disappearing underground. A Class III watercourse was observed directly behind the wired fence.

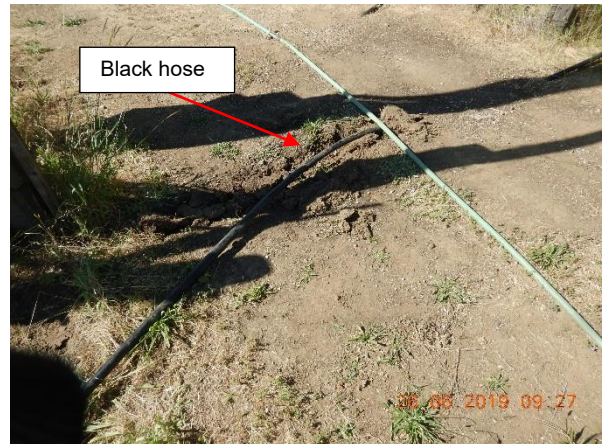
Photo Taken by: Pansy Yuen, 26 June 2019

Photo 26 – Southwest view of a black hose disappearing underground from Photo 25 and reappearing aboveground. The black hose is connected to a pump shown in Photo 23.

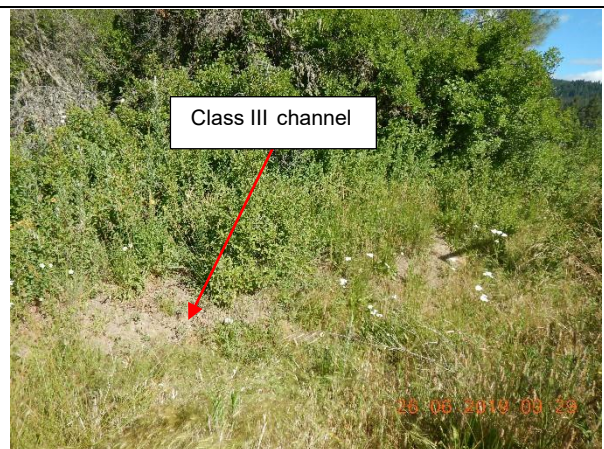
Photo Taken by: Pansy Yuen, 26 June 2019

Photo 30 – A close-up view of the Class III watercourse behind a wired fence shown in Photo 29.

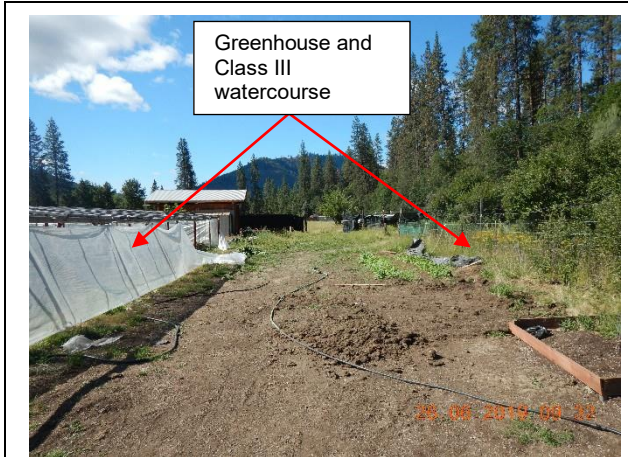
Photo Taken by: Pansy Yuen, 26 June 2019
Photo 31 – South view along Cultivation Site No. 2 with a greenhouse on the left and a Class III watercourse behind the wired fence on the right side of the photo.

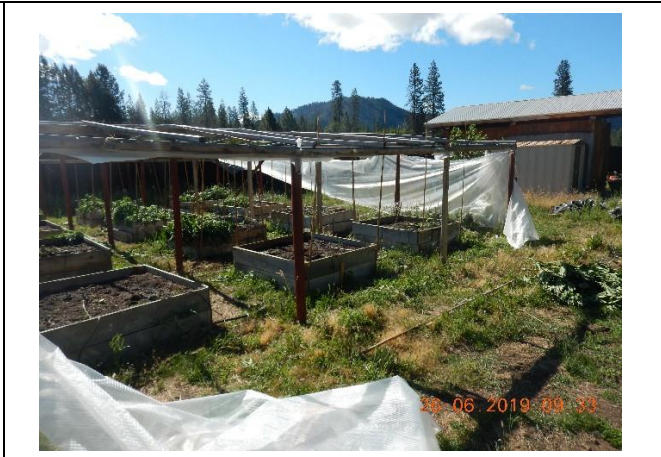
Photo Taken by: Pansy Yuen, 26 June 2019
Photo 32 – Southeast view of Cultivation Site No. 2 inside a greenhouse shown in Photo 31. Cannabis was grown in raised beds inside of a wooden box placed on the ground. Plants were watered using drip irrigation system.

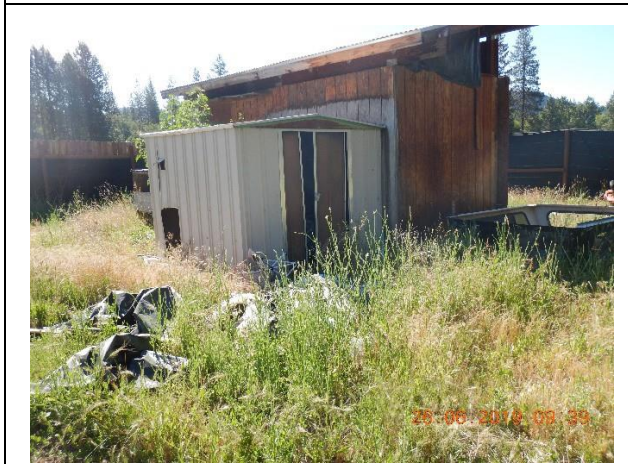
Photo Taken by: Pansy Yuen, 26 June 2019
Photo 33 – Southwest view of a metal and wooden sheds at the southern end of Cultivation Site No. 2.

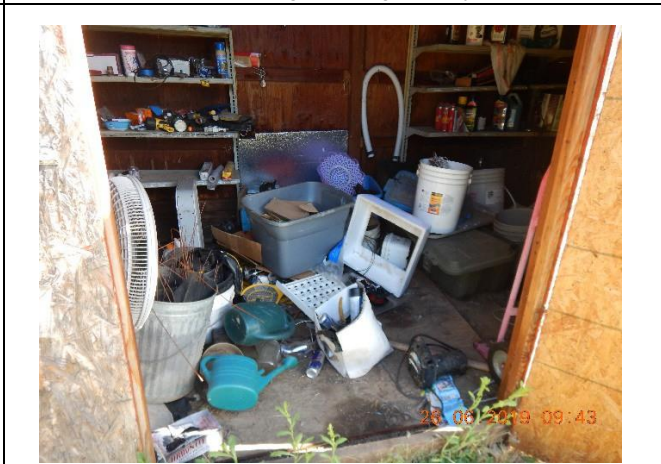
Photo Taken by: Pansy Yuen, 26 June 2019
Photo 34 – Materials including fertilizer and butane fuel canisters inside a wooden shed shown in Photo 33.

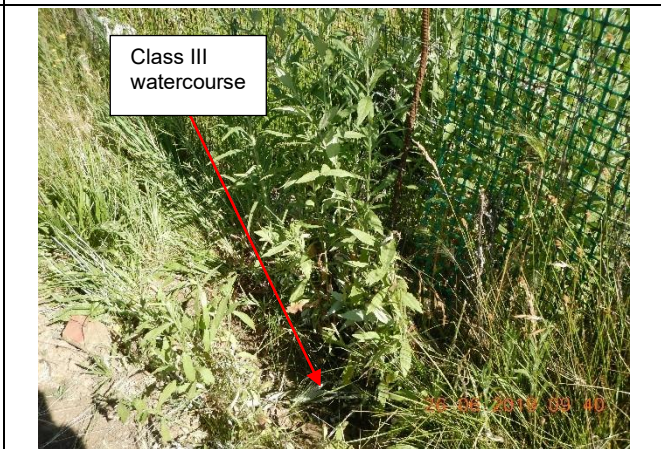
Photo Taken by: Pansy Yuen, 26 June 2019
Photo 36 – Close-up of a Class III watercourse located north of the fill.

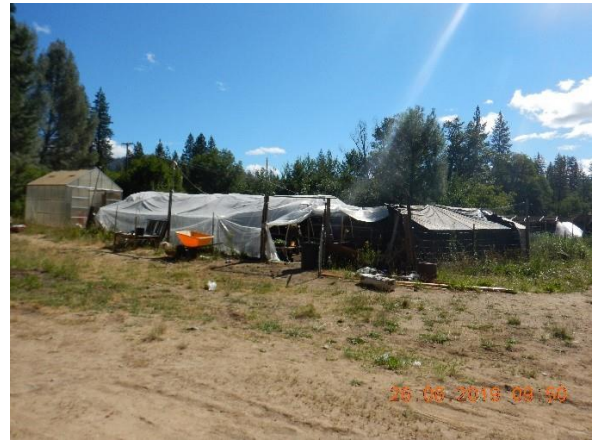
Photo Taken by: Pansy Yuen, 26 June 2019
Photo 40 – Northeast view of a greenhouse north of the entrance to the cultivation area.

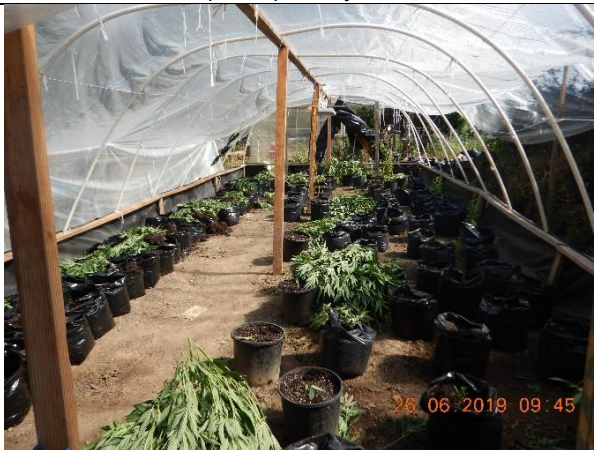
Photo Taken by: Pansy Yuen, 26 June 2019
Photo 41 – North view inside a covered greenhouse shown in Photo 40 with plants growing in pots and in plastic bags aboveground.

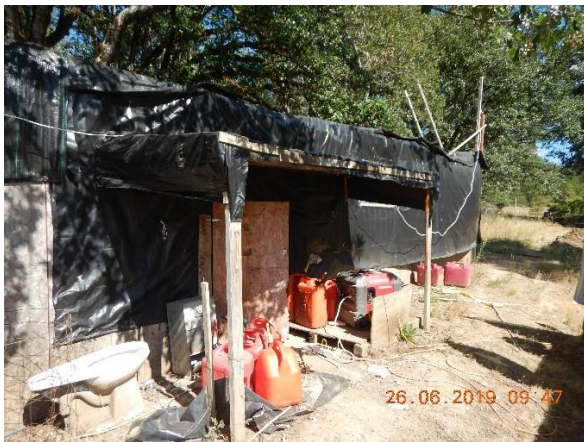
Photo Taken by: Pansy Yuen, 26 June 2019

Photo 45 – Northwest view of a wooden shed with storage of petroleum containers located on the west side of the parcel.

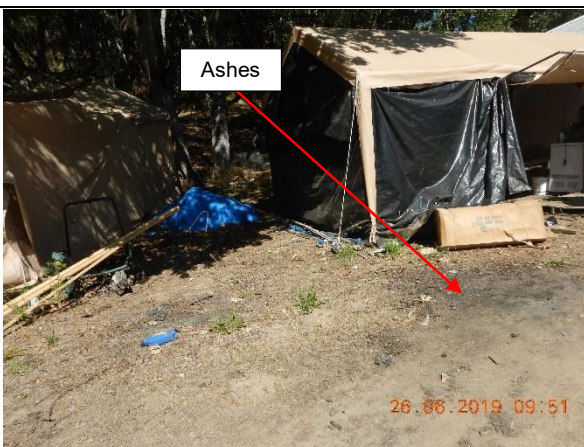
Photo Taken by: Pansy Yuen, 26 June 2019

Photo 47 – Northwest view of remnants of ashes on the ground.

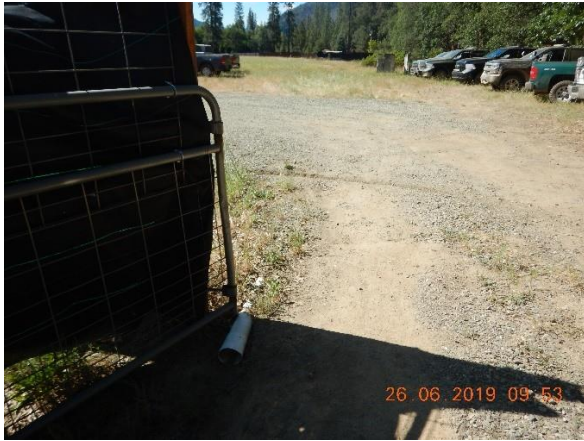
<i>Feature</i>	<i>Brief Description</i>	<i>Water Quality Violation</i>	<i>Applicable Water Code</i>	<i>Associated Photo(s)</i>
	were stored around the trash container.			
Operation of Water Pump within Riparian Setback of a Class I Watercourse	Water pump used to divert water from Barker Creek, a Class I watercourse, located on the east side of the parcel was measured to be 8 feet from Barker Creek.	Under Assessment	Under Assessment	60 to 63
Redirection of a Class III Watercourse	A Class III watercourse flowing south was redirected 17 feet east before it was redirected 4.5 feet south to enter a metal culvert under the main access road.	Under Assessment	Under Assessment	52 to 55
Property Drainage Pipe	A white 4-inch PVC drainage pipe next to an entrance of the cultivation area appeared to drain runoff from inside the cultivation area to an uncultivated area. Discharges from the cultivation site without protection threaten to impact nearby water quality.	Under Assessment	Under Assessment	49 to 51

Photo Taken by: Pansy Yuen, 26 June 2019
Photo 49 – South view of a white PVC pipe next to main entrance of the cultivation area. The pipe disappeared underground under a main access road.

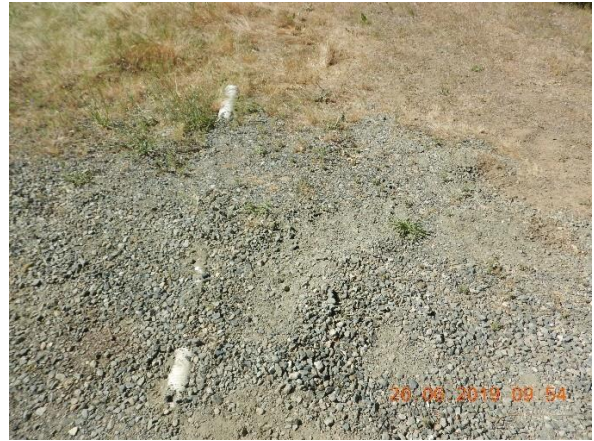
Photo Taken by: Pansy Yuen, 26 June 2019
Photo 50 – North view of a white PVC pipe shown in Photo 49 reappearing south of a main access road.

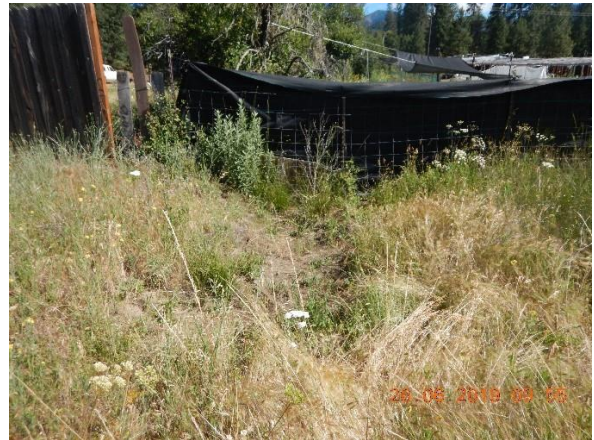
Photo Taken by: Pansy Yuen, 26 June 2019
Photo 52 – North view of a Class III watercourse upstream of the main access road located on the south side of the parcel.

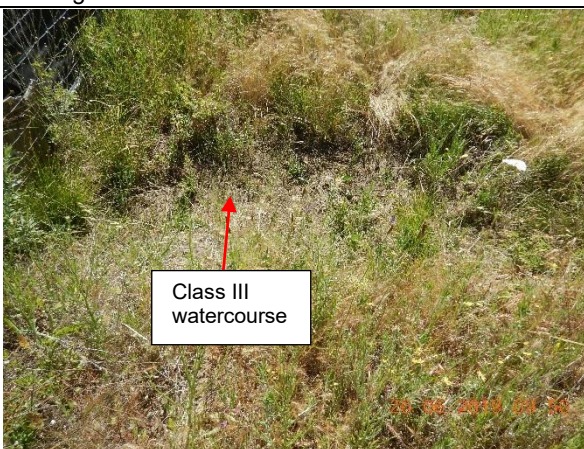
Photo Taken by: Pansy Yuen, 26 June 2019
Photo 53 – A close-up view of Photo 52, a Class III watercourse outlet point downstream of Cultivation Site No. 2.

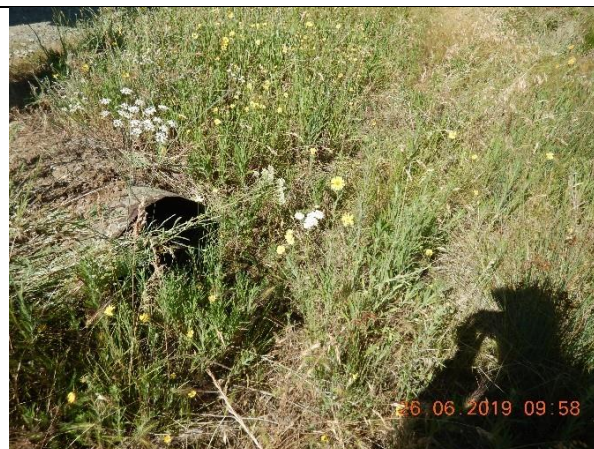
Photo Taken by: Pansy Yuen, 26 June 2019
Photo 54 – Southwest view of a culvert on the north side of a main access road downstream from the Class III watercourse.

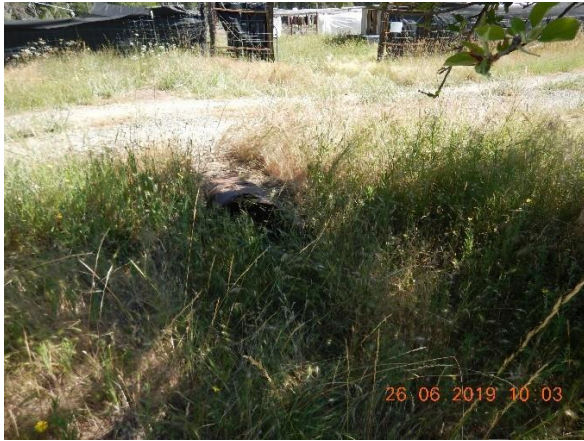
Photo Taken by: Pansy Yuen, 26 June 2019
Photo 55 – North view of a culvert on the south side of the main access road.

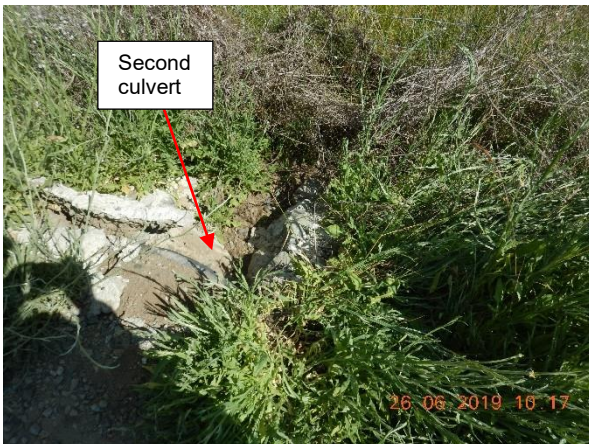
<i>Feature</i>	<i>Brief Description</i>	<i>Water Quality Violation</i>	<i>Applicable Water Code</i>	<i>Associated Photo(s)</i>
	contained white perlite. The measurements of the fill dimensions were 15 feet by 13 feet with a depth of 6 inches.			
Fuel Storage, Staining, and Storage within Riparian Setback	Fuel storage with no secondary containment or spill controls. There was an oil spill staining of plywood underneath a generator on the west side of the parcel and oil spill staining soil underneath a water pump located approximately 8 feet from Barker Creek. A fuel container was measured to be 25 feet from Barker Creek.	Under Assessment	Under Assessment	45, 46, 48, 64 to 66
Erosion on Main Access Road	Evidence of road surface soil erosion near two 18-inch metal culverts which provided a Class III watercourse crossing under the access road. There was also evidence of eroding concrete from armoring a metal culvert located approximately 50 feet from North Meadow Lane. Potential for discharge into a Class III watercourse through the culvert.	Under Assessment	Under Assessment	56 to 59

Photo Taken by: Pansy Yuen, 26 June 2019
Photo 57 – Northwest view of a second culvert outlet point downstream from Cultivation Site No. 2 and a Class III watercourse.

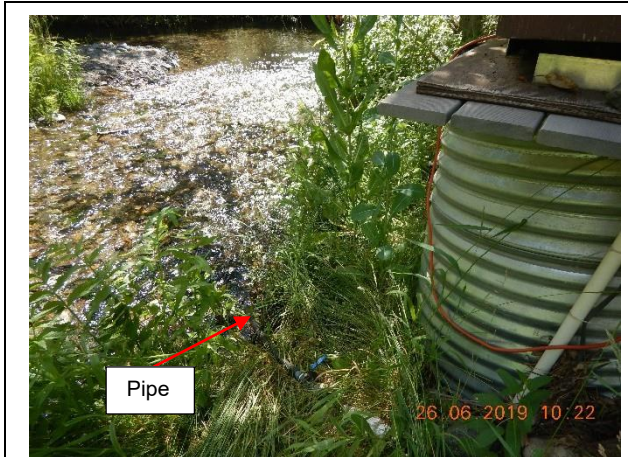
Photo Taken by: Pansy Yuen, 26 June 2019
Photo 61 – Southeast view of a pipe connected to a galvanized steel corrugated riser pipe near Barker Creek.

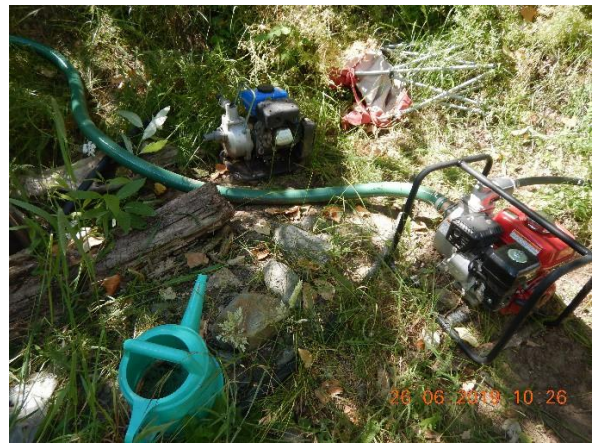
Photo Taken by: Pansy Yuen, 26 June 2019
Photo 62 – Close-up view of a water pump connected to a green suction hose stored behind the corrugated riser pipe.

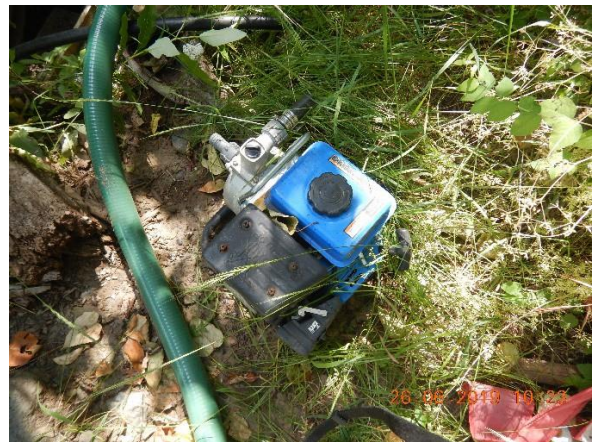
Photo Taken by: Pansy Yuen, 26 June 2019
Photo 64 – Close-up view of a blue water pump next to the galvanized steel corrugated riser pipe.
