FACILITIES INSPECTION REPORT

Place ID 844233	Facility Name: Prop A		
Address: 2020 Buck Mountain Road	City, State, Zip: Bridgeville, CA		
County: Humboldt	Latitude: 40.42629	Longitude: -123.59667	Method: Map Interpolation (digital)

Inspection Type: B Type compliance inspection

Inspection Map, Field Measurements and Photolog for March 25, 2021 inspection.

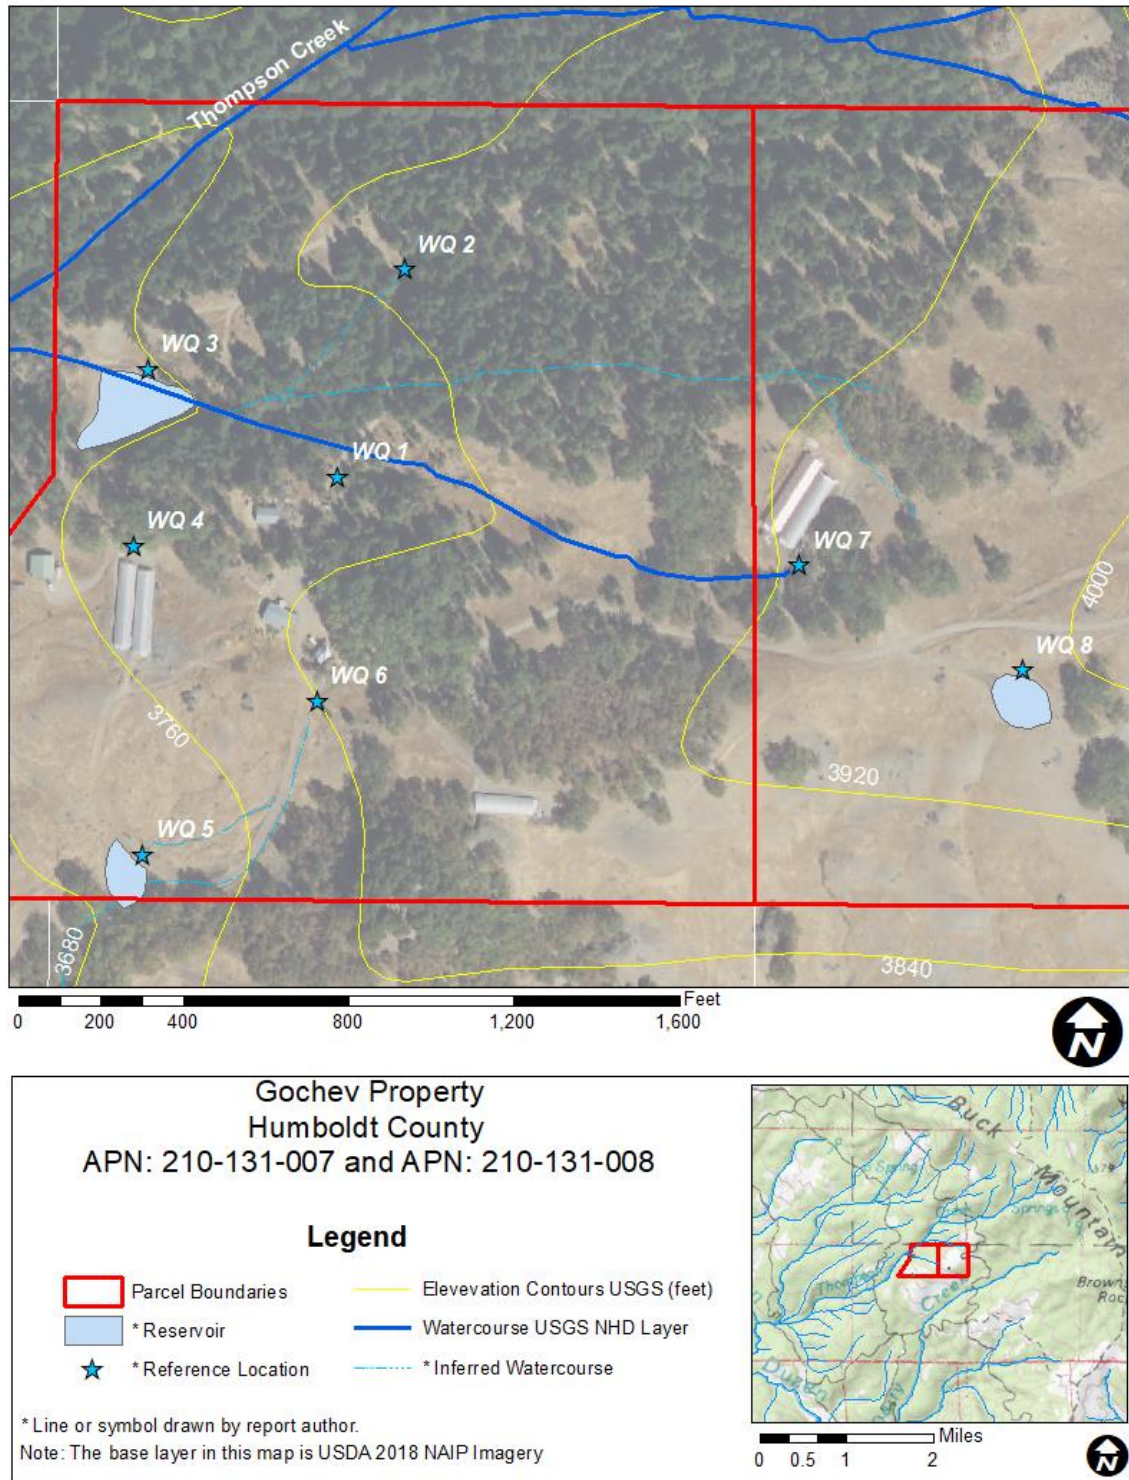
Figure 1: Map of Property, including inspection points of interest.

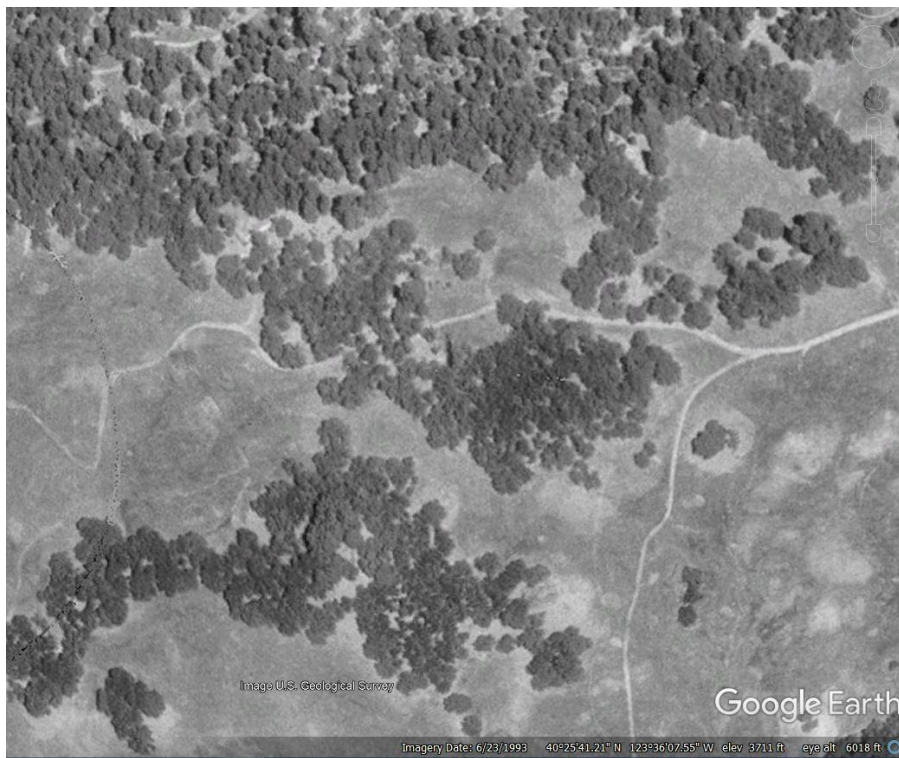
Aerial Image 1—dated June 23, 1993, accessed with Google Earth. Image shows roads but no reservoirs or graded pads on the property

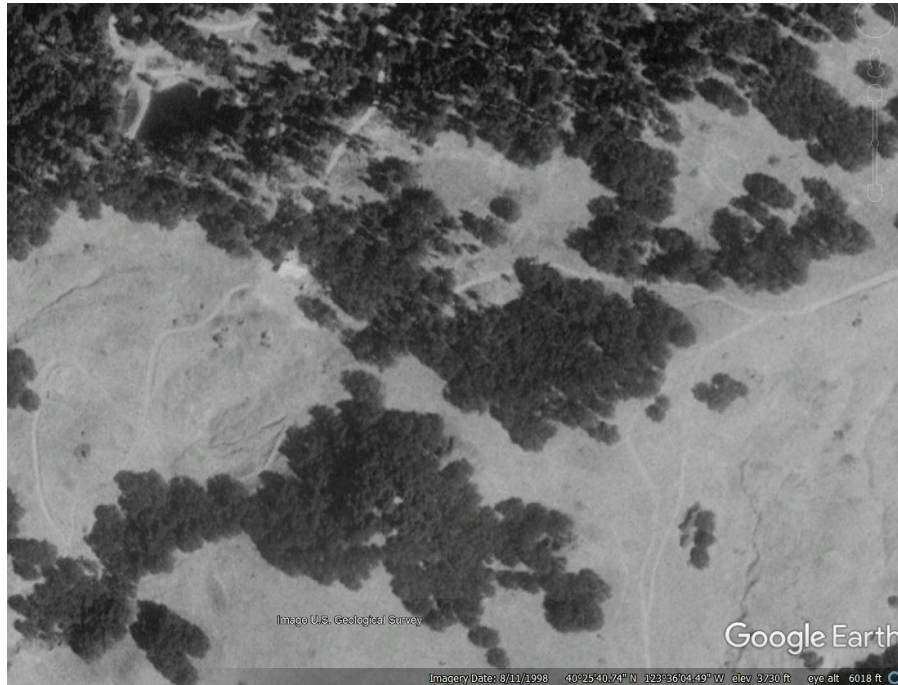
Aerial Image 2—dated August 11, 1998, accessed with Google Earth. Image shows an onstream reservoir in the top left of the image (Reservoir 1).

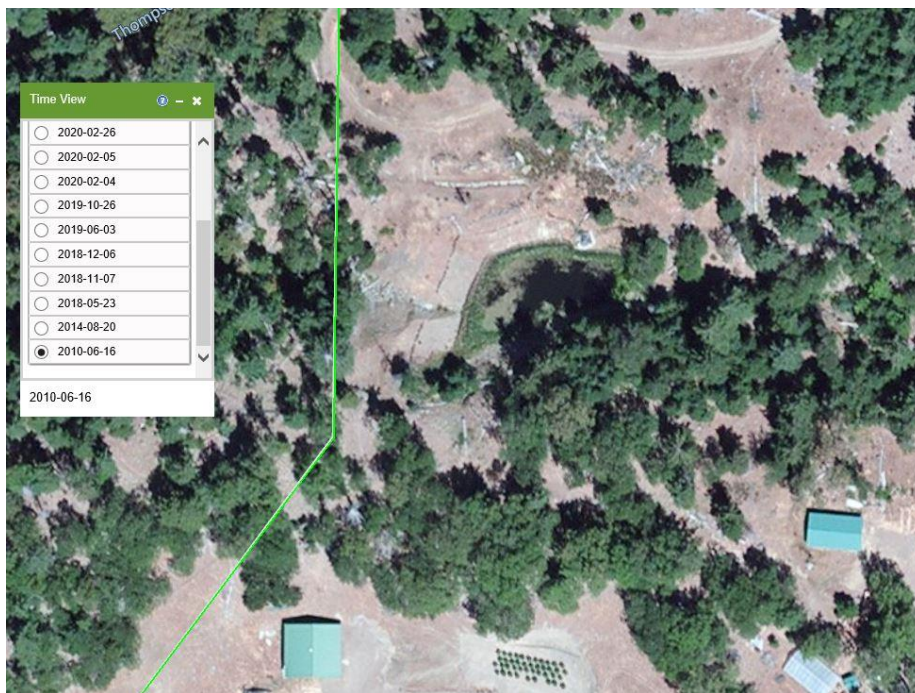
Aerial Image 5—dated June 16, 2010, accessed with Digital Map Products' Land Vision service. Image shows the same depression on the downstream buttness of Reservoir 1.

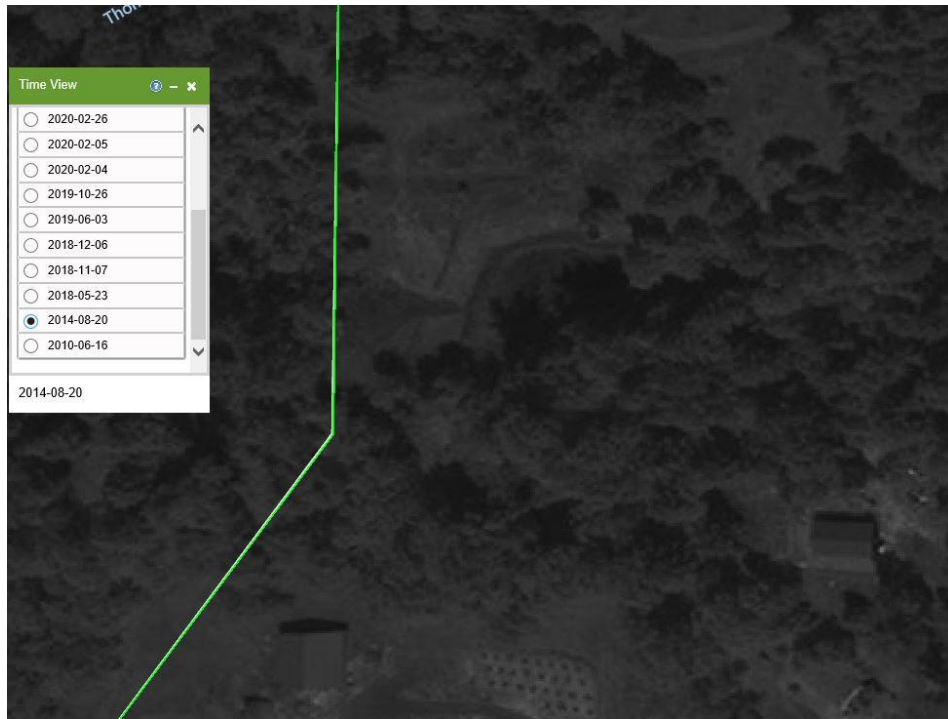
Aerial Image 8—dated August 20, 2014, accessed with Digital Map Products' Land Vision service. Image shows a channel fully crossing the downstream buttness of Reservoir 1.

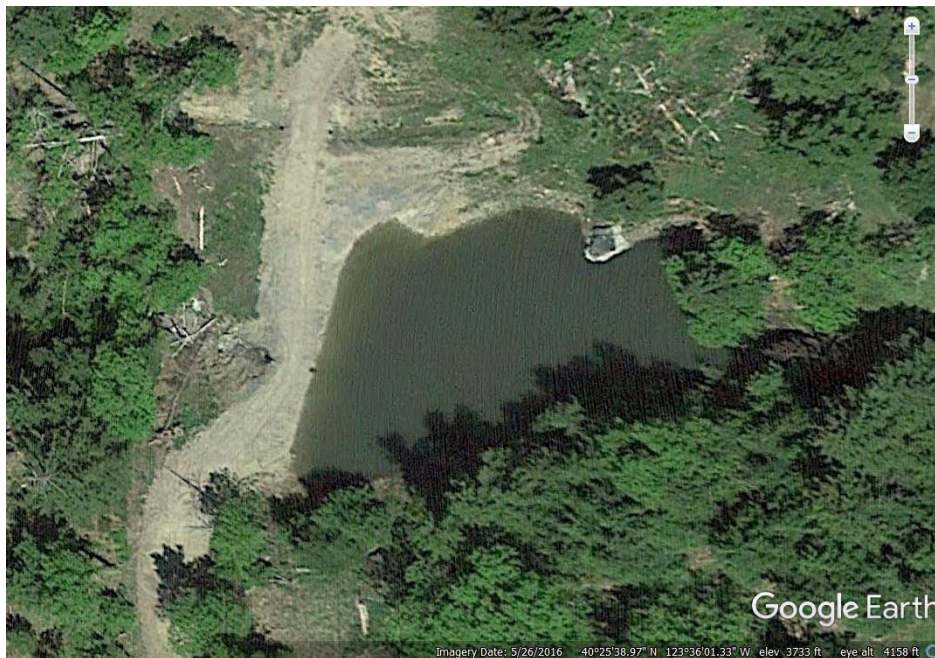
Aerial Image 9—dated May 26, 2016, accessed with Google Earth. Image shows a culvert installed in the channel fully crossing the downstream buttness of Reservoir 1.

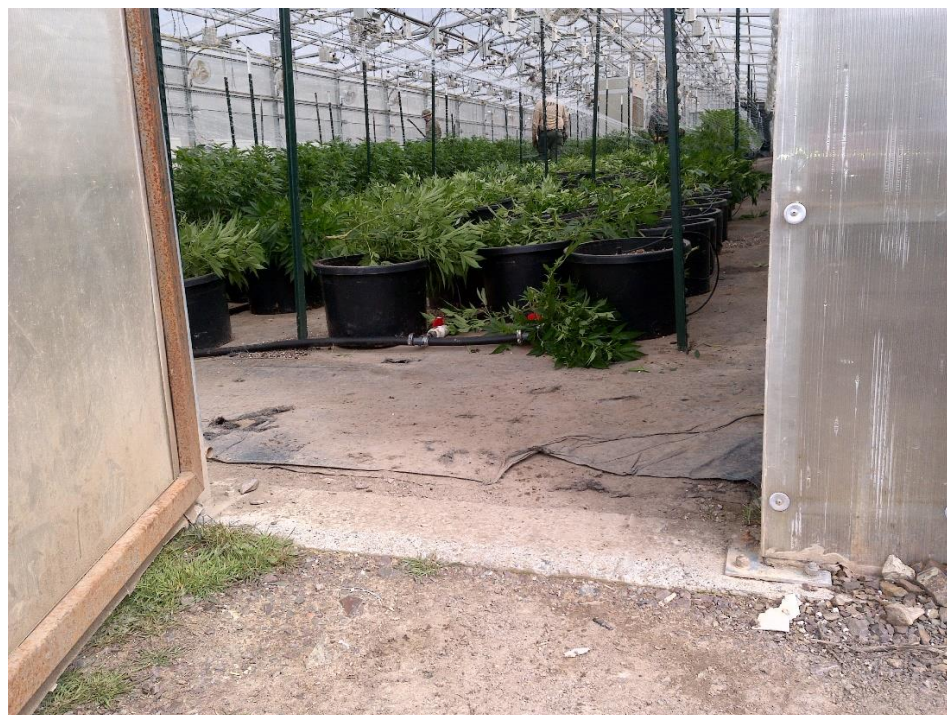
I drove to the greenhouse pad at WQ 7 and observed water emanating from a cut slope on the western edge of the pad and flowing to a watercourse to the east. The northeast of the pad was within 20 feet of a watercourse. I observed the reservoir at WQ 8 but I did not note any threats to Water Quality.

Photo 23—Greenhouse in the vicinity of WQ 7. The greenhouse floor is composed of a geotextile fabric covering dirt.

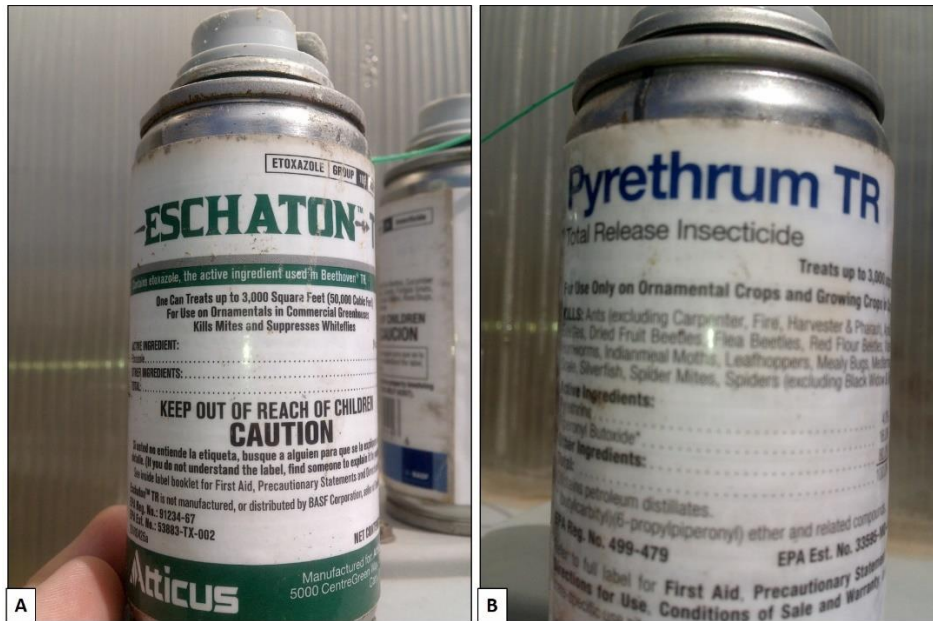
Photo 24—Looking at pesticide labels found at WQ 7.

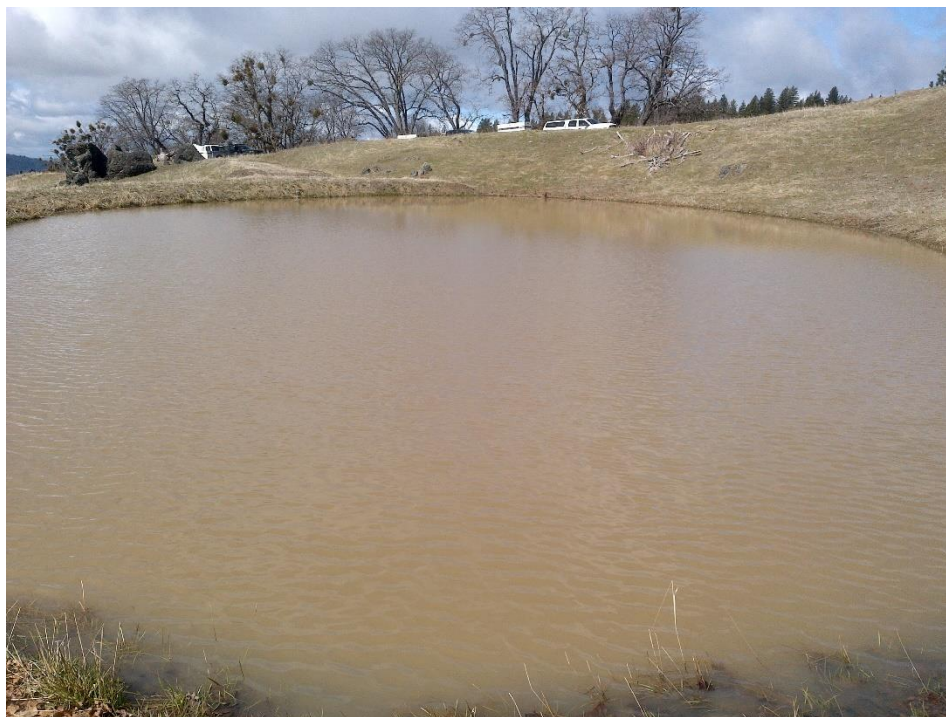
Photo 27—Looking north at reservoir (Reservoir No. 3) located at WQ 8.
