**FACILITIES INSPECTION REPORT**

Place ID 838403	Facility Name: Happy Ranger, LLC (Homested Road)	
Address: 5576 Homested Road	City, State, Zip: Blocksburg, CA 95514	
County: Humboldt	Latitude: 40.28108	Longitude: -123.680133 Method:

Inspection Type: B Type compliance inspection

April 23, 2021, Penev Inspection  
Map and Photo Appendix  
CIWQS Inspection ID 44136013

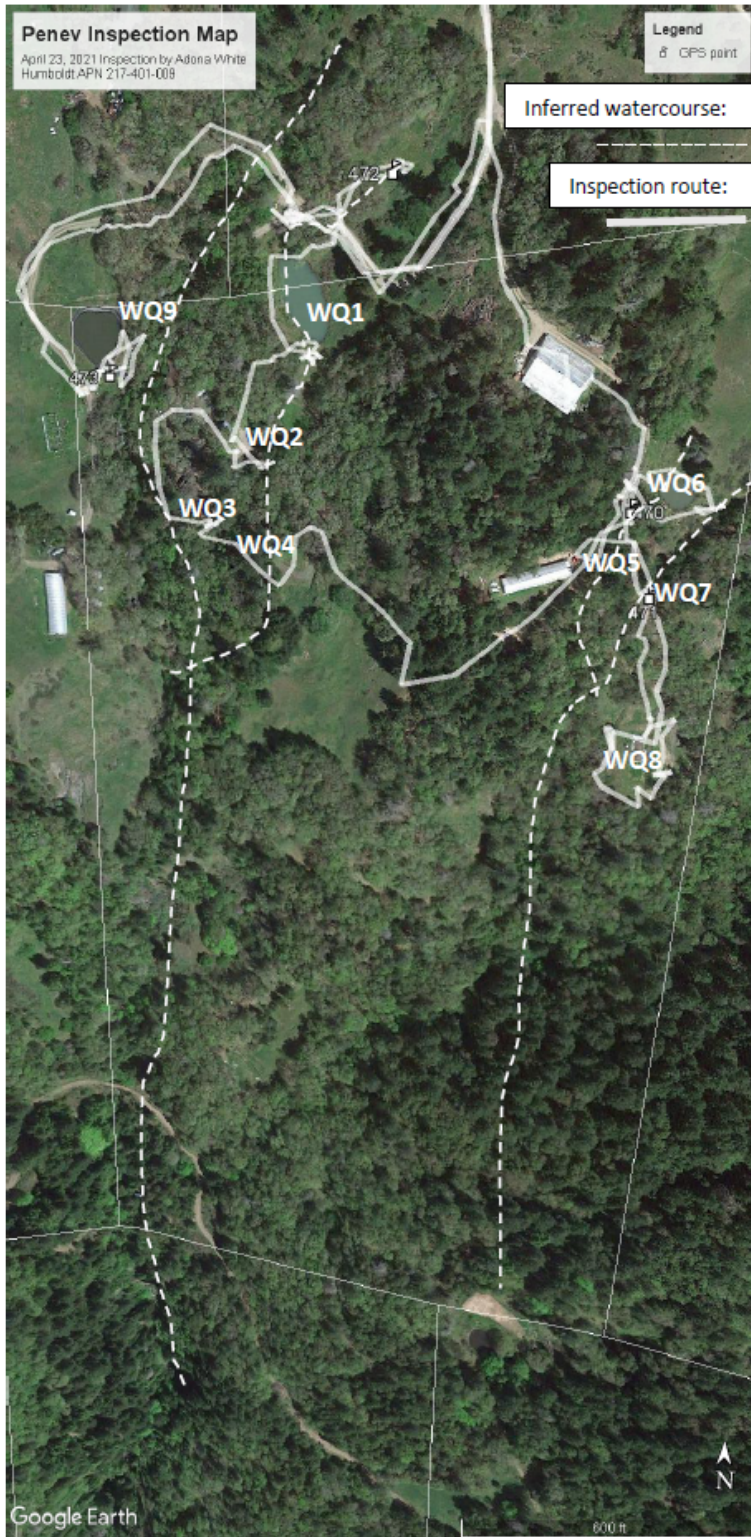
Figure 1. Inspection Map of Property map with aerial image, parcel boundaries, inspection route, inferred watercourses, GPS points, and locations of WQ concerns.
