Inspection Maps and Photolog for inspection conducted March 11, 2021
All maps and photos by Adona White, PE, Water Resource Control Engineer

Inspection Photographs

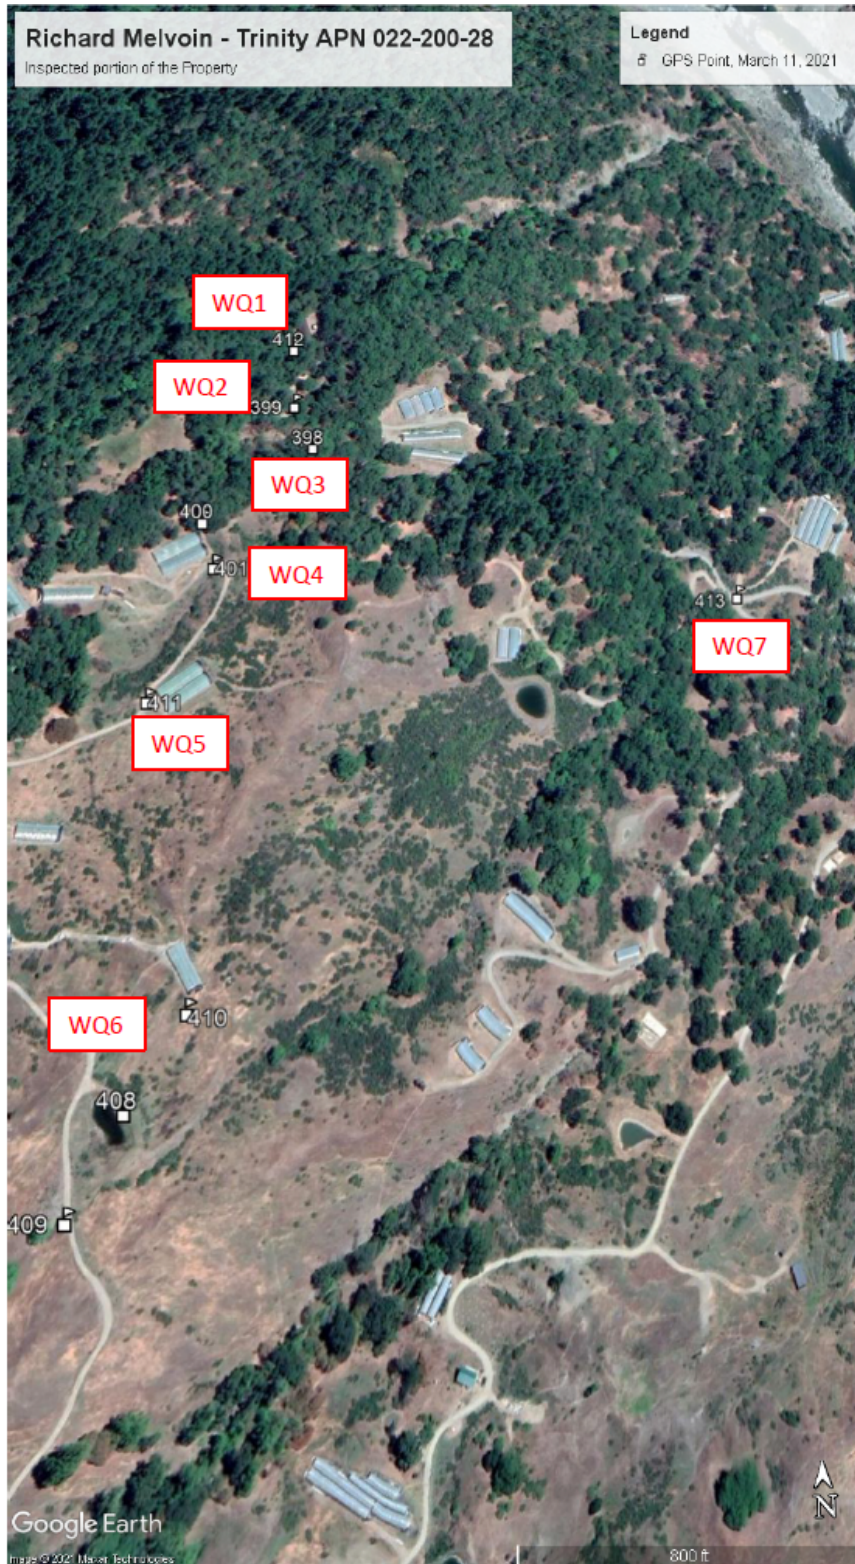
Figure 2. July 13, 2020 aerial imagery with inspection GPS locations shown with number and features described in text as WQ1-WQ7.
