## North Coast Regional Water Quality Control Board

Subject: **Notice of Violation for Failure to Comply with Cleanup and Abatement Order No. R1-2019-0051 (CAO) Required Actions Nos. 4 and 8**

**Inspection Report for March 1, 2021 Consent Inspection,  
Humboldt County Assessor's Parcel Numbers (APNs) 223-074-004-000,  
223-074-006-000, and 223-074-009-000 (the "Property")**

File: Cannabis Program Inspections, Humboldt County, March 1, 2021, Tobias Hafenecker-Dodge Property, CIWQS Place ID 823853

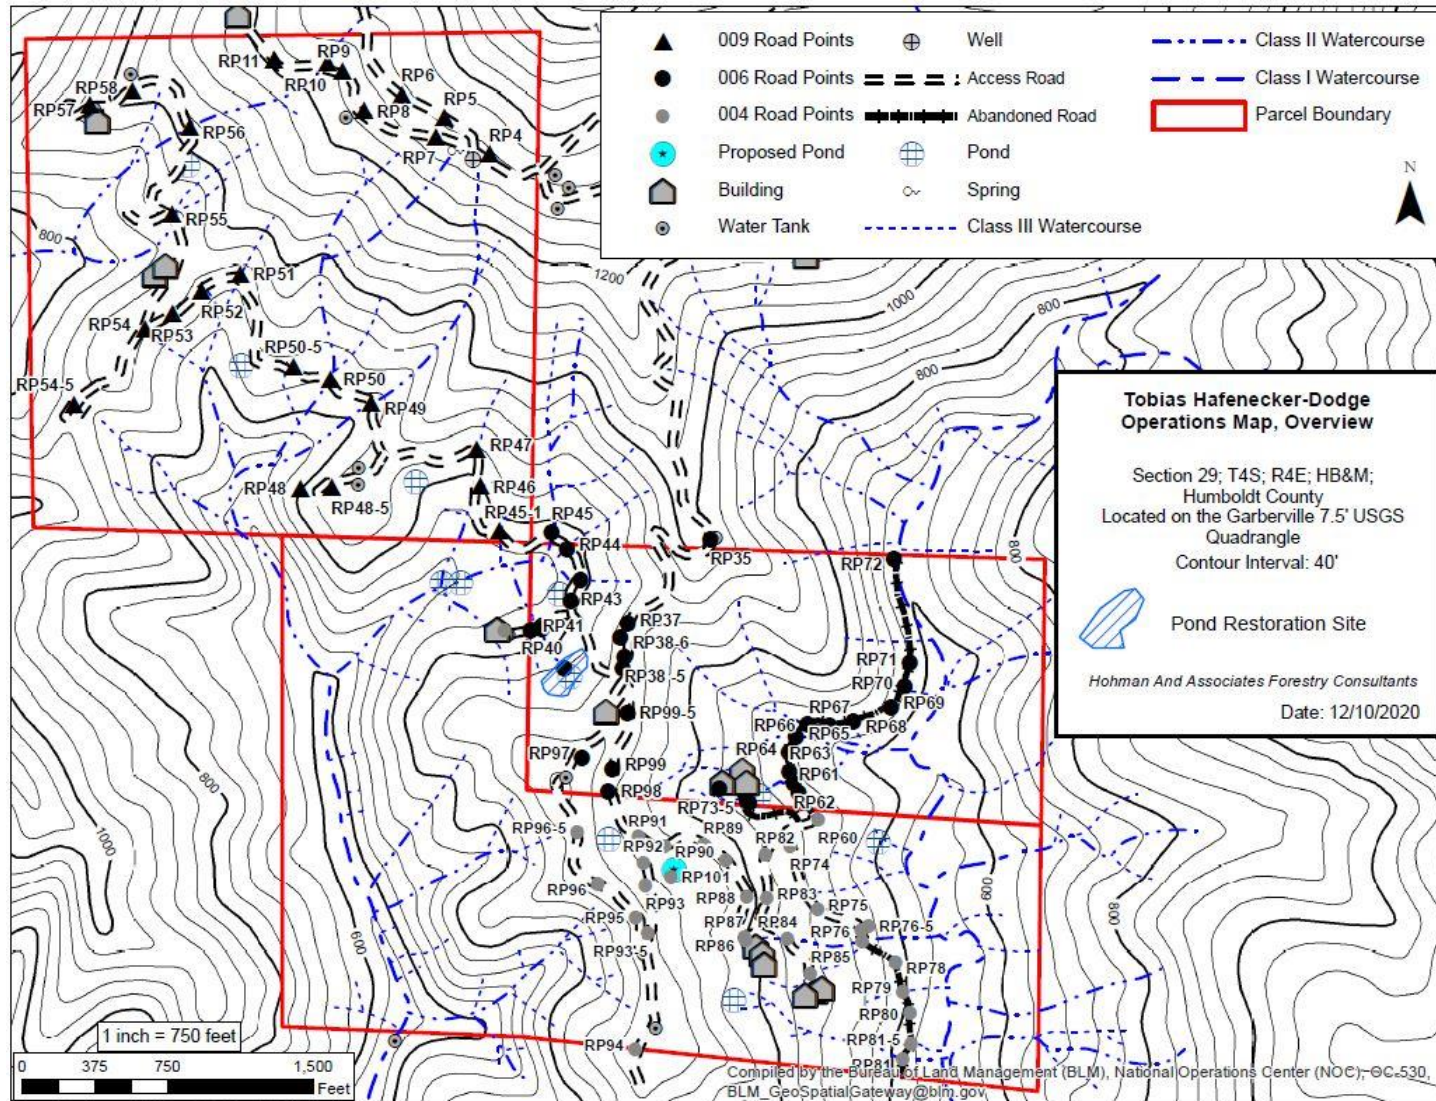
Figure 1: Inspection Map from page 54 of 2021 CRMP.

Attendees from Green Roads, CDFW and the Regional Water Board met at the turn-off from Alderpoint Road in the vicinity of latitude 40.107812, and longitude -123.747553. We drove onto the property and parked vehicles near the house in the center of the property in the vicinity of RP 38-5 (Figure 1). After a brief discussion about which sites the participants wanted to see and discuss, we decided to start at the northwest corner of the property and work south.

From the reservoir, we drove to the cultivation area at RP 91 (refer to Figure 1 and Figure 3) and walked to a crossing at the north-west corner of the cultivation pad at RP 98. I observed that the culvert outfall is directed to the north through a swale bounded to the south by a low rock berm, and that the vegetation within the swale included plants from the genus *juncus* (Photo 13). I acknowledged that the 2021 CRMP included a wetland delineation of the area, however the delineation described the current conditions and was not forensic. I explained that aerial imagery showed that part of the unauthorized activity in 2016 included expanding the cultivation pad (Figure 3). I added that the CAO requires a forensic assessment of this area to identify whether the pad
