## Construction General Permit Inspection

<b>FACILITY INFORMATION</b>
<b>Inspector's Name:</b> Regional Board Staff: Joshua Luders, Water Resource Control Engineer
<b>Facility Name:</b> Grove Village
<b>Facility WDID:</b> 1 49C387538
<b>Facility Address:</b> 2872 Stony Point Road, Santa Rosa, Sonoma County
<b>Construction General Permit Type and Level:</b> Sediment Risk: Medium; Receiving Water Risk: High; Risk Level: 2
<b>Legally Responsible Party:</b> City Ventures Homebuilding Inc; Director of Construction Quality Assurance: Gregory Clisby (Referred to as City Ventures or Discharger in this document)
<b>Name of QSD:</b> Ryan Bittner #20936 is the QSD listed in SMARTS
<b>Name of QSP:</b> Paul Keiran from Kaz and Associates verbally declared himself as the Site QSP on October 25, 2021
<b>INSPECTION INFORMATION</b>
<b>Inspection Date:</b> October 23, 2021 Drive-By, October 24, 2021 Drive-By, October 25, 2021 Morning Drive-By, October 25, 2021 After Morning Onsite, and October 29, 2021 Onsite

<b>Purpose of Inspection:</b> Follow up to October 23, 2021 pre-rain drive by inspection where site was observed to have minimal to no BMPs
<b>Parties Present During Inspection:</b> Regional

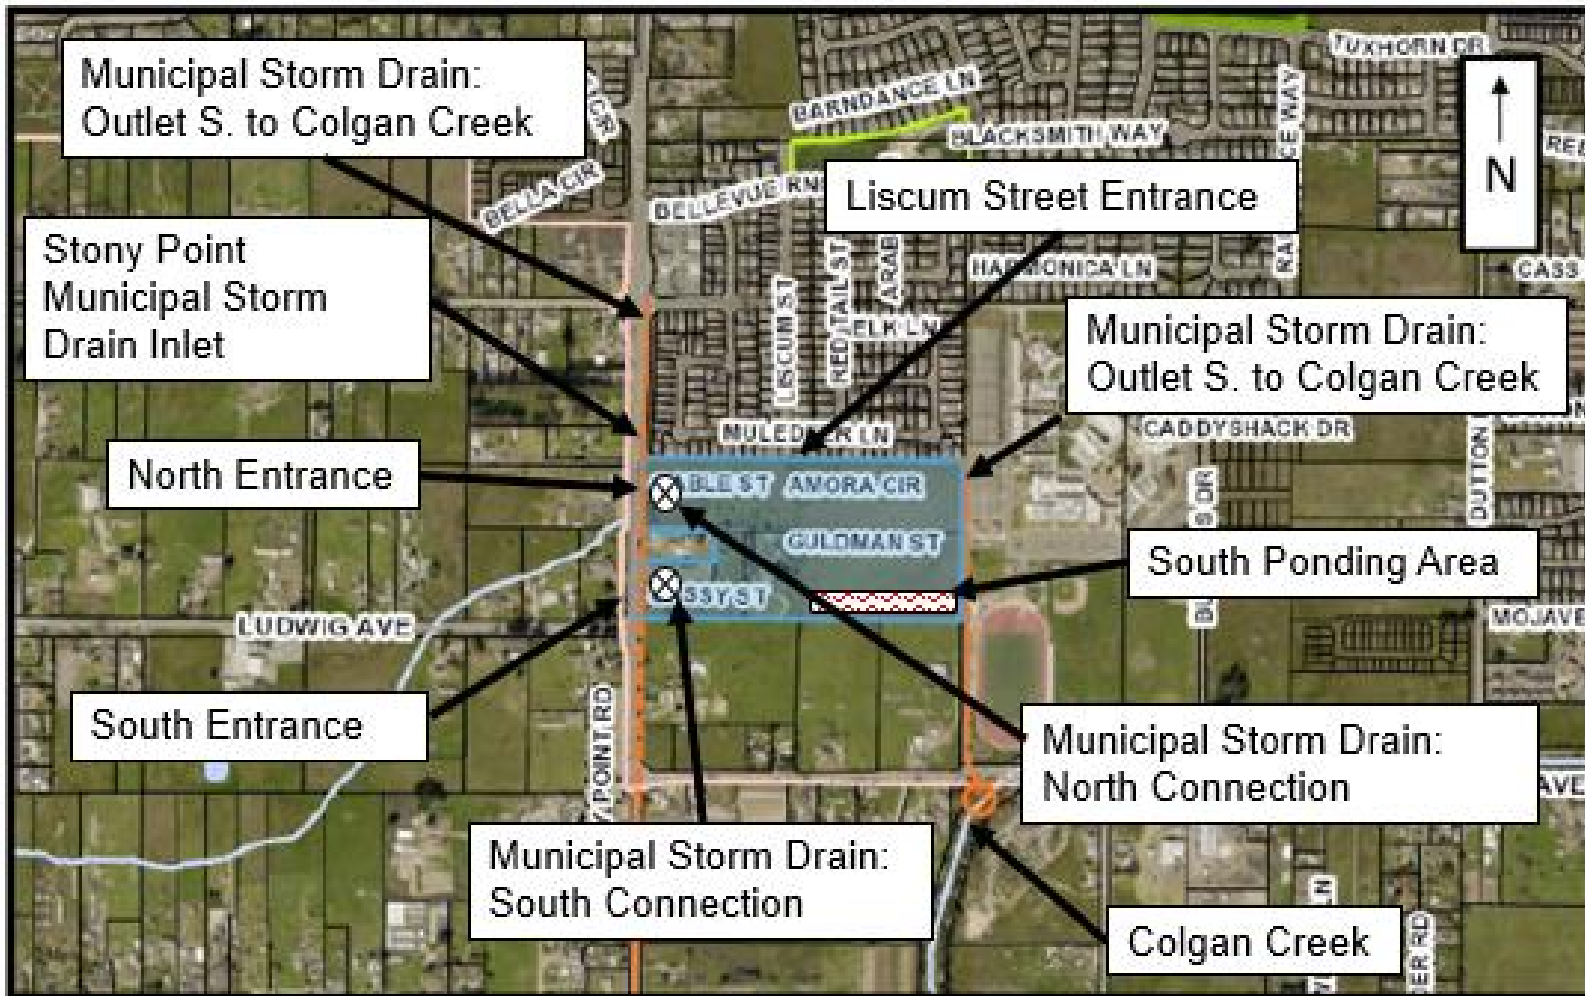
Map 1: Shaded blue area depicts the Project area. The black arrows indicate key features that are specific to the inspection observations below. (Image obtained from City of Santa Rosa staff Nick Sudano on October 28, 2021. Regional Water Board staff edited the image to include descriptive information regarding the observations below.)
