North Coast Regional Water Quality Control Board

Subject: **Notice of Violation and Transmittal of Inspection Report for October 25, 2021 Inspection of Sonoma County Assessor's Parcel Number 084-210-001-000**

File: Cannabis Program Inspections, Sonoma County, October 25, 2021, CIWQS Place ID No. 842542

## FACILITIES INSPECTION REPORT

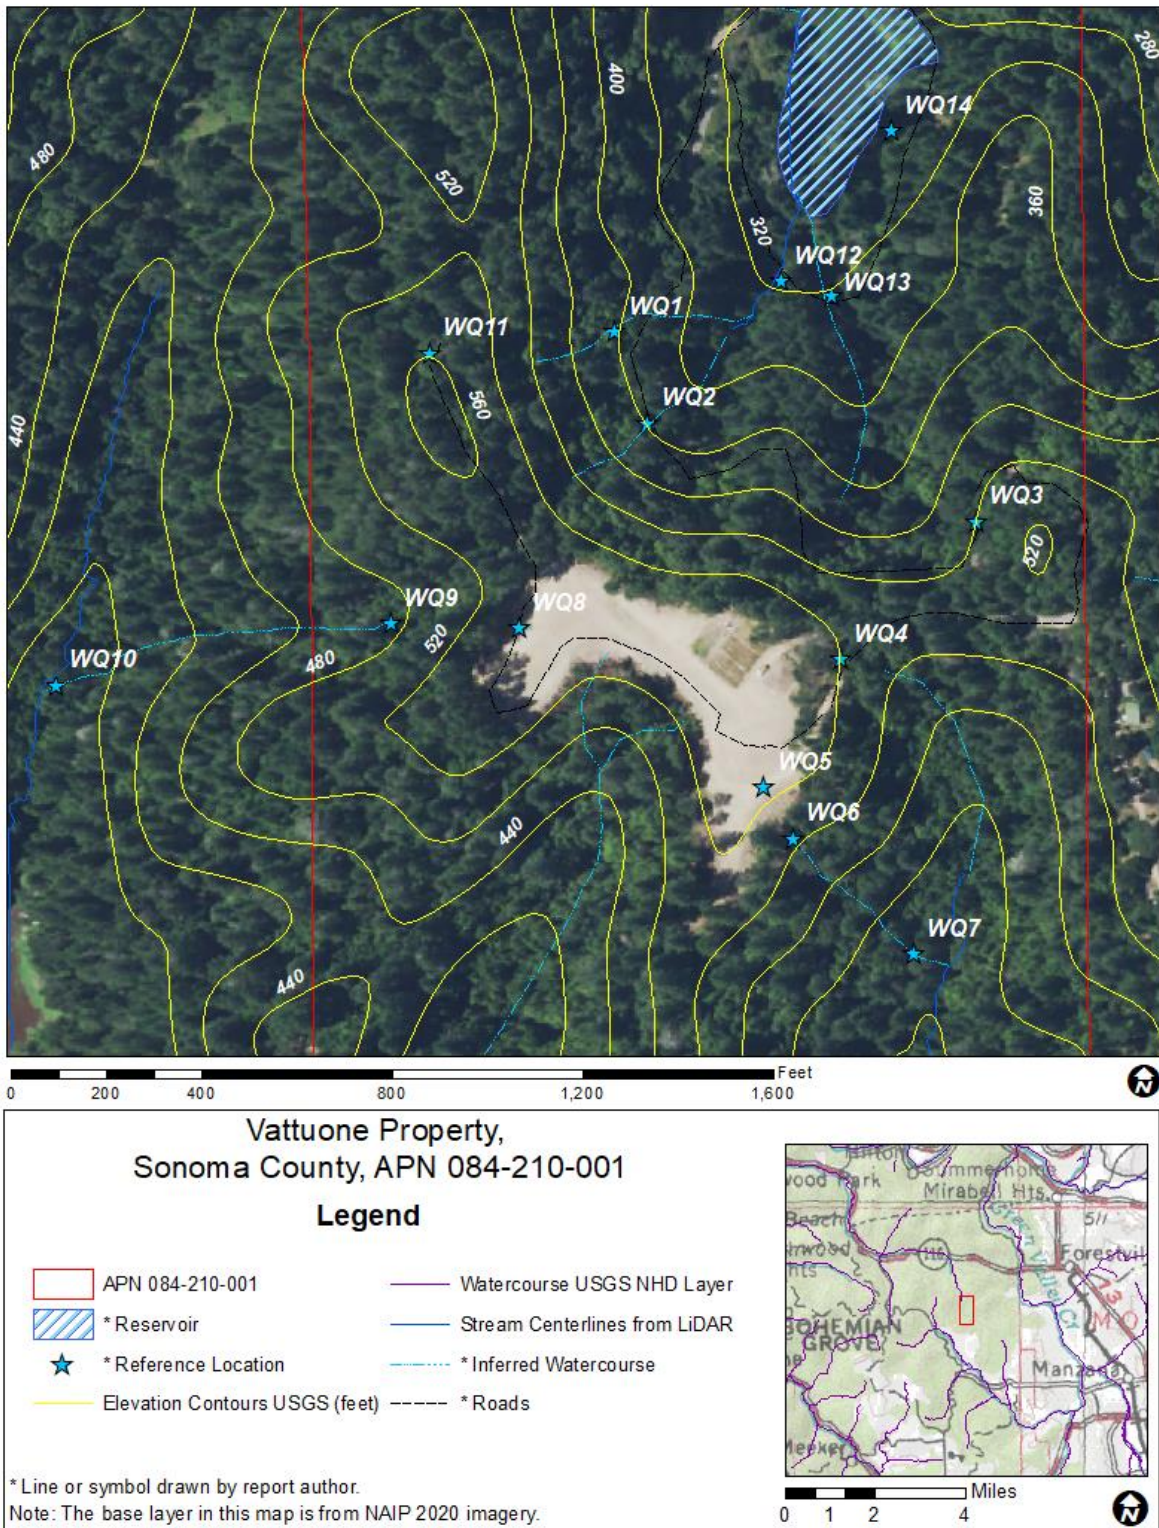
Figure 1: Map of Property, including inspection points of interest.

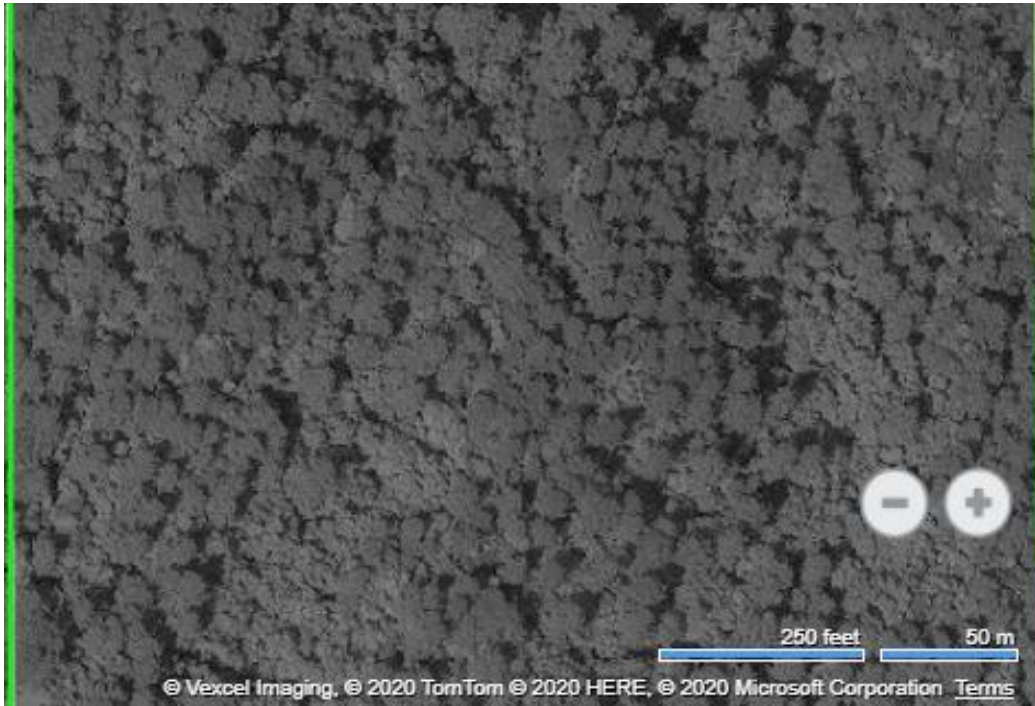
*Aerial Image 1—Shows the southern part of the property dated August 23, 2016, accessed with Digital Map Products' Land Vision service.*

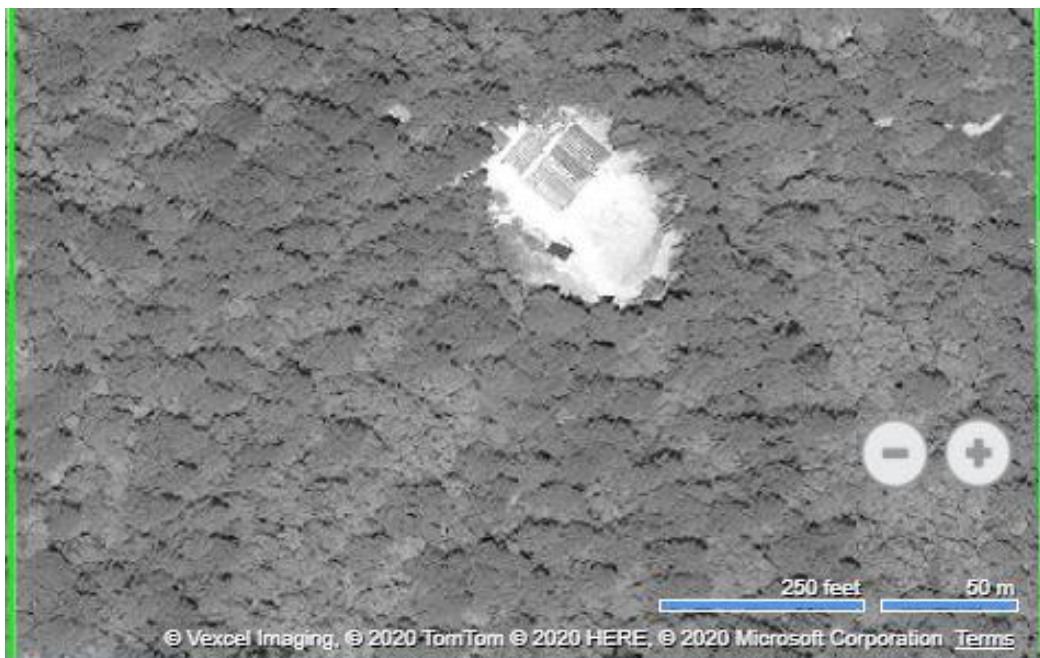
*Aerial Image 2—Shows the southern part of the property dated July 13, 2017, accessed with Digital Map Products' Land Vision service.*

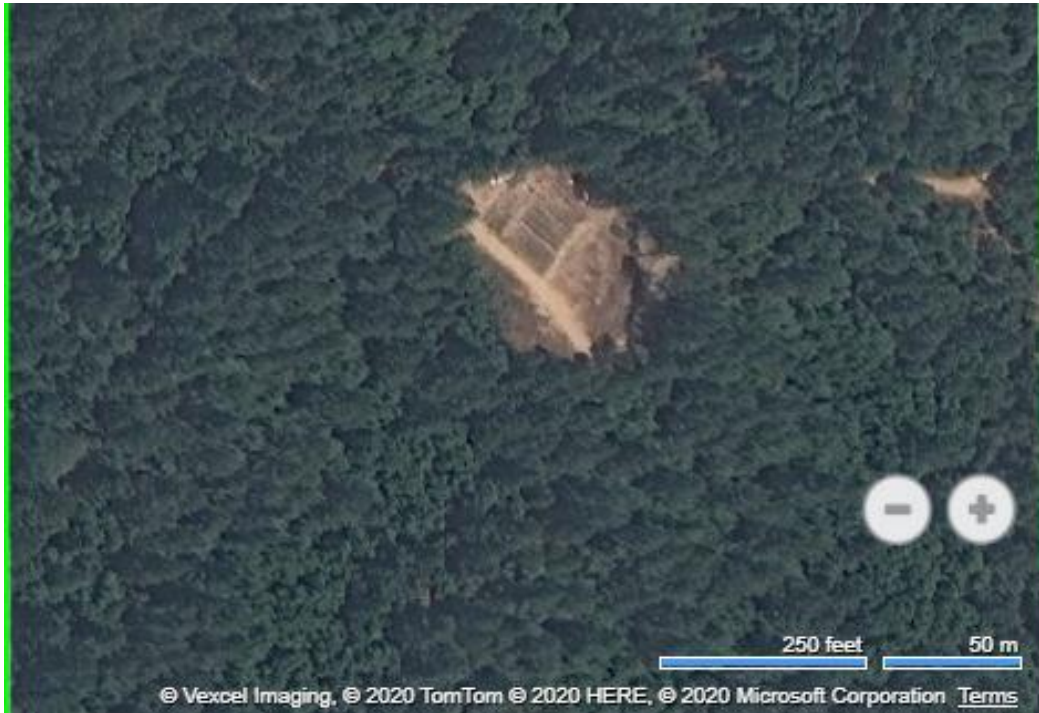
*Aerial Image 3—Shows the southern part of the property dated August 6, 2019, accessed with Digital Map Products' Land Vision service.*

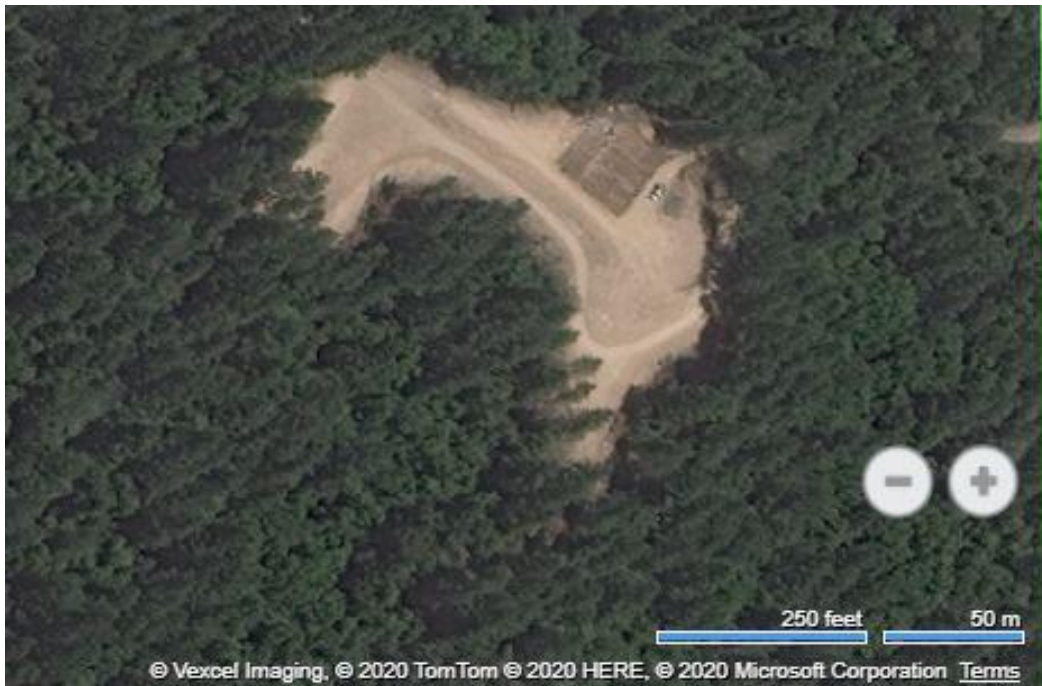
*Aerial Image 4—Shows the southern part of the property dated June 27, 2020, accessed with Digital Map Products' Land Vision service.*
