North Coast Regional Water Quality Control Board

Inspection Memorandum

Subject: Inspection Report for Interim Cleanup and Stabilization Plan (ICSP) in response to Cleanup and Abatement Order No. R1-2022-0009 for Emergency Notice 1-20EM-00125-SON

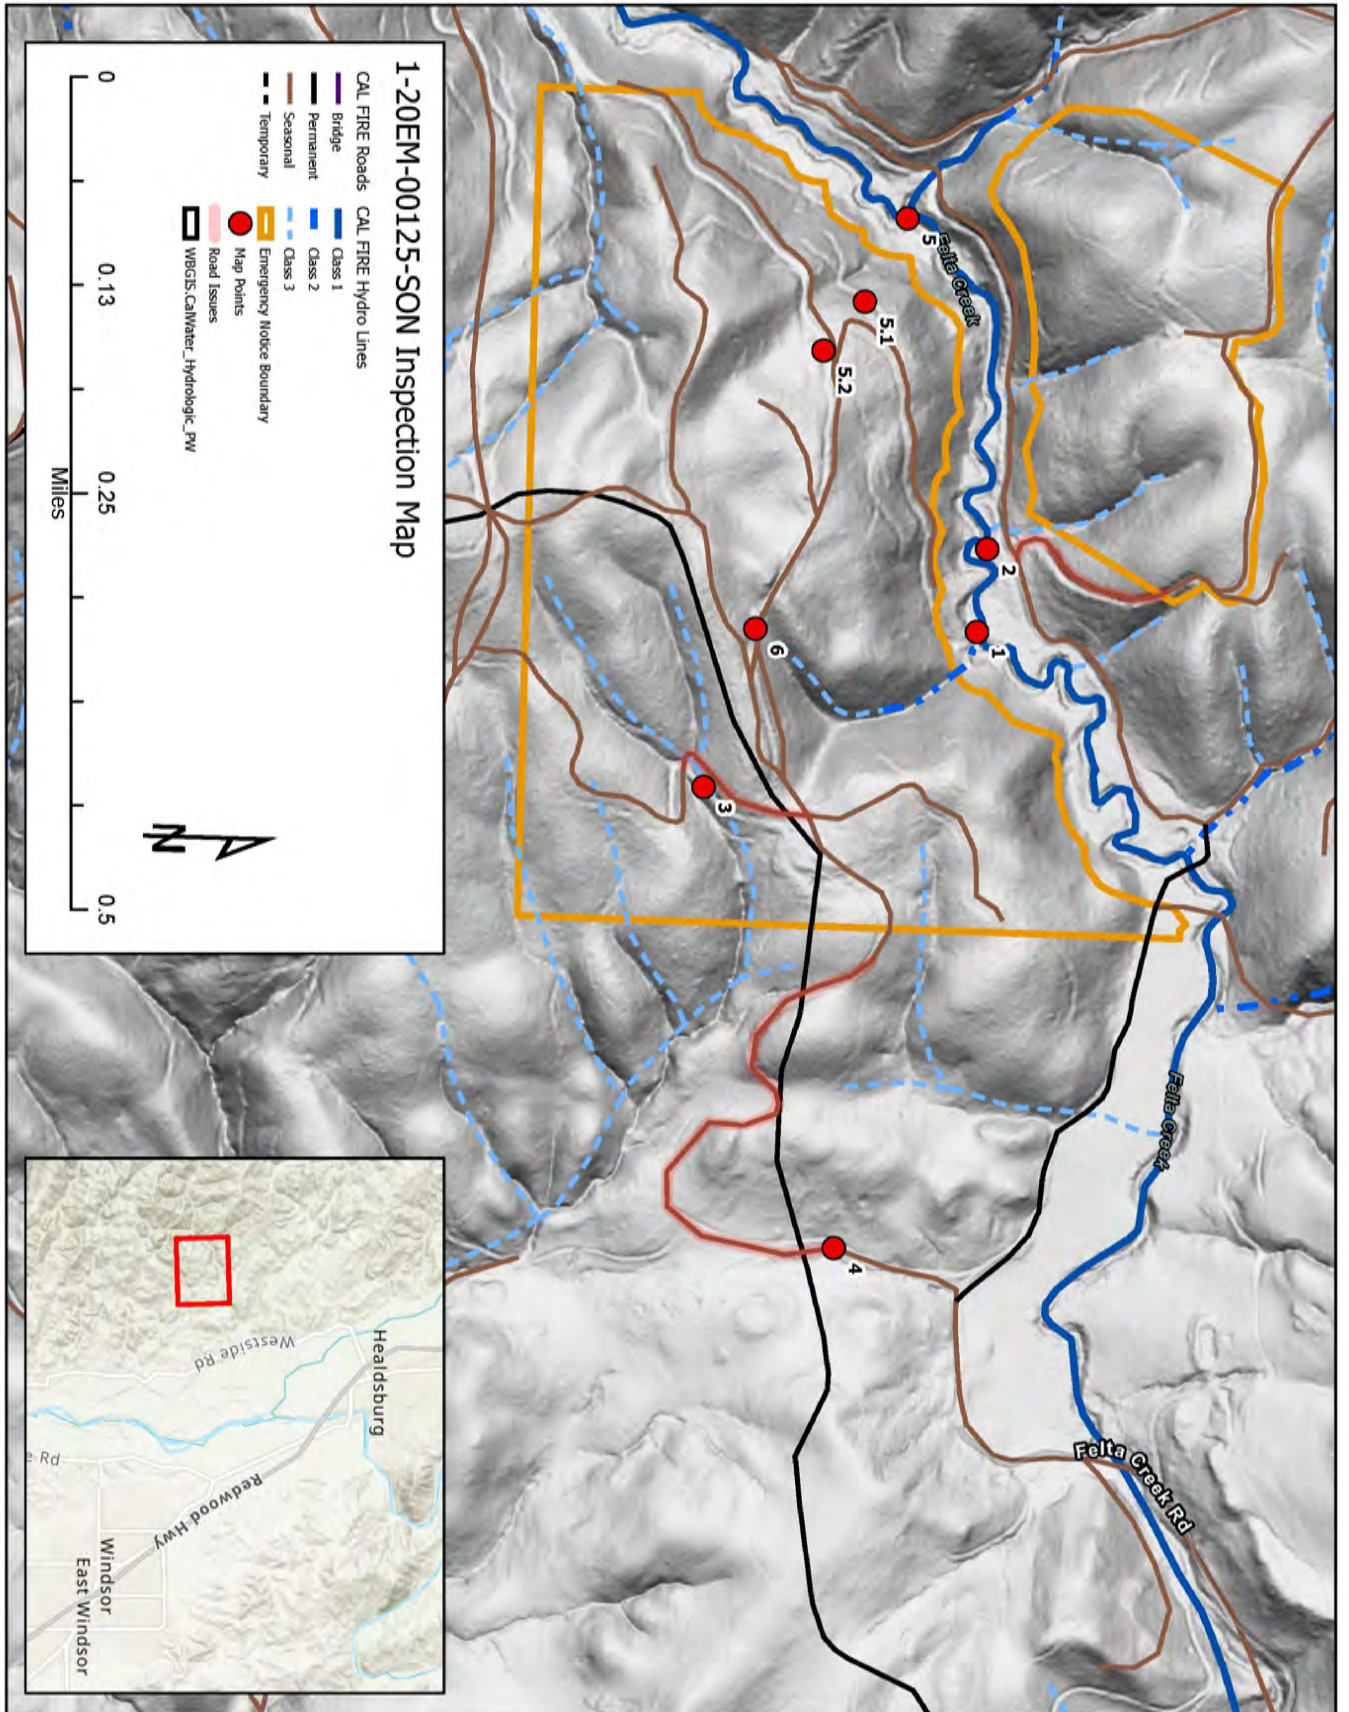
At Map Point 9, a Class III watercourse diverts down a permanent road for approximately 85 feet before exiting the road prism, causing gullying of the road surface. The watercourse then drains to Felta Creek through a breach in the outboard fill (Fig. 9).

Figure 9. Class III diversion down road delivering to Felta Creek through breach in outboard fill near ICSP Map Point
